PROJECT
Primrose Hill Studios, London

TITLE
Exploratory hole plan (current layout)

Appendix B Exploratory Hole Records

PROJECT Primrose Hill Studios, London					
TITLE Trial pit record					
METHOD OF EXCAVATION Hand tools				DATE OF WORKS 07.03.2022	
PROJECT NO. STU5616		SCALE AT A3 1:5		LOCATION REFERENCE TP01

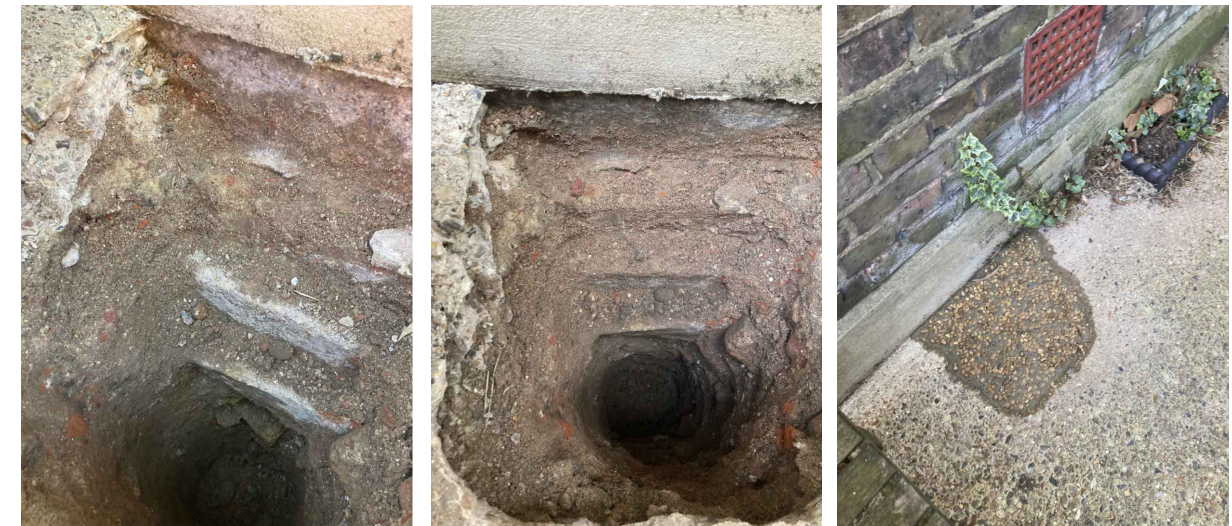
Photographic records

A. CONCRETE.
(MADE GROUND)

- B. [Medium dense] brown clayey gravelly SAND with occasional cobbles of brick. Gravel is fine to coarse angular to subrounded brick and flint.
(MADE GROUND)
- C. Firm dark brown slightly gravelly CLAY. Gravel is fine to medium angular to subangular brick, glass and coal.
(MADE GROUND)

1. Trial pit sides remained upright and stable.
2. Dimensions shown in millimetres.
3. No groundwater encountered.

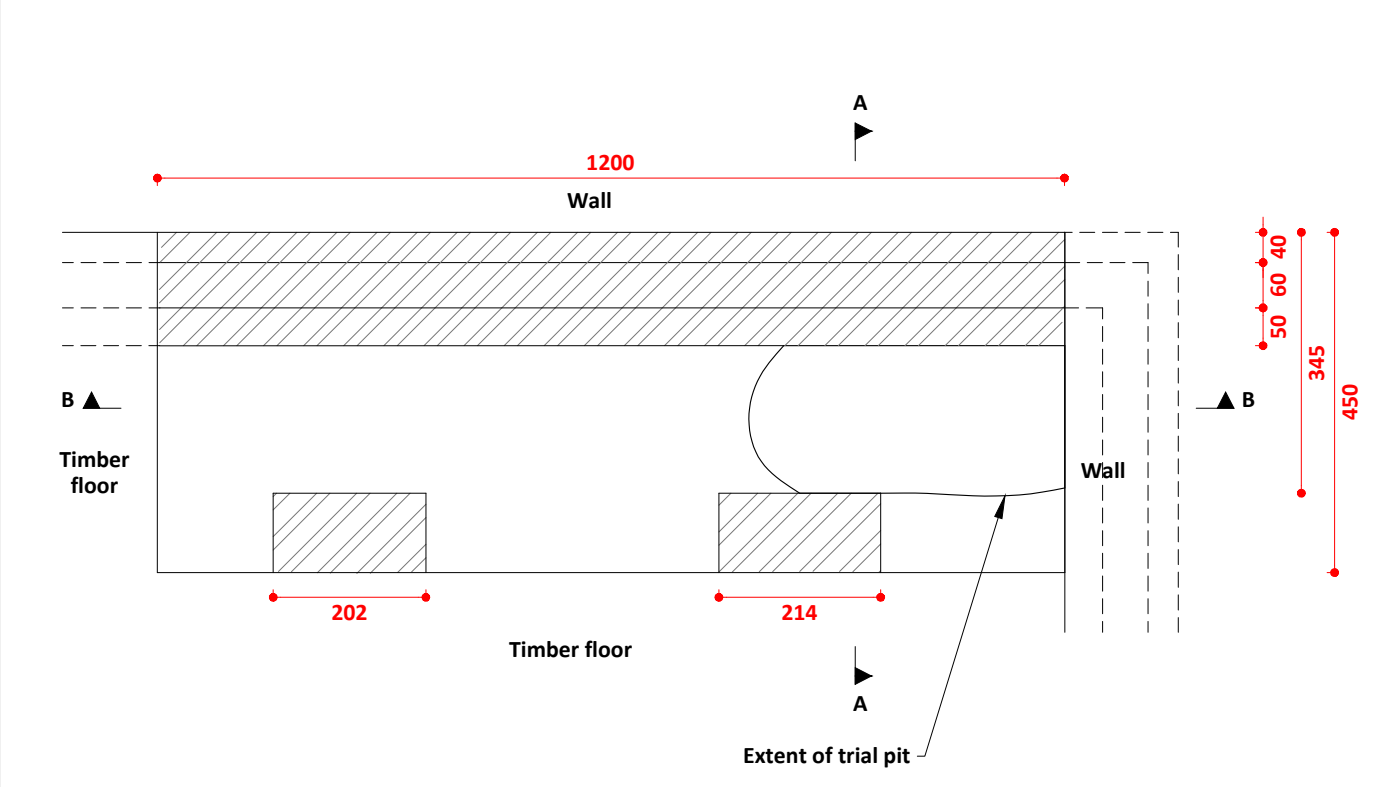
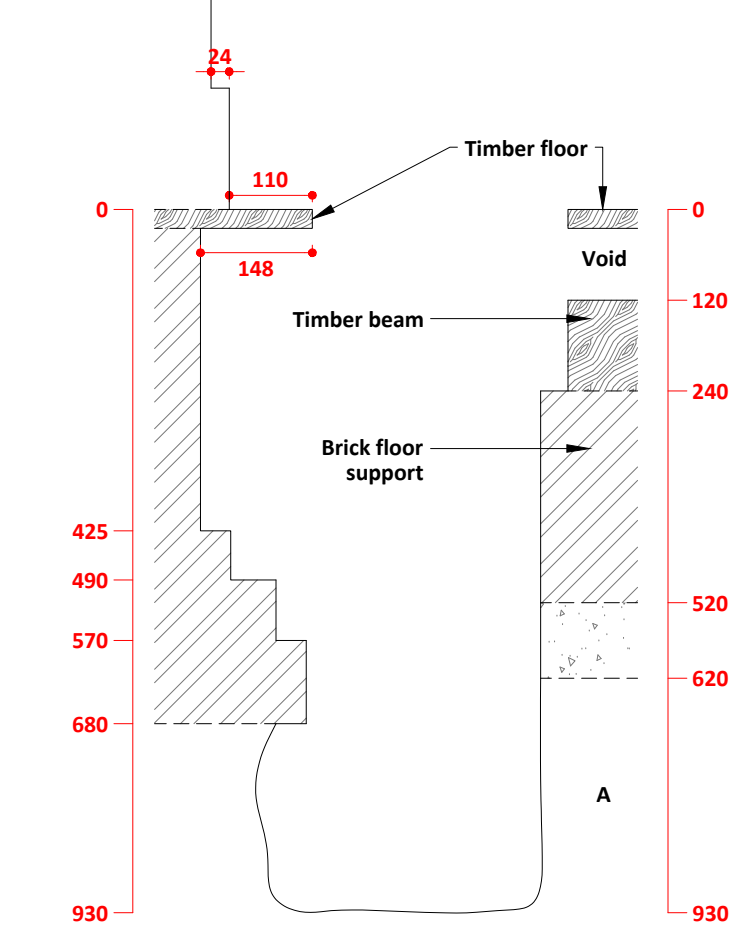
A. [Loose] brown gravelly SAND with occasional cobbles of brick. Gravel is fine to medium angular to subangular brick. (MADE GROUND)

- Trial pit sides remained upright and stable.
- Dimensions shown in millimetres.
- No groundwater encountered.

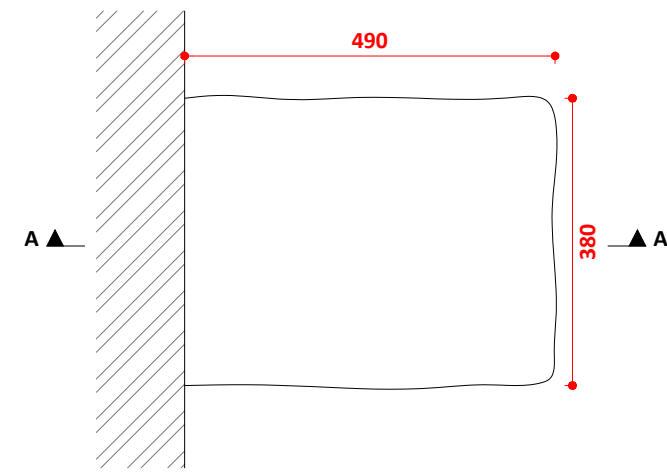
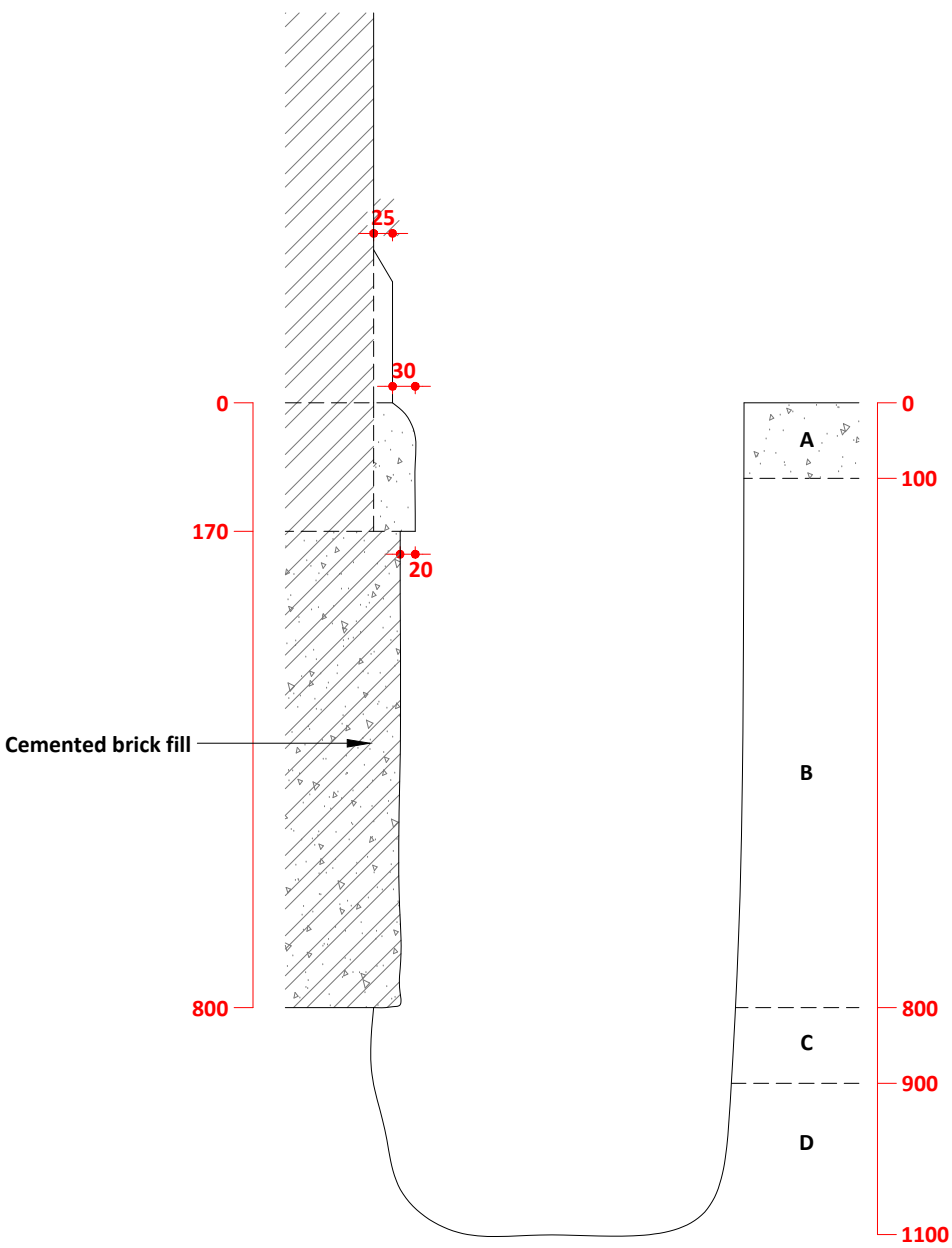
- A. CONCRETE.
(MADE GROUND)
- B. [Loose] brown slightly gravelly SAND with frequent cobbles of brick. Gravel is fine to coarse angular to subangular brick, concrete and flint.
(MADE GROUND)
- C. Firm grey mottled orangish brown slightly gravelly slightly sandy CLAY. Gravel is fine to medium angular to subangular brick.
(MADE GROUND)
- D. Firm grey mottled orangish brown CLAY with occasional organic fragments.
(LONDON CLAY FORMATION)

- Trial pit sides remained upright and stable.
- Dimensions shown in millimetres.
- No groundwater encountered.

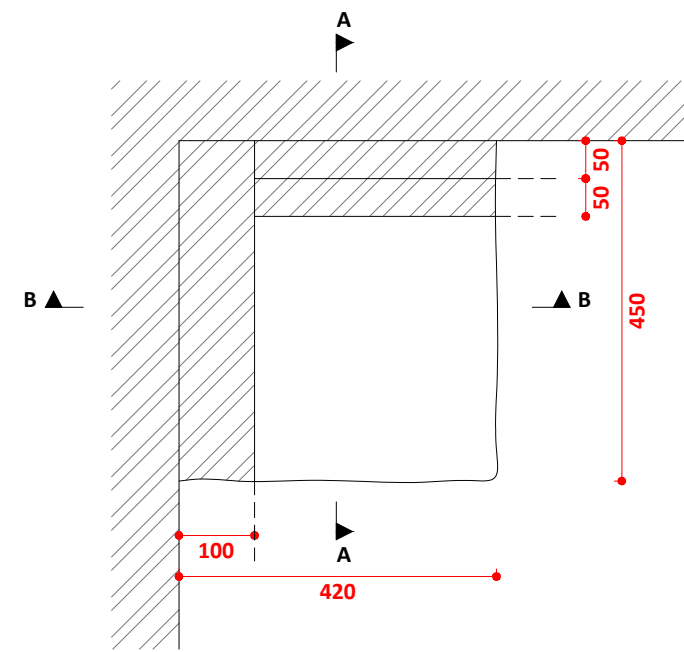
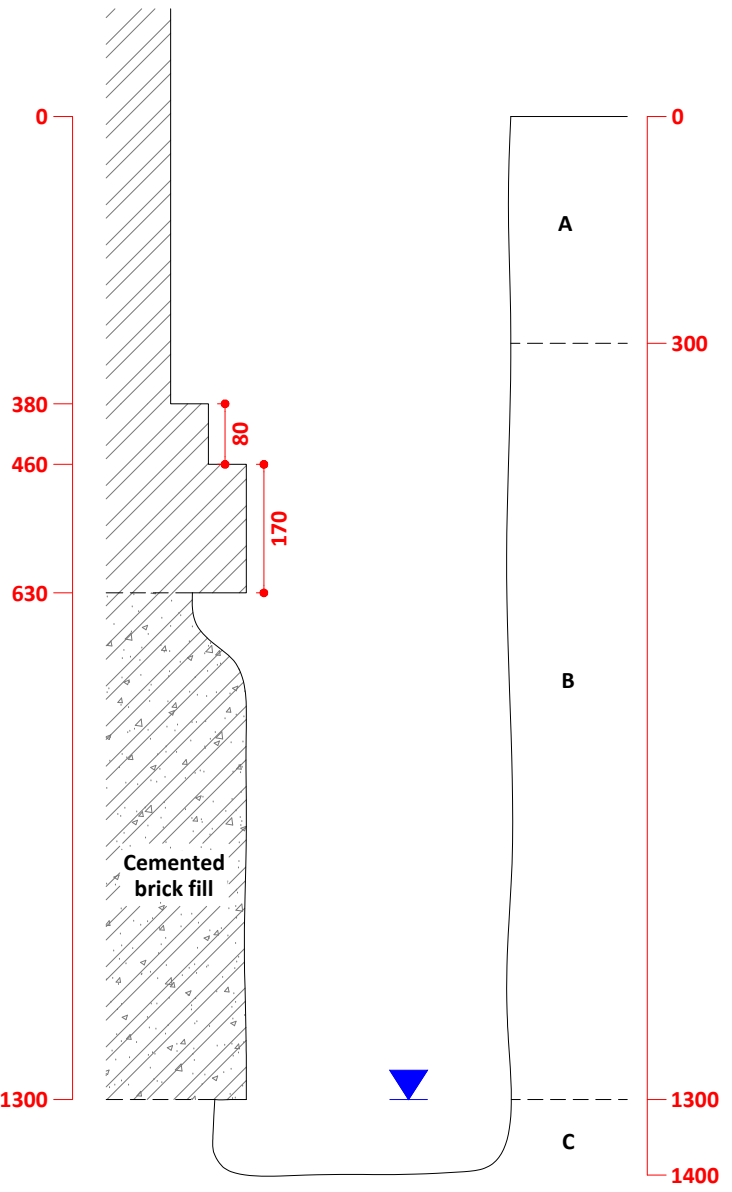
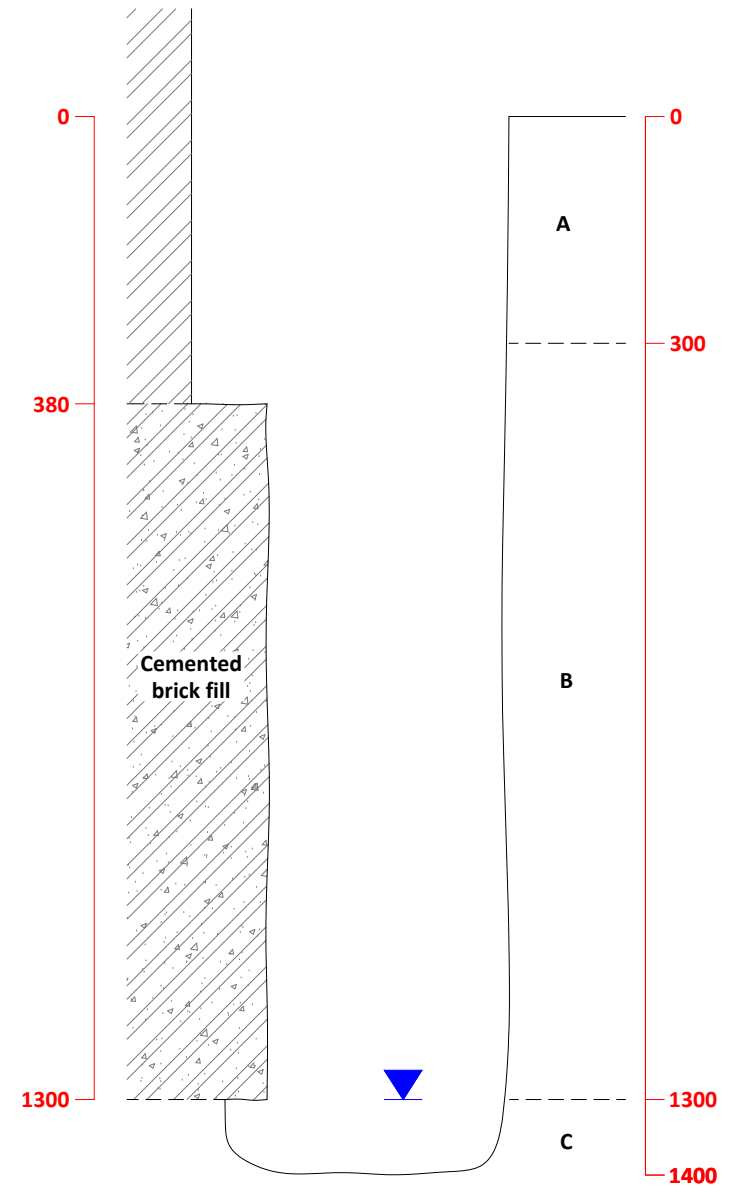
- Key**
- A. Reinforced CONCRETE. 6mm plain reinforcement bar located at 150mm depth. (MADE GROUND)
 - B. [Dense] brown very gravelly slightly clayey SAND with frequent cobbles of brick. Gravel is fine to coarse angular to subangular brick and concrete. (MADE GROUND)
 - C. Firm brown slightly gravelly slightly sandy CLAY. Gravel is fine to medium angular brick. Becoming soft at 1.3m depth as water present. (MADE GROUND)

- Notes**
- 1. Trial pit sides remained upright and stable.
 - 2. Dimensions shown in millimetres.
 - 3. Groundwater encountered at 1.3m depth, water level remained constant at 1.3m depth on completion. Slow seepage observed.

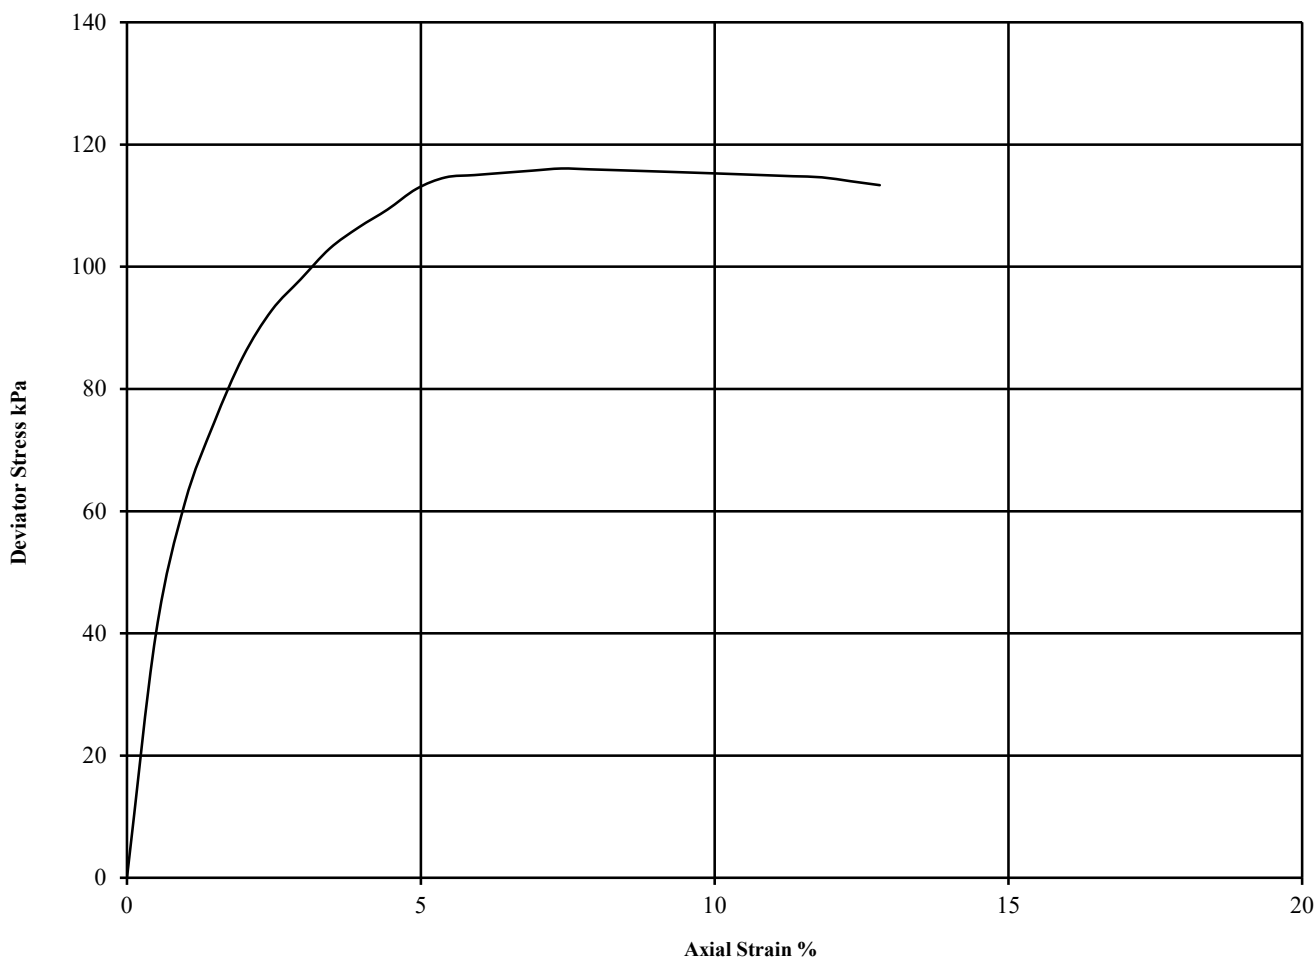
UNDRAINED SHEAR STRENGTH IN TRIAXIAL COMPRESSION

Diameter (mm):		102	Height (mm):		207	Test:	UU Single Stage		Remarks:
Specimen	Moisture Content (%)	Bulk Density (Mg/m3)	Dry Density (Mg/m3)	Cell Pressure (kPa)	Corr. Max. Deviator Stress (kPa)	Shear Strength Cu (kPa)	Failure Strain (%)	Mode of Failure	Undisturbed Sample Sample taken from top of tube Rate of strain = 2 %/min Latex Membrane used 0.2 mm thick, Correction applied 0.36 See summary of soil descriptions
				θ_3	$(\theta_1 - \theta_3)_f$	$\frac{1}{2}(\theta_1 - \theta_3)_f$			
1	32	1.91	1.44	40	116	58	7.4	Plastic

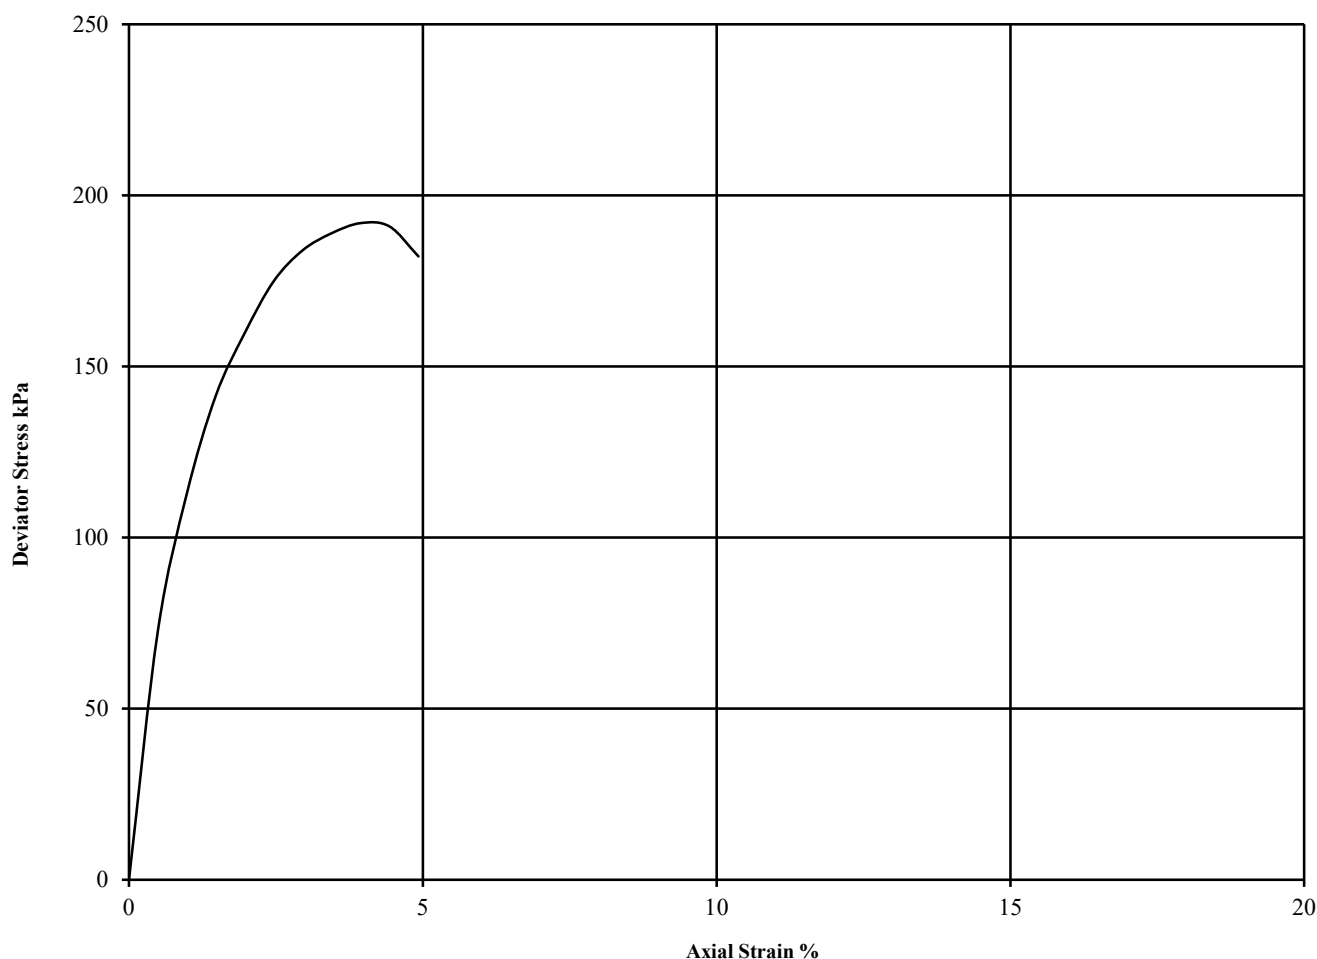
UNDRAINED SHEAR STRENGTH IN TRIAXIAL COMPRESSION

Diameter (mm):		102	Height (mm):		207	Test:	UU Single Stage		Remarks:
Specimen	Moisture Content (%)	Bulk Density (Mg/m ³)	Dry Density (Mg/m ³)	Cell Pressure (kPa)	Corr. Max. Deviator Stress (kPa)	Shear Strength Cu (kPa)	Failure Strain (%)	Mode of Failure	Undisturbed Sample Sample taken from top of tube Rate of strain = 2 %/min Latex Membrane used 0.2 mm thick, Correction applied 0.37 See summary of soil descriptions
				θ_3	$(\theta_1 - \theta_3)_f$	$\frac{1}{2}(\theta_1 - \theta_3)_f$			
1	32	1.89	1.43	100	192	96	3.9	Brittle

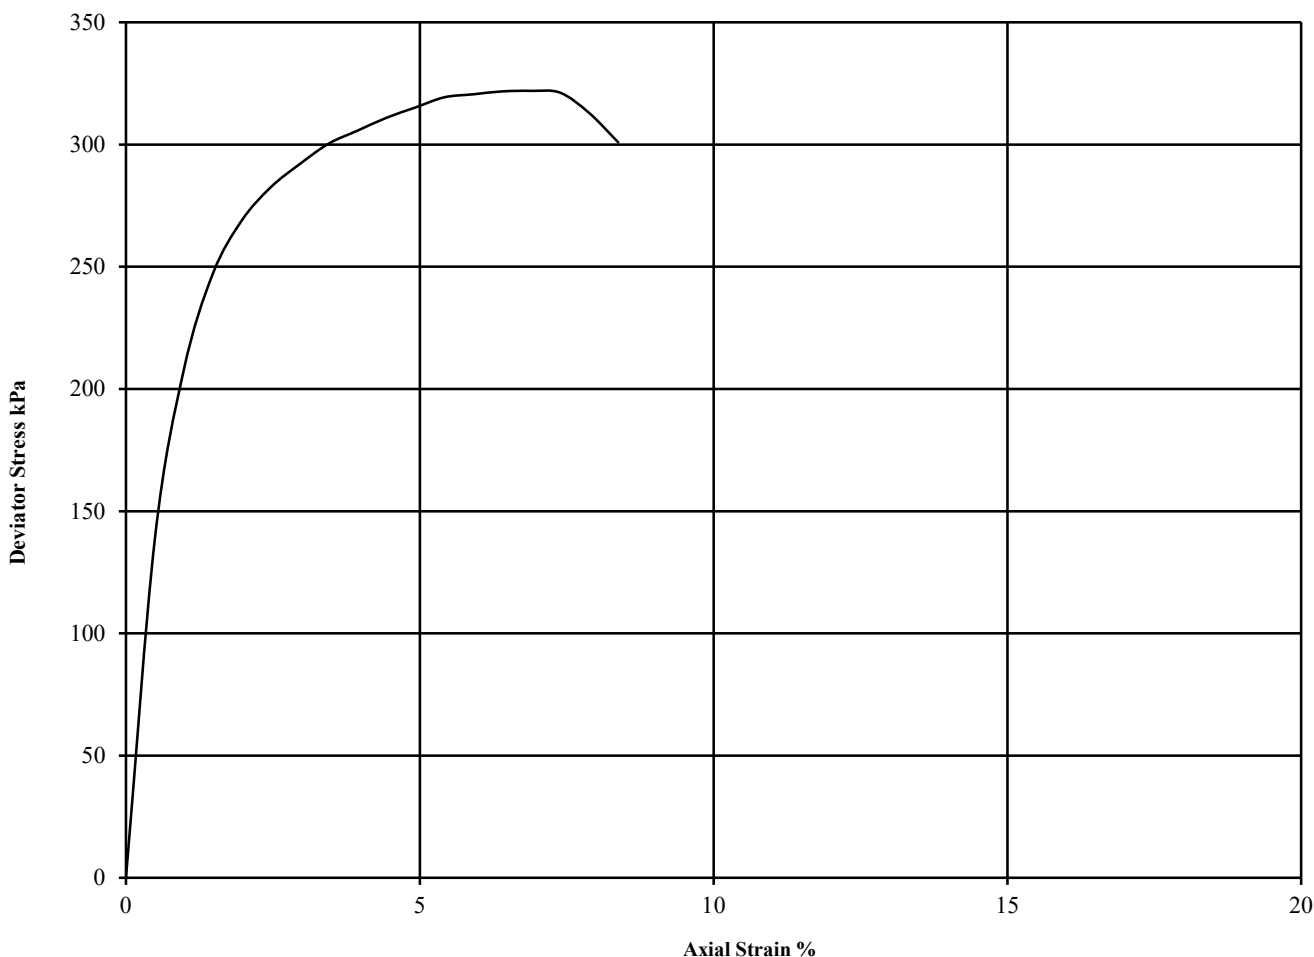
UNDRAINED SHEAR STRENGTH IN TRIAXIAL COMPRESSION

Diameter (mm):		102	Height (mm):		207	Test:	UU Single Stage		Remarks:
Specimen	Moisture Content (%)	Bulk Density (Mg/m3)	Dry Density (Mg/m3)	Cell Pressure (kPa)	Corr. Max. Deviator Stress (kPa)	Shear Strength Cu (kPa)	Failure Strain (%)	Mode of Failure	Undisturbed Sample Sample taken from top of tube Rate of strain = 2 %/min Latex Membrane used 0.2 mm thick, Correction applied 0.36 See summary of soil descriptions
				θ_3	$(\theta_1 - \theta_3)_f$	$\frac{1}{2}(\theta_1 - \theta_3)_f$			
1	29	1.94	1.51	180	322	161	6.9	Brittle

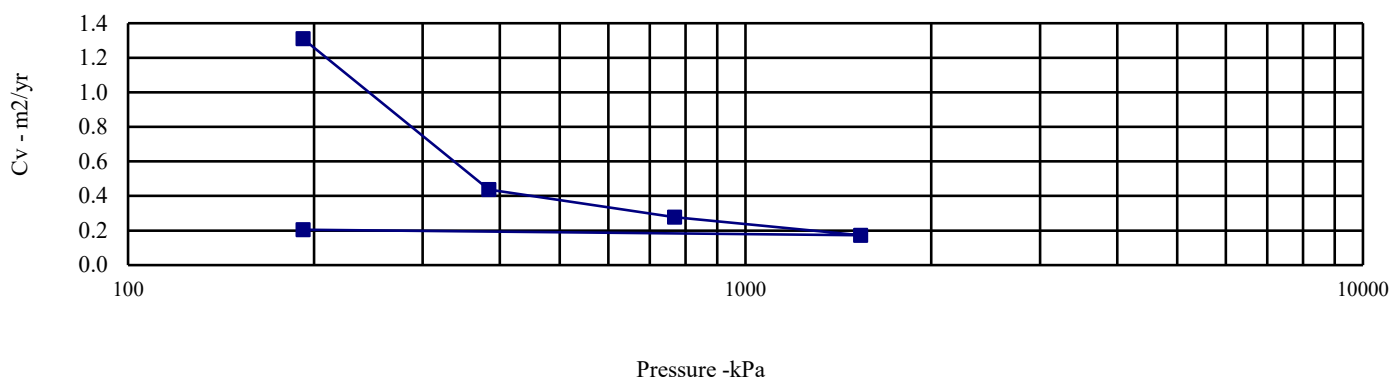
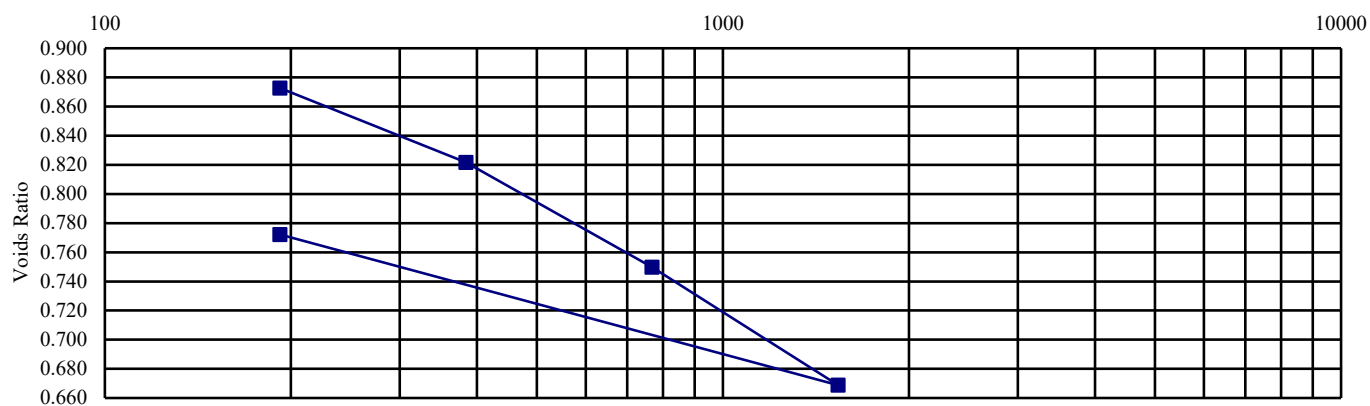
ONE DIMENSIONAL CONSOLIDATION TEST

Initial Conditions		Pressure Range		Mv	Cv	Specimen location	
Moisture Content (%):	32	kPa		m2/MN	m2/yr	within tube:	Top
Bulk Density (Mg/m3):	1.85	96	192	0.144	1.310	Method used to	
Dry Density (Mg/m3):	1.40	192	384	0.142	0.437	determine CV:	T90
Voids Ratio:	0.899	384	768	0.103	0.277	Nominal temperature	
Degree of saturation:	95.5	768	1536	0.060	0.173	during test ' C:	20
Height (mm):	20.108	1536	192	0.046	0.205	Remarks:	
Diameter (mm)	75.058					Swelling Pressure = 96 kPa	
Particle Density (Mg/m3):	2.65						
Assumed
