Job Information	
Client	Crawford & Co
Client ref	
Visit date	27/01/2023
Report date	13/02/2023

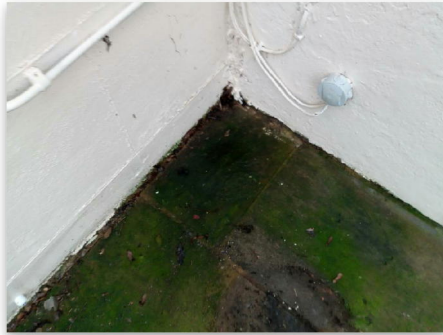
Fig 1.1: Trial Hole 1 Location

Findings	
Trial Hole Findings	<p>Within Trial hole 1 we revealed the footing but were unable to auger to the required depth (3m) in the proposed location due to hard soil (2.3m). We only took took soil samples down to 2m due to hard soil coupled with water suction, this meant we were unable to lift soil samples out anymore. These measurements are shown in Trial hole log 1 below. We were unable to collect root samples from TH1 because no roots were present during the trial hole, hence no samples were retrieved.</p> <p>In TH1, water was encountered at 0.9m</p> <p>Within TH1, we also took footing measurements from the Rear balcony extension. These measurements are shown in Trial Hole Log 1b below.</p> <p>Within Trial hole 2 we revealed the footing and augured to the required depth (3m) in the proposed location. We took the requested soil and root samples. These measurements are shown in Trial hole log 2 below.</p> <p>The base of the footing was determined by probing to a depth below 1m and therefore the exact profiles/depth cannot be guaranteed.</p>

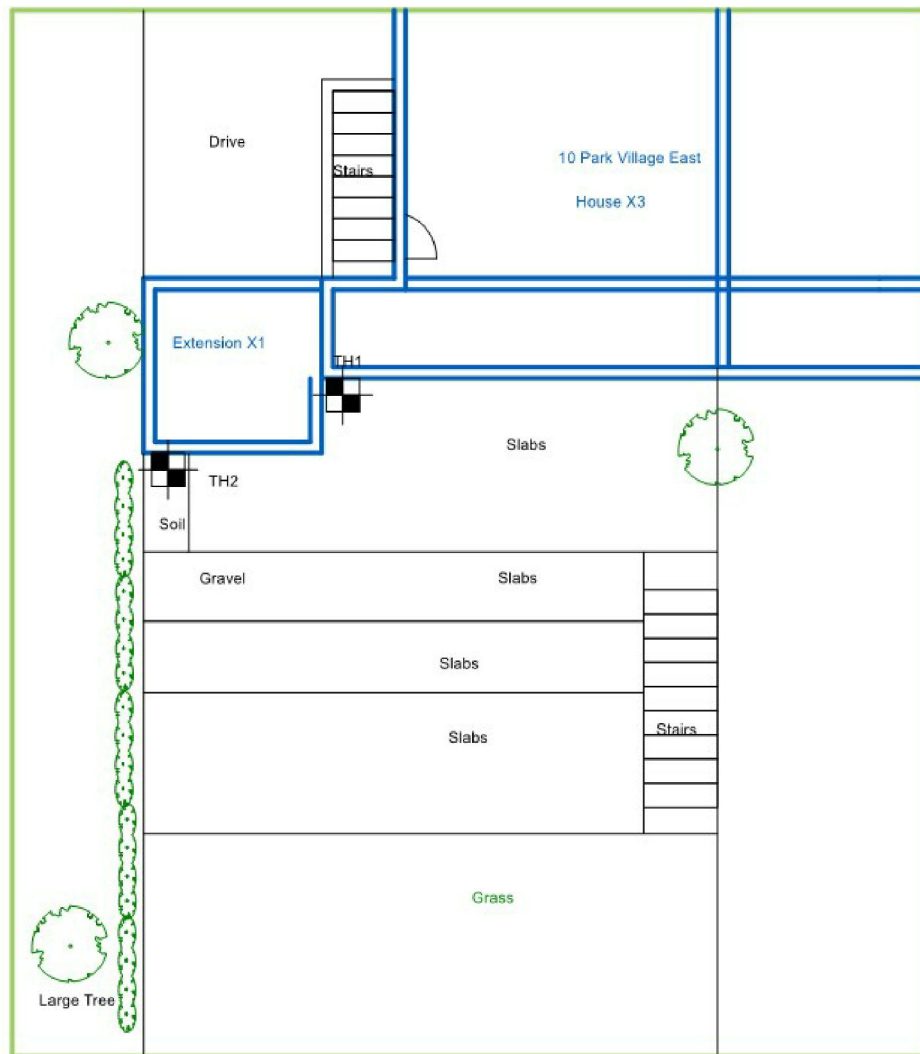
Existing Layout

FRONT OF PROPERTY

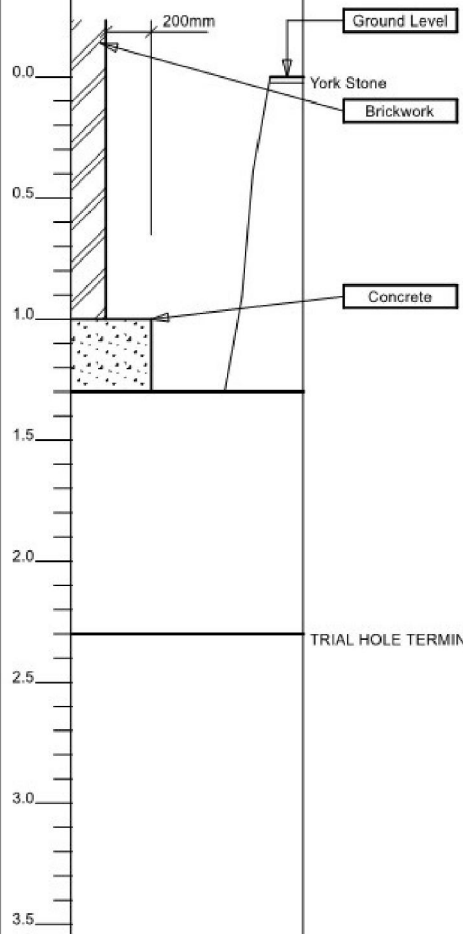
Trial Hole Log No.1b

Location: Rear Balcony Extension

Ground Level				
0.5		York Stone				
1.0		Brickwork				
1.5		Concrete				
2.0						
2.5		TRIAL HOLE TERMINATED				
3.0						
3.5

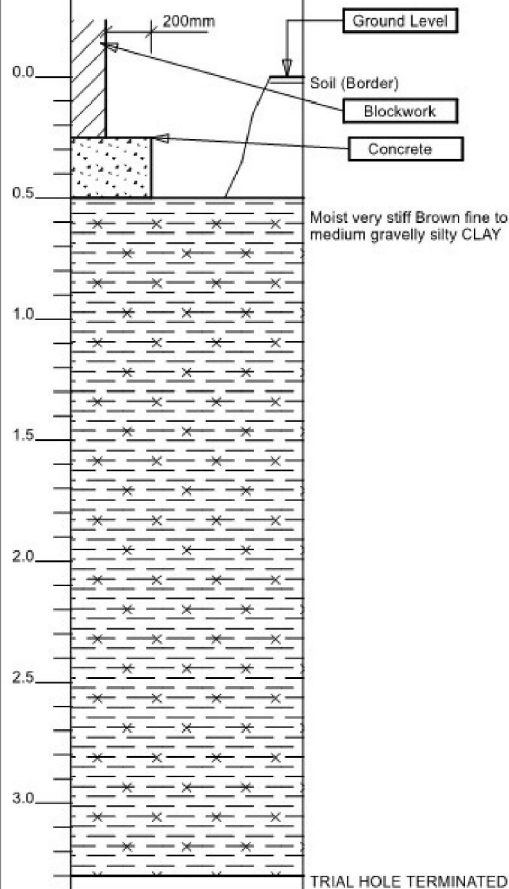
Trial Hole Log No.2

Location: Rear right corner

0.5		Moist very stiff Brown fine to medium gravelly silty CLAY	76kpa		Soil @ 0.5m	Root @ 0.5m
1.0			86kpa		Soil @ 1m	
1.5			94kpa		Soil @ 1.5m	
2.0			140kpa		Soil @ 2m	
2.5			140kpa		Soil @ 2.5m	
3.0			140kpa		Soil @ 3m	
3.5		TRIAL HOLE TERMINATED	140kpa

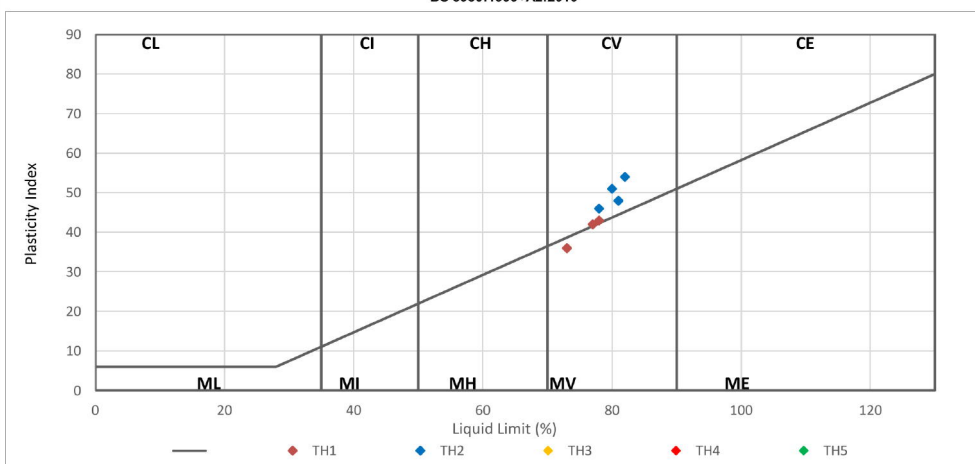
PLASTICITY CHART FOR CASAGRANDE CLASSIFICATION
BS 5930:1999+A2:2010

Modified Plasticity Index (PI) <10 : Non Classified
 Modified PI = 10 to <20 : Low volume change potential (LOW VCP)
 Modified PI = 20 to <40 : Medium volume change potential (Med VCP)
 Modified PI = 40 or greater : High volume change potential (HIGH VCP)
