Flat 3, 101 Greencroft : London, NW6 3PG

PLANNING

250 : Front Elevation E&P

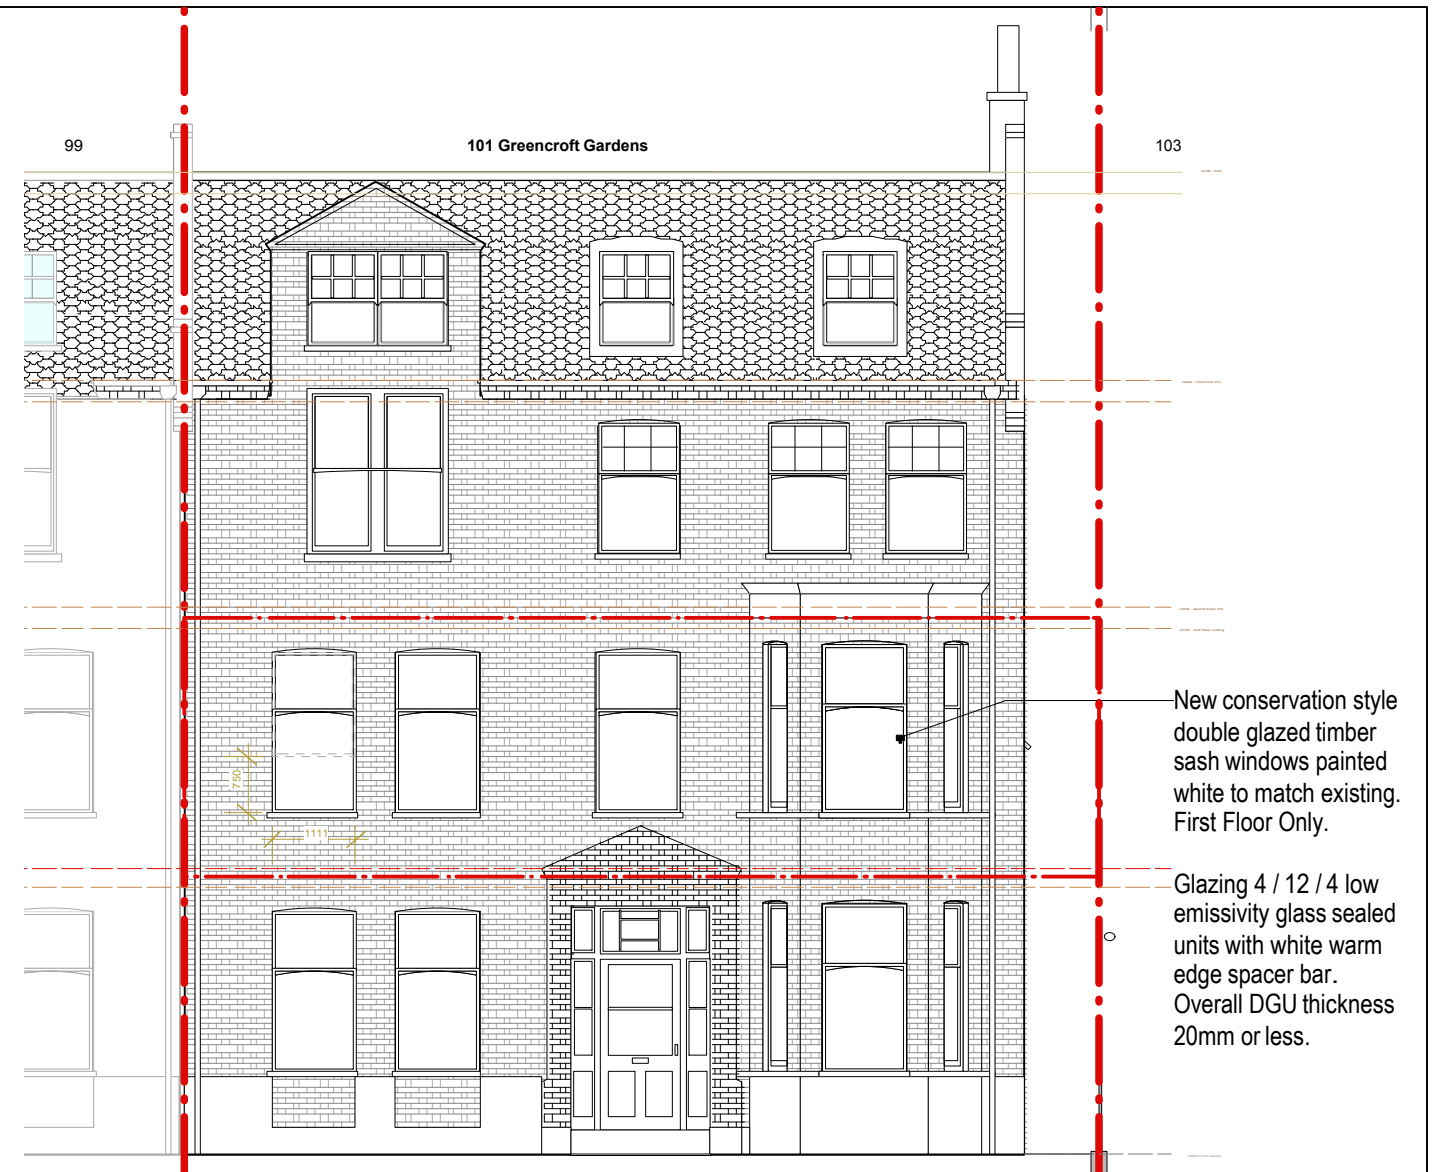
2 Proposed Front Elevation  
Scale: 1:100

Rotten timber framed sash windows at first floor with cracked single glazing to be replaced with new timber frame sash windows with double glazing frames to match existing.
