## PMF58 – SAMPLE/BENCHMARK/MOCK UP ISSUE SHEET

### 18, 21 & 22 Southampton Place & 46 Bloomsbury Square

Job Number: 23026

Date of issue: 03/04/2023

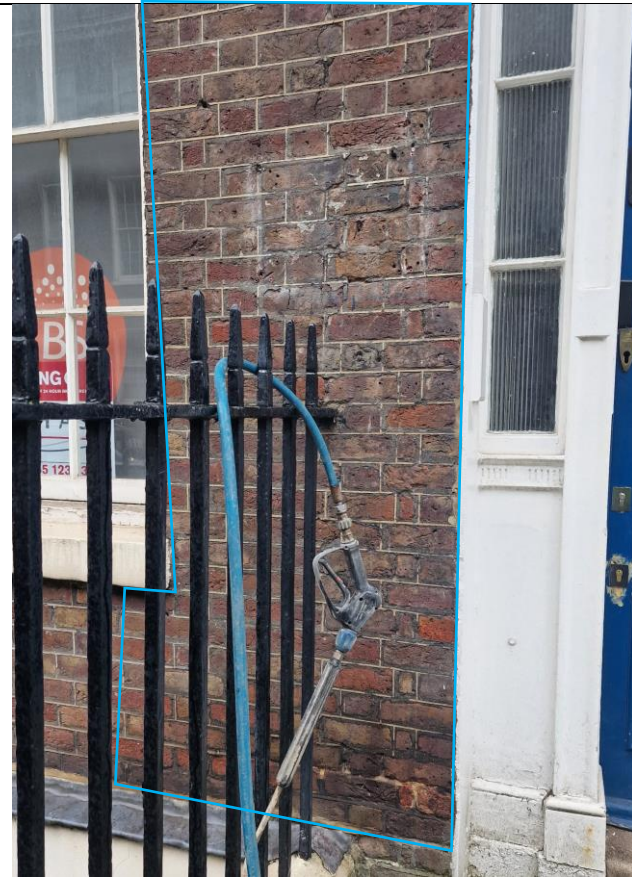
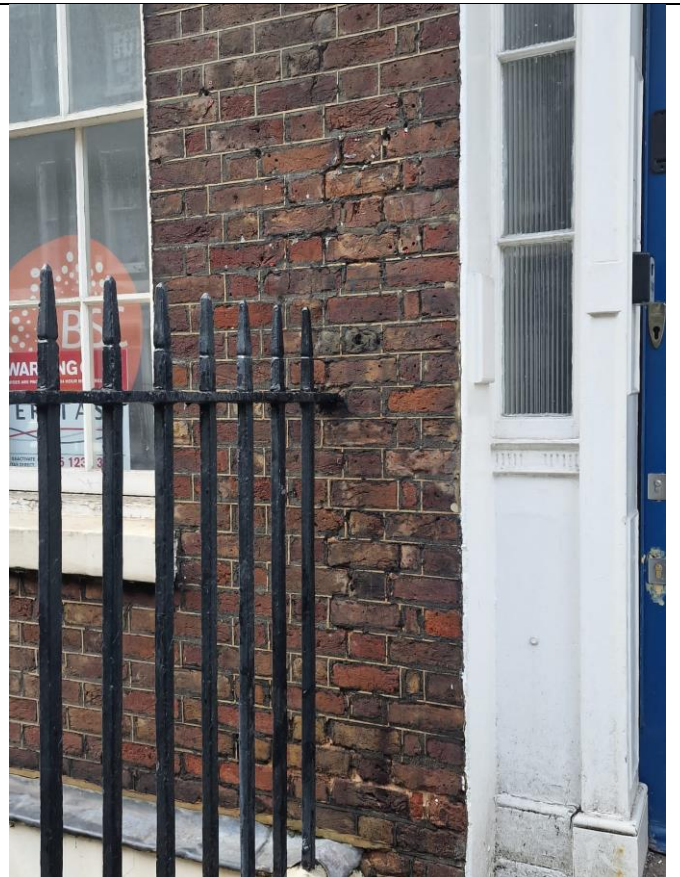
## 18 Southampton Place – Cleaning Sample (Pressurised Steam Clean)

The area highlighted in Blue highlights the cleaning sample location.

The brickwork has been refreshed, with light surface soiling / dust having successfully been removed. Although, no huge difference in visual appearance.

Remnants of some tack / glue / dust / paint residue removed from old sign location.

Some defective mortar joints washed / blown out.

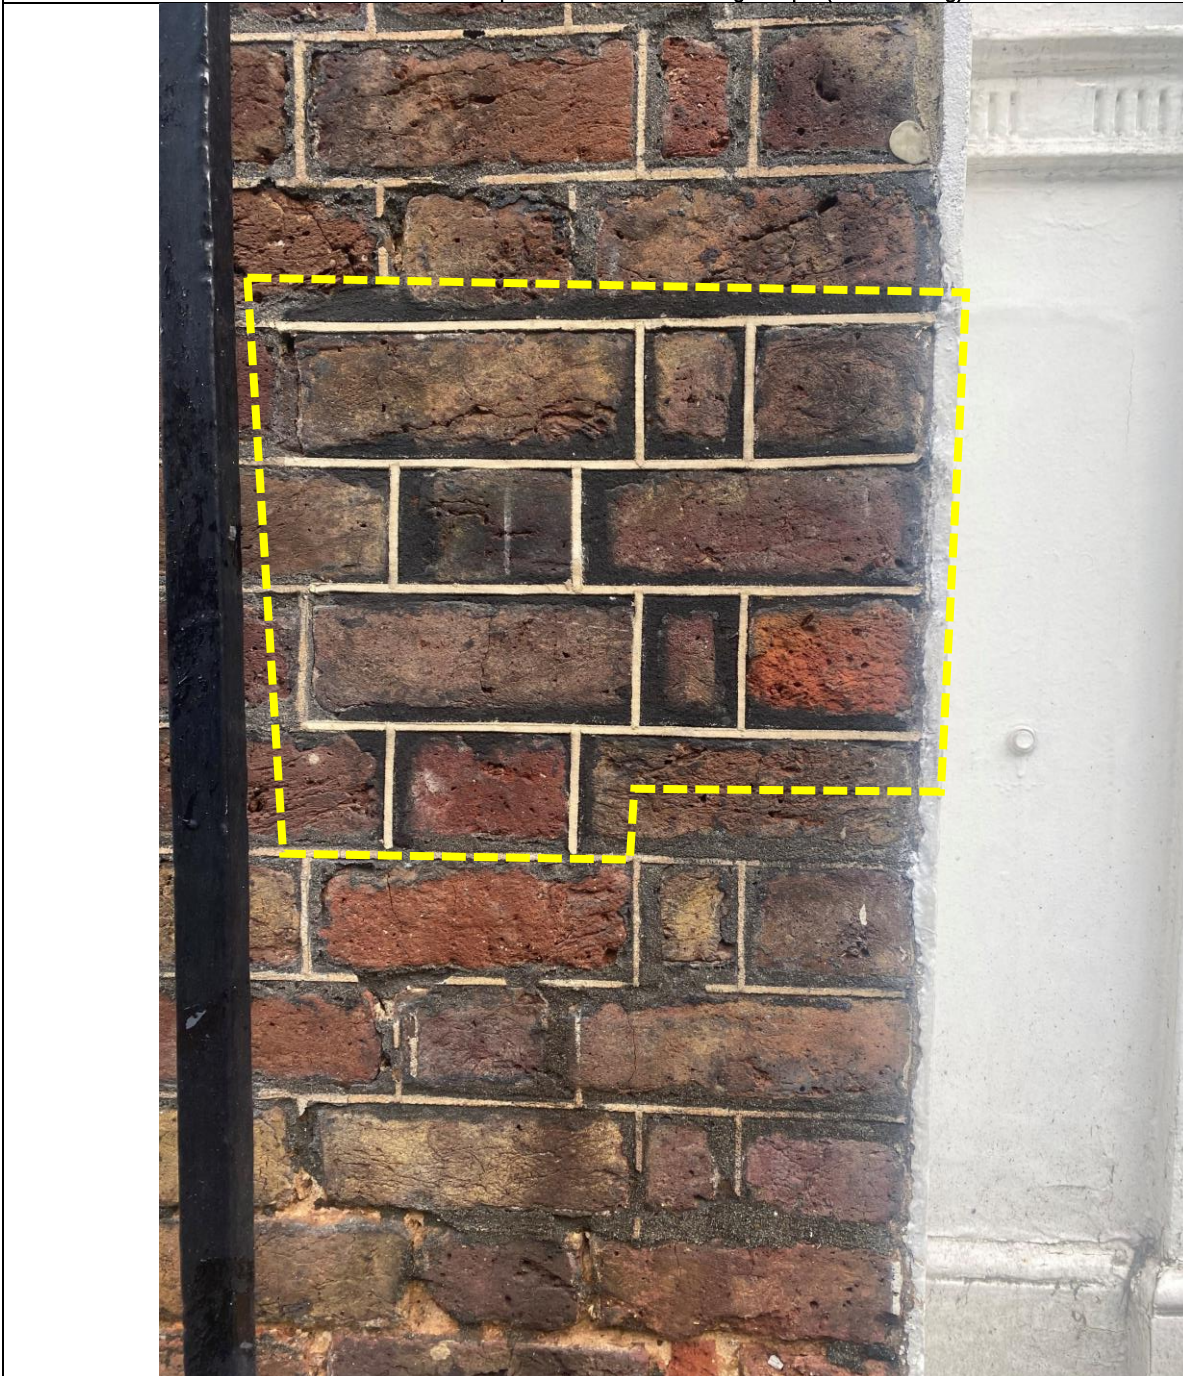
18 Southampton Place – Brick Pointing Sample (Tuck Pointing)

Black coloured, lime (NHL 3.5) and well graded sand 'stopping' mortar installed, with white lime putty ribbon installed on top, to emulate the style of the surrounding historic tuck pointing.

The brilliant white lime putty has been slightly toned down in a so as to marry in with the adjacent historic tuck pointing.

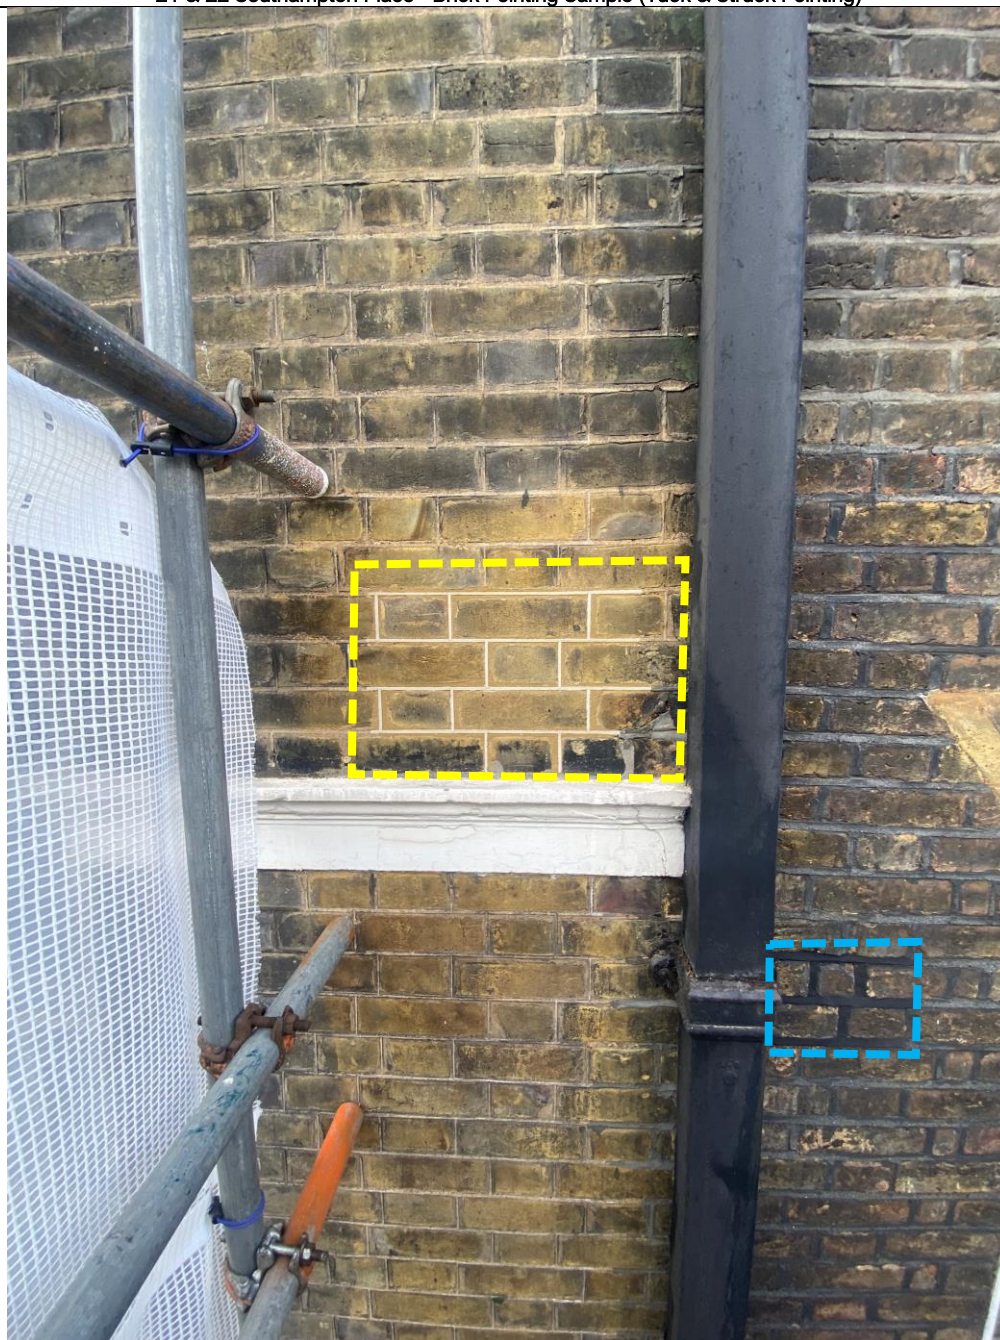
21 &amp; 22 Southampton Place - Brick Pointing Sample (Tuck &amp; Struck Pointing)

No. 21 SP: Yellow coloured, lime (NHL 3.5) and well graded sand 'stopping' mortar installed, with white lime putty ribbon installed on top, to emulate the style of the surrounding historic tuck pointing.

The brilliant white lime putty has been slightly toned down.

No. 22 SP: Black coloured, lime (NHL 3.5) and well graded sand mortar installed, in a struck style to emulate the adjacent historic pointing.

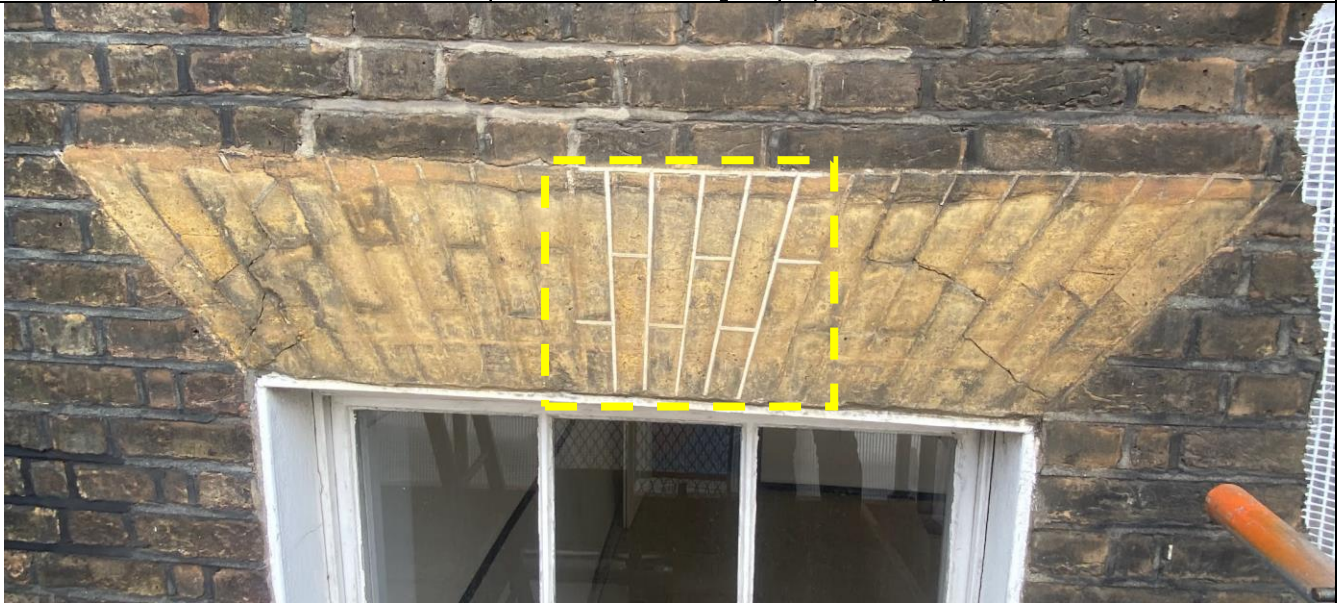
22 Southampton Place - Brick Pointing Sample (Tuck Pointing)

No. 22 SP: White lime putty ribbon installed on top, to emulate the style of the surrounding remnants of historic tuck pointing. Please note no stopping mortar has been installed, as the mortar to the arch in this location was sound.

The brilliant white lime putty has been slightly toned down.

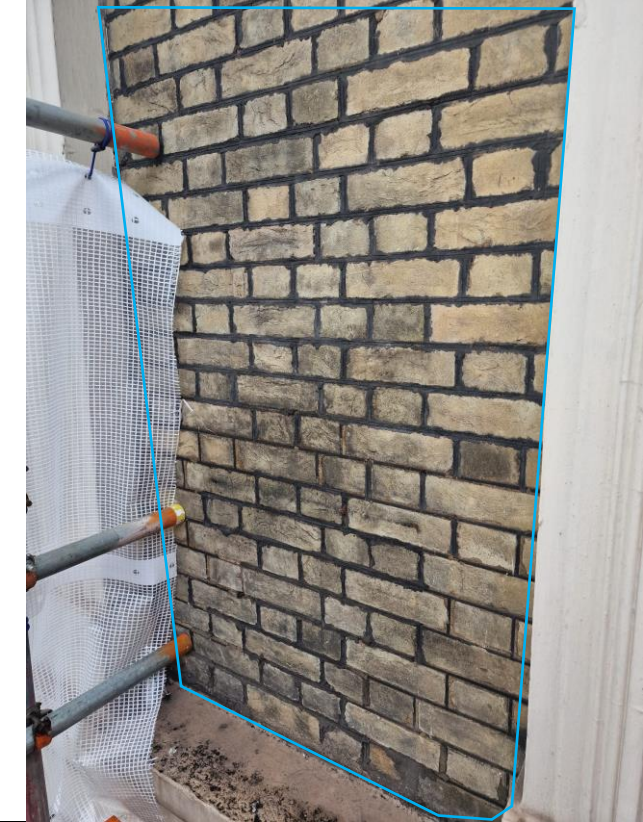
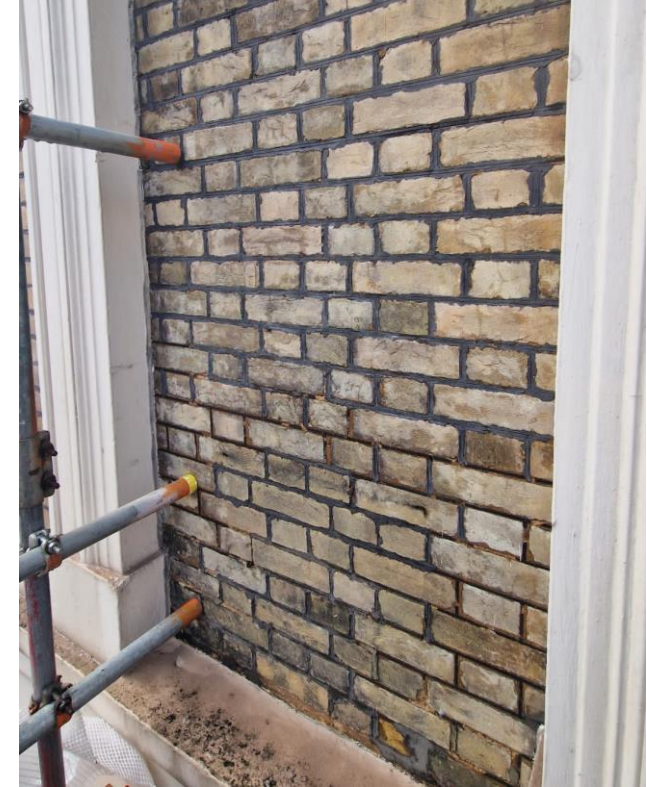
46 Bloomsbury Square - Cleaning Sample (Pressurised Steam Clean)	
Before	After

Observations	
<p>The area highlighted in Blue highlights the cleaning sample location.</p> <p>Some light surface soiling has been removed, however, barely any difference noticeable and heavy deposits of atmospheric pollutants remain.</p> <p>Some defective mortar joints have been washed / blown out.</p>

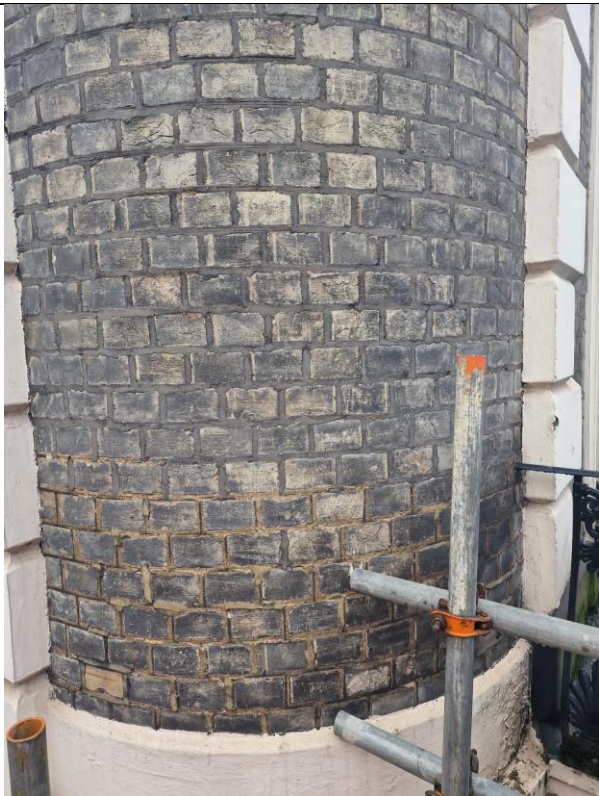
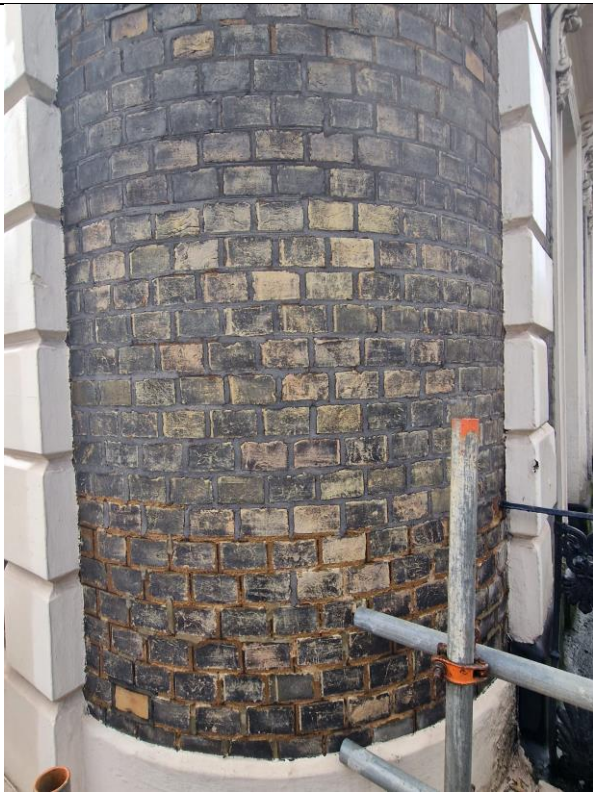
46 Bloomsbury Square - Cleaning Sample (Pressurised Steam Clean)	
Before	After

Observations	
<p>The area highlighted in Blue highlights the cleaning sample location.</p> <p>Some light surface soiling has been removed, however, barely any difference noticeable and heavy deposits of atmospheric pollutants remain.</p> <p>Some of the bricks have brightened slightly in appearance in comparison to the previous steam cleaning sample at 46 BS shown to the bricked-up window.</p> <p>Some defective mortar joints have been washed / blown out.</p>

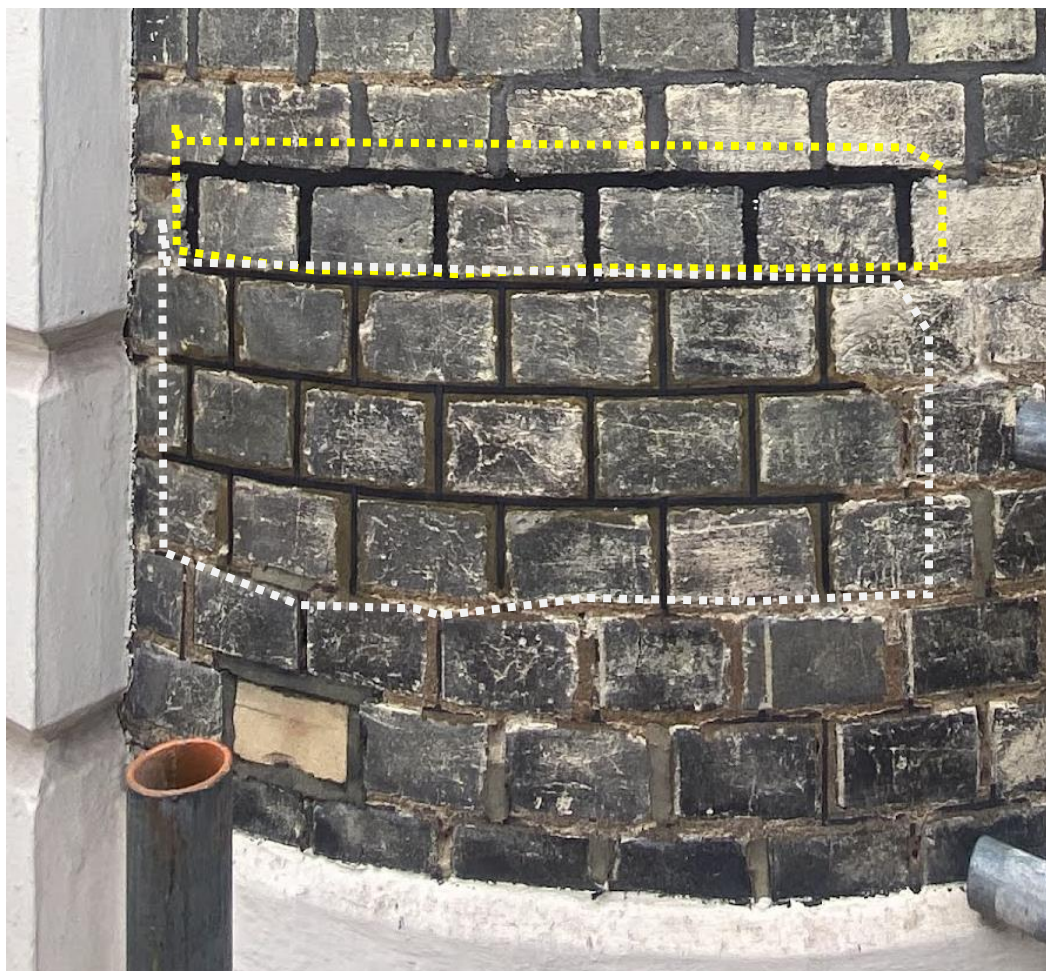
46 Bloomsbury Square - Brick Pointing Sample (Tuck Pointing)

There are differing style of pointing found on this façade. Where the bricks are light, cream / buff coloured, the pointing mortar is black so as to provide contrast. You will see remnants of the tuck in the lower portion of the photo.

We believe this façade was also originally tuck pointed with a lighter colour stopping mortar, with a black ribbon laid on top, however, you will observe a change of style – to a flush, black / dark grey coloured, mortar joint.

We imagine that the light-coloured brick will not be returned to it's original colour and as such have tried to emulate the more recent Tuck pointing repairs in the vicinity, that have adopted a grey / brown colour stopping mortar, which allows the black lime putty ribbon to be more pronounced against the heavily polluted brickwork.

We have also installed a dark coloured, flush style lime-based mortar, as there are areas on the scope that may require this style as well, to help blend the array of styles of pointing found on this façade.
