4.0 Clarifications

4.1 Clarification on the content of this submission

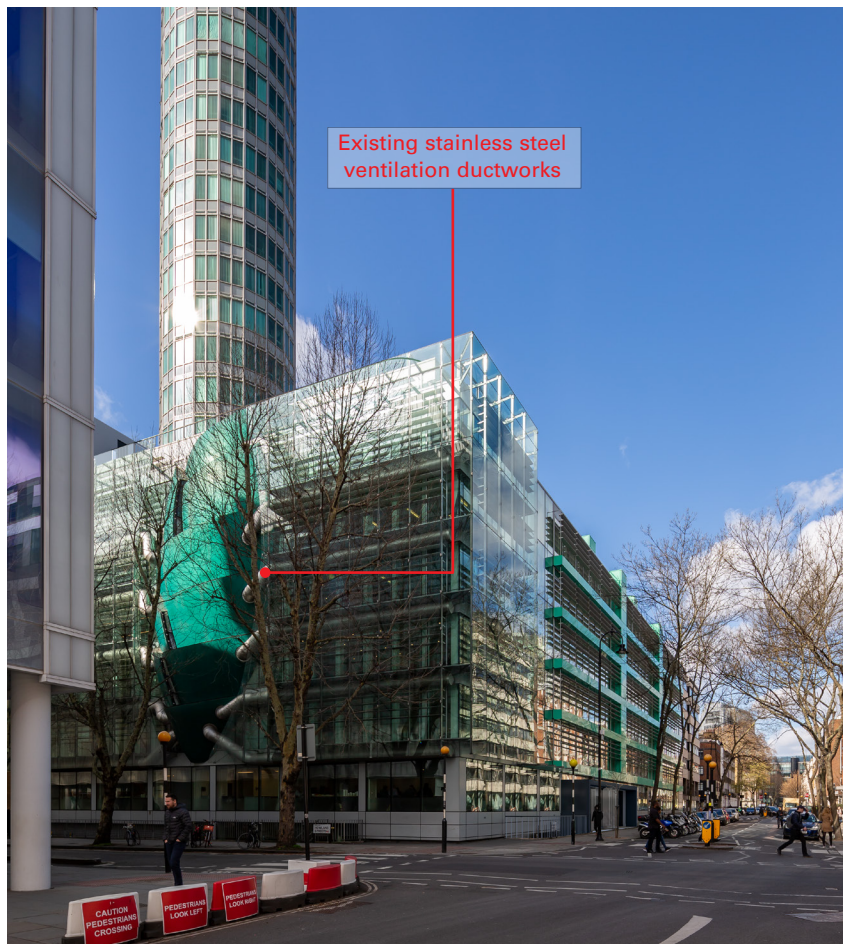
Fig. 4.4 - Existing View - Along Charlotte Street

Existing stainless steel
ventilation ductworks

To clearly demonstrate that, the following page incorporates the existing, consented and proposed elevations, which highlight the relevant ductwork in question. The next page also incorporates comparison between the existing photograph along Charlotte Street (Fig. 4.4), consented view (Fig. 4.5) and proposed view (Fig. 4.6) showing that the ductwork is kept as per existing.
