PRELIMINARY UNEXPLODED ORDNANCE (UXO) THREAT ASSESSMENT

6 ALPHA PROJECT NUMBER	P7366	ORIGINATOR	J. Webber
LANDMARK ORDER NUMBER	217730197_2	REVIEWED BY	S. Barratt (13 th September 2019)
CLIENT REFERENCE	1084	RELEASED BY	S. Barratt (13 th September 2019)
STUDY SITE	1 Museum Street & West Central Street, Holborn, London		
RECOMMENDATION	This Study Site requires a Detailed UXO Threat and Risk Assessment

1 MUSEUM STREET & WEST CENTRAL STREET, HOLBORN, LONDON

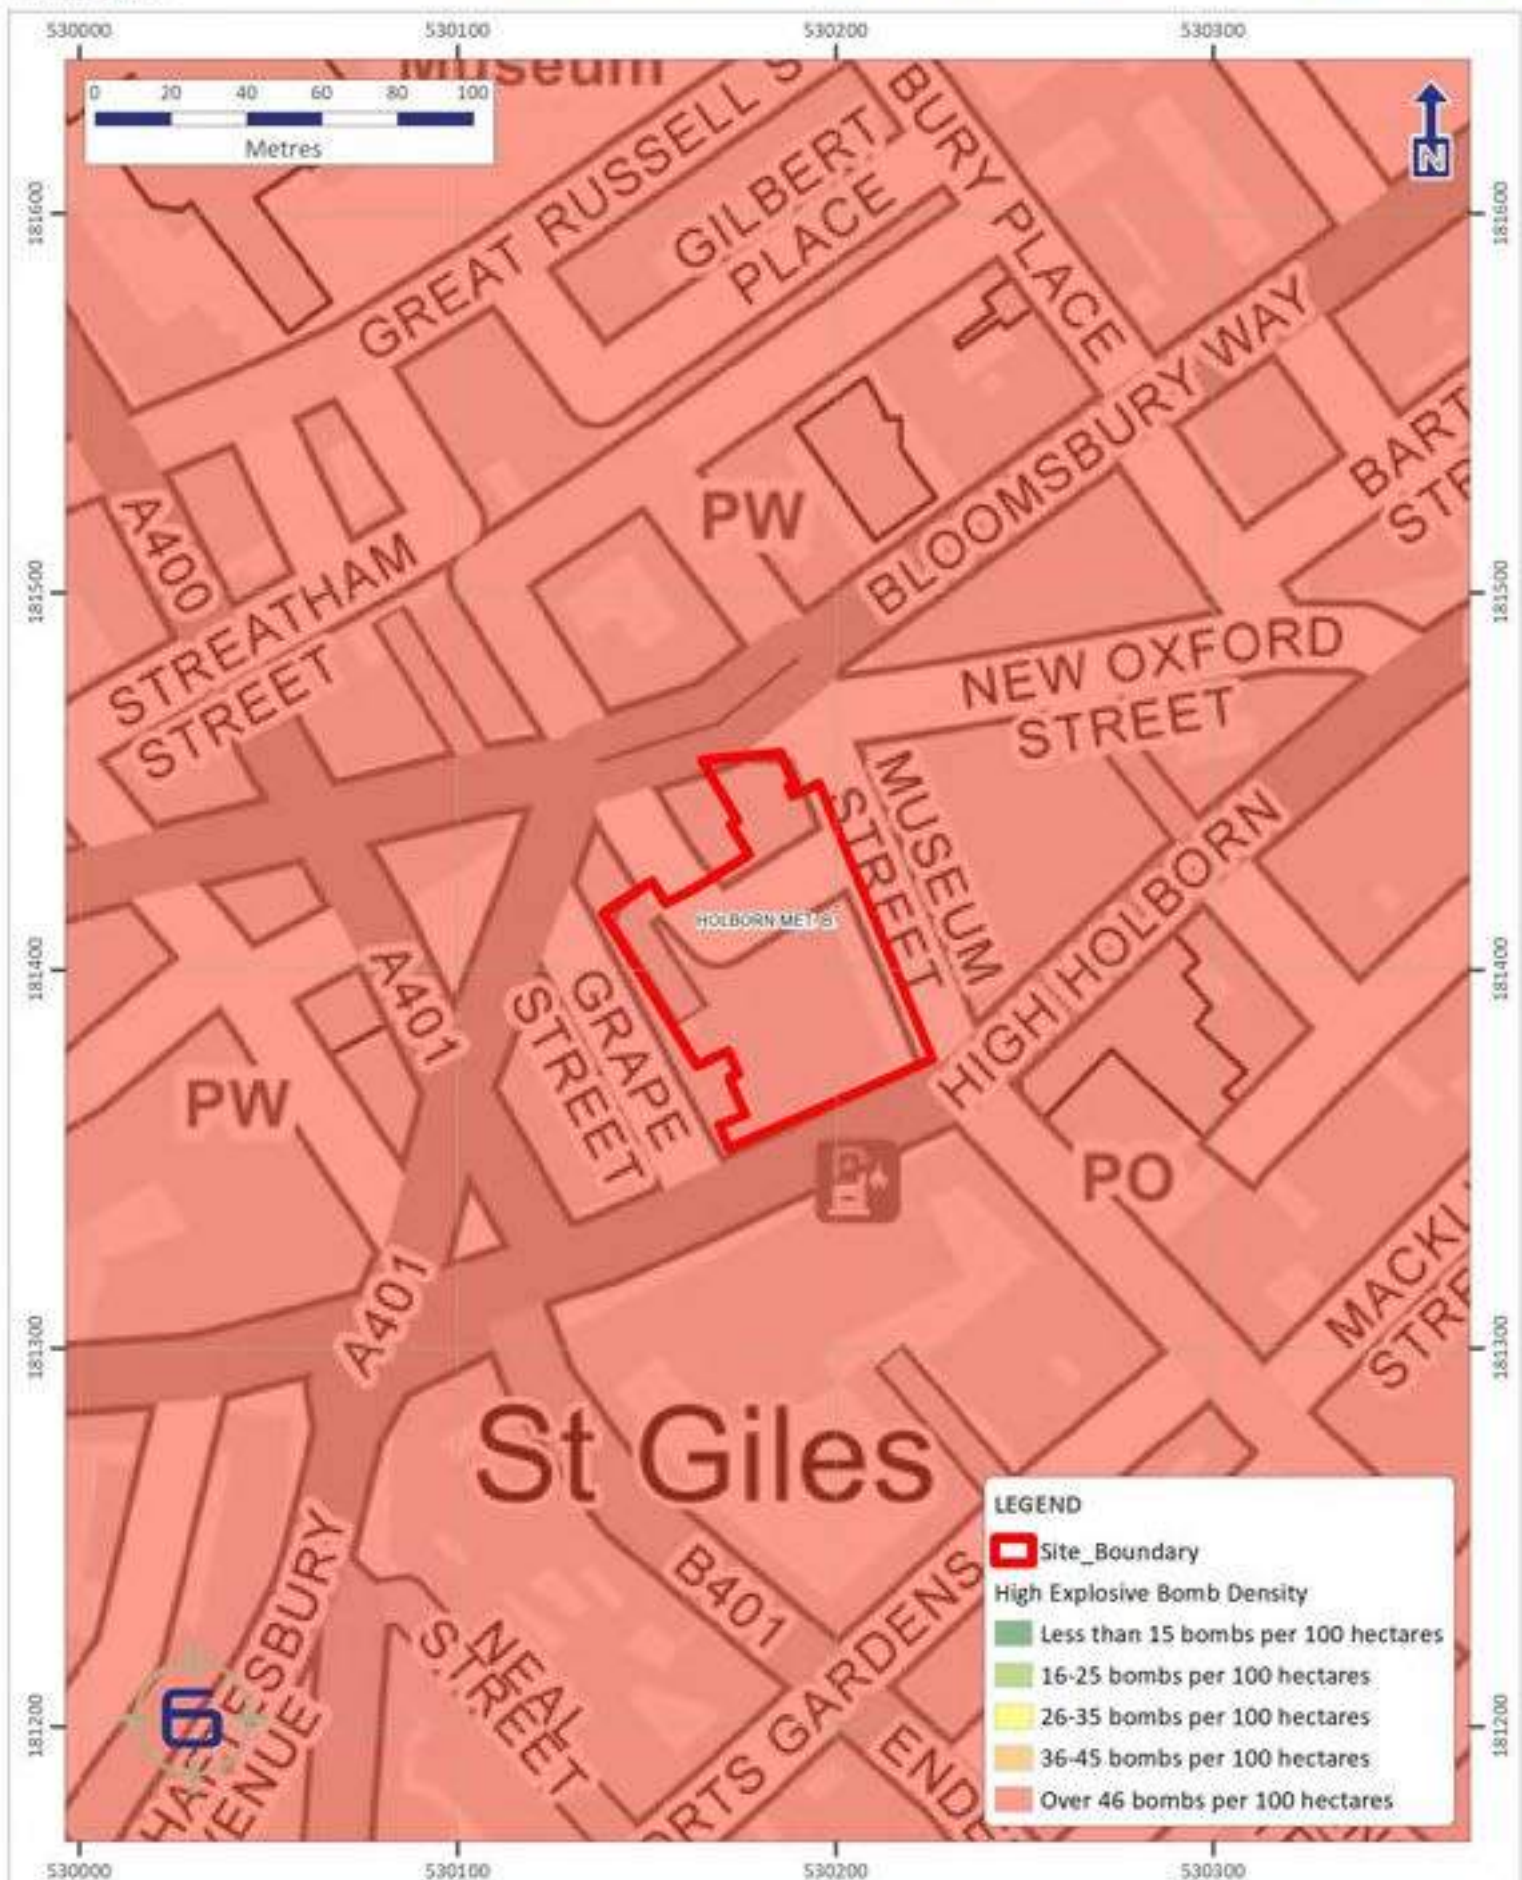
PROJECT NO. P7633	FIGURE 1	DRAWN CC	CHECKED SB	DATE 12 September 2019	Contains Ordinance Survey data © Crown copyright and database rights 2017	Produced by and Copyright to 6 Alpha Associates Ltd. Users noting any errors please notify 6 Alpha.

WWII Bombing Density Per 100 Hectares	✓	The Study Site was located within <i>Holborn Metropolitan Borough</i> , which recorded 216 HE bomb strikes per 100 hectares.

WWII High Explosive Bomb Density

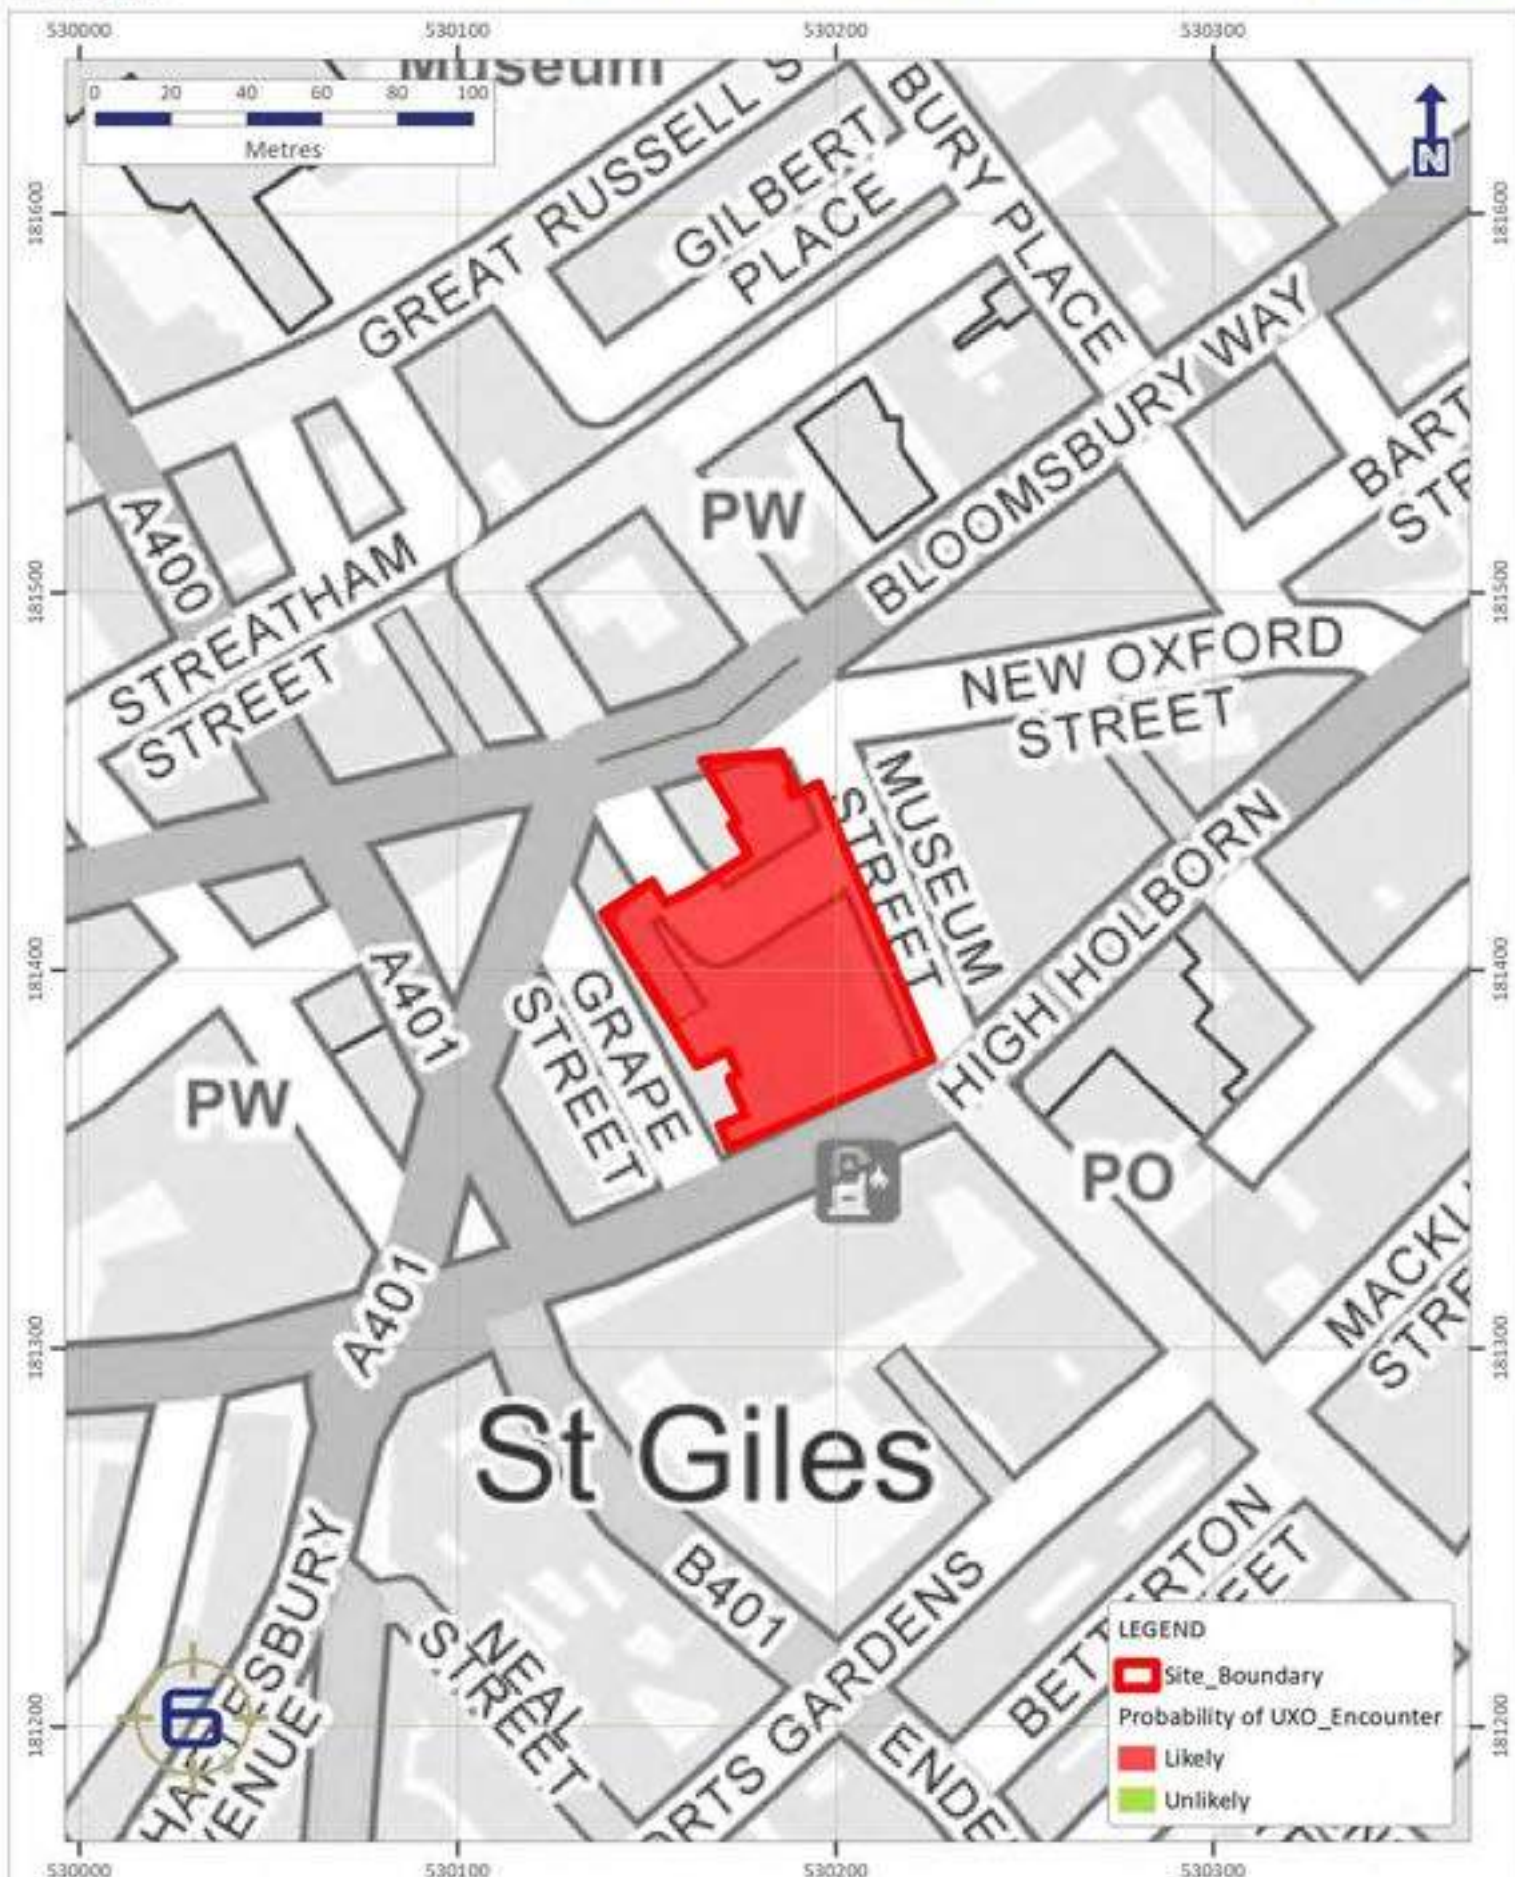
The potential for a UXO hazard to occur, and more specifically, the potential for unexploded WWI and WWII ordnance to exist at this site is assessed as being **LIKELY** (Figure 2).

In accordance with CIRIA C681 Chapter 5 on managing UXO risks, 6 Alpha recommends that the next stage in the risk management framework is:

DETAILED UXO THREAT & RISK ASSESSMENT
