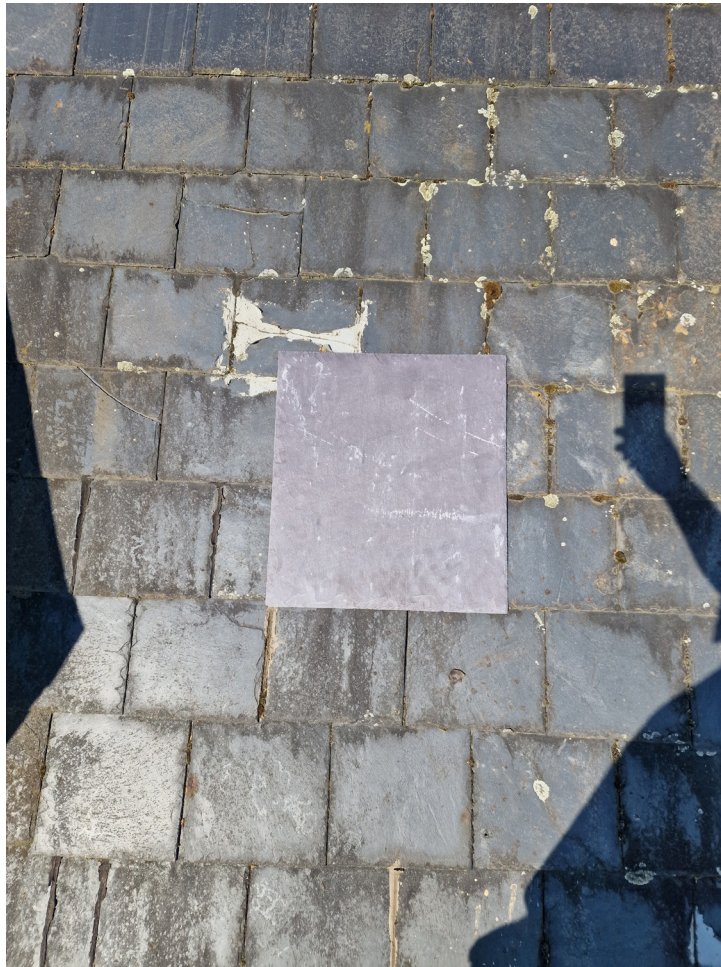
Please note:

- Pictured tile is 450x500mm 'Penryhn Welsh Slate' (tile and a half)
- Actual tile proposed for repair will be 300x500mm to match existing.
- The tiles are a natural product there will be natural variation.
- Likewise the new tile hasnt weathered yet and developed a patination.

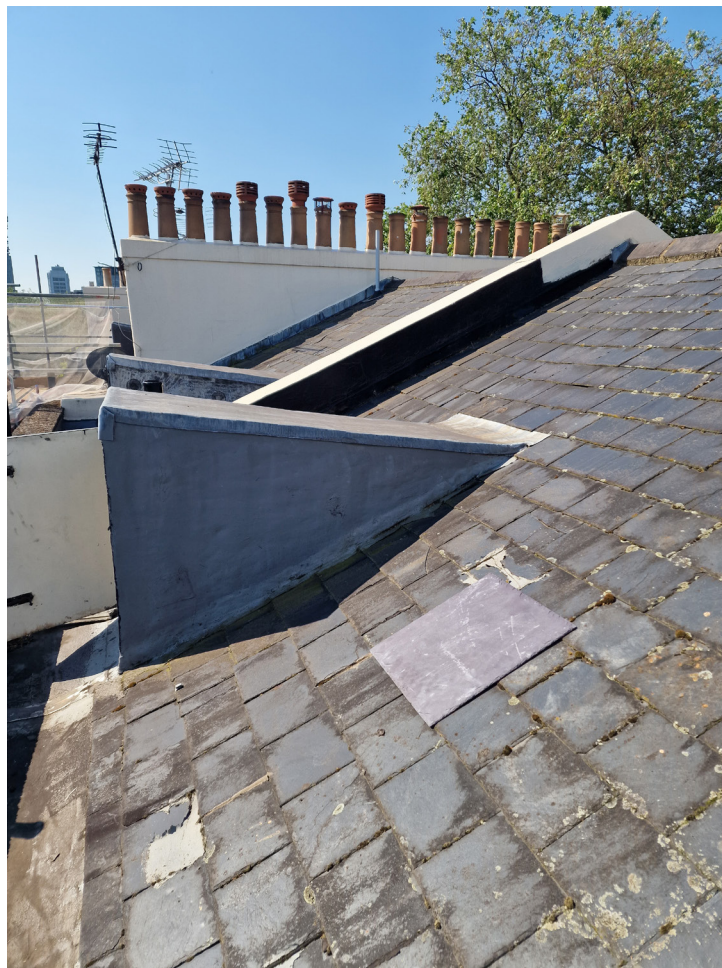
Please note:

- Pictured tile is 450x500mm 'Penryhn Welsh Slate' (tile and a half)
- Actual tile proposed for repair will be 300x500mm to match existing.
- The tiles are a natural product there will be natural variation.
- Likewise the new tile hasn't weathered yet and developed a patination.
