**Ref: 2022/4794/P and 2023/0106/L**

1. This is a further letter to raise concerns and object to the excavation of the studio building at the rear of 28 Charlotte Street London.

**Photos of 10 Crabtree Place London (within the 7 to 15 Whitfield Street Development)  
with respect to the studio at 28 Charlotte Street London.**

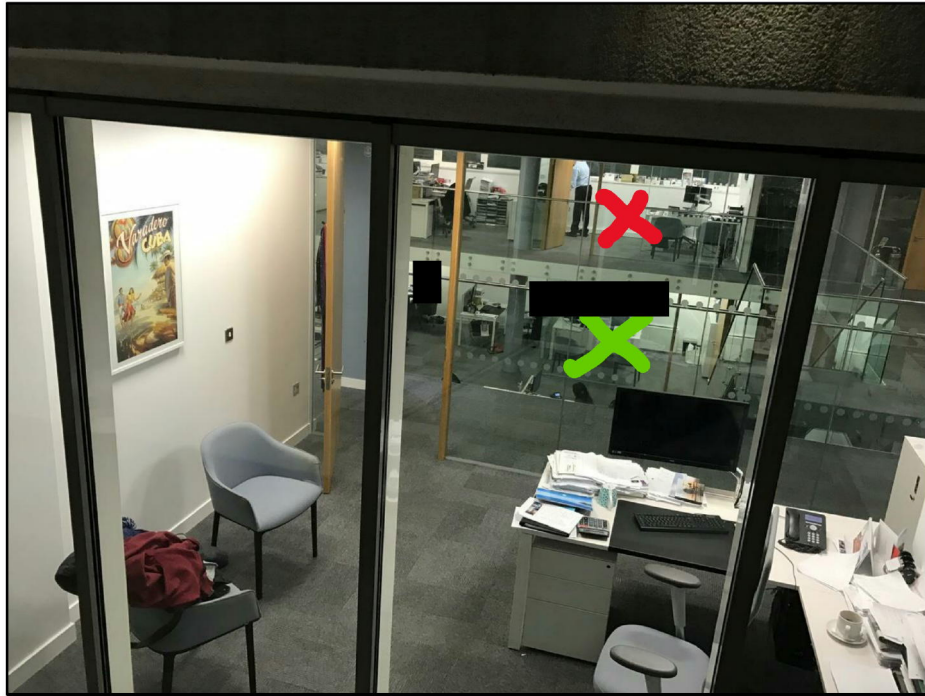
Two levels of offices located in the basement underneath 7 – 15 Whitfield Street development.

Level 1 marked with **RED X**.

Level 2 marked with **GREEN X**.

The office basement is 7 metres from the proposed excavation of the studio at 28 Charlotte Street.

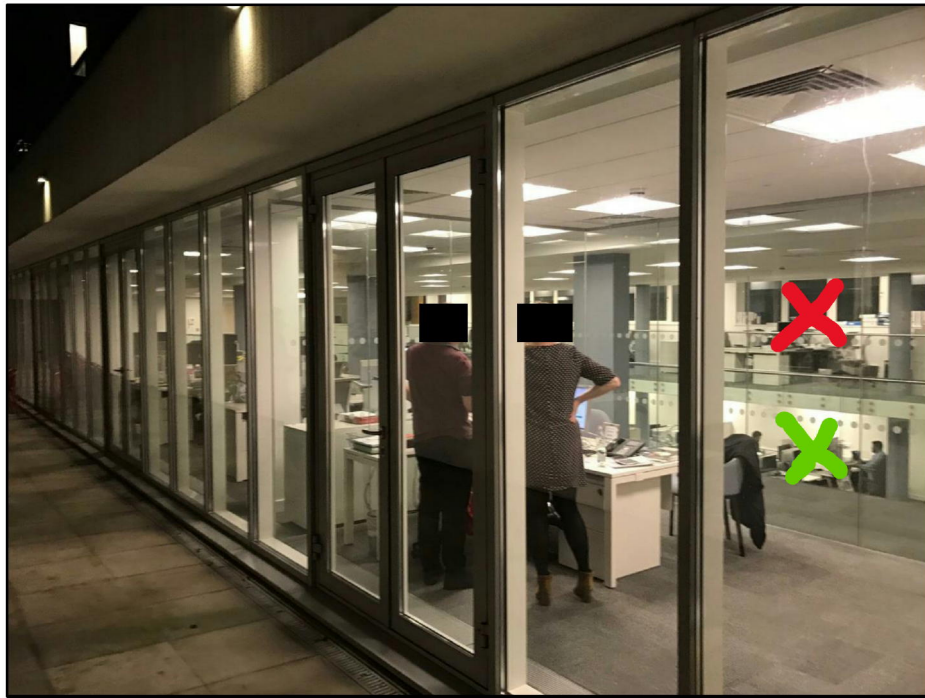
7 – 15 Whitfield Street development has an extensive office two level basement below its flats and houses. This basement and its plant room butt onto the proposed development wall and proposed basement excavation.

**Level 1 marked with RED X.**

**Level 2 marked with GREEN X.**

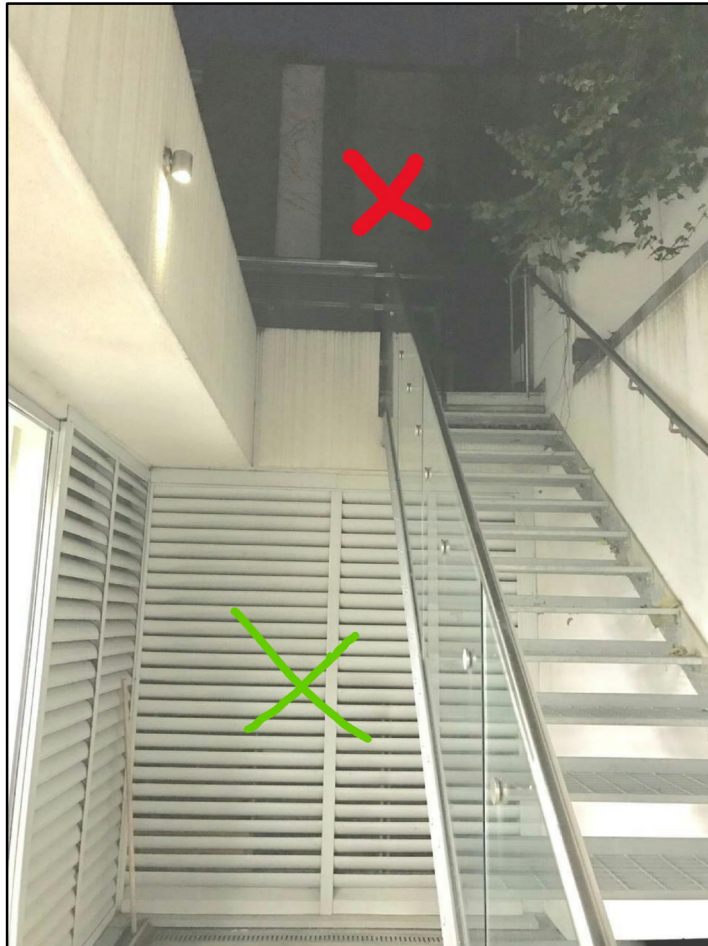
**Photo plant room of the basement offices of 7 -15 Whitfield Street Development marked **GREEN X**.**

**Above the plant room is the studio 28 Charlotte Street marked in **RED X**.**

The plant room which runs to the end of the party wall to the proposed excavation of the studio at 28 Charlotte Street. No indication has been provided regarding the extent of the basement excavation and its relationship with respect to the services in the plant room which runs to the party wall.
