Ref: 2022/4794/P and 2023/0106/L

1. This is a further letter to raise concerns and object to the excavation of the studio building at the rear of 28 Charlotte Street London.

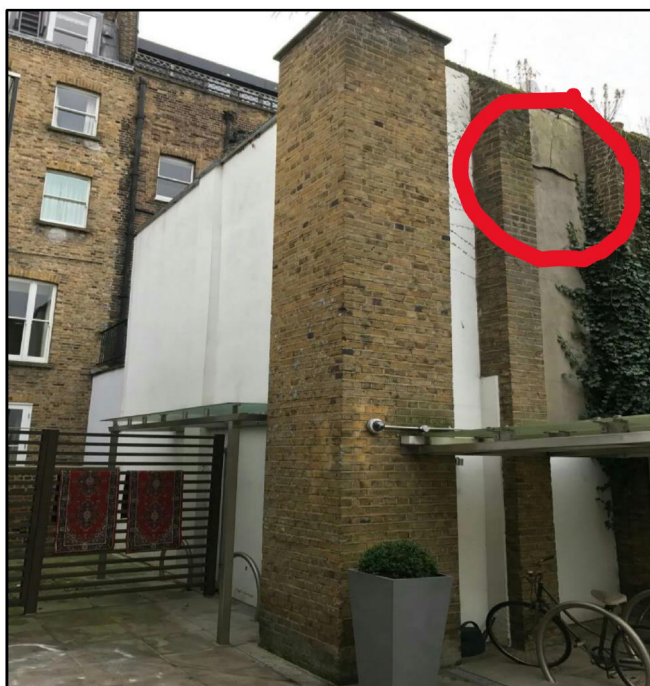
5. There are several large cracks in the external brickwork and external walls of the studio at 28 Charlotte Street and other areas that makes the building unstable. These cracks are presently hidden behind the ivy growing on the wall of the studio facing the 7 -15 Whitfield Street development.

6. These cracks on the wall of the studio at 28 Charlotte Street have not been caused by the ivy as the ivy does not have the root structure to crack the brick work.

7. The photo below in 2017 of the studio at 28 Charlotte Street shows the cracks.

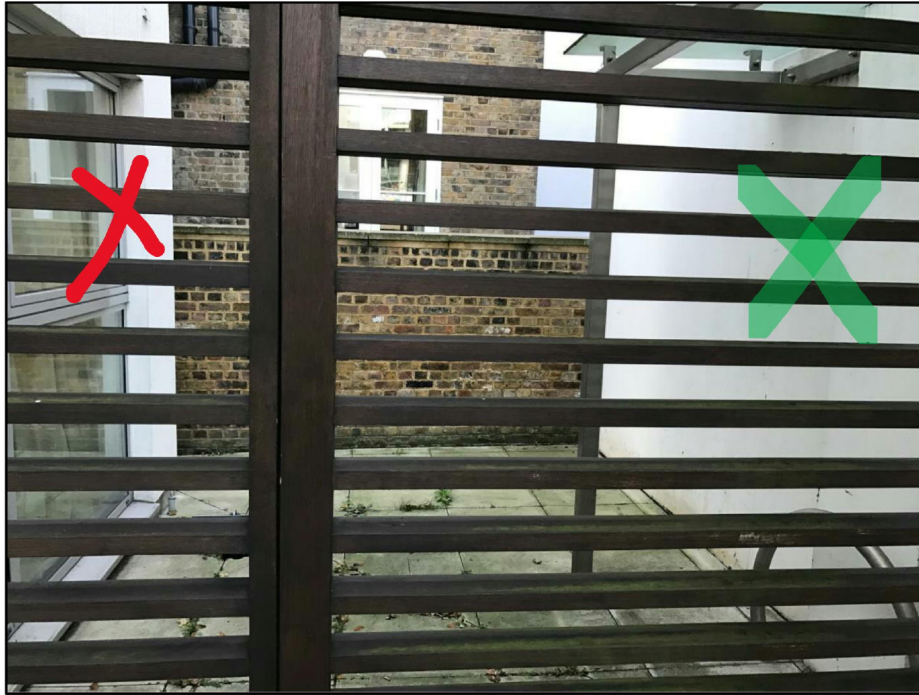
10 Crabtree Place on the left marked with RED X.
Studio / 28 Charlotte Street on the right marked with GREEN X.

There is 3 metres between the wall of No 10 Crabtree Place (Within the 7 -15 Whitfield Street development) and the proposed excavation on the right of photo of the studio at 28 Charlotte Street.

I have concern of the excessive basement excavation due to the proximity between the two buildings and what it will do to the structure of 10 Crabtree Place.

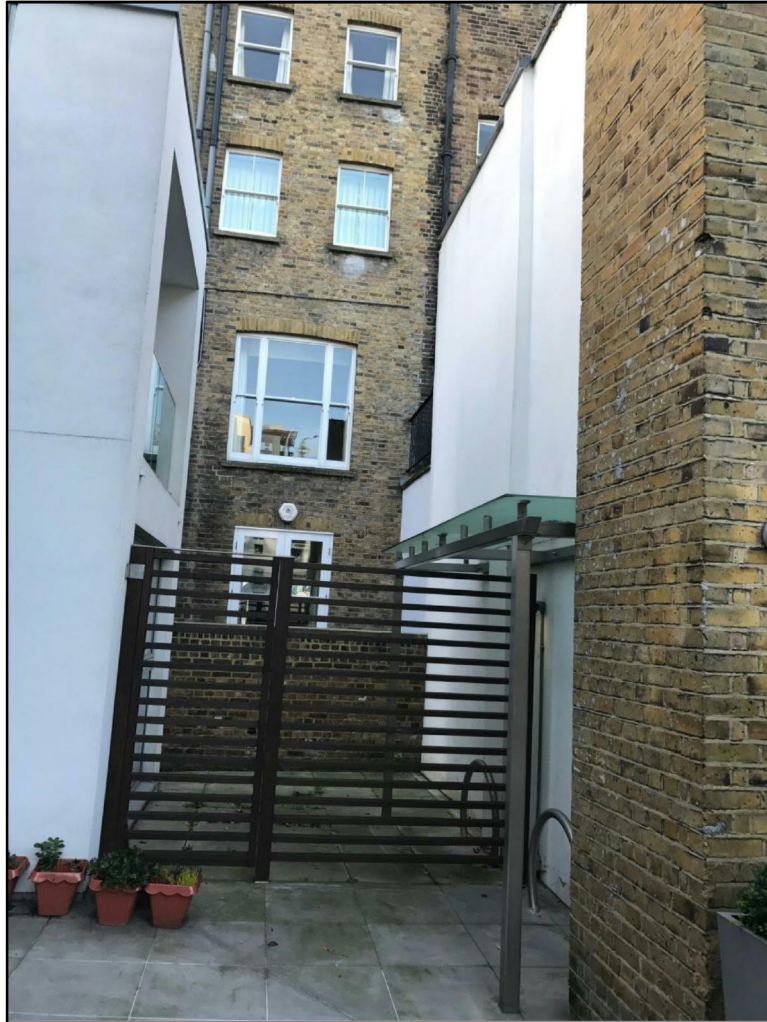
There is a 3-metre distance between no 10 Crabtree Place (building on left) and the proposed excavation to the studio of 28 Charlotte St (building on right)

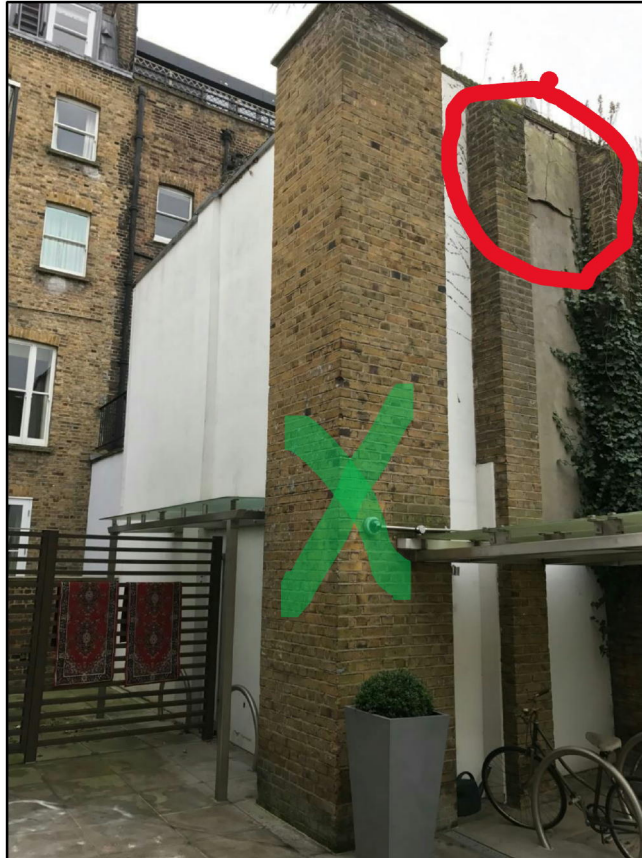
Proposed excavation of Artist Studio at Rear of 28 Charlotte Street seen from 7 – 15 Whitfield Street development.

The buttress on the corner marked with a **GREEN X** of the studio building at 28 Charlotte St shown in brown brick supports the entire studio building. No mention in planning application on how that will be supported or dealt with in the excavation.

The **red circle** shows some of the cracks on the studio wall.

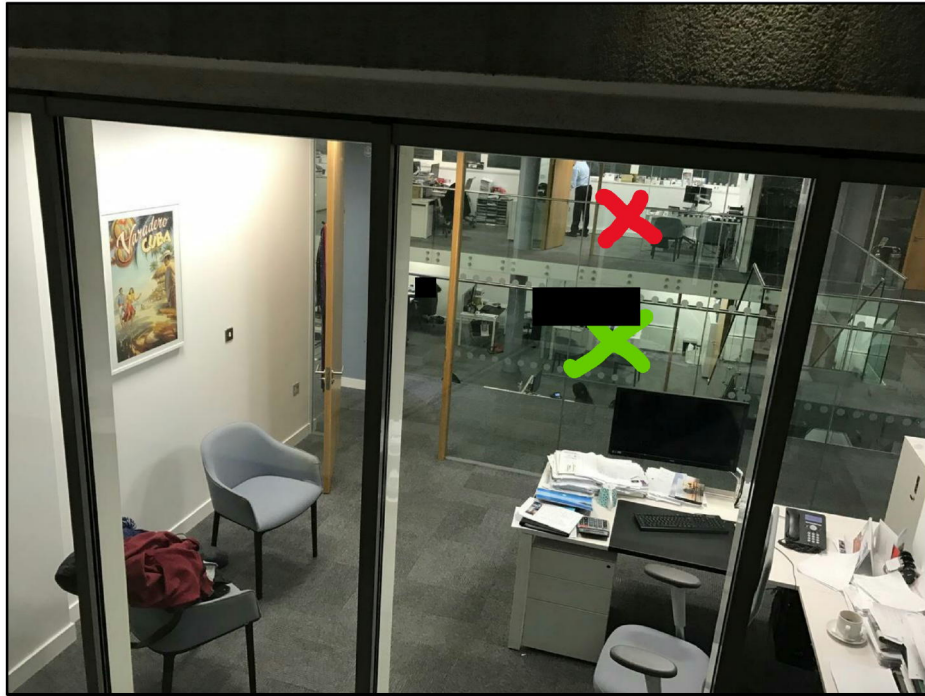
Two levels of offices located in the basement underneath 7 – 15 Whitfield Street development.

Level 1 marked with **RED X**.

Level 2 marked with **GREEN X**.

The office basement is 7 metres from the proposed excavation of the studio at 28 Charlotte Street.

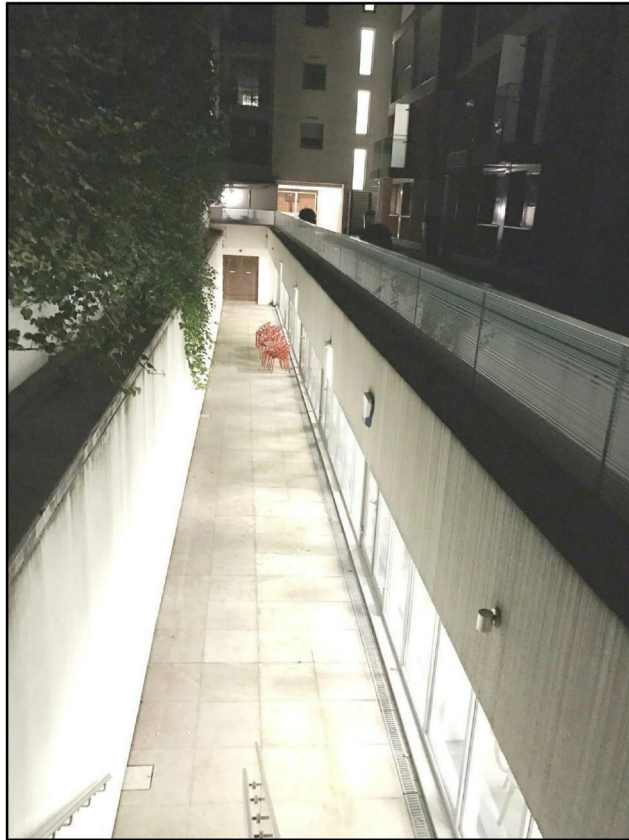
7 – 15 Whitfield Street Development has two levels in its basement of offices.

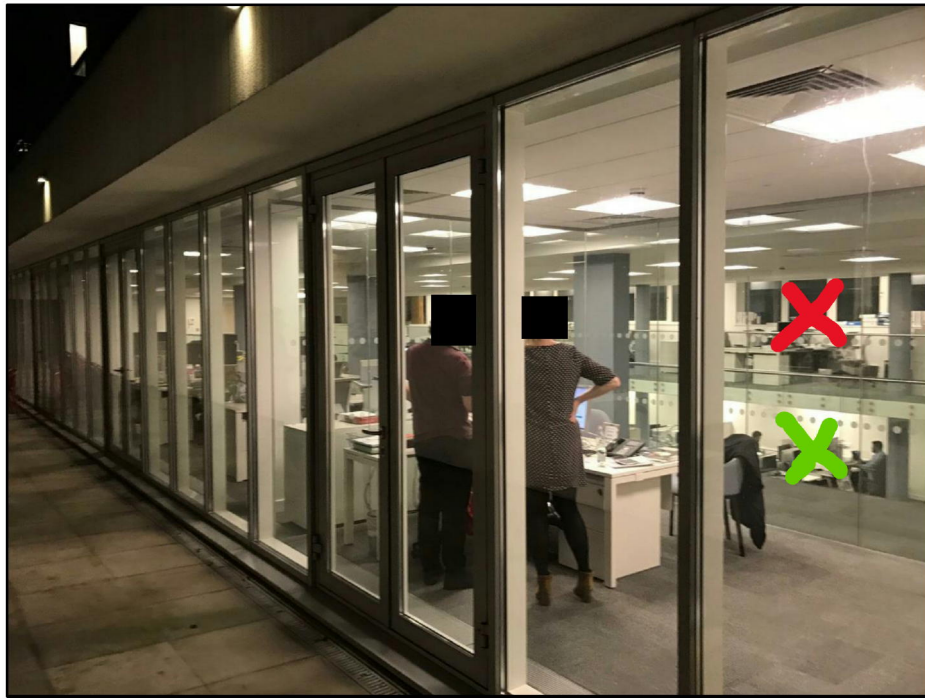
7 – 15 Whitfield Street development has an extensive office two level basement below its flats and houses. This basement and its plant room butt onto the proposed development wall and proposed basement excavation.

Level 1 marked with RED X.

Level 2 marked with GREEN X.

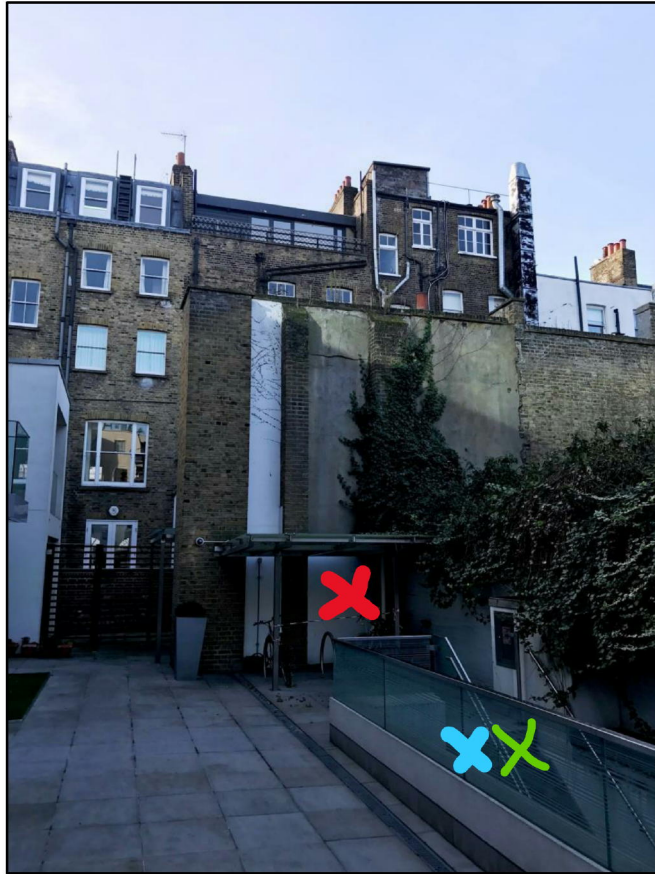
Photo of rear of 28 Charlotte Street 'Artist Studio' marked RED X

Note: Staircase on right marked with a **GREEN X** is the fire exit of the Offices below.

At the bottom of the staircase is the plant room marked **BLUE X** which goes back towards the

The studio wall of 28 Charlotte Street marked with a **RED X**.

These plant room services have not been considered in the basement excavation as they are abutting the party wall.

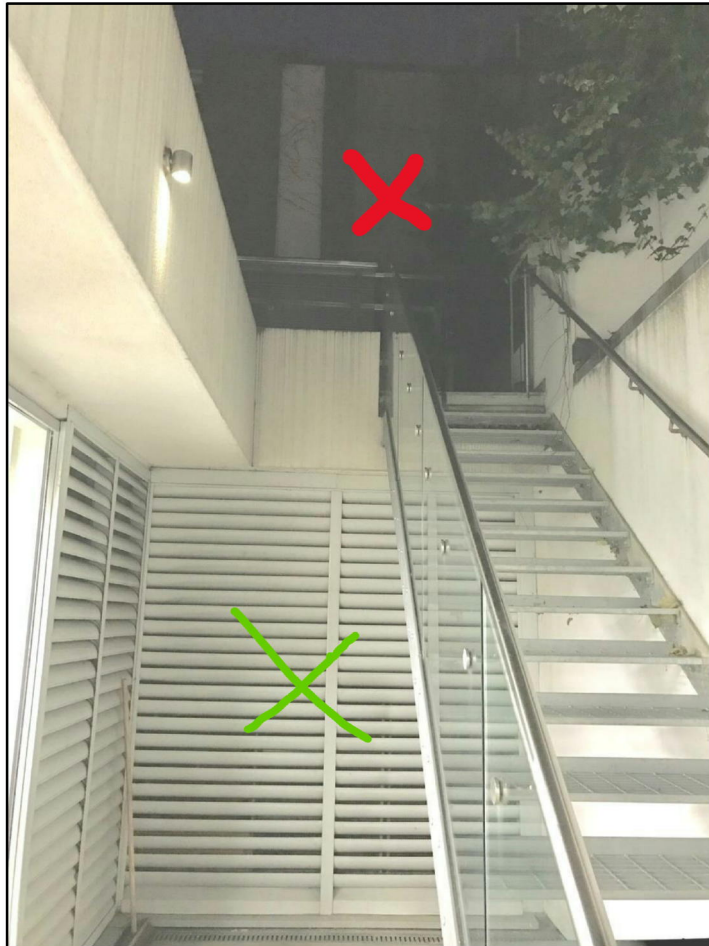
Photo plant room of the basement offices of 7 -15 Whitfield Street Development marked **GREEN X.**

Above the plant room is the studio 28 Charlotte Street marked in **RED X.**

The plant room which runs to the end of the party wall to the proposed excavation of the studio at 28 Charlotte Street. No indication has been provided regarding the extent of the basement excavation and its relationship with respect to the services in the plant room which runs to the party wall.

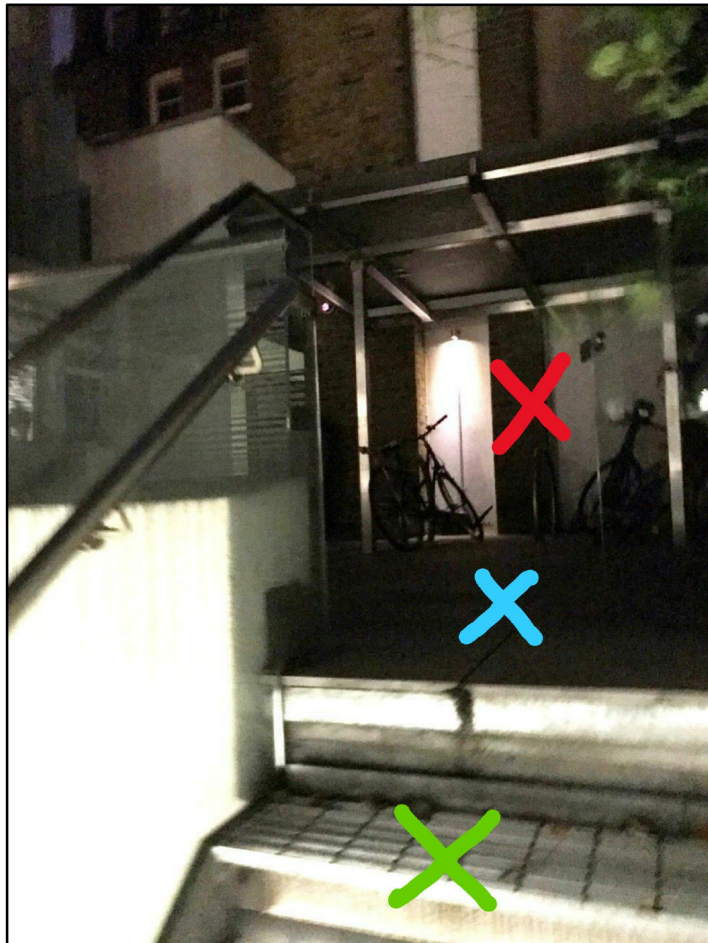
Plant room under stairs of basement at 7 -15 Whitfield Street Development marked **GREEN X**.

Above the plant room is the roof of the plant room marked with **BLUE X** which extends to the studio at 28 Charlotte Street marked in **RED X**.
