Client: Grolar Developments Ltd
Project: 32 Winchester Road, Swiss Cottage NW3 3NT
Title: TREE CONSTRAINTS PLAN

Date: 20/06/23 Scale: 1: 100 @A1 (CHECK PRINTER SPEC)
Drawn: MW Checked: PW Client Ref:
Drawing Number: CT11WR-WLA-V2-XX-DR-Y-TCP
Rev: B

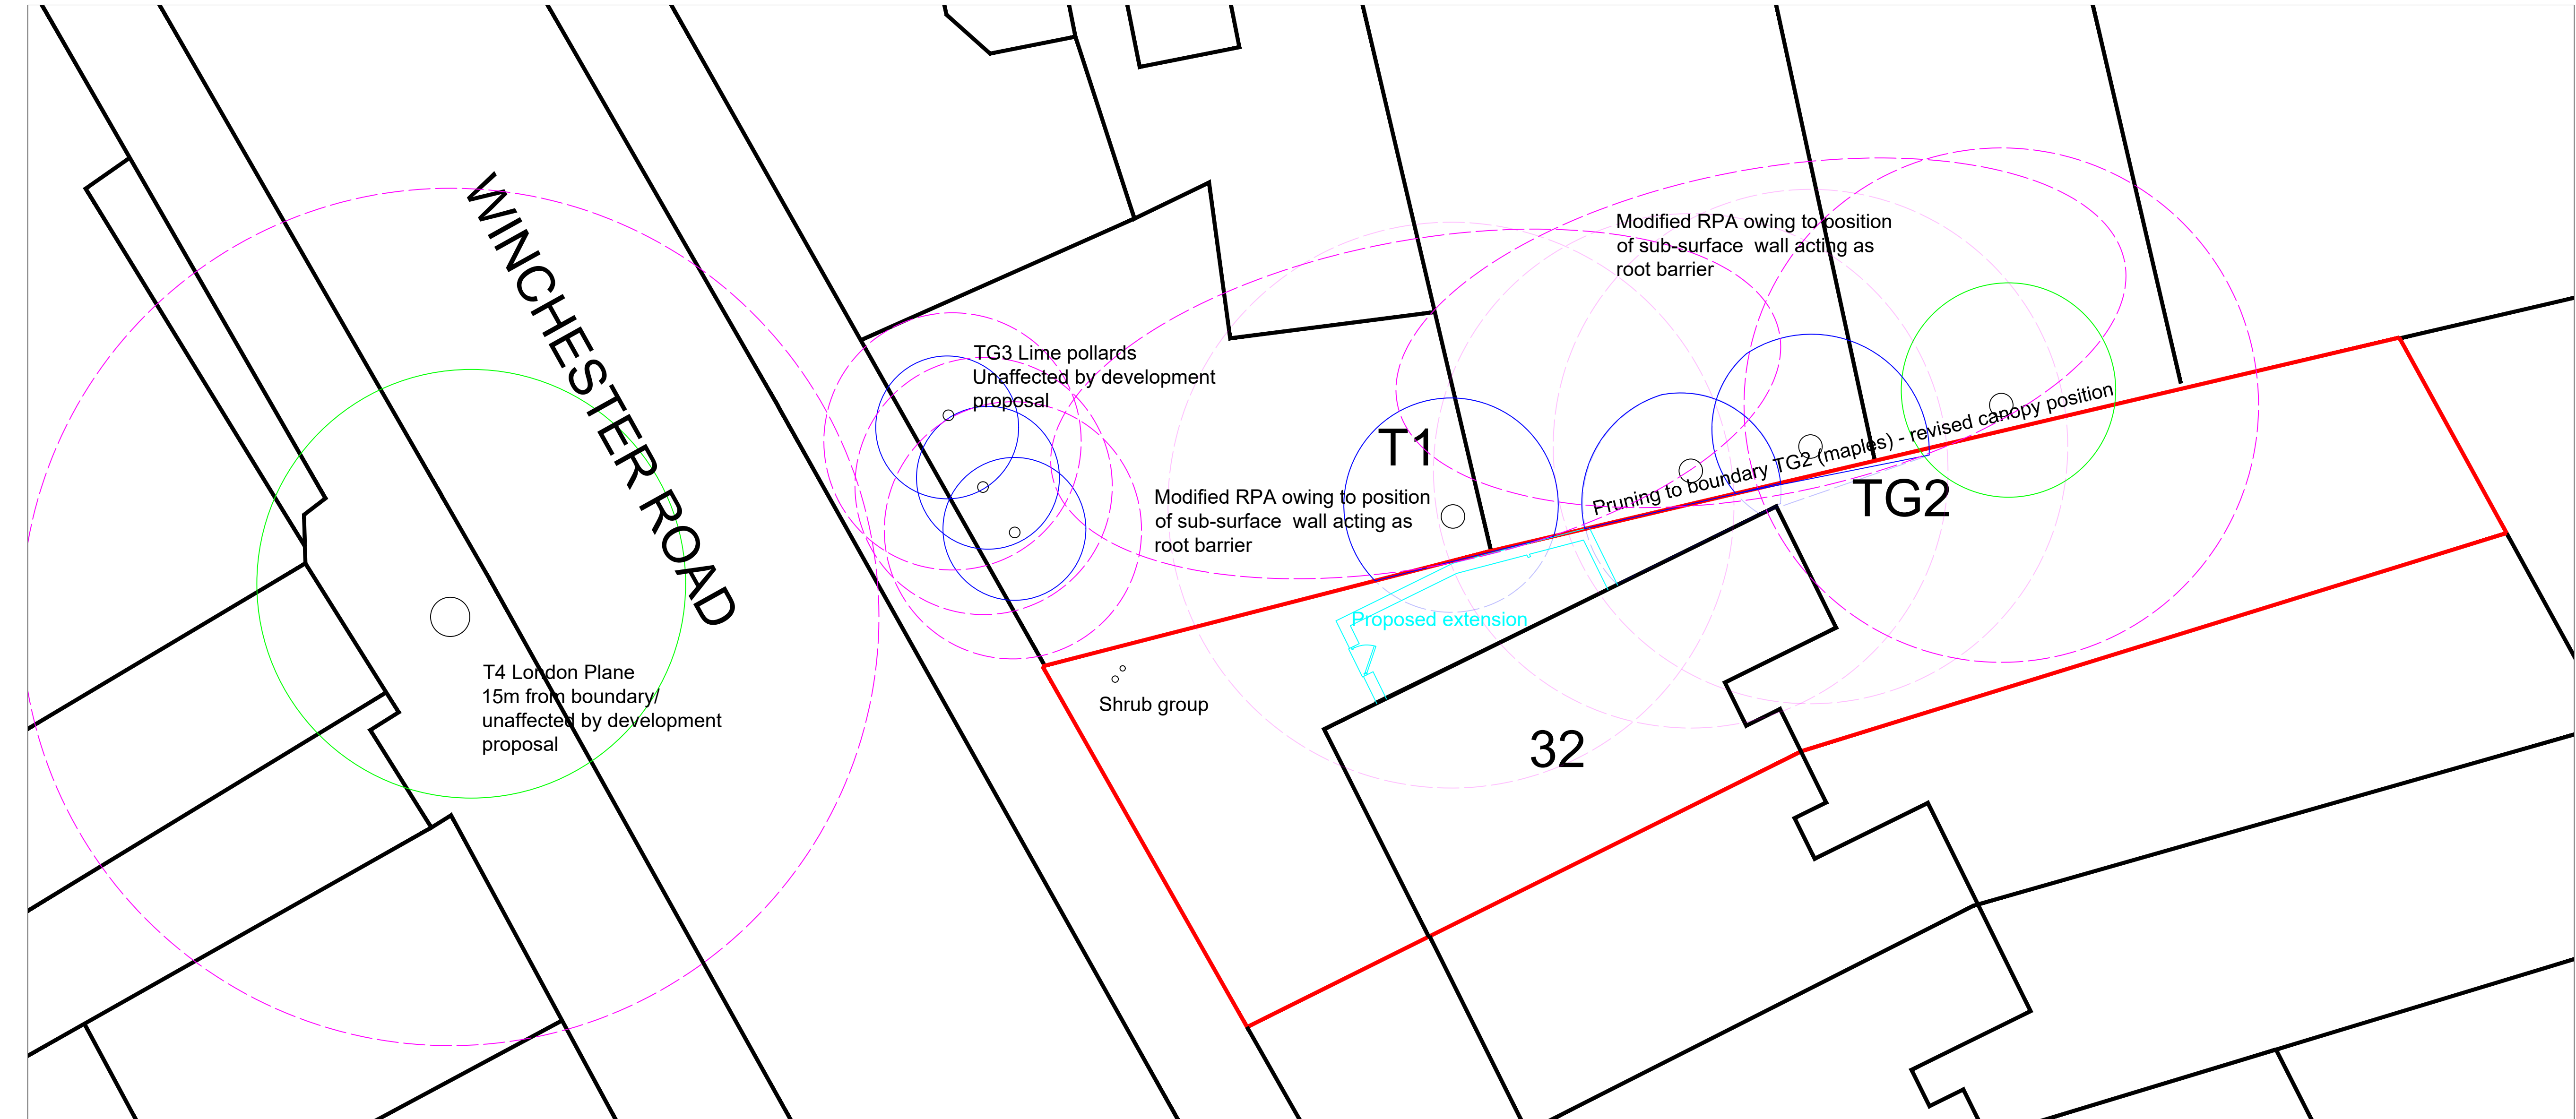
Figure 1: Trial pit excavations along the boundary with the car park revealed that root growth of T1 and TG2 has proliferated along the top of a historic boundary wall. The trial pit revealed roots have not grown beyond the boundary wall and trespass is limited to fine, hair-like roots within the soil on top of the sunken structure, therefore structures inside of this boundary would have no harmful effect on tree roots.

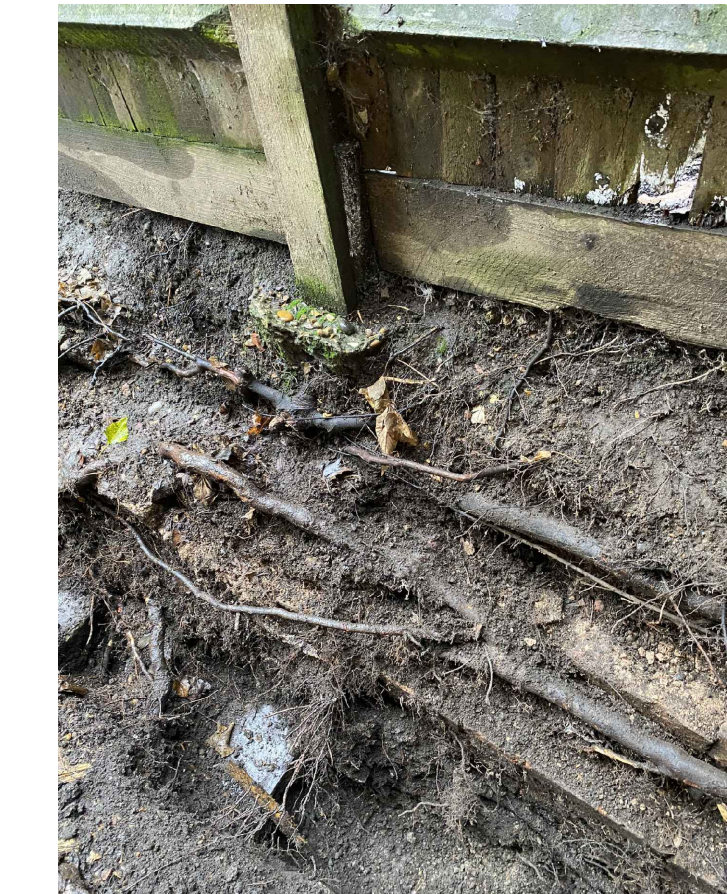
Fig 2: Position of pile foundations (1:100). Boundary wall as shown in blue hatching. Root growth on top of wall and wall left in situ, undisturbed. Piles 150mm diameter, supporting ground beam 600mm x 400mm, refer to GM Structures Foundation Plan drawing C101 16/3/23
