HERITAGE APPRAISAL & IMPACT STATEMENT IN CONSIDERATION OF PROPOSED ROOF RENEWAL WORKS

MORETON HOUSE
HOLLY WALK
LONDON
NW3 6RA

RENNIE & PARTNERS
26 HIGH ROAD
EAST FINCHLEY
N2 9PJ

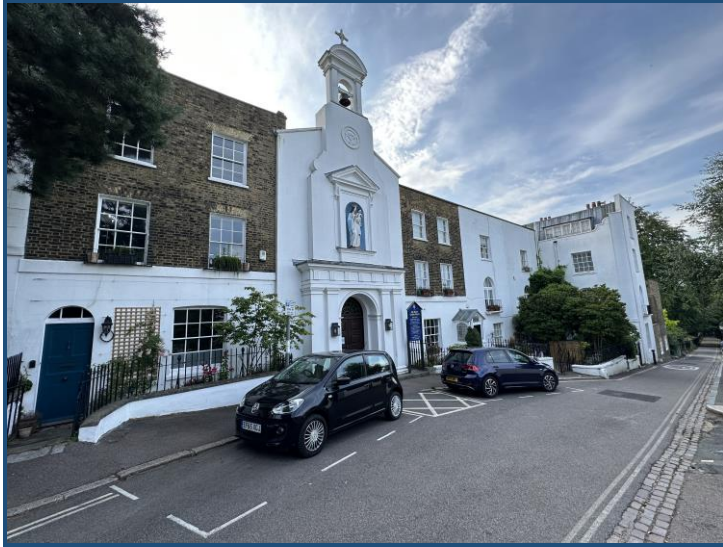
Photo 3 - View of church and c18 houses along west side of Holly Walk.

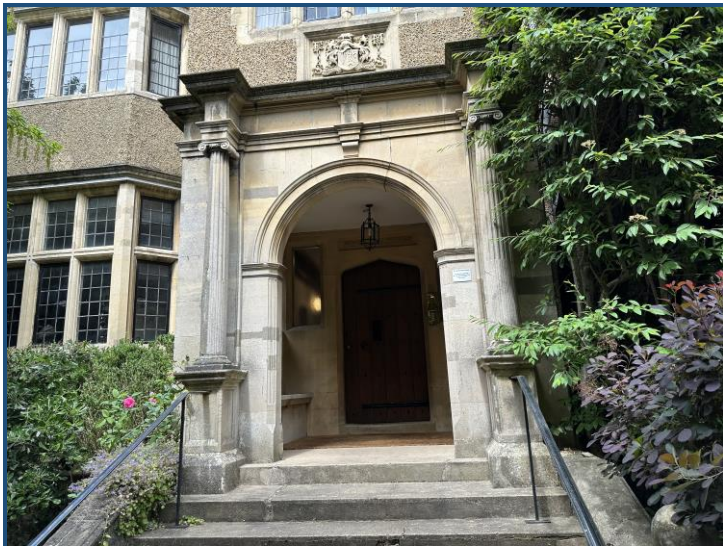
Photo No.4 - entrance porch to flats 1-5.

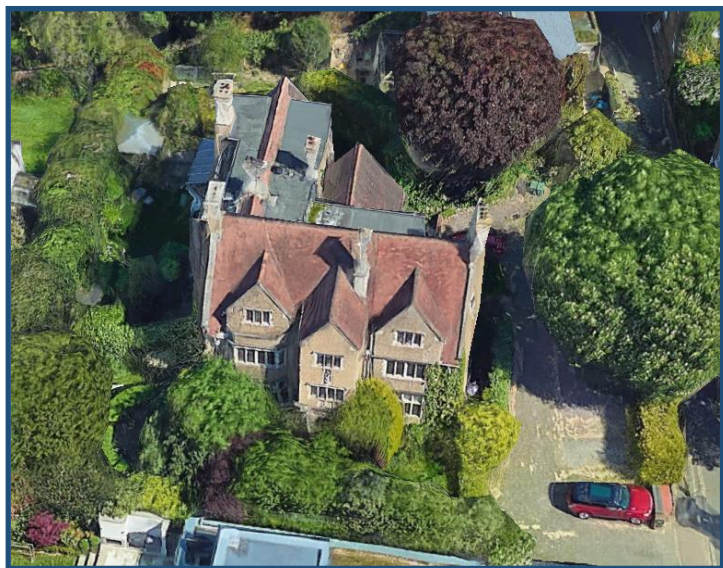
Photo No.5 - aerial view of house with dormers along east and west elevations.

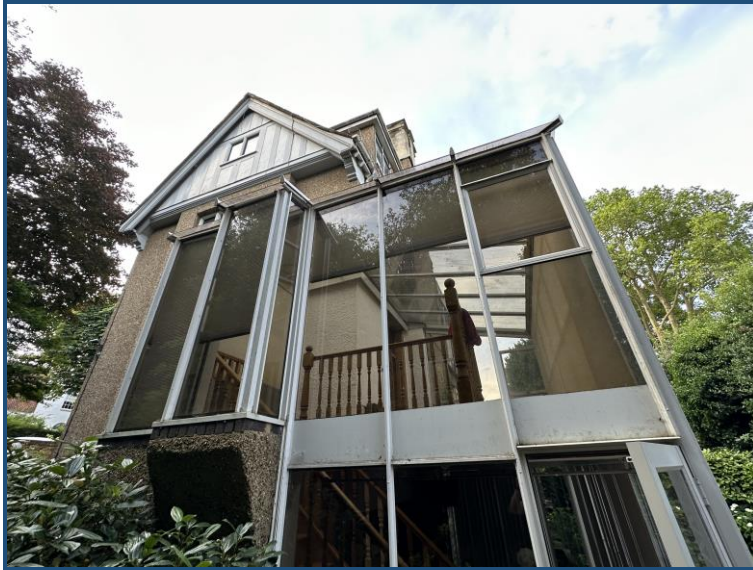
3.01.02 The list description gives a reasonable description of the building but it does detail the alterations and extensions that have been made to the building when it was converted into 6 homes (Moreton Lodge and Flats 1 – 5, Moreton House). The Lodge is self-contained with its own entrance on the east elevation (facing Holly Walk), whilst the 5 No. flats are served by the main porch entrance on the south elevation (photo No.4). The building has been extended with large dormers (ariel photo No.5) to the main roof facing west and east and a conservatory serving the Lodge, located on the northwest corner of the main building (photo No.6). The main pitched roofs were replaced at the time of the conversion and dormer constructions.

Photo No.6 - view of conservatory to Lodge.

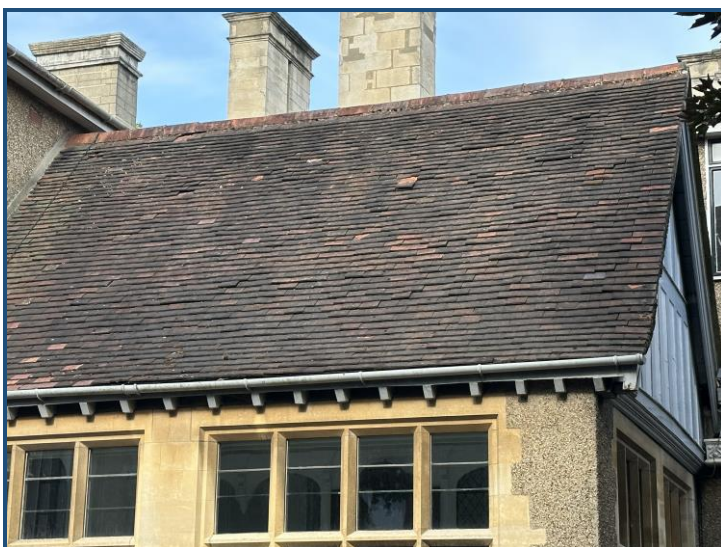
Photo No.7 - view of tiled roof coverings. Note significant slipped and lifting tiles.

3.02.02 The pitched roof slopes have in the past been recovered with plain clay tiles. Although not original they retain the character of the building (photo No.7).

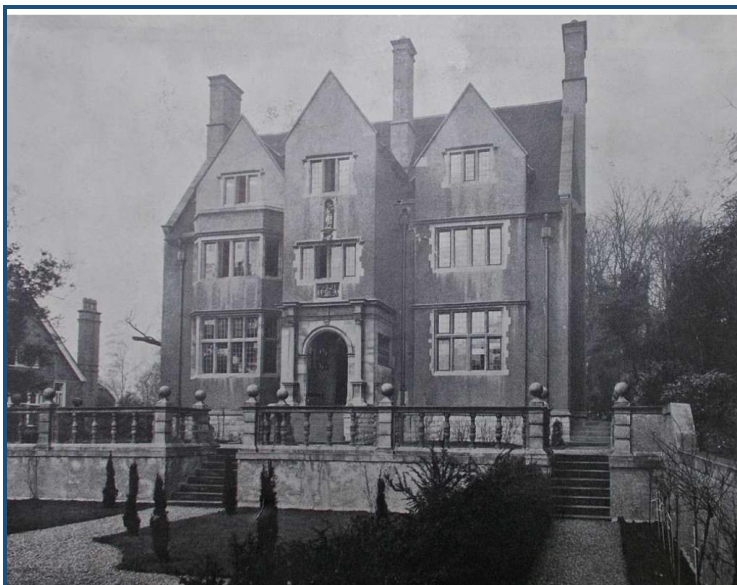
Photo No.10

- 4.03.01 The exterior and interior of the property c. 1900 was clearly depicted in an article entitled "Of London Houses" held in the Camden Local Studies Library. The interiors had a Jacobean influence, probably influenced by Flitwell Manor. The exterior south elevation is detailed within Photo No.10.

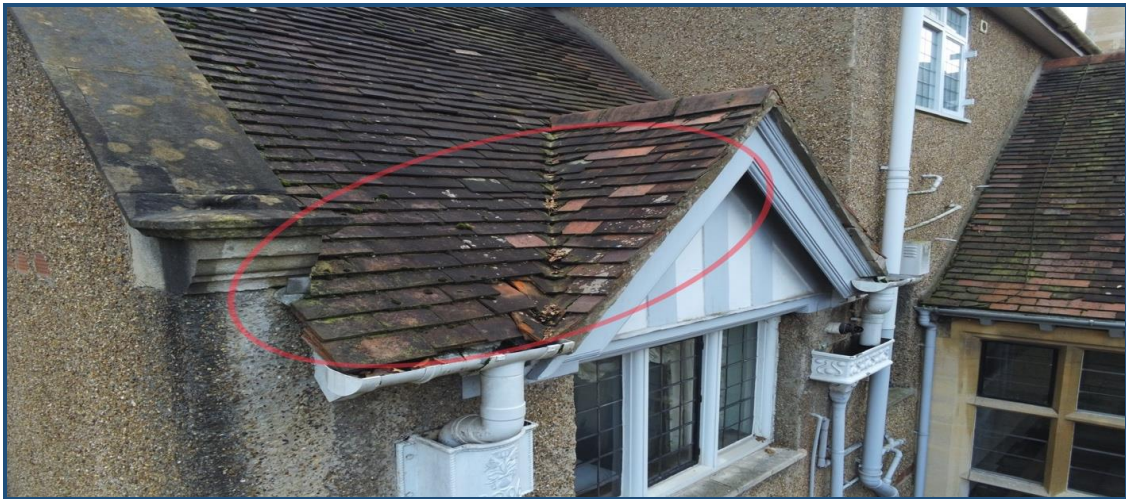
Photo No.11 - Note localised replaced tiles and other adjacent slipped tiles.

6.01.01 The main roof slopes are covered with plain clay tiles. The front (south) roof slope and associated apex's is in fair condition to suggest these slopes have been historically recovered. The remaining roof slopes have undergone localised past patch repairs (Photos No.11 & 12). The tiles to these roof slopes are reaching the end of their usable life and are increasingly breaking/slipping out of position (photos No.11 and 12 & 13). This increases the risk of rainwater ingress into the building and potential damage to original ornate plastered ceilings. It is proposed to sympathetically replace the existing plain clay tiles with matching tiles laid on a breathable underfelt. The new tiles will match existing and include all necessary valley tiles and cement fillets to match present installation.

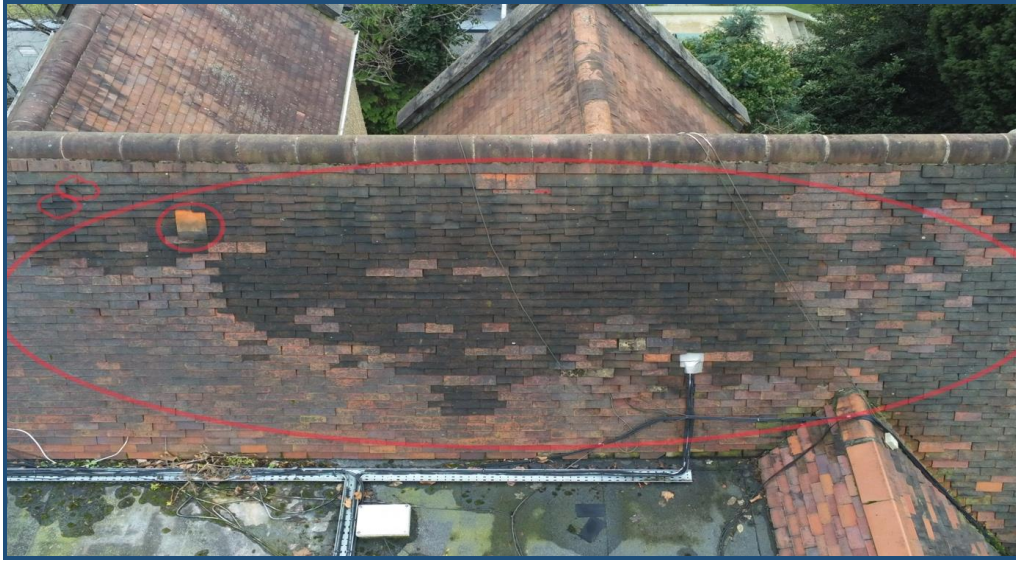
Photo No.12 - note localised past patch repairs to roof coverings.

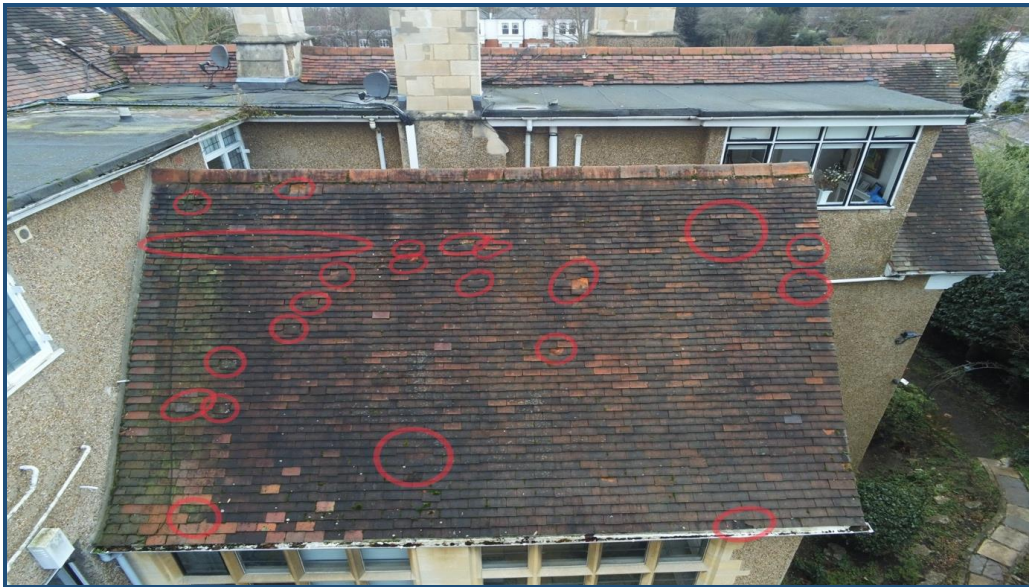
Photo No.13 - Note slipped, broken and laminated tiles highlighted in red.

- 7.01.03 The pitched roof slopes are covered with plain clay tiles encompassing: cement fillet junctions with the abutting walls; valley tiles along the junction of abutting roof slopes and clay ridge tiles. The front (south) facing roof slope with its 3 No. main apex roofs appears to have been historically recovered and is in fair condition. The remaining roof slopes have been historically patched repaired. These roof slopes have a considerable quantity of loose/slipping/broken tiles and frost damaged tiles. These slopes will become increasingly susceptible to further slipped and missing tiles leading to rainwater damage to the interior fabric of the building
