A2 Site Investigation

50 Maresfield Gardens

Interpretive Report

26822-A2SI-XX-XX-RP-Y-0003-00

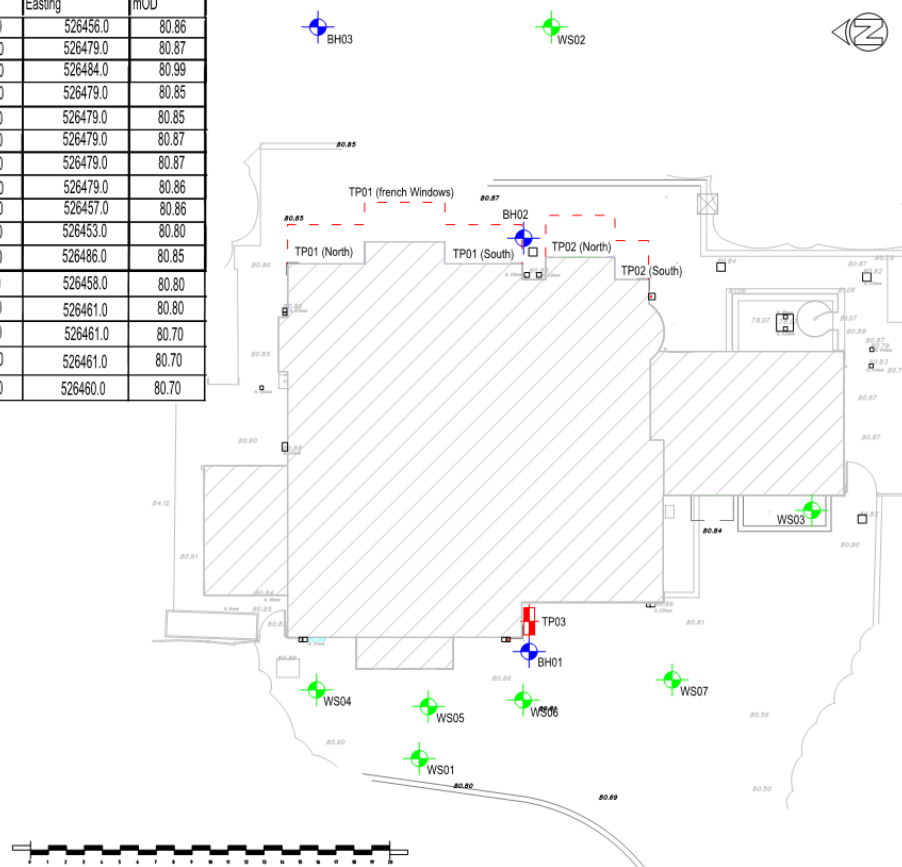
Figure 4.1 Exploratory location plan

- 1no. cable percussive borehole to 20m (extended to 30m) (BH01) to facilitate parallel seismic testing.
- 2no. cable percussive boreholes to 10m and 20m (BH02 and BH03 respectively) to facilitate sampling and in-situ testing.
- 1no. machine and hand excavated trench to determine the location and geometry of pile foundations, and pile reinforcement using ferro-scanning. The trench was reorganized into 6no. individual trial pits.
- 2no. hand excavated trial pits to determine ground floor beam dimensions.
- 7no. dynamic window samples (WS01-07) to facilitate geo-environmental sampling.
- Installation of 8no. standpipes within BH03 and WS01-07 to facilitate groundwater and ground gas monitoring.
- In-situ and laboratory geotechnical testing.
- In-situ and laboratory geo-environmental testing.
- 7no. return visits for ground water and ground gas monitoring.

Location ID	Northing	Easting	mOD
BH01	185140.0	526456.0	80.86
BH02	185145.0	526479.0	80.87
BH03	185150.0	526484.0	80.99
TP01 (North)	185150.0	526479.0	80.85
TP01 (FW)	185148.0	526479.0	80.85
TP01 (South)	185147.0	526479.0	80.87
TP02 (North)	185145.0	526479.0	80.87
TP02 (South)	185143.0	526479.0	80.86
TP03	185140.0	526457.0	80.86
WS01	185141.0	526453.0	80.80
WS02	185144.0	526486.0	80.85
WS03	185134.0	526458.0	80.80
WS04	185065.0	526461.0	80.80
WS05	185063.0	526461.0	80.70
WS06	185060.0	526461.0	80.70
WS07	185054.0	526460.0	80.70

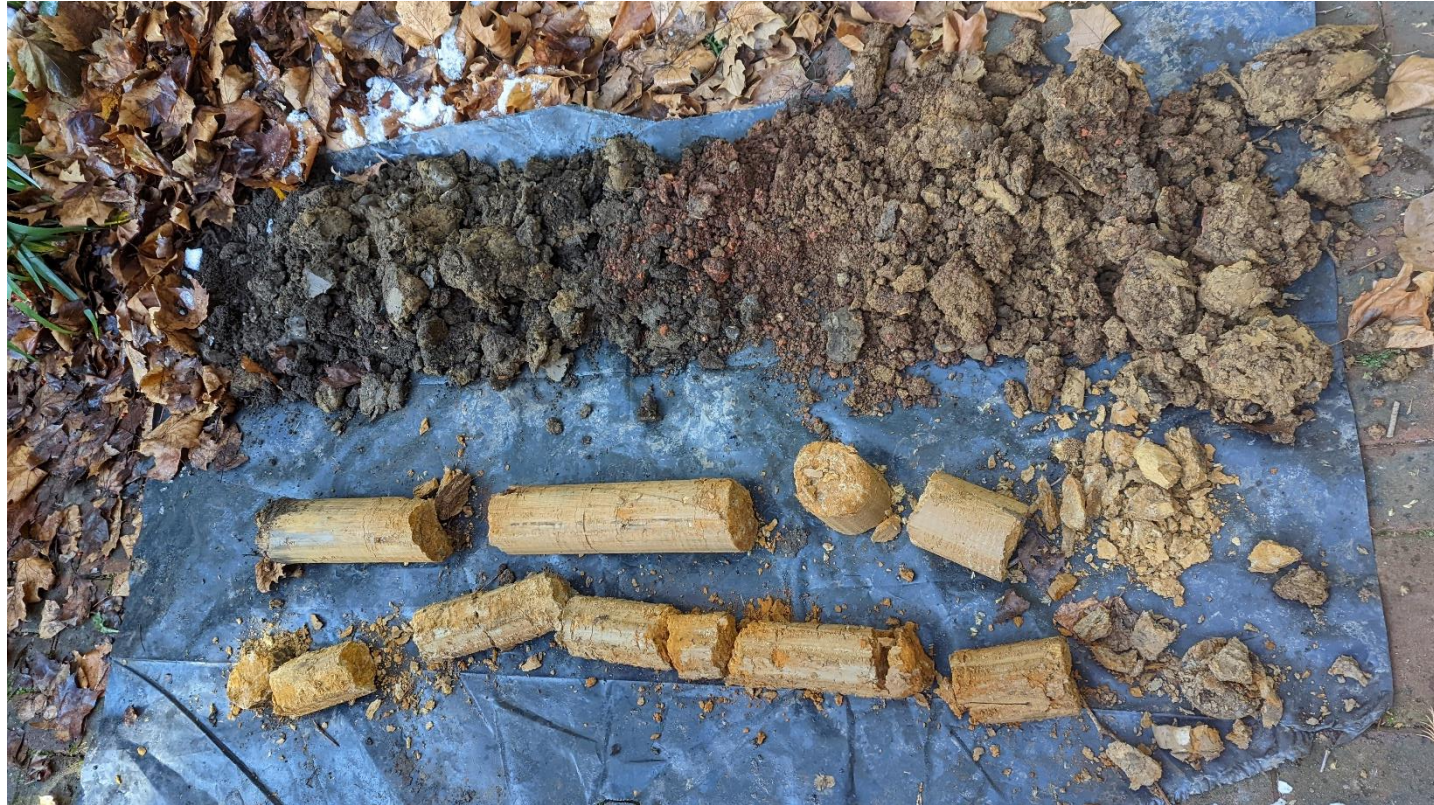
Client CHI AND JUNE CHEUNG	Title WS01		Site 50 Maresfield Gardens		
	Core Run		Created JP	Checked AB	Authorised DS
	Depth From (m) 1.20	Depth To (m) 4.00	Status FINAL	Rev 00	Project No 26822

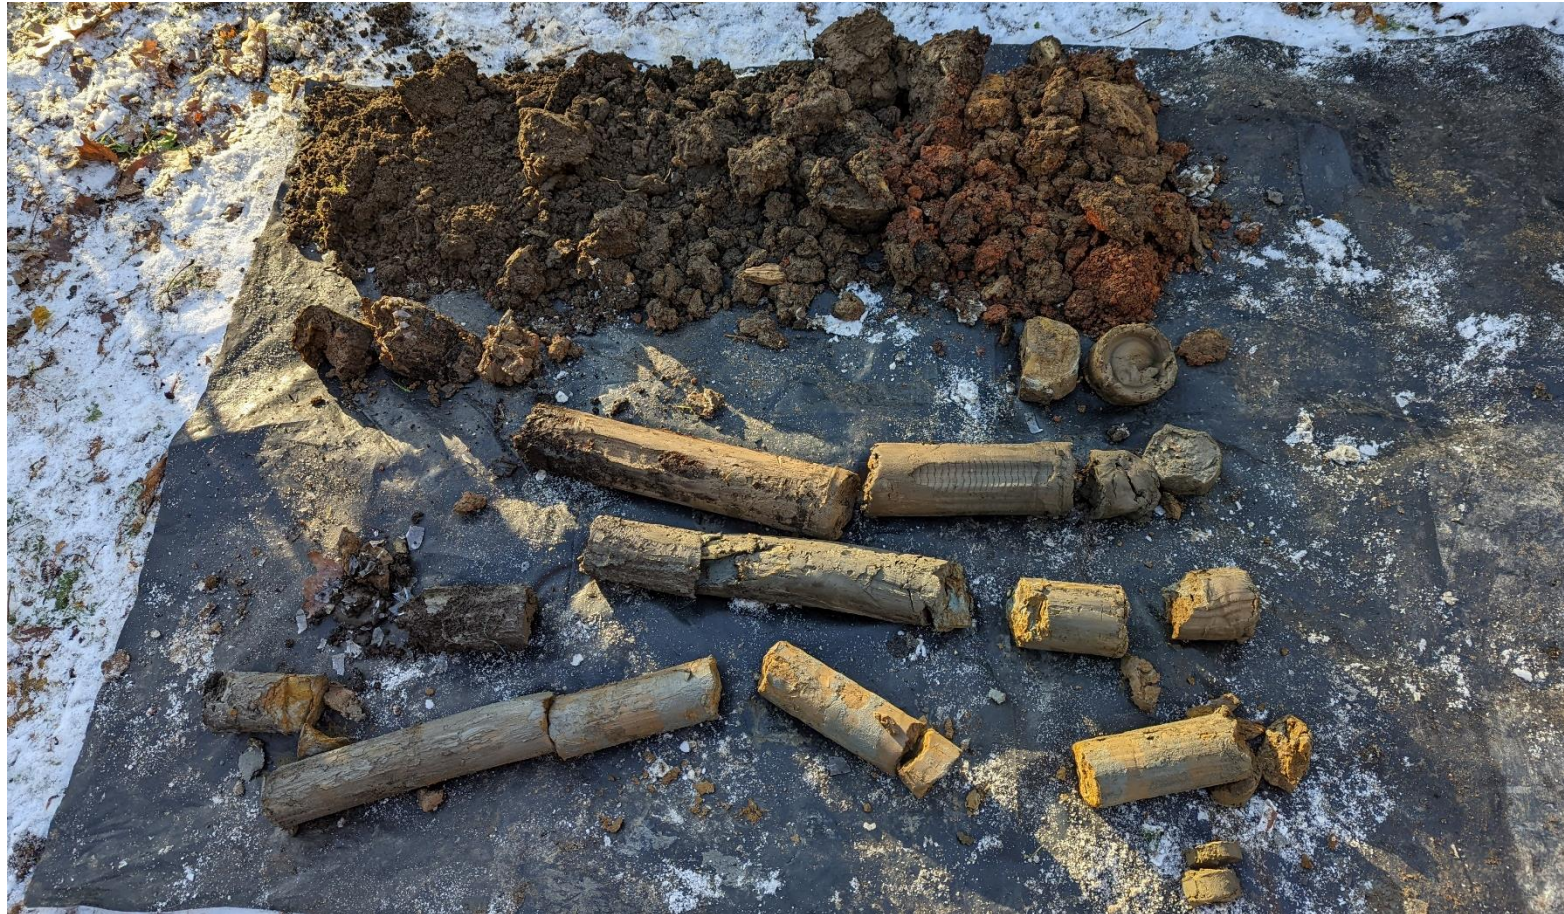
Client CHI AND JUNE CHEUNG	Title WS02		Site 50 Maresfield Gardens		
	Core Run		Created JP	Checked AB	Core Run DS
	Depth From (m) 1.20	Depth To (m) 6.00	Status FINAL	Rev 00	Project No 26822

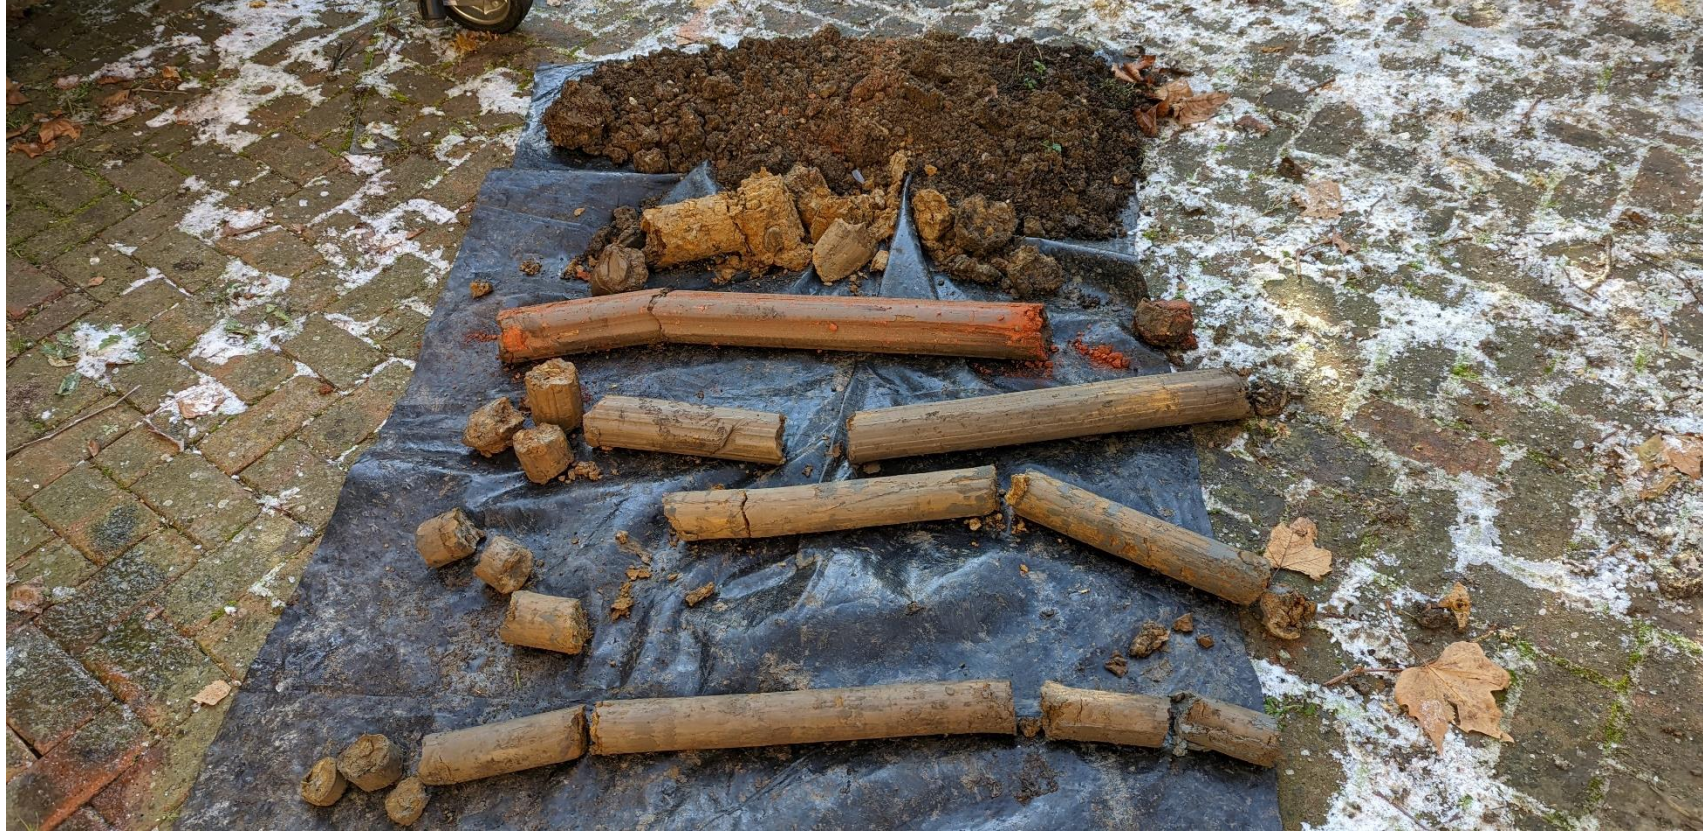
Client CHI AND JUNE CHEUNG		Title WS03		Site 50 Maresfield Gardens		
		Core Run		Created JP	Checked AB	Authorised DS
		Depth From (m) 0.00	Depth To (m) 6.00	0Status FINAL	Rev 00	Project No 26822

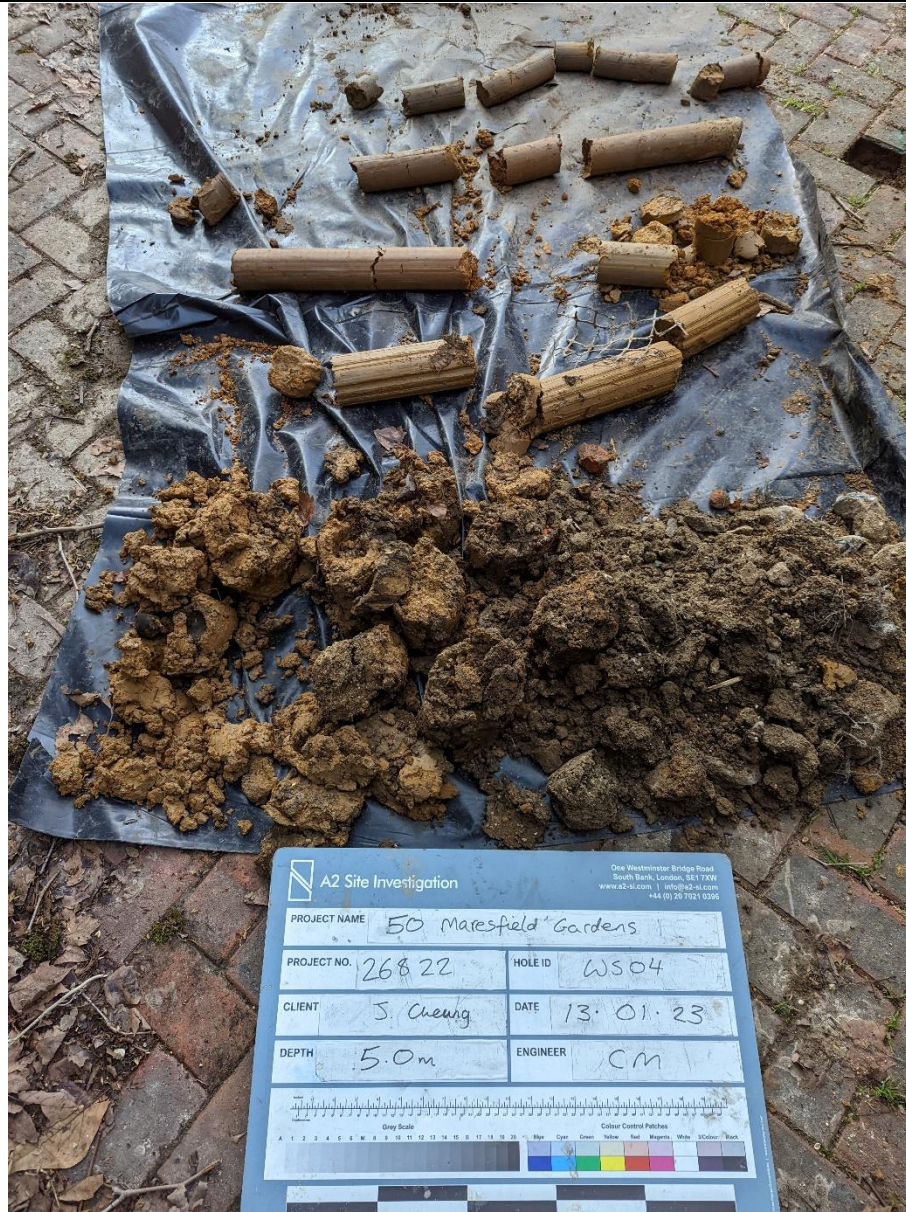
Client CHI AND JUNE CHEUNG	Title WS04		Site 50 Maresfield Gardens		
	Core Run		Created JP	Checked AB	Authorised DS
	Depth From (m) 0.00	Depth To (m) 5.00	Status FINAL	Rev 00	Project No 26822

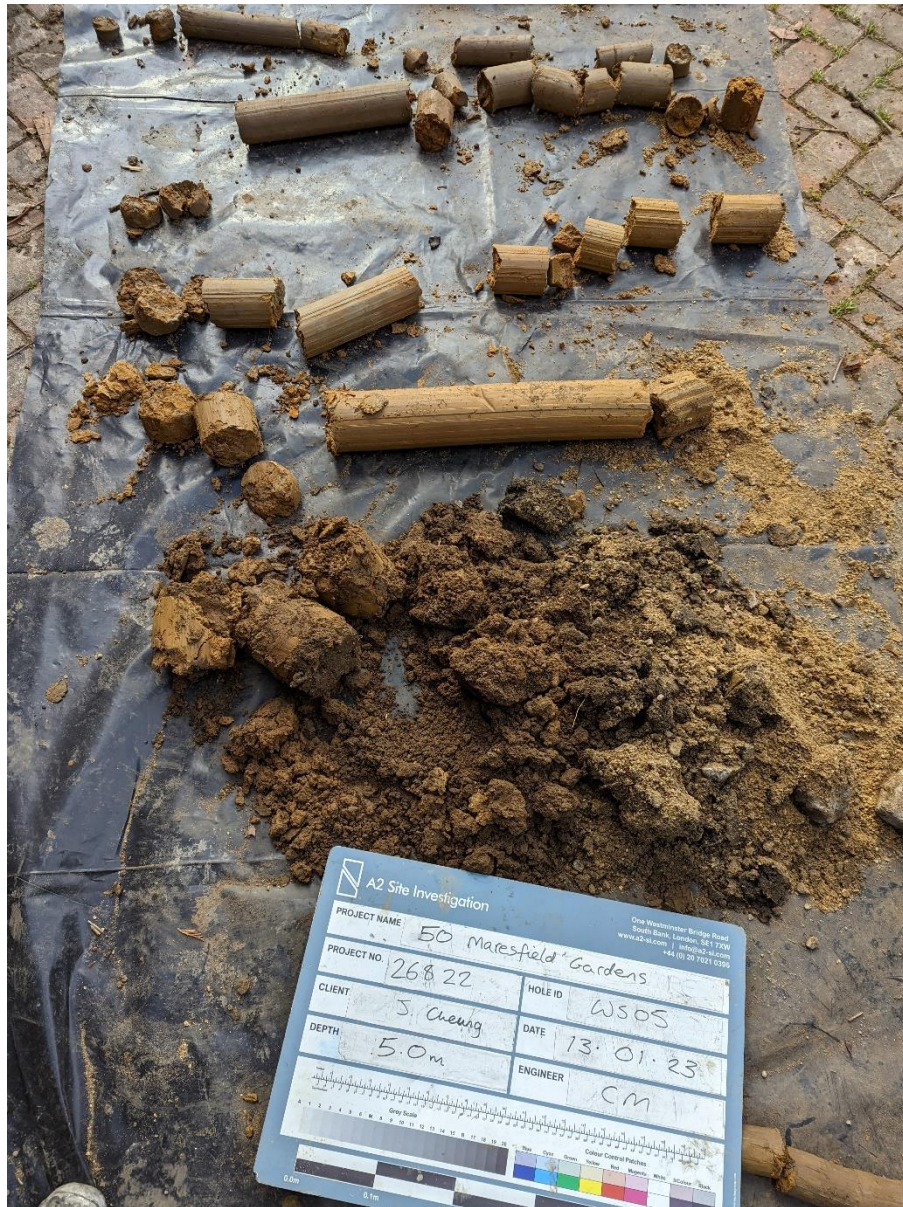
Client CHI AND JUNE CHEUNG	Title WS05		Site 50 Maresfield Gardens		
	Core Run		Created JP	Checked AB	Core Run DS
	Depth From (m) 0.00	Depth To (m) 5.00	Status FINAL	Rev 00	Project No 26822
