Project 9 Bedford Row

Code QA220

Date 28th July 2023

Revision	Issue Date	Issued for
A	28/07/2023	Draft Issue to consultants

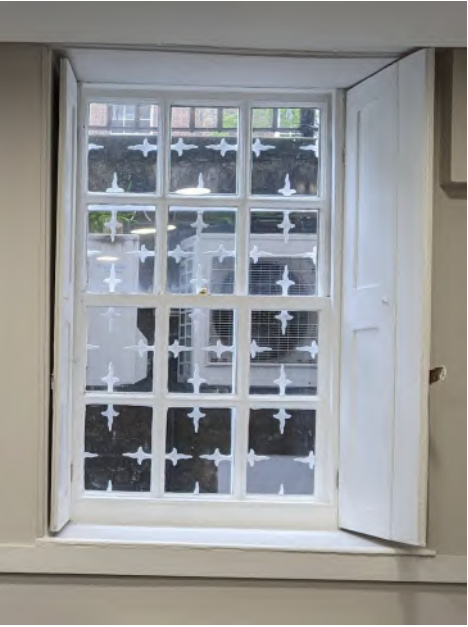
Code	Location	Existing Condition	Photo	Proposed Condition
Basement				
WB.01	Bedford Row	Meeting (B06) <ul style="list-style-type: none">Existing 6 over 6 timber sash windowSecurity bars in front of window on exterior faceSide hung foldable internal shutters

<ul style="list-style-type: none">Sashes and sash box retained and refurbishedSills to be repaired locally where necessarySashes to be sanded back and redecorated
WB.02		Meeting (B06) <ul style="list-style-type: none">Existing 6 over 6 timber sash windowSecurity bars in front of window on exterior faceSide hung foldable internal shutters

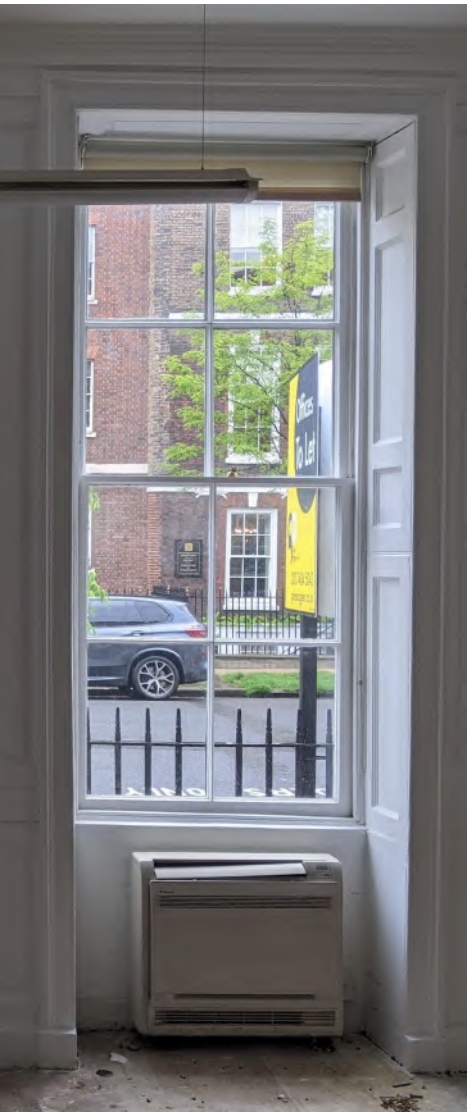
Code	Location	Existing Condition	Photo	Proposed Condition
Ground Floor				
WG.01	Meeting (G02)	<ul style="list-style-type: none">Existing 4 over 4 timber sash windowSide hung foldable internal shutters sealed open

<ul style="list-style-type: none">Sashes and sash box retained and refurbishedSills to be repaired locally where necessarySashes to be sanded back and redecoratedFoldable internal shutters to be made operable
WG.02	Meeting (G02)	<ul style="list-style-type: none">Existing 4 over 4 timber sash windowSide hung foldable internal shutters sealed open

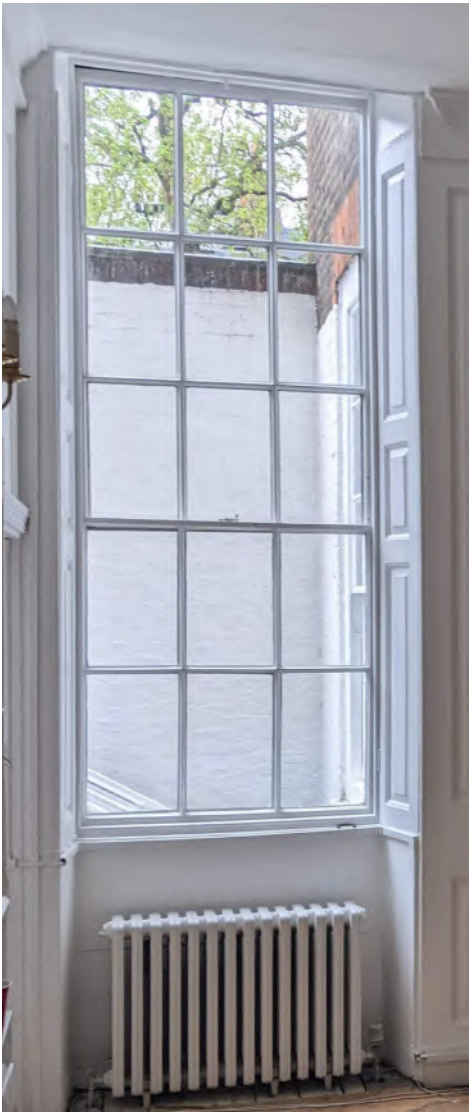
Code	Location		Existing Condition	Photo	Proposed Condition
WG.05	Bedford Row	Meeting (G04)	<ul style="list-style-type: none">Existing 9 over 6 timber sash windowSide hung foldable internal shutters sealed open

<ul style="list-style-type: none">Sashes and sash box retained and refurbishedSills to be repaired locally where necessarySashes to be sanded back and redecoratedFoldable internal shutters to be made operable
WG.06		Hall (G06)	<ul style="list-style-type: none">Existing 2 over 2 timber sash windowSecurity bars in front of window on internal face

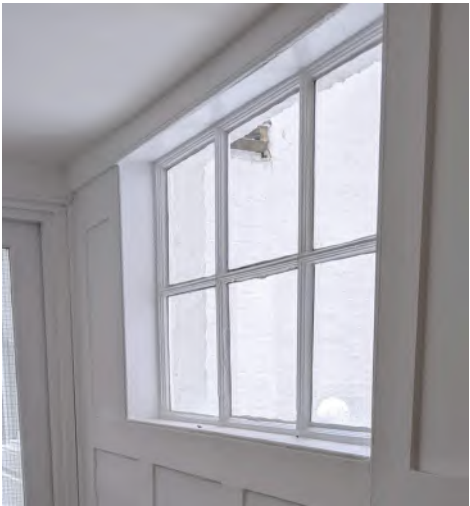
<ul style="list-style-type: none">Sashes and sash box retained and refurbished to become operableSills to be repaired locally where necessarySashes to be sanded back and redecorated
WG.07		Hall (G06)	<ul style="list-style-type: none">Existing 6 pane fixed window

<ul style="list-style-type: none">New timber sash window to match existing detailsSill height lowered to match windows on adjacent walls

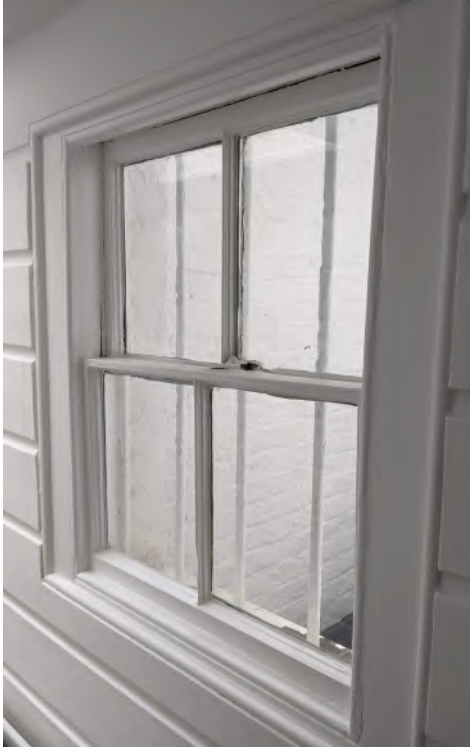
Code	Location		Existing Condition	Photo	Proposed Condition
WG.08		Hall (G09)	<ul style="list-style-type: none">Existing 2 over 2 timber sash windowSecurity bars in front of window on external face

<ul style="list-style-type: none">New timber sash window to match existing detailsSill height lowered to match windows on adjacent lightwell walls
WG.09		Meeting (G05)	<ul style="list-style-type: none">Existing 9 over 6 timber sash windowSide hung foldable internal shutters sealed open

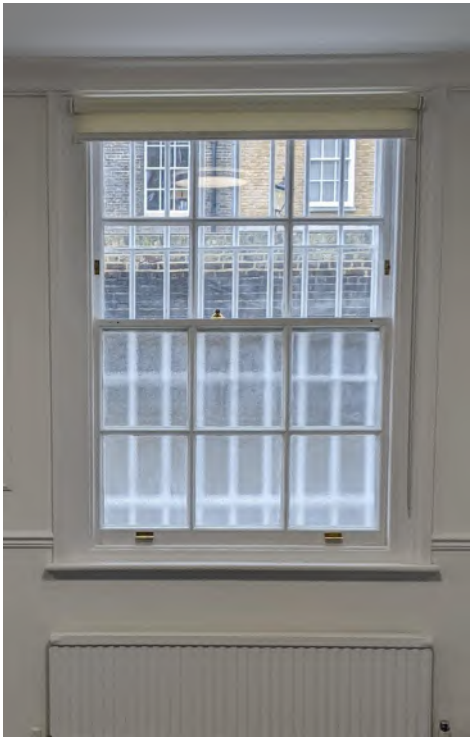
Code	Location		Existing Condition	Photo	Proposed Condition
WG.16		Office (G19)	<ul style="list-style-type: none">Existing non original 6 over 6 timber sash windowSecurity bars in front of window on exterior face

<ul style="list-style-type: none">Sashes and sash box retained and refurbishedSills to be repaired locally where necessarySashes to be sanded back and redecorated
WG.17		Office (G19)	<ul style="list-style-type: none">Existing non original 6 over 6 timber sash window

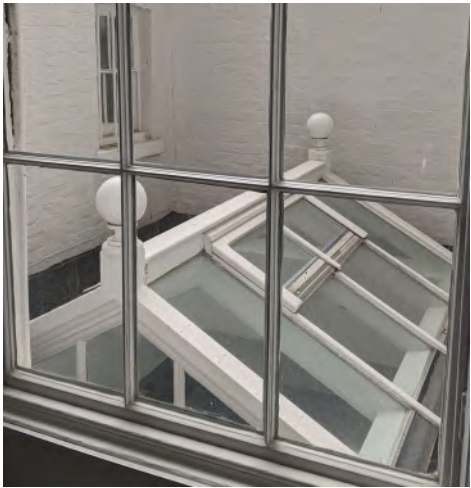
<ul style="list-style-type: none">Sashes and sash box retained and refurbishedSills to be repaired locally where necessarySashes to be sanded back and redecorated
WG.18	Bedford Row	Kitchen (G07)	<ul style="list-style-type: none">None	<ul style="list-style-type: none">N/A	<ul style="list-style-type: none">New 9 over 6 timber sash window with details to match existing
RG.01	Bedford Row	Central Lightwell	<ul style="list-style-type: none">Existing metal rooflight above basement

<ul style="list-style-type: none">Rooflight omitted

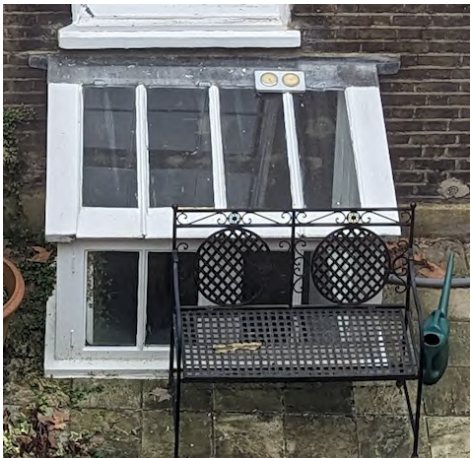
Code	Location		Existing Condition	Photo	Proposed Condition
RG.02	Bedford Row	Courtyard	<ul style="list-style-type: none">Existing metal rooflight above basement

<ul style="list-style-type: none">Rooflight omitted
First Floor					
W01.01		Office (101)	<ul style="list-style-type: none">Existing 9 over 6 timber sash windowSide hung foldable internal shutters sealed open

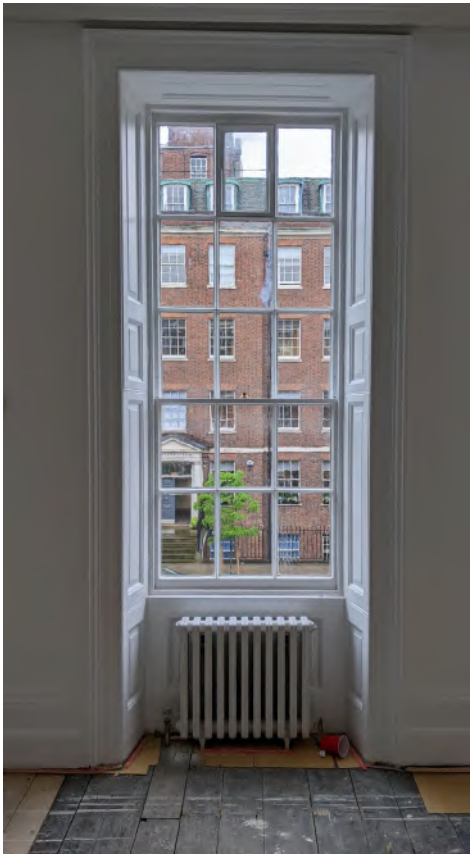
<ul style="list-style-type: none">Sashes and sash box retained and refurbishedSills to be repaired locally where necessarySashes to be sanded back and redecoratedFoldable internal shutters to be made operable
W01.02		Office (101)	<ul style="list-style-type: none">Existing 9 over 6 timber sash windowSide hung foldable internal shutters sealed open

<ul style="list-style-type: none">Sashes and sash box retained and refurbishedSills to be repaired locally where necessarySashes to be sanded back and redecoratedFoldable internal shutters to be made operable

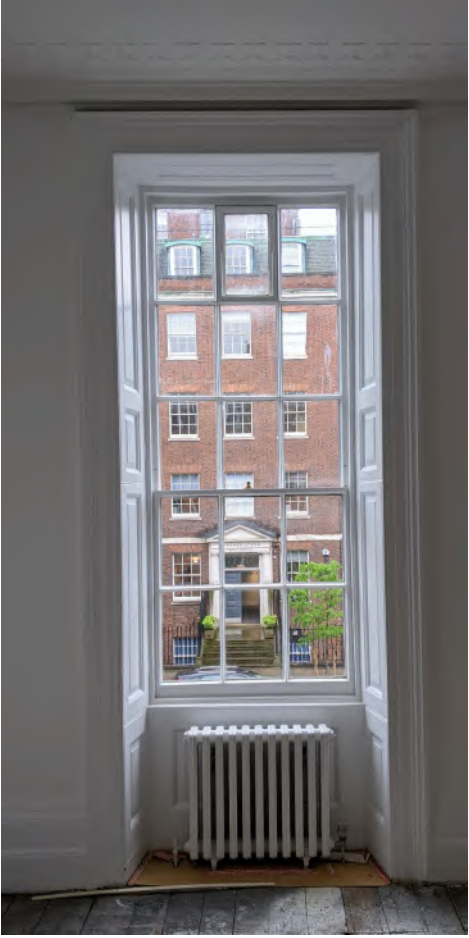
Code	Location		Existing Condition	Photo	Proposed Condition
W01.03	Bedford Row	Office (101)	<ul style="list-style-type: none">Existing 9 over 6 timber sash windowSide hung foldable internal shutters sealed open

<ul style="list-style-type: none">Sashes and sash box retained and refurbishedSills to be repaired locally where necessarySashes to be sanded back and redecoratedFoldable internal shutters to be made operable
W01.04		Office (105)	<ul style="list-style-type: none">Existing 9 over 6 timber sash windowSide hung foldable internal shutters sealed open

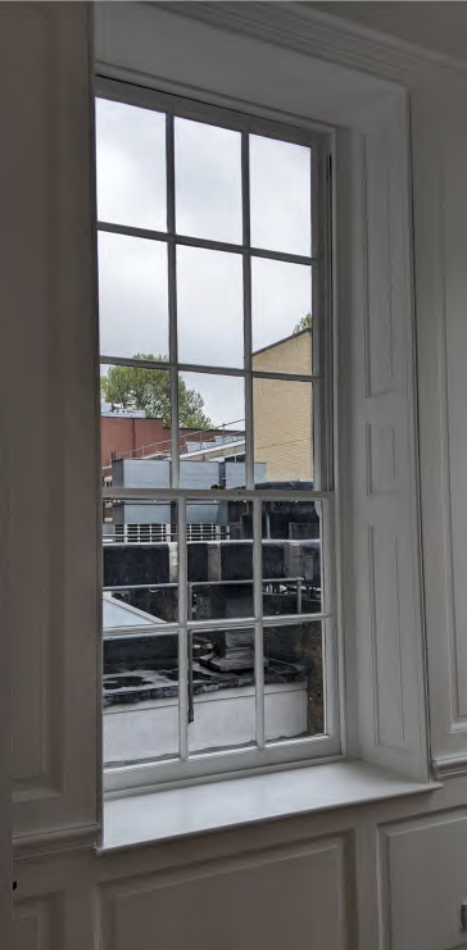
Code	Location		Existing Condition	Photo	Proposed Condition
W01.05		Office (105)	<ul style="list-style-type: none">Existing 9 over 6 timber sash windowSide hung foldable internal shutters sealed open

<ul style="list-style-type: none">Sashes and sash box retained and refurbishedSills to be repaired locally where necessarySashes to be sanded back and redecoratedFoldable internal shutters to be made operable
W01.06		Office (103)	<ul style="list-style-type: none">Existing 9 over 6 timber sash windowSide hung foldable internal shutters sealed open

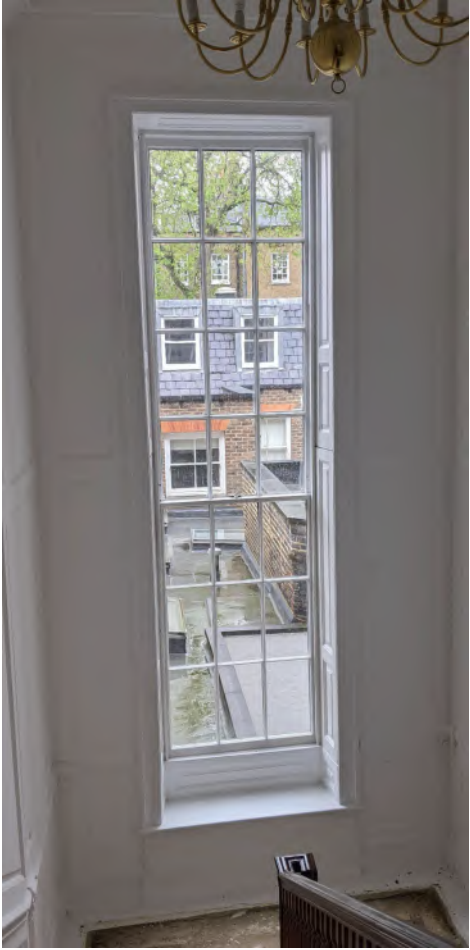
Code	Location		Existing Condition	Photo	Proposed Condition
W01.07		Stairhall (104)	<ul style="list-style-type: none">Existing 12 over 9 timber sash windowSide hung foldable internal shutters sealed open

<ul style="list-style-type: none">Sashes and sash box retained and refurbishedSills to be repaired locally where necessarySashes to be sanded back and redecorated
W01.08		Office (114)	<ul style="list-style-type: none">Existing 1 over 1 sash window

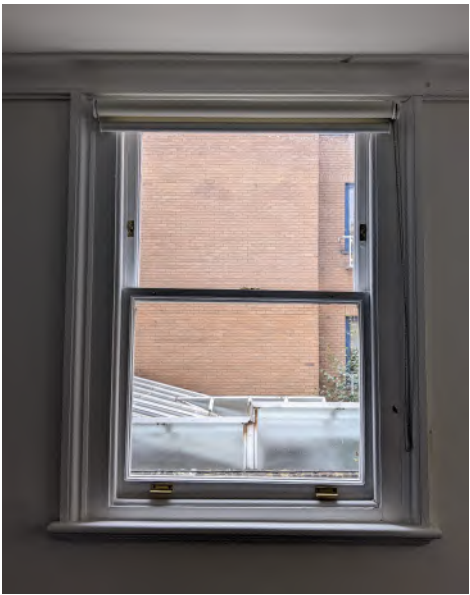
<ul style="list-style-type: none">Omitted
W01.09		Office (114)	<ul style="list-style-type: none">Existing 1 over 1 sash window

<ul style="list-style-type: none">Omitted

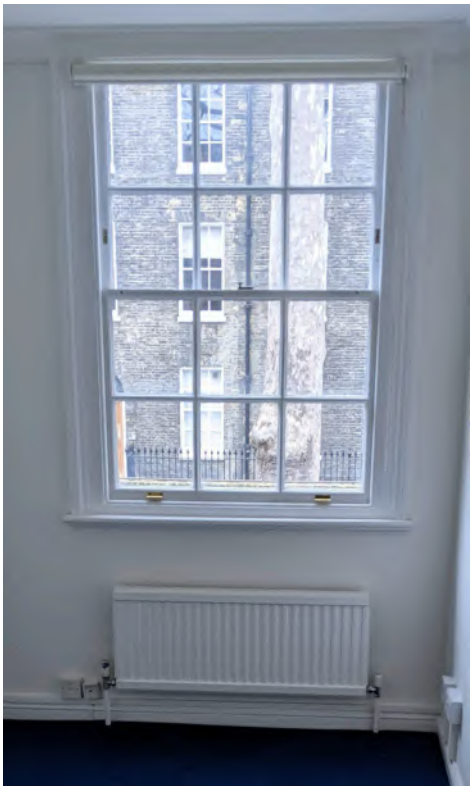
Code	Location		Existing Condition	Photo	Proposed Condition
W01.13		Office (108)	<ul style="list-style-type: none">Existing non original 6 over 6 timber sash window

<ul style="list-style-type: none">Sashes and sash box retained and refurbishedSills to be repaired locally where necessarySashes to be sanded back and redecoratedNew ironmongery
W01.14		Office (107)	<ul style="list-style-type: none">Existing non original 6 over 6 timber sash window

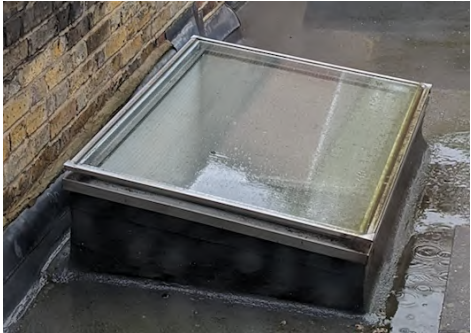
<ul style="list-style-type: none">Sashes and sash box retained and refurbishedSills to be repaired locally where necessarySashes to be sanded back and redecoratedNew ironmongery
W01.14		Studio (110)	<ul style="list-style-type: none">None	<ul style="list-style-type: none">N/A	<ul style="list-style-type: none">New metal casement window
R01.01	Bedford	Above link	<ul style="list-style-type: none">Existing rooflight over modern link

<ul style="list-style-type: none">Omitted

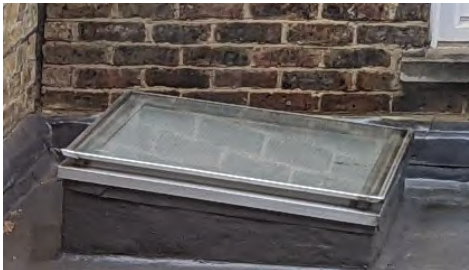
Code	Location		Existing Condition	Photo	Proposed Condition
R01.03	Row	Above link	<ul style="list-style-type: none">Existing rooflight over modern link

<ul style="list-style-type: none">Omitted
R01.04		Above link	<ul style="list-style-type: none">Existing rooflight over modern link

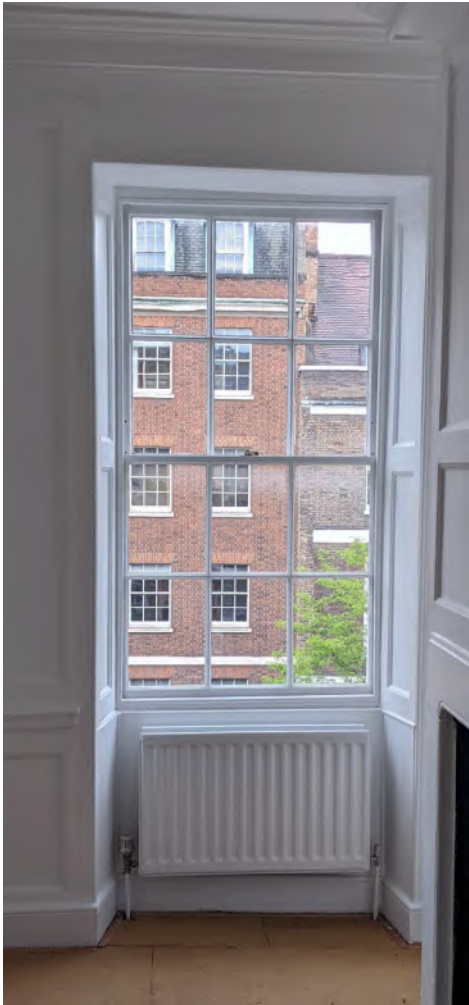
<ul style="list-style-type: none">Omitted
R01.05		Above Kitchen	<ul style="list-style-type: none">N/A	<ul style="list-style-type: none">N/A	<ul style="list-style-type: none">Aluminium profile roof light with double glazed panels
Second Floor					
W02.01		Office (203)	<ul style="list-style-type: none">Existing 6 over 6 timber sash windowSide hung foldable internal shutters sealed open

<ul style="list-style-type: none">Sashes and sash box retained and refurbishedSills to be repaired locally where necessarySashes to be sanded back and redecoratedFoldable internal shutters to be made operableNew ironmongery

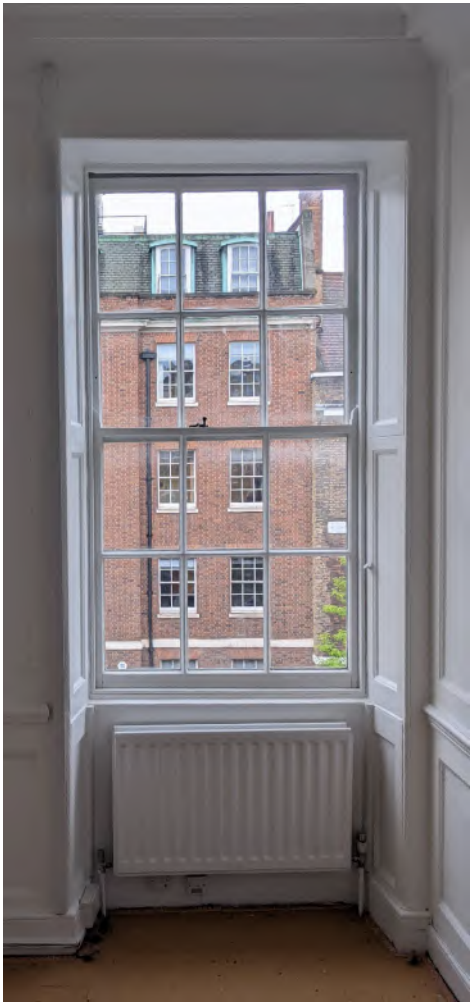
Code	Location		Existing Condition	Photo	Proposed Condition
W02.02		Office (204)	<ul style="list-style-type: none">Existing 6 over 6 timber sash windowSide hung foldable internal shutters sealed open

<ul style="list-style-type: none">Sashes and sash box retained and refurbishedSills to be repaired locally where necessarySashes to be sanded back and redecoratedFoldable internal shutters to be made operableNew ironmongery
W02.03		Office (205)	<ul style="list-style-type: none">Existing 6 over 6 timber sash windowSide hung foldable internal shutters sealed open

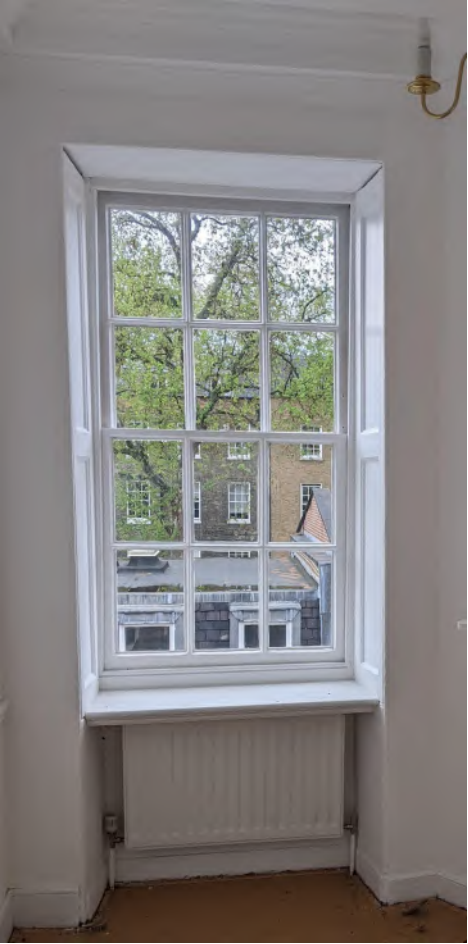
Code	Location		Existing Condition	Photo	Proposed Condition
W02.04	Bedford Row	Office (208)	<ul style="list-style-type: none">Existing 6 over 6 timber sash windowSide hung foldable internal shutters sealed open

<ul style="list-style-type: none">Sashes and sash box retained and refurbishedSills to be repaired locally where necessarySashes to be sanded back and redecoratedFoldable internal shutters to be made operableNew ironmongery
W02.05		Office (208)	<ul style="list-style-type: none">Existing 6 over 6 timber sash window	 	<ul style="list-style-type: none">Sashes and sash box retained and refurbishedSills to be repaired locally where necessarySashes to be sanded back and redecoratedNew ironmongery

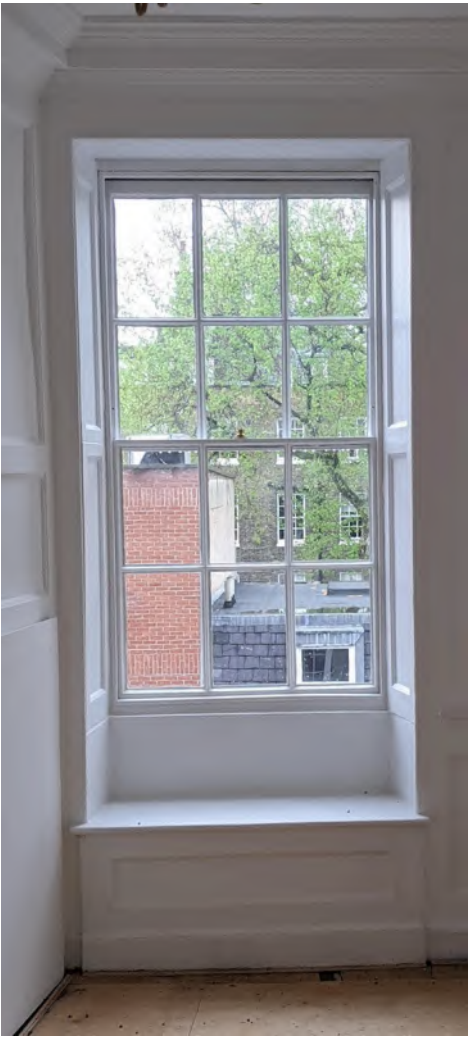
Code	Location		Existing Condition	Photo	Proposed Condition
W02.06		Office (207)	<ul style="list-style-type: none">Existing 6 over 6 timber sash windowSide hung foldable internal shutters sealed open

<ul style="list-style-type: none">Sashes and sash box retained and refurbishedSills to be repaired locally where necessarySashes to be sanded back and redecoratedInternal shutters refurbished to be made operableNew ironmongery
W02.07		Office (206)	<ul style="list-style-type: none">Existing 6 over 6 timber sash windowSide hung foldable internal shutters sealed open

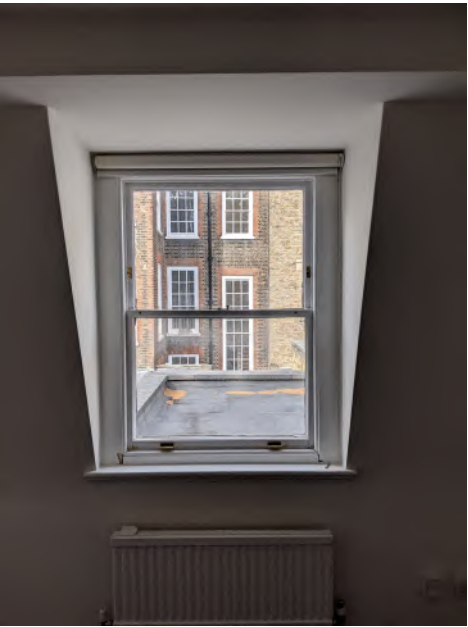
Code	Location		Existing Condition	Photo	Proposed Condition
W02.08		Office (213)	<ul style="list-style-type: none">Existing 1 over 1 timber sash window

<ul style="list-style-type: none">Existing non original window stripped outNew metal window
W02.09		Office (213)	<ul style="list-style-type: none">Existing 1 over 1 timber sash window

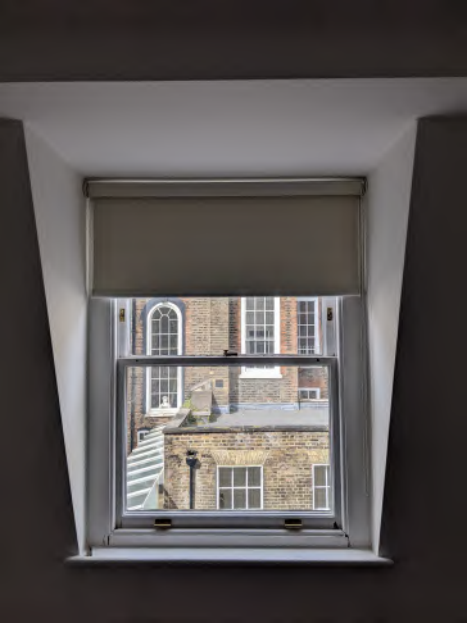
<ul style="list-style-type: none">Existing non original window stripped outNew metal window
W02.10		Office (212)	<ul style="list-style-type: none">Existing 1 over 1 timber sash window

<ul style="list-style-type: none">Existing non original window stripped outNew metal window

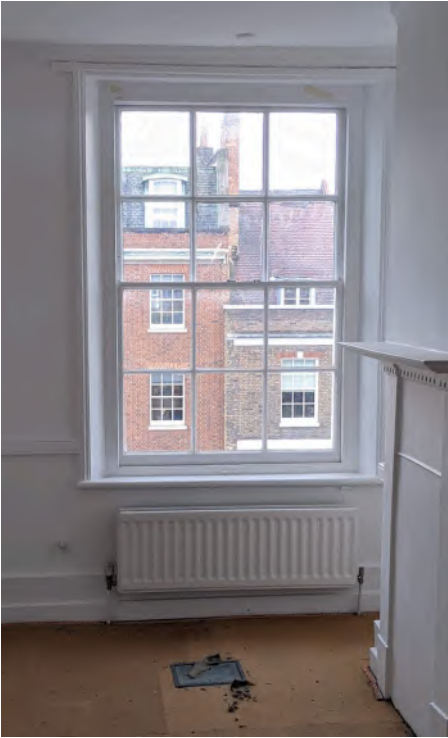
Code	Location	Existing Condition	Photo	Proposed Condition
Third Floor				
W03.01	Office (304)	<ul style="list-style-type: none">Existing 6 over 6 timber sash window

<ul style="list-style-type: none">Sashes and sash box retained and refurbishedSills to be repaired locally where necessarySashes to be sanded back and redecoratedNew ironmongery
W03.02		<ul style="list-style-type: none">Existing 6 over 6 timber sash window

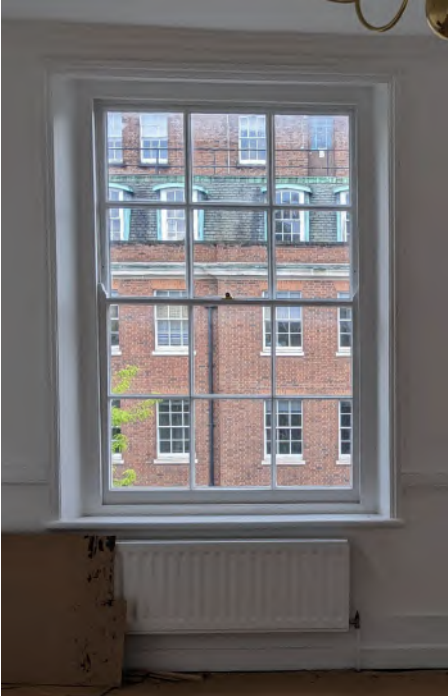
<ul style="list-style-type: none">Sashes and sash box retained and refurbishedSills to be repaired locally where necessarySashes to be sanded back and redecoratedNew ironmongery
W03.03		<ul style="list-style-type: none">Existing 6 over 6 timber sash window

<ul style="list-style-type: none">Sashes and sash box retained and refurbishedSills to be repaired locally where necessarySashes to be sanded back and redecoratedNew ironmongery

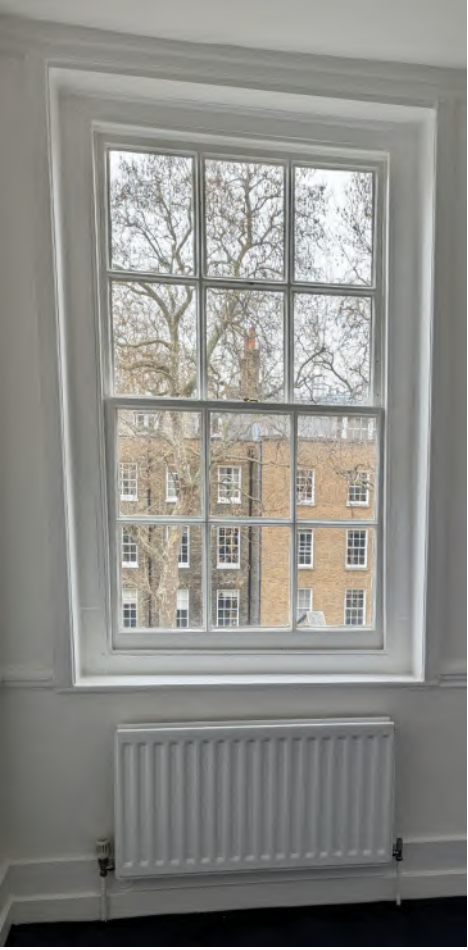
Code	Location		Existing Condition	Photo	Proposed Condition
W03.04	Bedford Row	Office (308)	<ul style="list-style-type: none">Existing 6 over 6 timber sash window

<ul style="list-style-type: none">Sashes and sash box retained and refurbishedSills to be repaired locally where necessarySashes to be sanded back and redecoratedNew ironmongery
W03.05		Office (306)	<ul style="list-style-type: none">Existing 6 over 6 timber sash window	 	<ul style="list-style-type: none">Sashes and sash box retained and refurbishedSills to be repaired locally where necessarySashes to be sanded back and redecoratedNew ironmongery

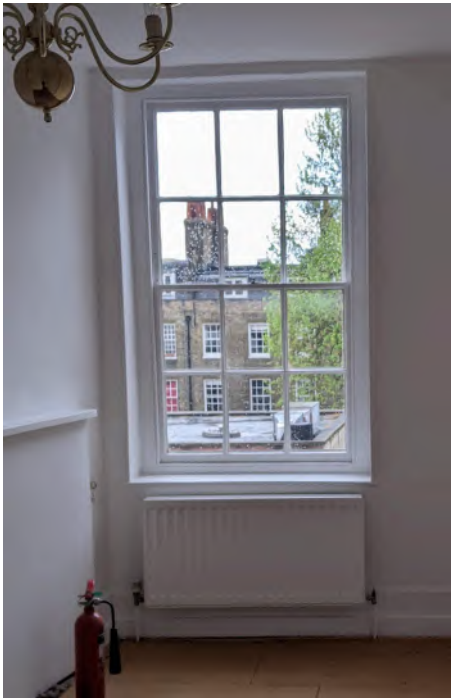
Code	Location		Existing Condition	Photo	Proposed Condition
W03.06		Office (307)	<ul style="list-style-type: none">Existing 6 over 6 timber sash window

<ul style="list-style-type: none">Sashes and sash box retained and refurbishedSills to be repaired locally where necessarySashes to be sanded back and redecoratedNew ironmongery
R03.01	Jockey's Fields	Above stair	<ul style="list-style-type: none">Existing metal openable roof light

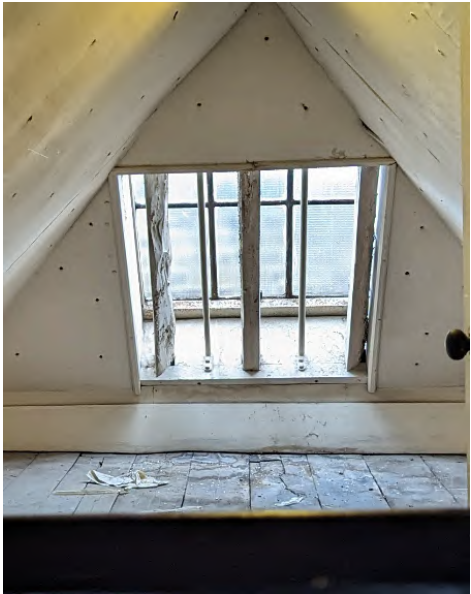
<ul style="list-style-type: none">Roof light refurbished
Roof / Loft					
W04.01		Loft	<ul style="list-style-type: none">Existing 6 pane fixed timber window

<ul style="list-style-type: none">Window frame retained and refurbishedSills to be repaired locally where necessary

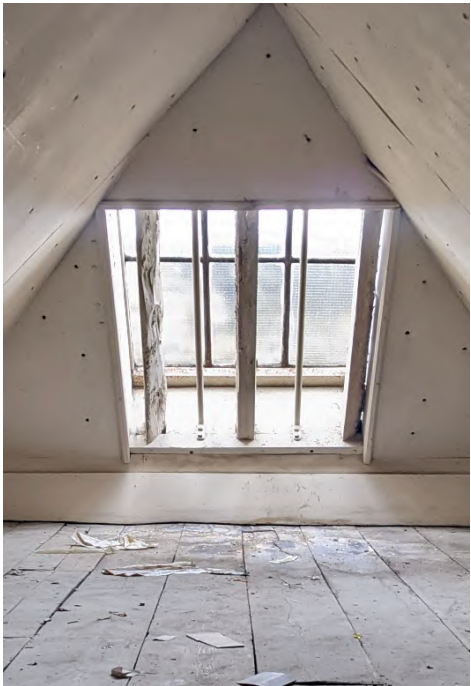
Code	Location		Existing Condition	Photo	Proposed Condition
W04.02	Bedford Row	Loft	<ul style="list-style-type: none">Existing 6 pane fixed timber window

<ul style="list-style-type: none">Window frame retained and refurbishedSills to be repaired locally where necessary
W04.03		Loft	<ul style="list-style-type: none">Existing 6 pane fixed timber window

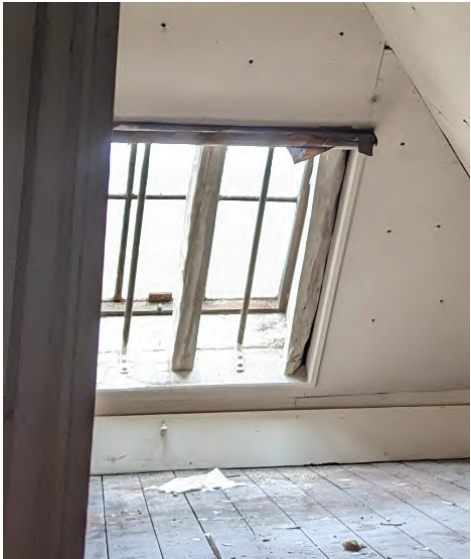
<ul style="list-style-type: none">Window frame retained and refurbishedSills to be repaired locally where necessary
W04.04		Loft	<ul style="list-style-type: none">Existing 6 pane fixed timber window

<ul style="list-style-type: none">Window frame retained and refurbishedSills to be repaired locally where necessary
