St John's Downshire Hill

Design, Access, and Conservation statement

Site Address: Downshire Hill, London NW3 1NU

Ref: 2026-MEB-XX-XX-RP-A-3-900

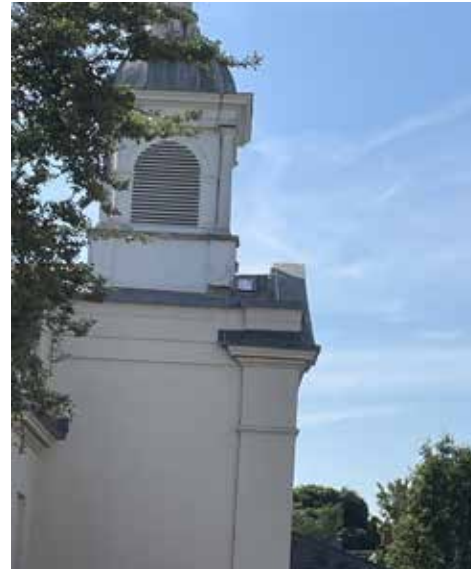
Image 7: North face of cupola

The cupola with its dome and side louvres, is constructed from timber, and clad in lead. Its pedestal is formed from a timber frame which is clad in render on all 4 sides.

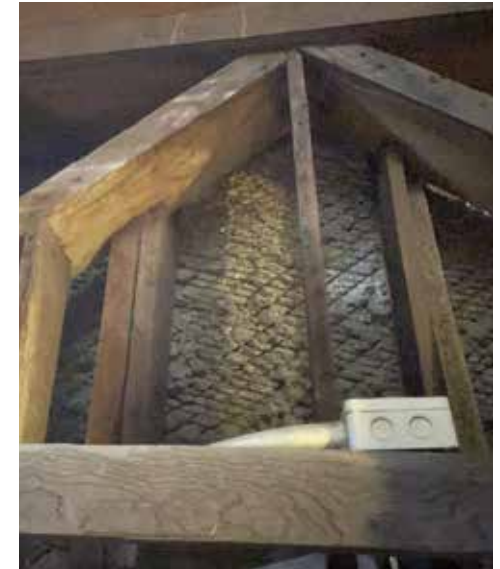
The original render to the plinth and its key (assumed to originally be timber lath) has been removed over the years and repaced with a modern metal lath. So nothing original of the pedestal apart from its timber carcass remains. When this replacement was done is not known, but is suspected to be during the 1960s.

The lath is now rusty (see image 8), and the render badly damaged on the north west corner (see image 9). The upstand junction with the roof in itself is also a very weak detail and has been the subject of previous repairs to the timber internally.

Image 8: rusting metal lath

The lath now needs to be replaced, the render repaired and the upstand improved, though to replace the lath will require all the render to be replaced. These necessary repairs give opportunity to improve the weathering of the junction of the roof and the render.

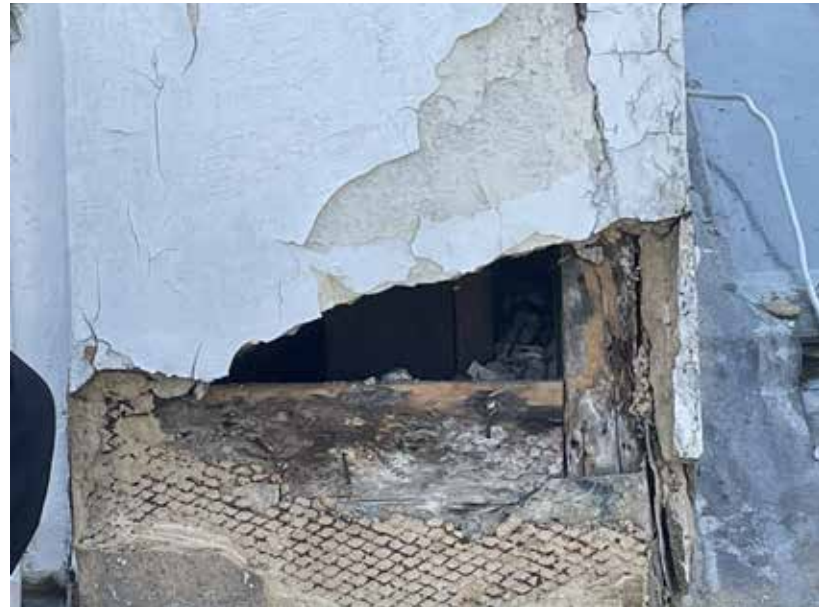
Image 9: render damaged - base north west corner of cupola

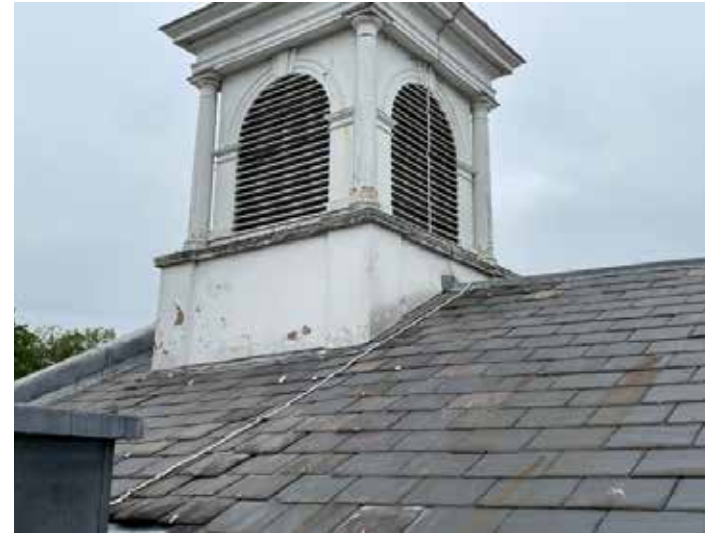
Image 10 - existing arrangement

Image 11: details of the base

- Remove all render and lath on the pedestal.
- Replace the lath with a stainless steel lath.
- Carry out any repairs to the timber carcass as required.
- Install a code 4, 150mm high, milled lead upstand flashing to all four sides of the pedestal following the roof lines.
- Rerender the pedestal using a hydraulic lime finishing on a stop bead.
- Decorate the render (to match) with a mineral paint.
