STATEMENT OF SIGNIFICANCE

2 Holly Terrace, London, N6 6LX

Emily Banks

Date: June 2022

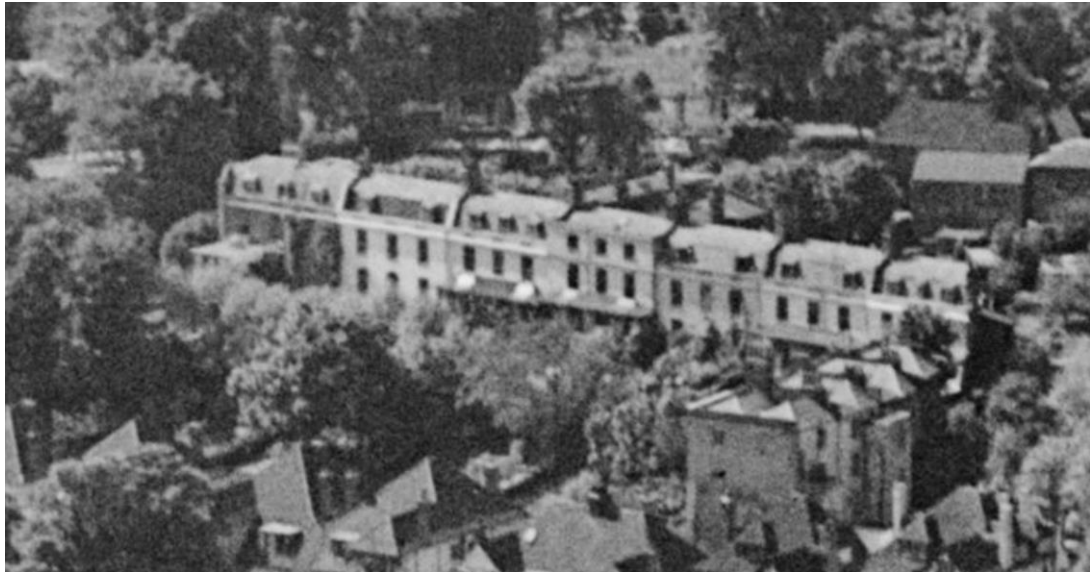
- 2.10 The properties are generally two storeys, plus basement and attic accommodation, except the central property, No.4, which has a full second floor. This was almost certainly an original feature, intended to form a central pavilion to the terrace, rather than a later change. This likelihood is supported by the building line to No.4 being set very slightly forward of the adjacent properties. If a later change, it had certainly occurred by 1939, when it can be seen on the aerial image at **Fig.1** (Historic England ref.EPW061150).

Fig.1. Aerial image from 26th May 1939 (Historic England ref.EPW061150)

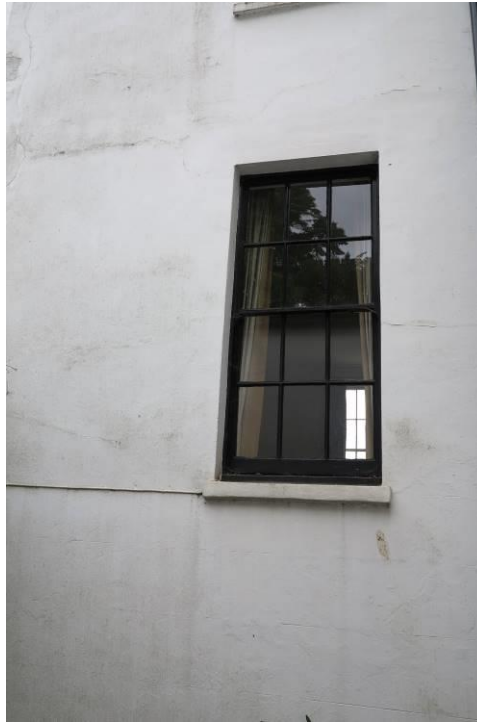
- 2.18 This infill was not removed until the mid-/late 20th century and examination of the existing ground-floor window opening in the eastern bay of the rear elevation indicates that this was reformed following the removal of the infill. For instance, the window itself is a modern horned sash and the opening has a flat head, while other window openings on the rear of this and adjacent buildings tend to have a slight camber (**plates 1 & 2**). Internally the window opening lacks the angled, panelled reveals/shutters and upstand found on all other windows to principal rooms, confirming that it has been either inserted or reformed at a later date.

Plate 1. The ground-floor window opening to the eastern bay on the rear elevation is a modern insertion or reinstatement

- 2.43 The drawing room to the east has a modern fireplace (**plate 31**). The front window here is set in a deep, canted reveal, with a panelled upstand and shutters (**plate 32**). As noted at paragraph 2.17 above, the rear window opening is a modern insertion or reinstatement and lacks these details.

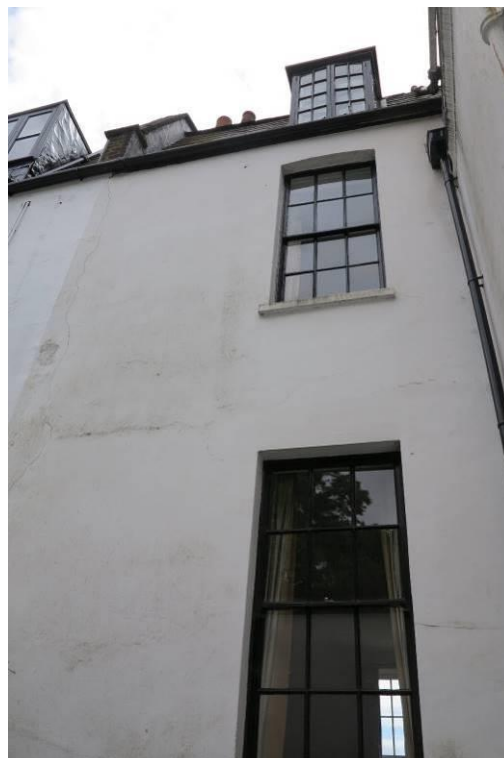
Plate 2. Original window openings on the rear of this and other of the Holly Terrace properties tend to have a slightly-cambered head

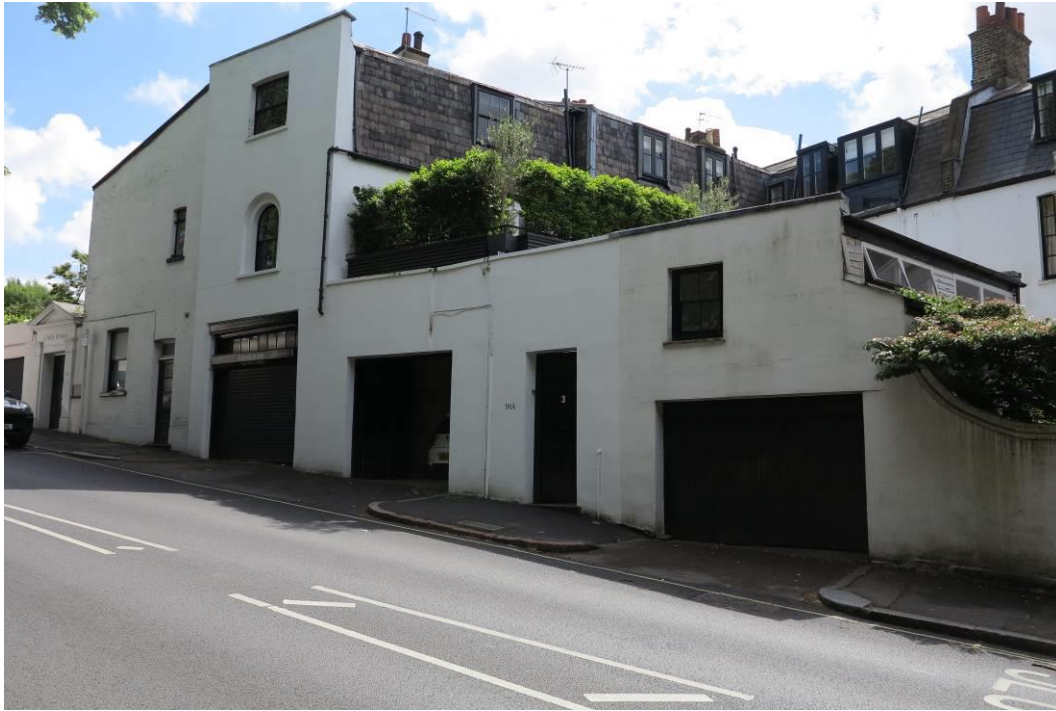
- 2.19 The rear elevations and yards of the Holly Terrace properties are visible when travelling down Highgate West Hill. These rear elements of the listed terrace have a highly-varied character, only really unified by their shared palette of white render (in some areas lightly rusticated) and slate roof coverings (**plate 3**).
- 2.20 The full-height rear projection to No. 4 extends all the way to the street boundary, as does the single-storey projection to No.3, which incorporates a garage and roof terrace.

Plate 3. The rear of Holly Terrace has a varied character

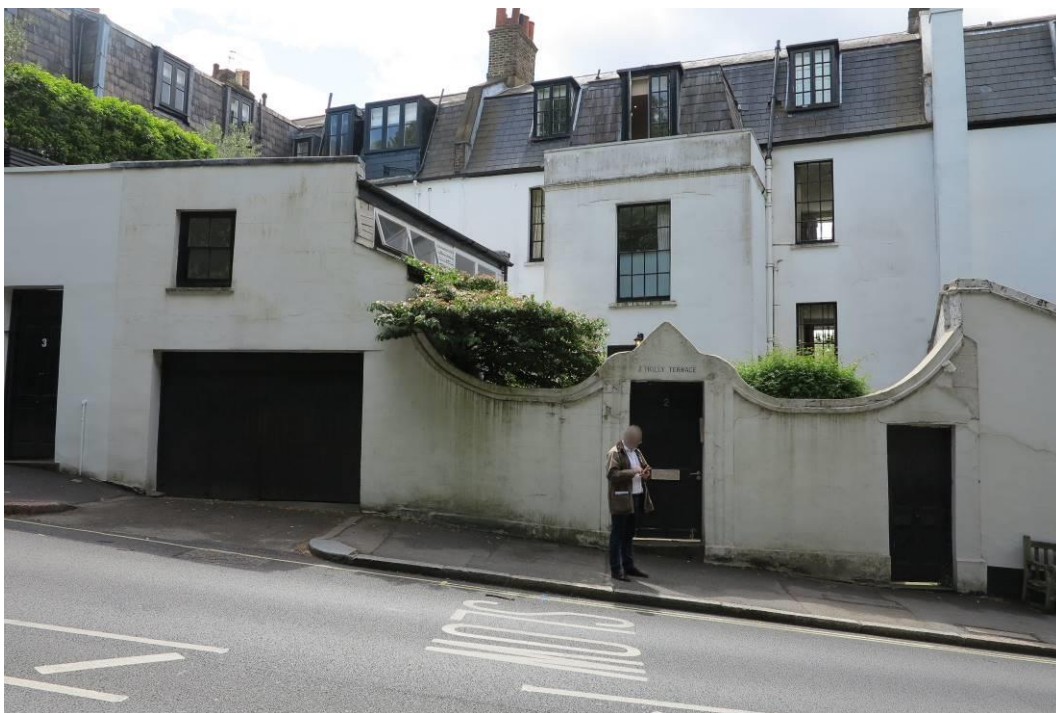
-
- 2.21 The street boundary to No.2 comprises the garage/coach-house block, which presents a garage opening to the street, and an attractive boundary wall, with a simplified pediment over the central entrance (**plate 4**).

- 2.22 The garage block is not an attractive feature of the view and has been visibly extended upwards, with an unsympathetic mansard set behind a parapet that has been lifted to match the adjacent parapet level to No.3.

Plate 4. The rear of No.2 from the street

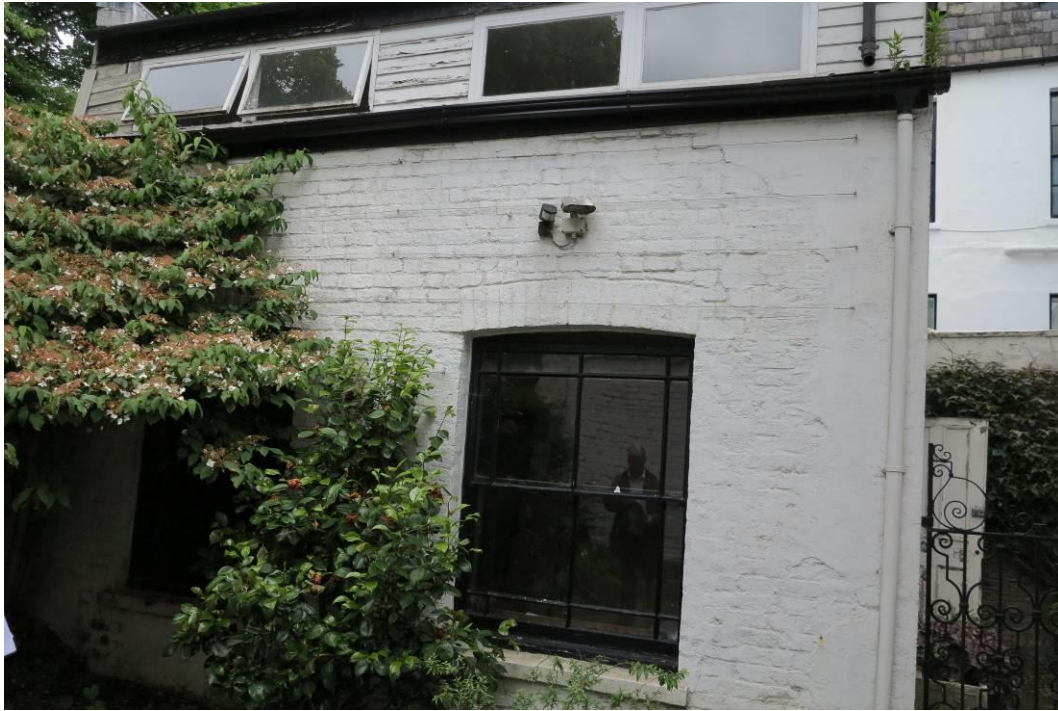
- 2.25 Moving into the yard, the garage/coach-house is a 19th-century, brick-built outbuilding, retaining mid-Victorian sashes with marginal glazing, but it has been very poorly treated, notably through the addition of the timber-clad mansard in the mid-/late 20th century (**plates 5 & 6**). Internally, this has involved inserting a first floor that cuts across the historic window heads (**plate 7**). The stair here is also a mid-/late 20th-century insertion and there is nothing of interest internally within the garage (**plates 8 & 9**). While I use the term 'garage/coach-house' in this report, the use of domestic windows suggests that the original use of this building was more likely an outbuilding directly associated with the function of the house, such as domestic offices.

Plate 5. The garage/coach-house from the yard

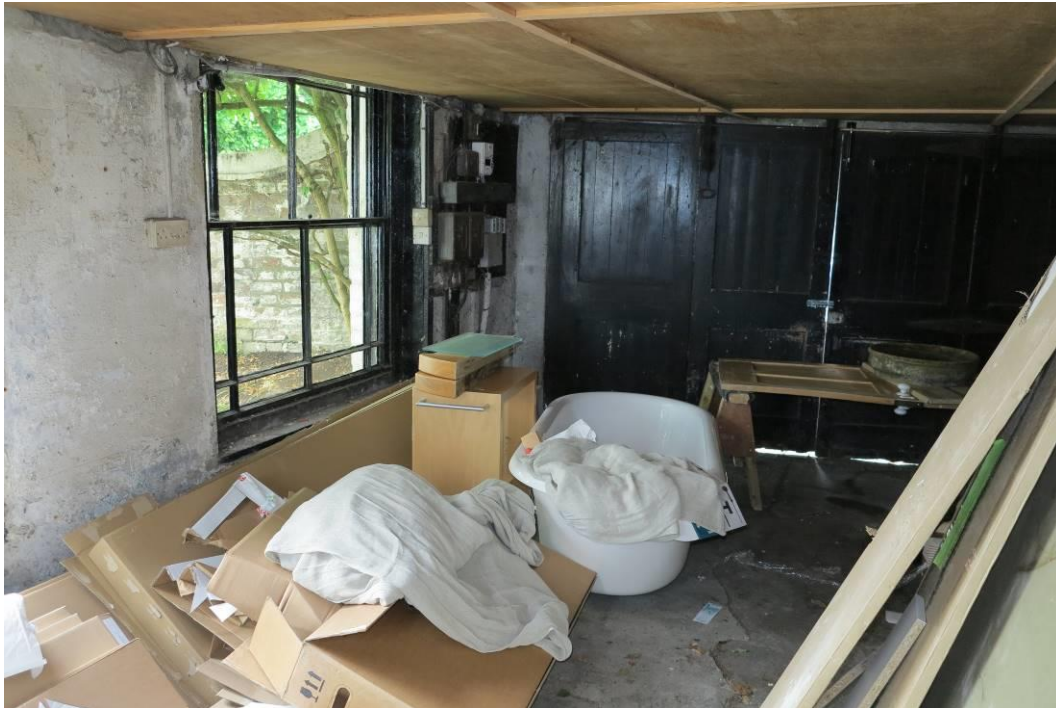
Plate 7. A first floor has been inserted in the garage/coach-house, cutting across the window openings

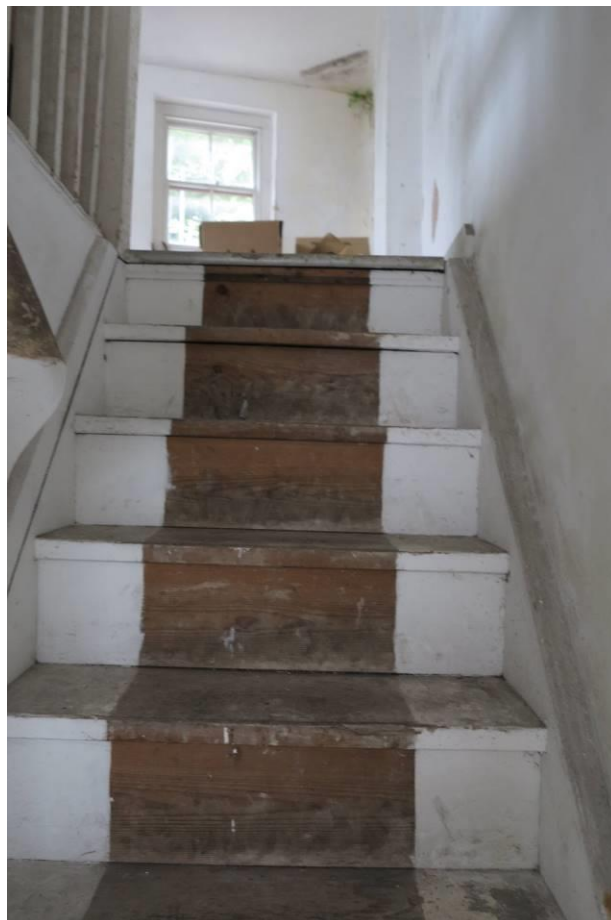
Plate 8. Modern stair in the garage/coach-house

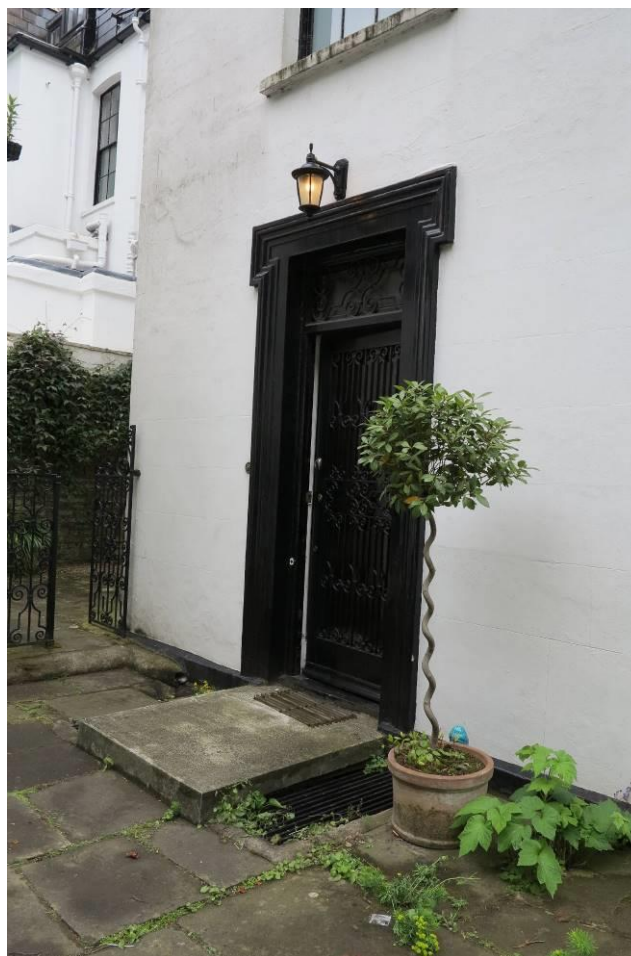
- 2.26 Returning to the main building, the closet wing provides a rear entrance. This has a rather grand, lugged, Baroque architrave, which must be a modern addition (**plate 10**).

Plate 10. The rear entrance set in the closet wing

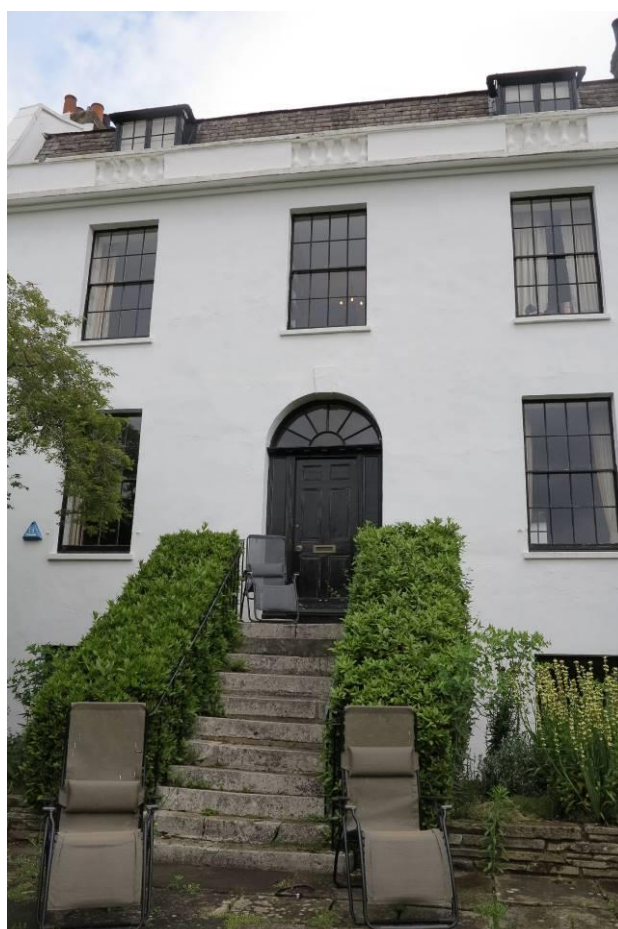
- 2.31 The southern elevation of No.2 is clearly its principal or 'front' elevation. Like the rest of the terrace, it is faced in plain, white stucco and is arranged as three bays set over two storeys plus basement and attic. The ground floor is set higher than the garden level, accessed from a stone stoop, with the basement windows, set into the lightwell, visible from the garden (**plate 16**).

Plate 16. The façade of No.2

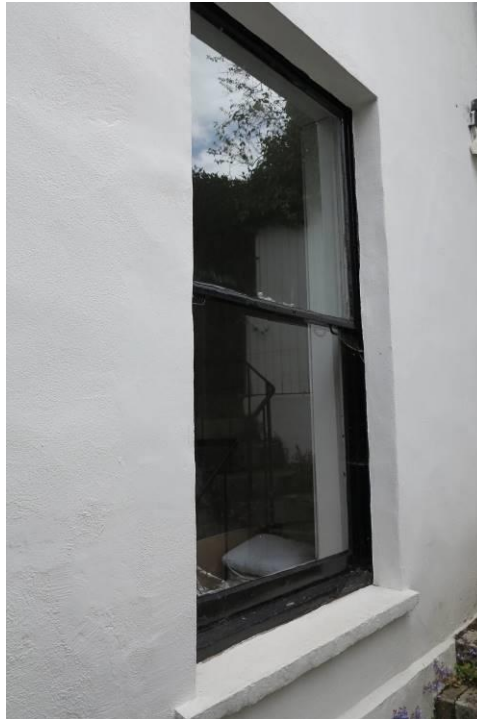
- 2.34 Windows are generally the original, unhorned, glazing-bar sashes, although the central first-floor window has been replaced with a horned sash. Basement windows are replacement plate-glass sashes of no interest (**plate 17**). There is a narrow lightwell, served by a stair to the eastern side (**plate 18**).

Plate 17. Replacement windows to the basement

- 3.14 On the southern elevation, it is worth noting that windows to the ground and first floor are largely original (the central window on the first floor is a later replacement) and have little capacity for change. The basement windows are, however, plate-glass replacements of substantially less interest.

- 3.25 I note particularly that the windows at the front of the basement rooms are later replacements and there may be scope to alter these openings in a sensitive manner (bearing in mind the effect on the principal elevation) in order to increase light into these living areas.

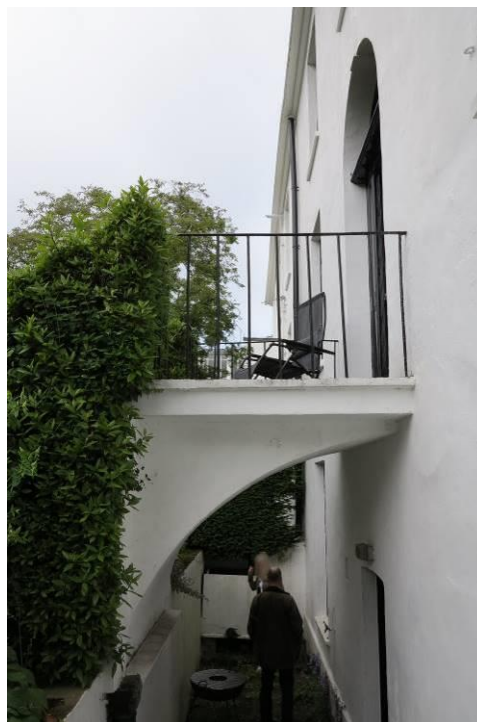
Plate 18. The lightwell to the front of No.2

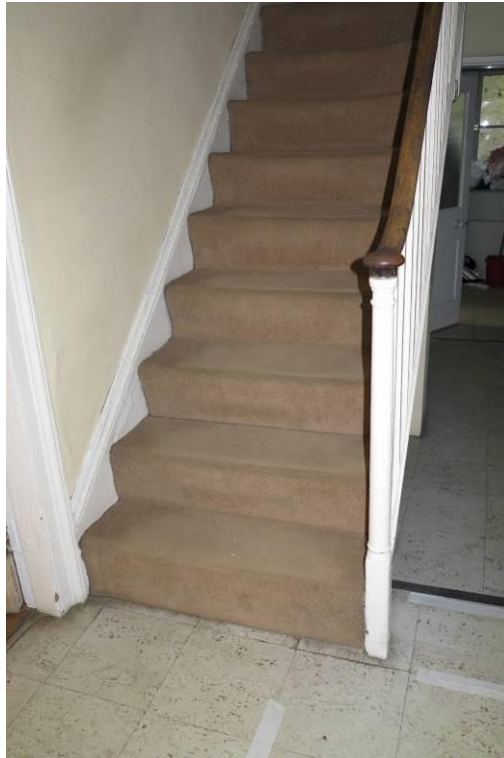
- 2.37 The original stair remains and is typical of its period, with an open string, simple, turned newels and stick balusters (**plate 19**). Between the ground floor and the first half-landing only, there are turned balusters, which are likely later replacements (**plate 20**).

Plate 19. The early 19th-century stair, seen from the basement hall

- 3.27 More generally within the building, the most significant features, which have little scope for alteration, are the original stair and the fireplaces in the western ground-floor room and in the first-floor rooms. Cornice moulding on the ground floor is also of interest, as are shutters/panelling, and surviving historic floor boards under modern floor finishes (these finishes can clearly be replaced without harming the character of the building). Timber panelled doors within the building are of architectural interest and would benefit from sympathetic replacement of door furniture.

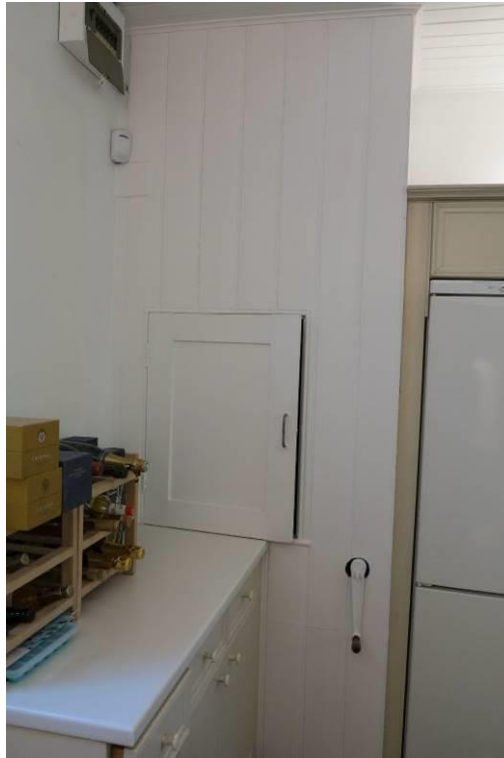
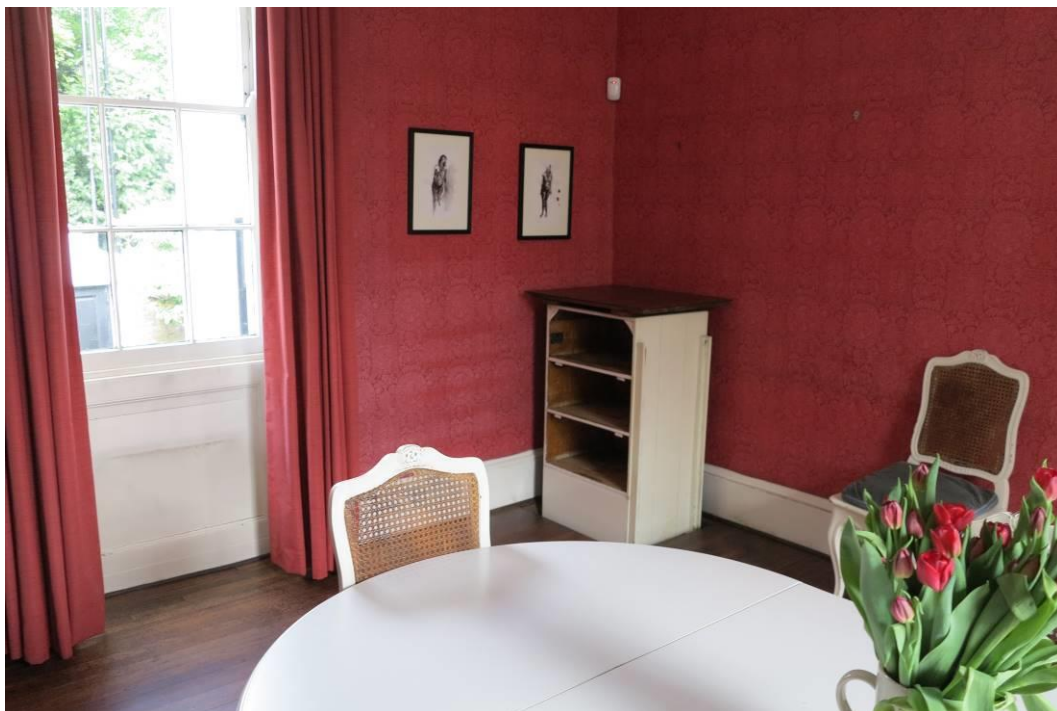
- 2.38 Moving through the building, the basement incorporates a hallway with modern linoleum floor finishes (**plate 19**). A glazed and timber screen (a mid-20th-century addition with obscure glazing and nailed joints) separates this from the entrance to the front lightwell (**plate 21**). On the western side of the hall is the kitchen. This has modern fittings and finishes, including a suspended ceiling (**plate 22**). The western wall is boxed out to negotiate the chimneybreast. The only item of interest in here is the dumb waiter in the north-eastern corner, which serves the dining room above (**plates 23 & 24**).

Plate 23. Dumb waiter in the kitchen

Plate 24. Dumb waiter in the dining room (western ground-floor room)

- 3.28 Otherwise, modern kitchen and bathroom fittings are of no interest and there is clear scope for their replacement. The dumb waiter in the kitchen/dining room is, however, of clear architectural/historic interest.

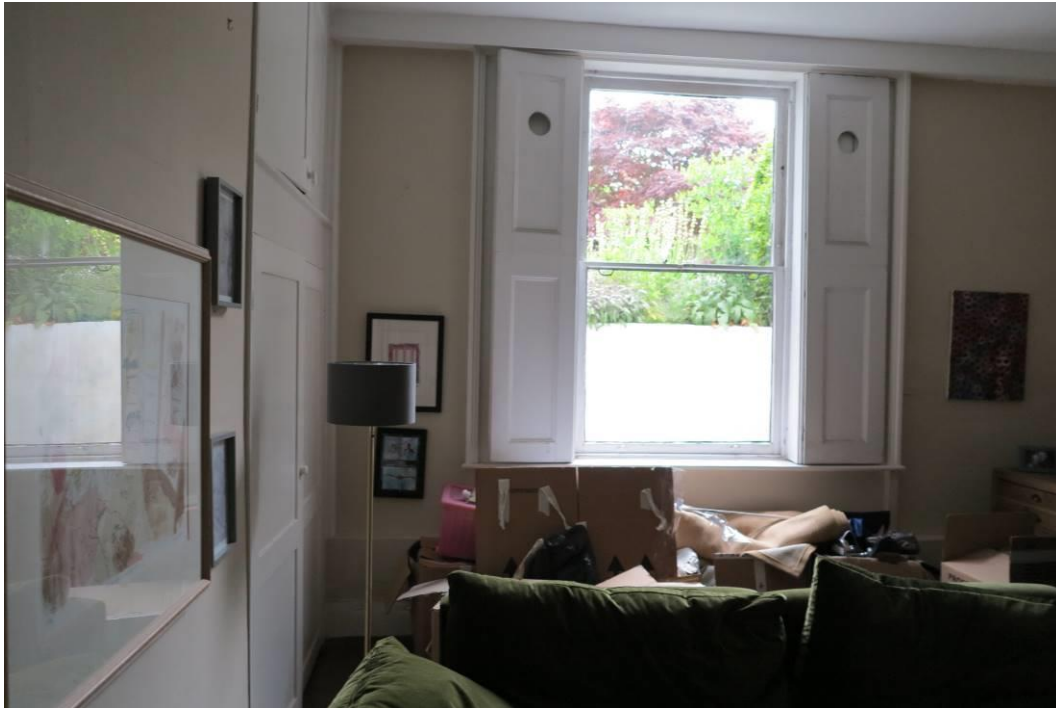
- 2.39 On the eastern side of the building, a further room (probably originally a servants' hall) retains its shutters on the window to the front lightwell (**plate 25**). There is little else of interest here (and it is unlikely these basement rooms historically incorporated much in the way of architectural embellishment) and the lack of a window to the rear indicates the presence of a vault to the rear of the building.

Plate 25. The eastern basement room

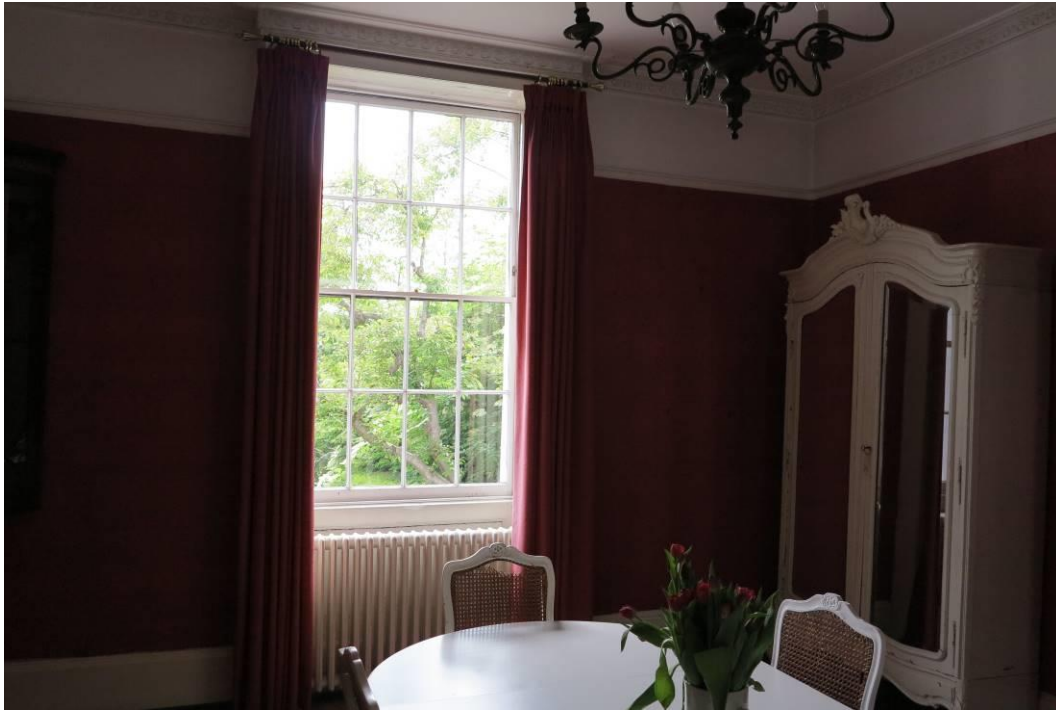
- 2.44 The dining room to the west has a similar character, although both window openings here are original (**plates 33 & 34**). The simple fireplace here is likely also original, as is the cast-iron hob grate, which is a typical feature of the early 19th century and of the sort found in M & G Skidmore's popular 1811 *Metalwork Pattern Book: Fire Grate, Stove, Balcony and Fencing Designs* (**plate 35**).

Plate 33. Window to the front of the building in the dining room (western ground-floor room)

Plate 34. Window to the rear of the building in the dining room

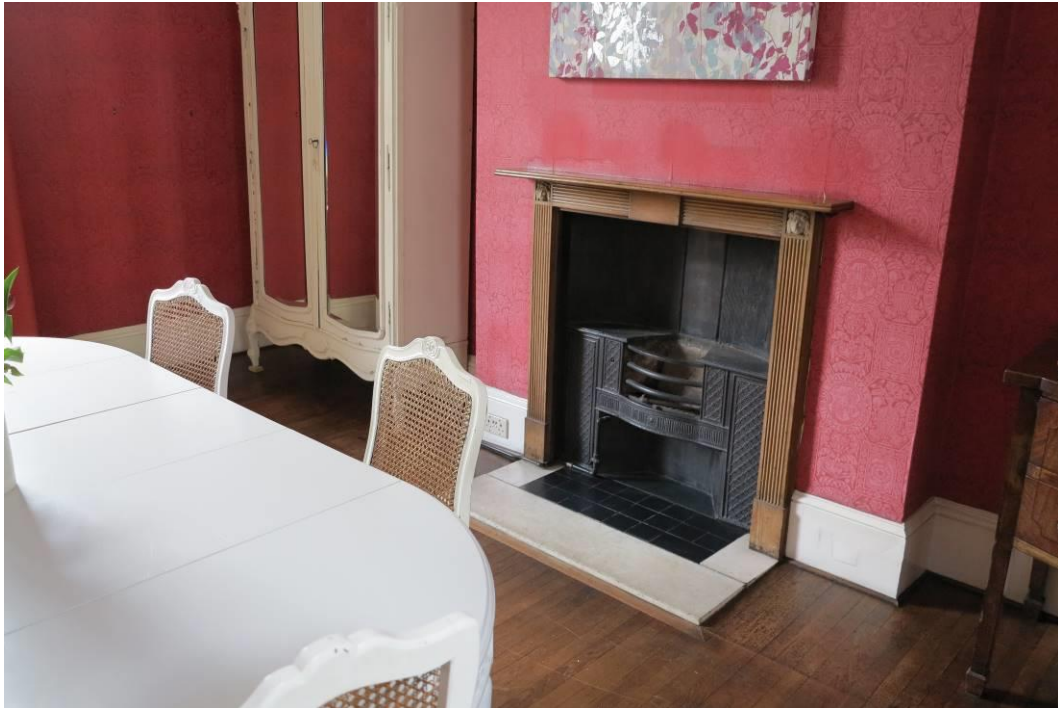
Plate 35. Fireplace in the dining room
