81 Belsize Park Gardens

Client : Fine Arts College Ltd

Scale @ A1: Date: 04/08/2023 Drawing Title: Demolition Elevations

Drawing No.: 4279 CDC XX XX DR A (DM) 410 A

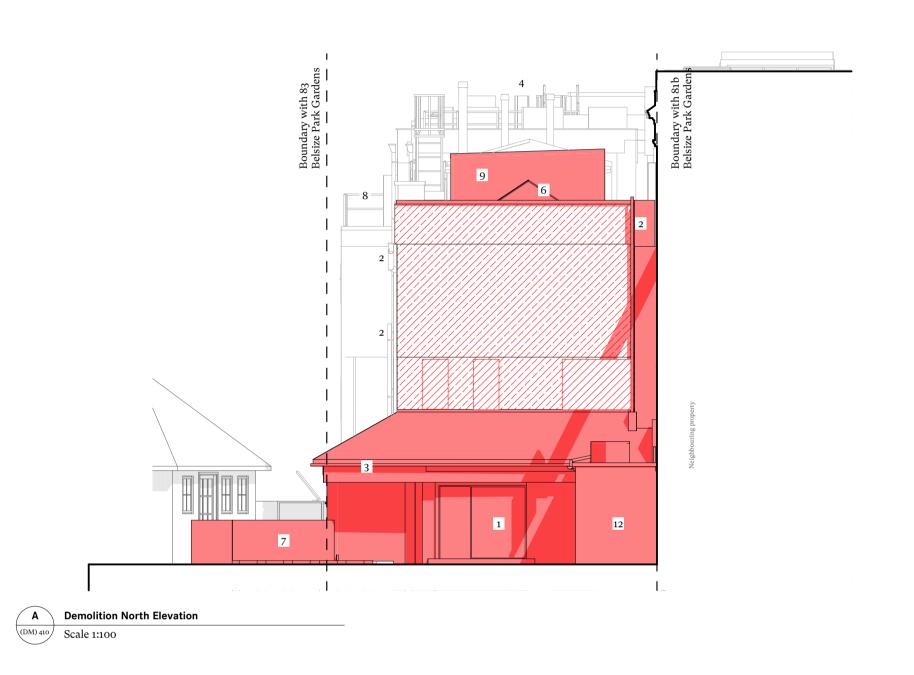
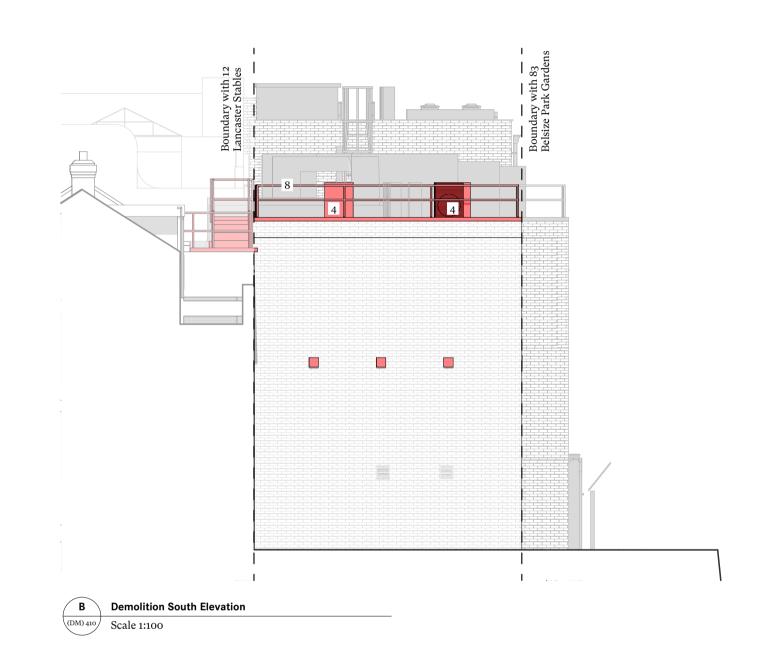
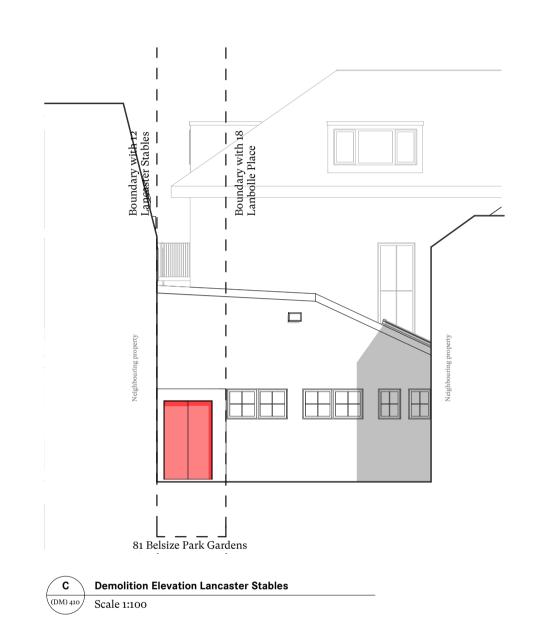
1 Windows to be removed and replaced throughout 2 RWP to be removed

3 Covered walkway to be demolished

4 Plant equipment to be removed 5 Timber screen to be removed

6 Rooflight to be removed 7 Boundary wall to be demolished and replaced

8 Roof edge protection to be removed 9 Rooftop plant enclosure to be demolished

10 Coping to be demolished and replaced

11 Roof access ladder to be demolished and replaced 12 Front enclosure to be demolished and replaced
