**DETAILED**  
**UXO RISK ASSESSMENT**

## STAGE 2 DETAILED UXO RISK ASSESSMENT

**Client:** Campbell Reith  
**Project Ref:** CAMP06R  
**Site:** Site 4 Heybridge, Camden  
**Report Ref:** DRA-21-1242-CAMP06R-Site4Heybridge,Camden  
**Revision:** 1  
**Status:** Final  
**Release Date:** 22<sup>nd</sup> March 2021

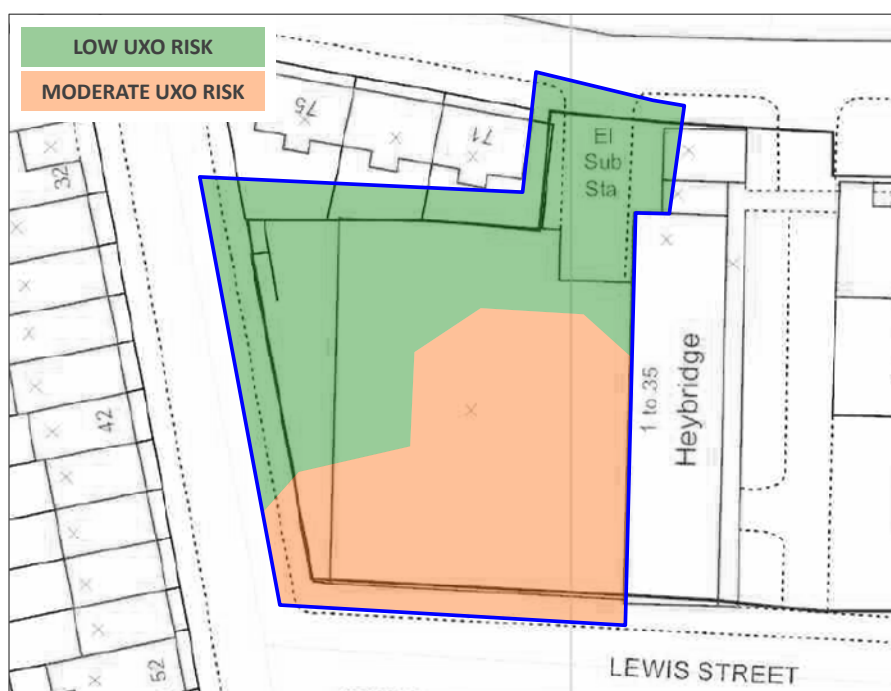
**RISK MAP:**

Risk Mitigation Measure	Recommendation
UXO Safety Awareness Briefings	Prior to all intrusive works commencing within both risk zones.
EOD Engineer - On Site Supervision	Watching brief of all ‘open’ mechanical excavations and magnetometer survey of any borehole locations within the <b>Moderate Risk Zone</b> only.
Intrusive Magnetometer Probe Survey	Of all pile positions within the <b>Moderate Risk Zone</b> only.

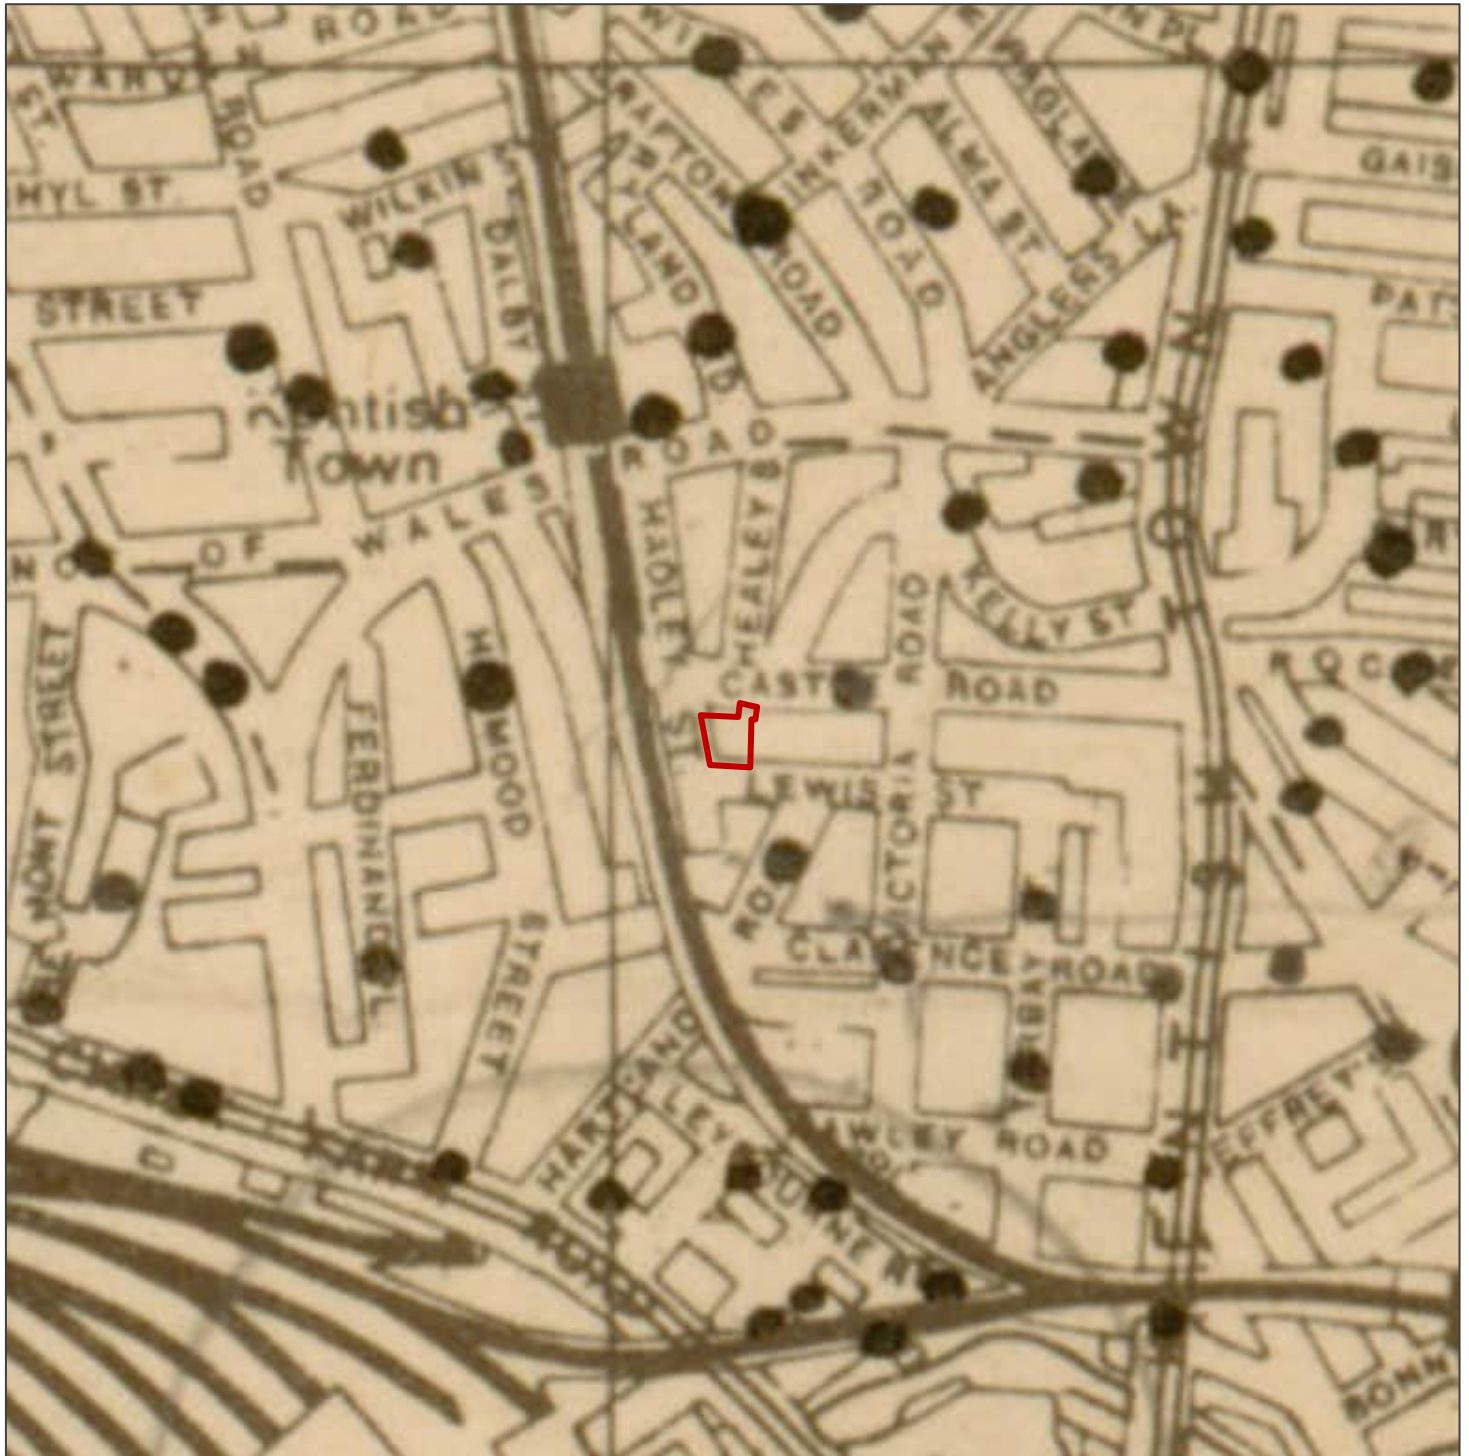
**Note:**  
As there are no weekly plot maps available for this period and the bombing density is high, bomb-sticks (individual aircraft bombloads) cannot be confirmed.

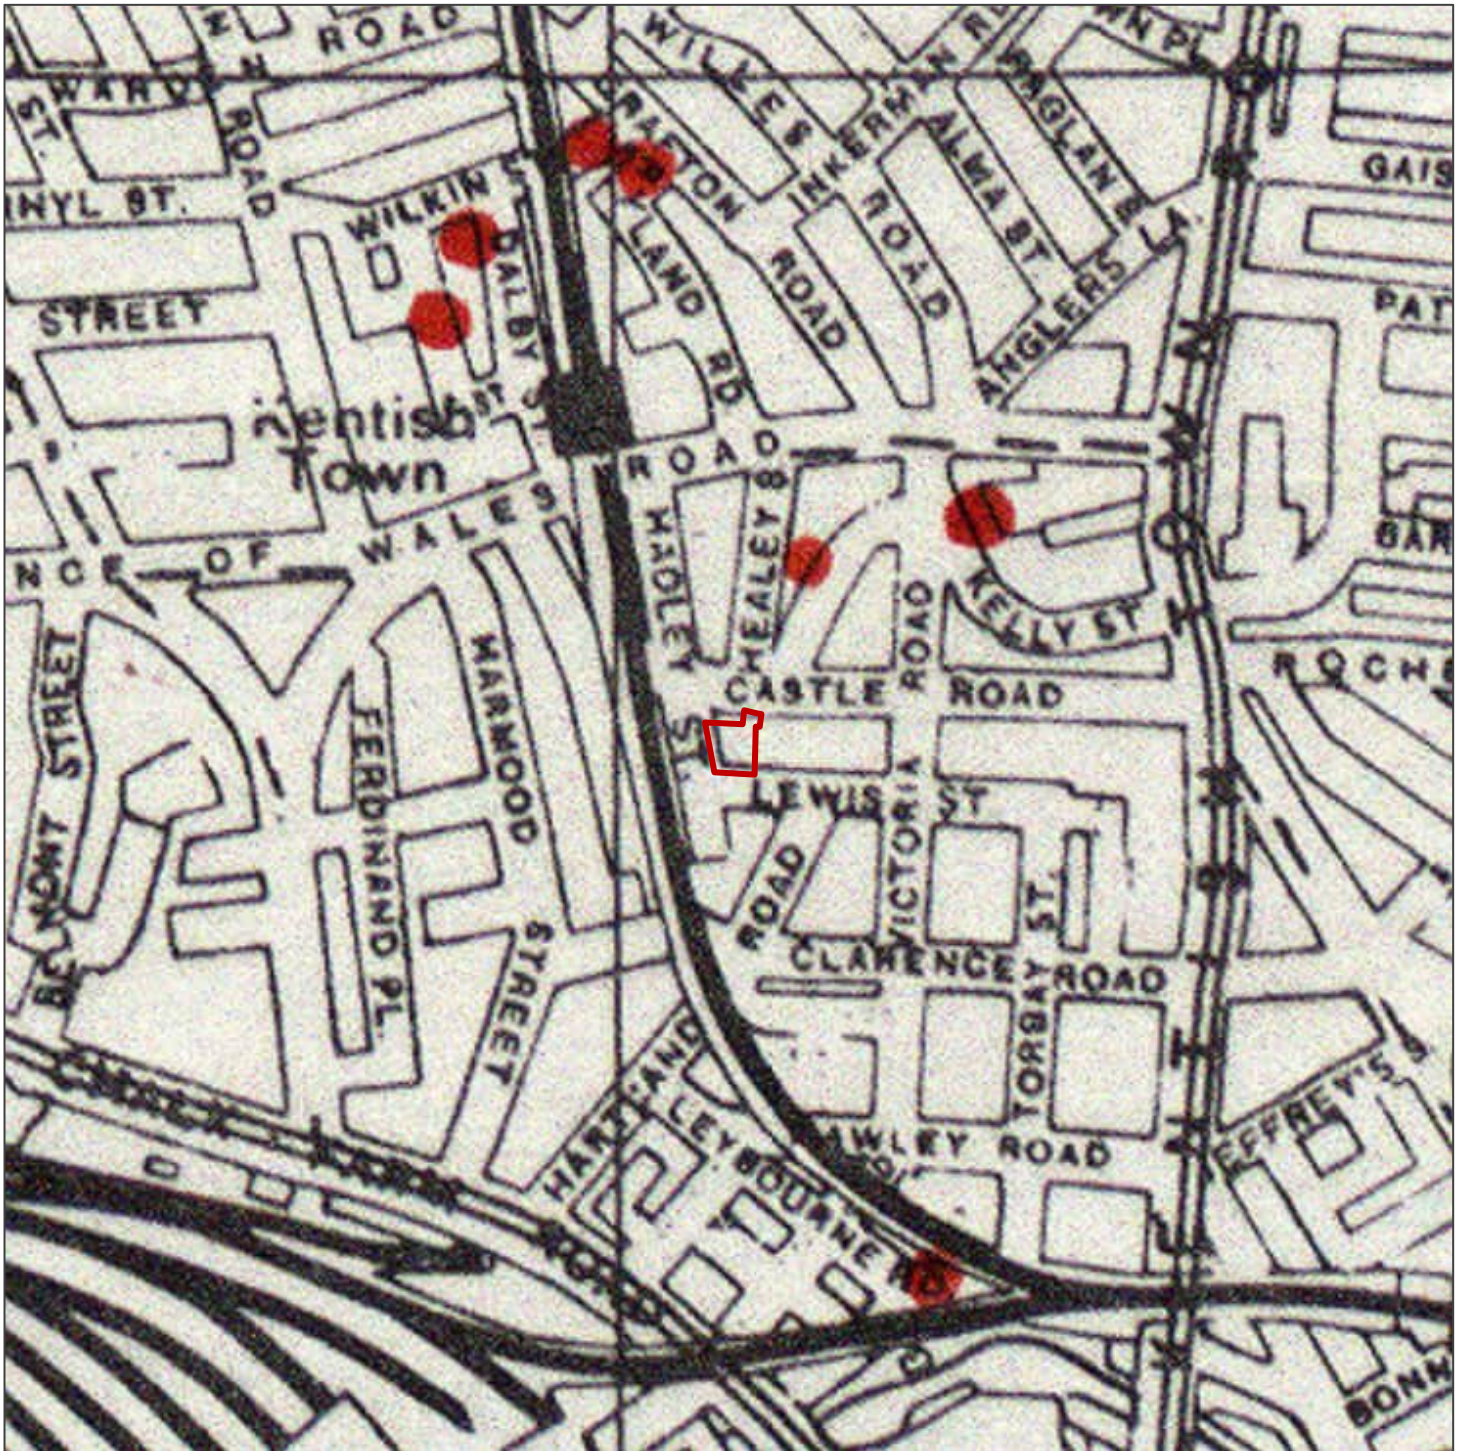
Note: As there are no weekly plot maps available for this period, bomb-sticks cannot be confirmed. However, some probable bomb-sticks are visible.

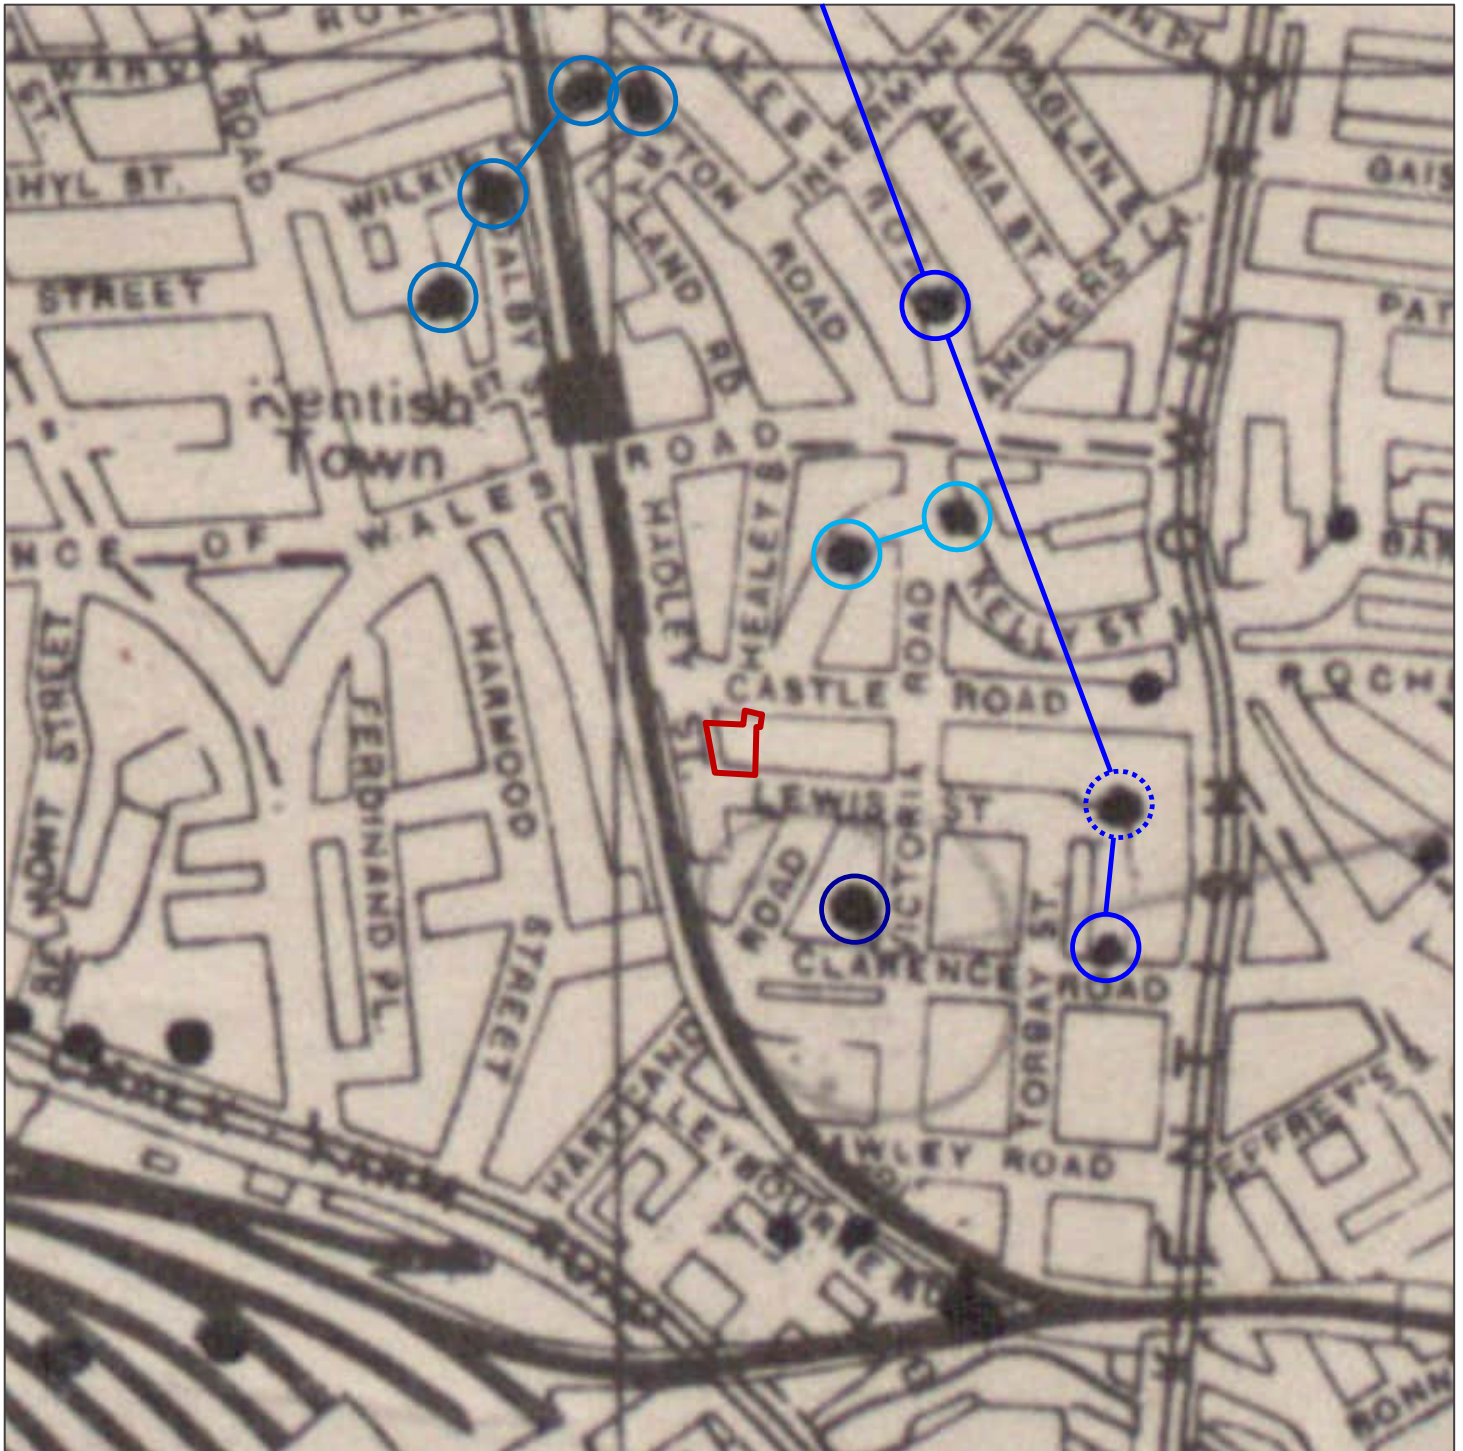
**Notes:**  
 Blue circles and lines identify confirmed or probable bomb-sticks.  
 Unconnected blue circles highlight solitary bomb strikes (not part of closely spaced bomb-stick).  
 Dotted line circles represent confirmed UXBs.  
 Unhighlighted bomb strikes were not plotted on any weekly plot maps. NB: one weekly plot map (14/10/40 - 21/10/40) is missing from the collection.

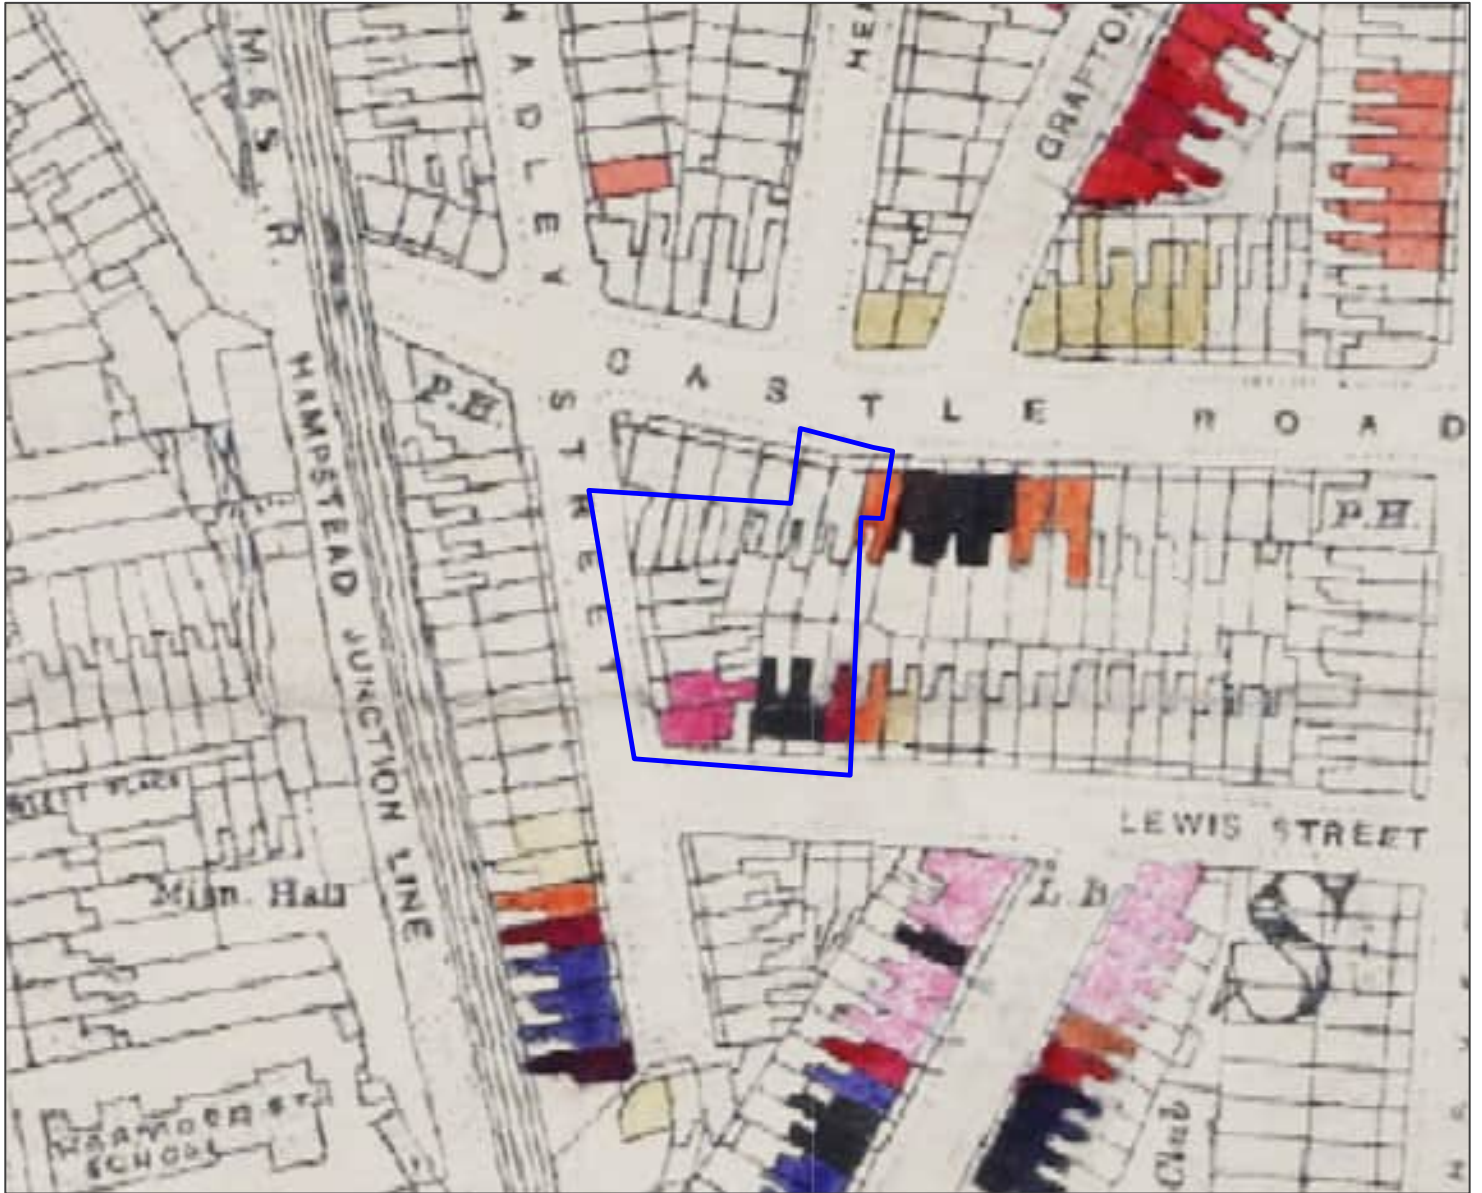
- Pre-war clearance
- Minor blast damage
- General blast damage; not structural
- Serious damage; repairable at cost
- Serious damage; doubtful if repairable
- Damage beyond repair
- Total destruction

BSI has reviewed an original war damage map covering the study area. The map was produced by the Engineer and Surveyors Department of the London County Council and was updated throughout the bombing campaign. A section of the map covering the study area is displayed at **FIGURE 7**.

Most of the houses on and immediately north of the Site have not been assigned any degree of bomb damage.

In the south-west, two houses have sustained 'serious damage'. In the south-east two houses have been 'totally destroyed' and a third has been 'seriously damaged'. The house at the north-east corner has sustained 'general blast damage'.

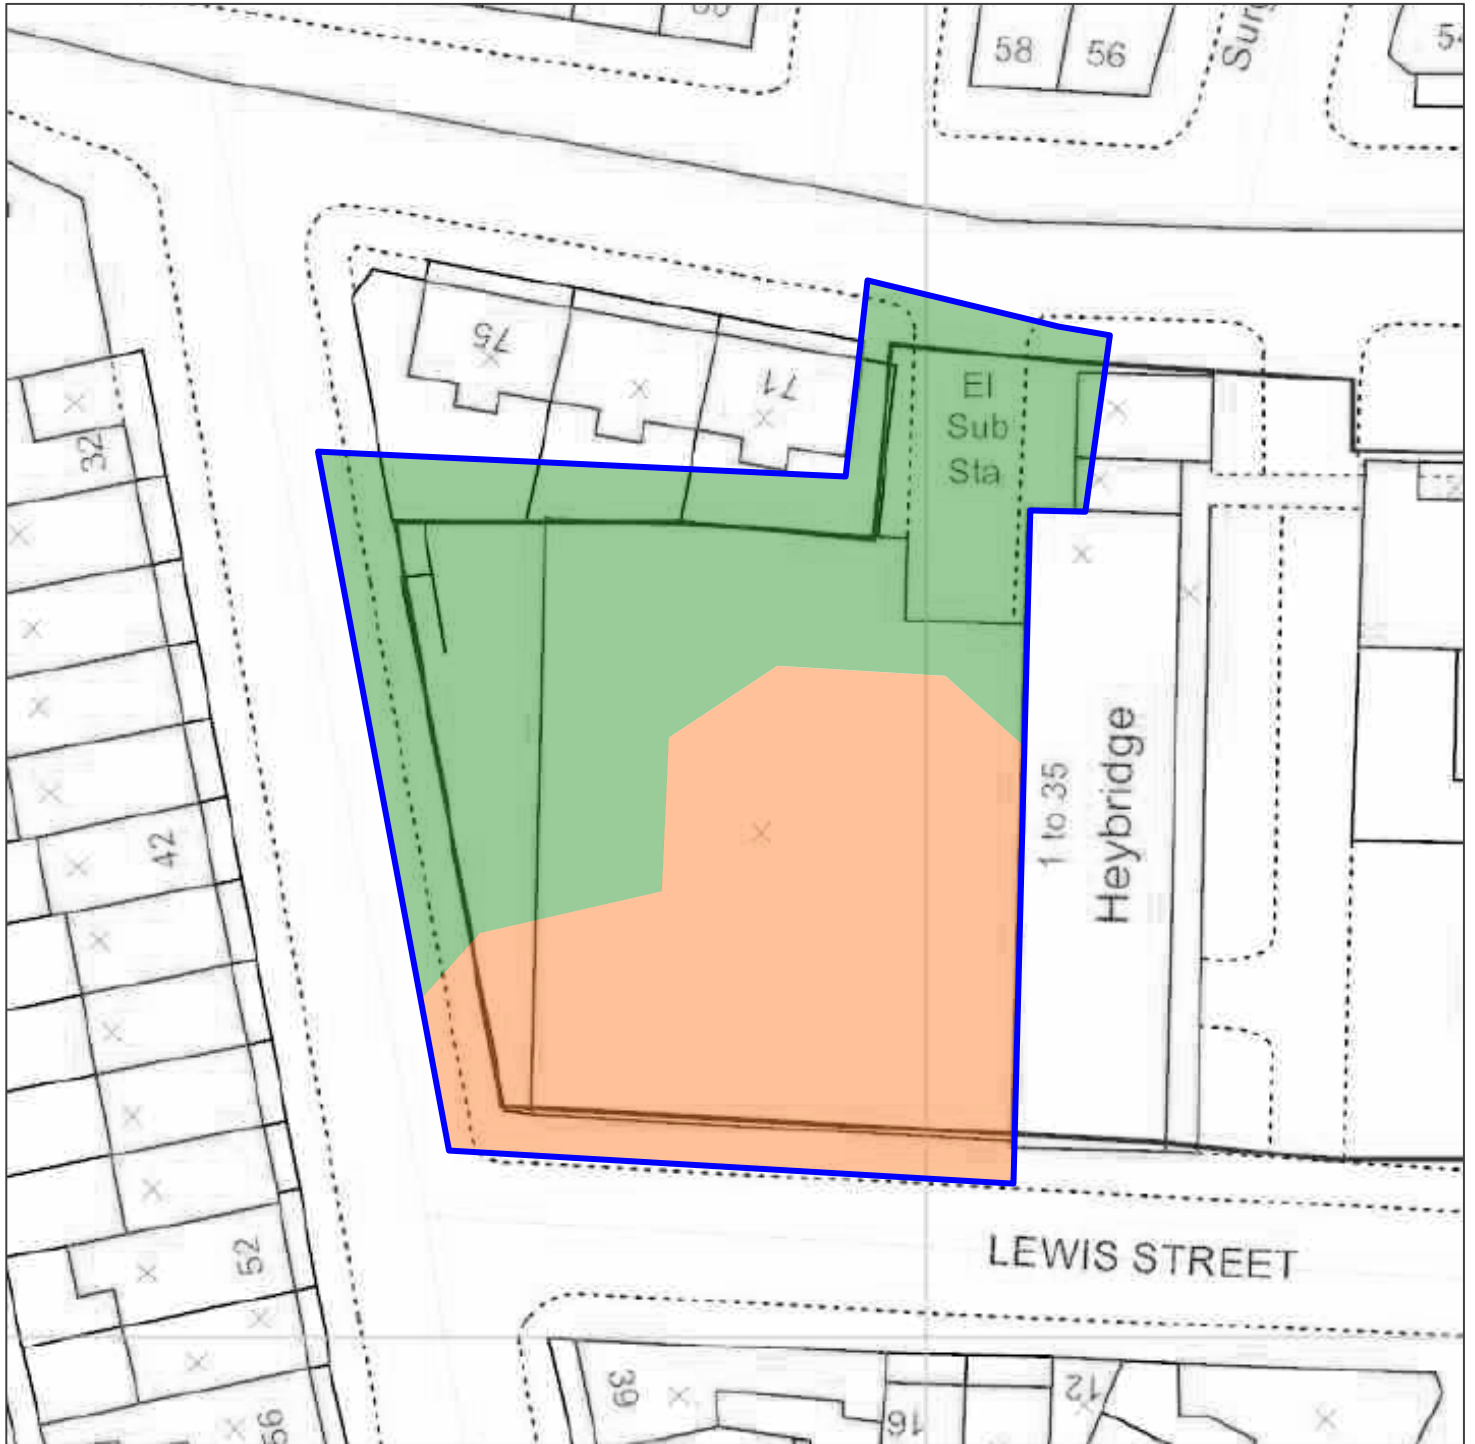
**LOW UXO RISK:** Low likelihood of German and British UXO remaining here.

**MODERATE UXO RISK:** Elevated likelihood of German HE UXBs remaining here (includes a ~5.0m J-Curve Effect buffer area).

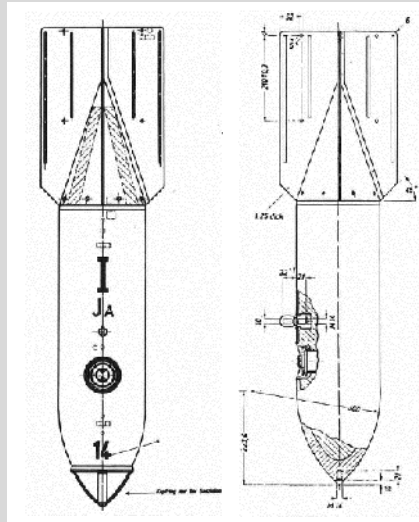
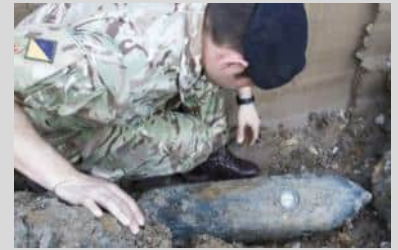
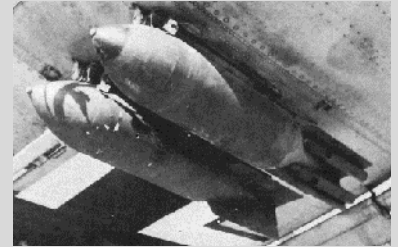
**SC 50**

**Bomb Weight:** 40-54kg (110-119lb)  
**Explosive Weight:** 25kg (55lb)  
**Filling:** TNT, Amatol or Trialen  
**Charge/Weight Ratio:** 46%  
**Fuse Type:** Electrical impact fuse or mechanical delayed action fuse  
**Body Dimensions:** 1,100mm length x 200mm diameter  
**Appearance:** Bomb body and tail painted grey/green with a yellow stripe on the tail unit. Steel construction.  
**Variants:** 8 x variants. Additional fittings: Kopfring nose for limited penetration and Stabbo nose for dive-bombing.

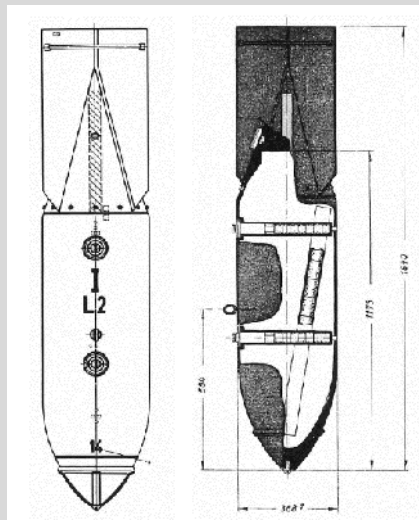
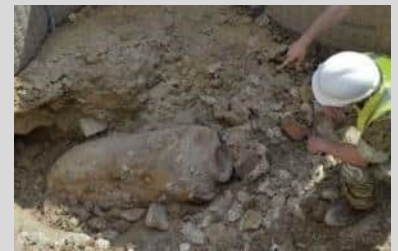
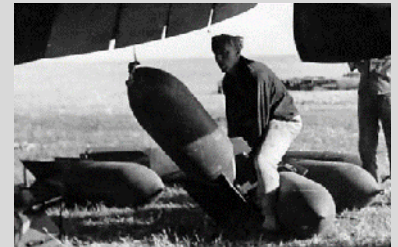
**SC 250**

**Bomb Weight:** 245-256kg (540-564lb)  
**Explosive Weight:** 125-130kg (276-287lb)  
**Filling:** TNT, Amatol and Trialen mix  
**Charge/Weight Ratio:** 44%  
**Fuse Type:** 1 or 2 electrical impact fuse(s) or mechanical delayed action fuse(s)  
**Body Dimensions:** 1,173mm length x 368mm diameter  
**Appearance:** Bomb body and tail painted grey/green with a yellow stripe on the tail unit. Steel construction.  
**Variants:** 8 x variants. Kopfring nose for limited penetration. Stabbo nose for dive-bombing.

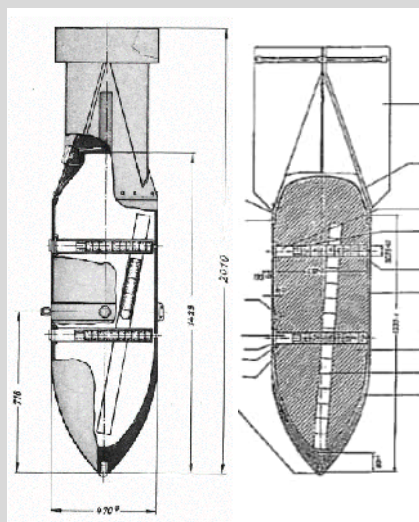
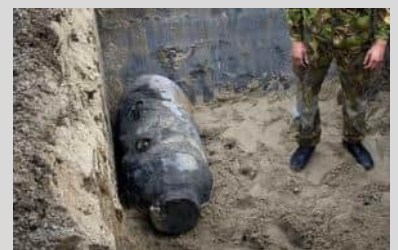
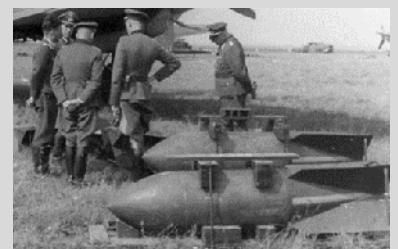
**SC 500**

**Bomb Weight:** 480-520kg (1,058-1,146lb)  
**Explosive Weight:** 220kg (485lb)  
**Filling:** TNT, Amatol and Trialen mix  
**Charge/Weight Ratio:** 44%  
**Fuse Type:** 2 electrical impact fuses or mechanical delayed action fuses  
**Body Dimensions:** 1,423mm length x 470mm diameter  
**Appearance:** Bomb body and tail painted grey/green or buff with a yellow stripe on the tail unit. Steel construction.  
**Variants:** 3 x variants. Kopfring nose for limited penetration.

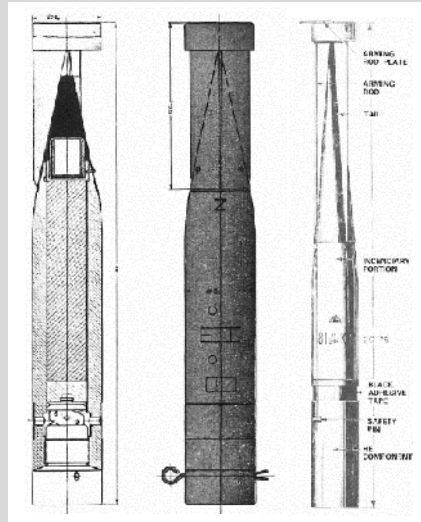
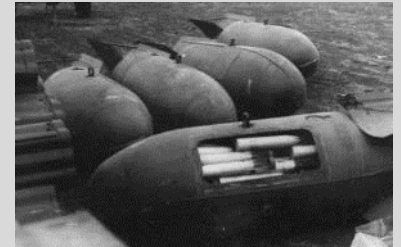
**B-1E Sub-Munition**

**Bomb Weight:** 1-1.3kg (2.2-2.87lb)  
**Incendiary Weight:** 680g (1.4lb)  
**Filling:** Thermite  
**Fuse Type:** Simple impact fuse  
**Body Dimensions:** 247mm length x 50mm diameter  
**Appearance:** Grey body and dark green painted tail unit. Magnesium alloy case.  
**Operation:** Small percussion charge ignites Thermite (>1,000°C burn).  
**Variants:** Most common variant: B 2EZ (2kg) included a small HE charge  
**Remarks:** Drop containers varied in size. The smallest cluster bomb held 36 x B-1Es and the largest 620 x B-1Es.

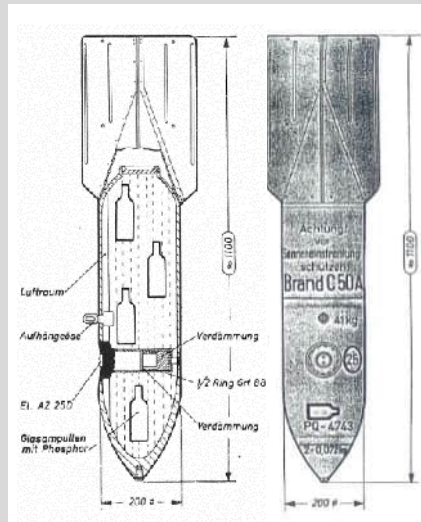
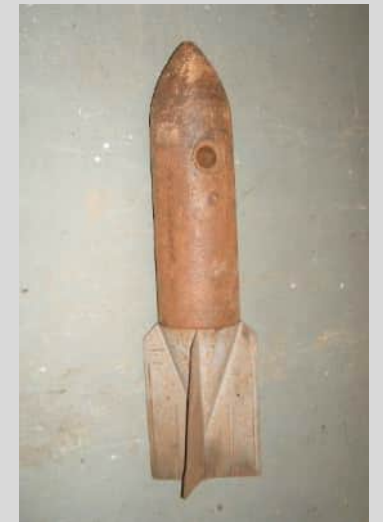
**Brand C50**

**Bomb Weight:** 41kg (90.4lb)  
**Incendiary Weight:** 13kg (30lb)  
**Filling:** Main fill (86% Benzine, 10% Rubber) plus 4% Phosphorus in glass bottles  
**Fuse Type:** 1 x electrical impact fuse  
**Bomb Dimensions:** 762mm length x 203mm diameter  
**Appearance:** bomb body and tail painted grey or green with the rear of the bomb painted red and a red band around the centre of the body.  
**Variants:** C 50 B: 77% White Phos fill  
 C 250 A: 87.7% Petroleum, 11.7% Polystyrene, 0.5% White Phos (185kg version)

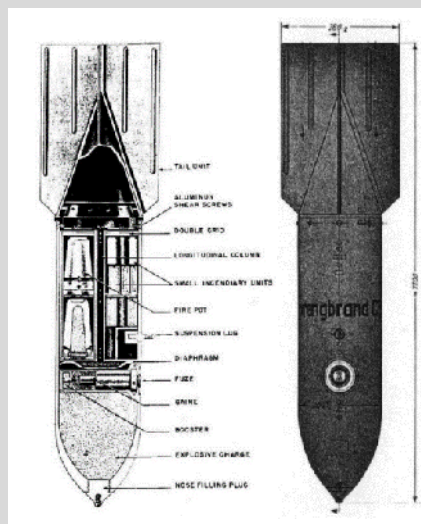
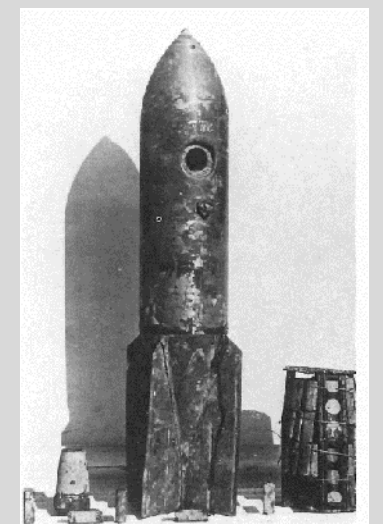
**Spreng-Brand C50 - Fire Pot**

**Bomb Weight:** 34kg (75lb)  
**Explosive Weight:** 9kg (20lb)  
**Filling:** TNT burster charge, 6 x Thermite containers (fire pots) and 67 x small triangular incendiary elements.  
**Fuse Type:** 1 x electrical impact fuses or aerial burst fuse  
**Bomb Dimensions:** 711mm length x 203mm diameter  
**Appearance:** Bomb body and tail painted grey/green or pale blue with red base plug and red or green incendiary markings. Steel construction.  
**Operation:** A charge blows off the base plate, firing a plume of incendiary mixture 100 yds. Approx 1 second later the HE charge detonates.

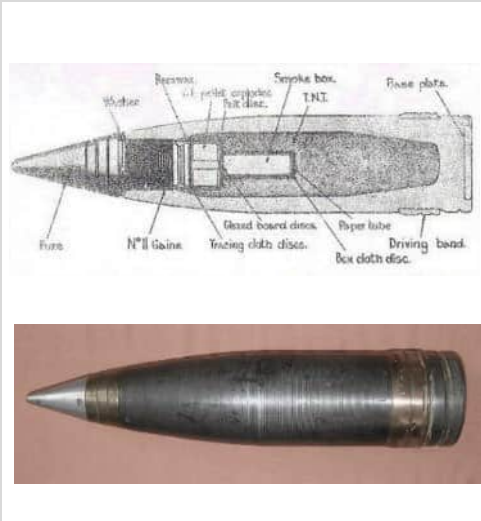
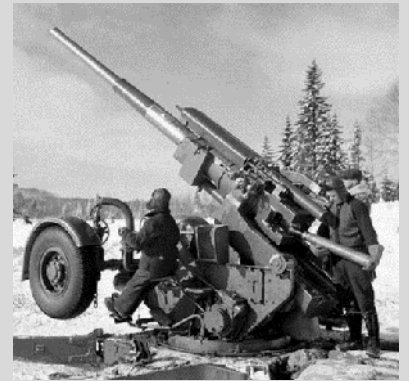
### HAA Battery - 3.7" QF Shell

**Shell Weight:** 12.7kg  
**Shell Dimensions:** 94mm x 438mm  
**Fill Weight:** 1.1kg  
**Fill Type:** TNT  
**Fuse Type:** Mechanical Time Delay fuse  
**Appearance:** Grey body, copper driving bands, brass neck  
**Rate of Fire:** 10 - 20 rpm  
**Ceiling:** 9,000 - 18,000m  
**Variants:** HE or shrapnel shells.  
 Note, the 4.5" gun was also used in an HAA role throughout the UK.

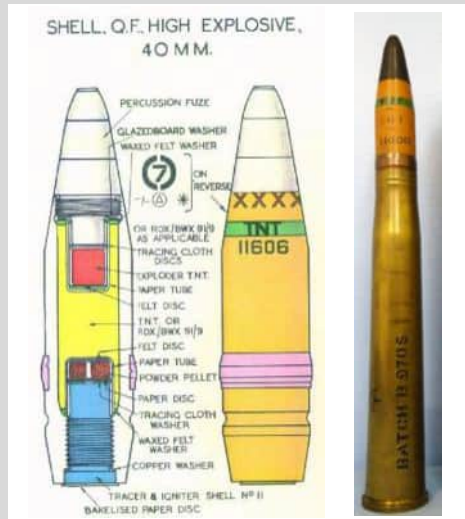
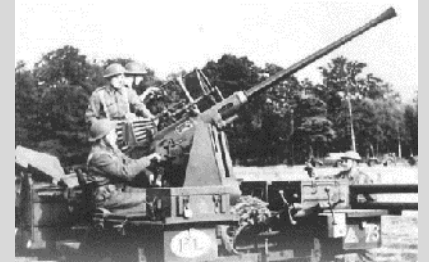
### LAA Battery - 40mm Bofors Shell

**Shell Weight:** 0.84kg  
**Shell Dimensions:** 40mm x 180mm  
**Fill Weight:** 70g  
**Fill Type:** TNT  
**Fuse Type:** Impact fuse  
**Appearance:** Grey body, copper driving bands, brass neck  
**Rate of Fire:** 120 rpm  
**Ceiling:** 7,000m  
**Variants:** HE or AP shells. Both with rear tracer compartment

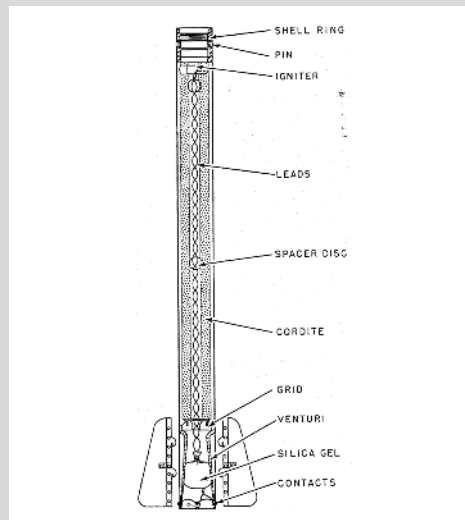
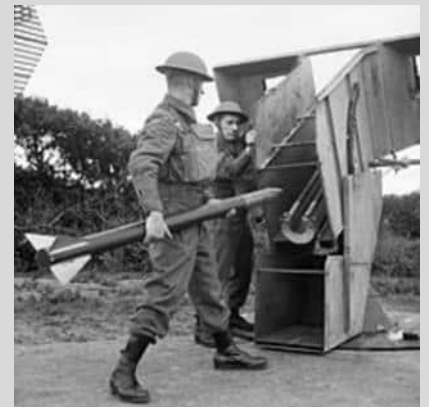
### Z Battery - 3" U.P Rocket

**Rocket Weight:** 24.5kg  
**Warhead Weight:** 1.94kg  
**Filling:** TNT warhead. Black Powder solid fuel rocket motor.  
**Fuse Type:** Mechanical Time Delay fuse  
**Rocket Dimensions:** 1,930mm x 76mm  
**Ceiling:** 6,770m  
**Operation:** Fired from single, tandem and (later) 36 x rail launchers (Z Batteries). Limited use throughout the UK.
