HURDWICK HOUSE
Arboricultural Survey

09 December 2022

| JOB NAME: | HURDWICK HOUSE, CAMDEN |
| REPORT NUMBER: | TF1228-FAB-00-XX-RP-G-8201 |

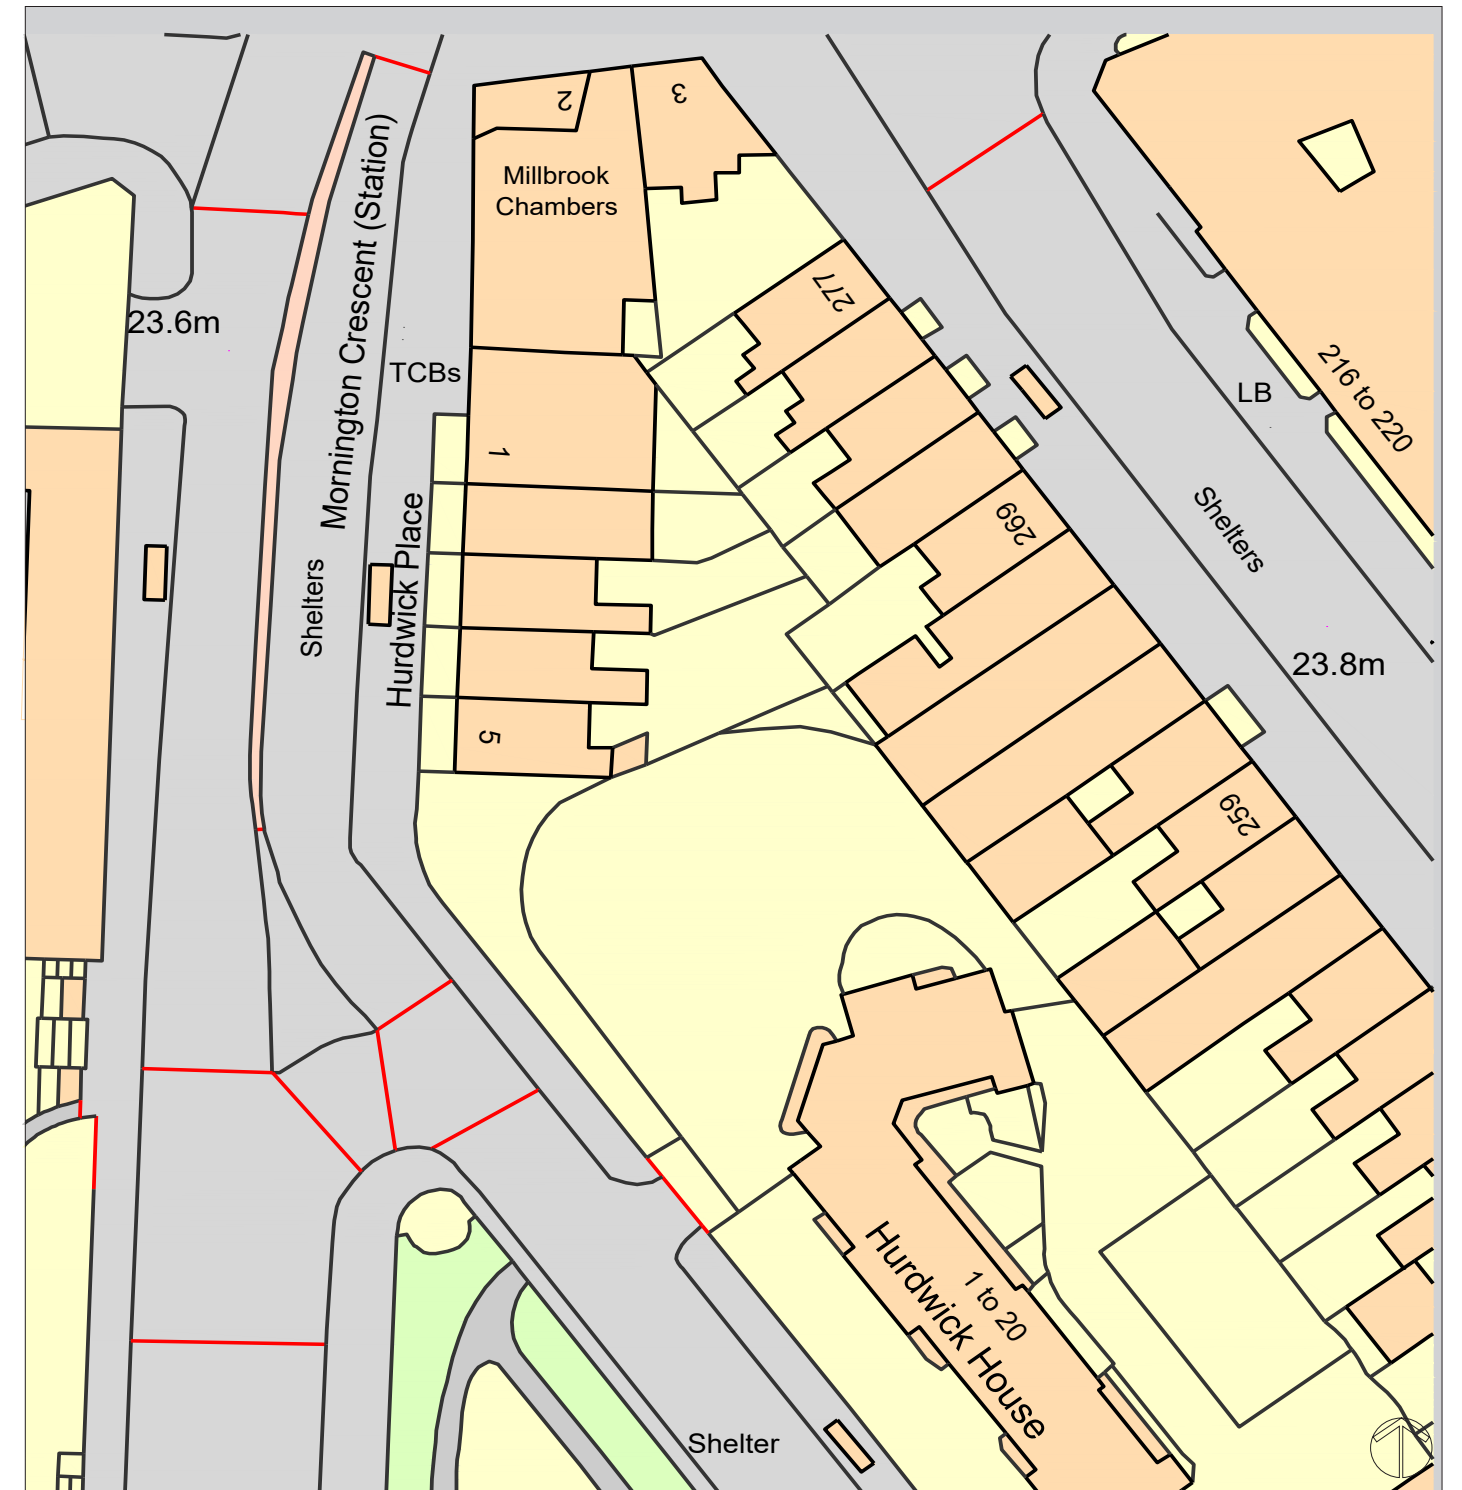
FIGURE 1 - AERIAL OF SITE - (PROMAP)

- 2.1** The site is located within the borough of Camden and is formed by land adjacent to Hurdwick Place . The site consists of car parking area to accompany Hurdwick House.
- 2.2** The site is typically cover in hard surfacing throughout the site, with the exception of a few grassed and panted areas. The site is access through a security gate and only accessible to residents. The topography of the site is relatively level with walled boundaries connecting to adjacent properties.

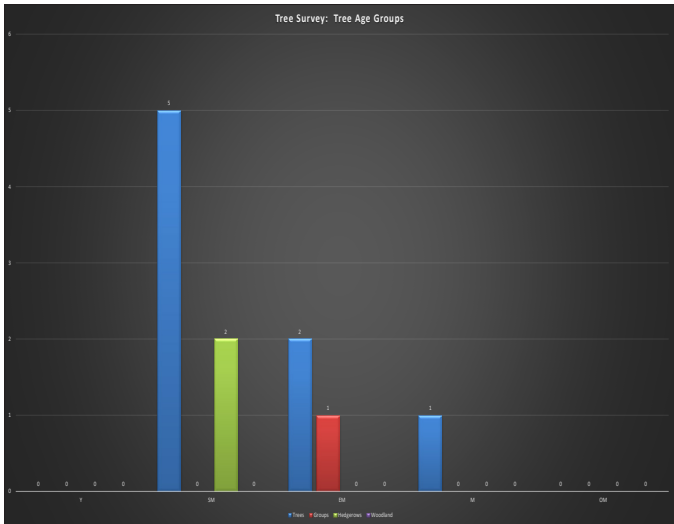
FIGURE 5 - AGE CLASS DISTRIBUTION

- 5.2.1 A total of 8 individual trees, 1 groups and 2 hedgerows were assessed within the survey schedule including 1 category 'A' trees (High quality) and 10 category 'C' trees, groups and hedgerows (Low quality) in accordance with British Standards 5837 (2012) 'Trees in relation to design, demolition and construction'.
- 5.2.2 Trees assessed as category 'U' are considered to be of such condition that they cannot realistically be retained as living trees in context of the current land use for longer than 10 years.
- 5.2.3 The site is relatively missing significant arboricultural features with the only features on site are identified as trees H1, T2 and T3. All other trees and vegetation are off site trees.
- 5.2.4 The most significant local feature tree (T7) is located off site within Harrington Square.

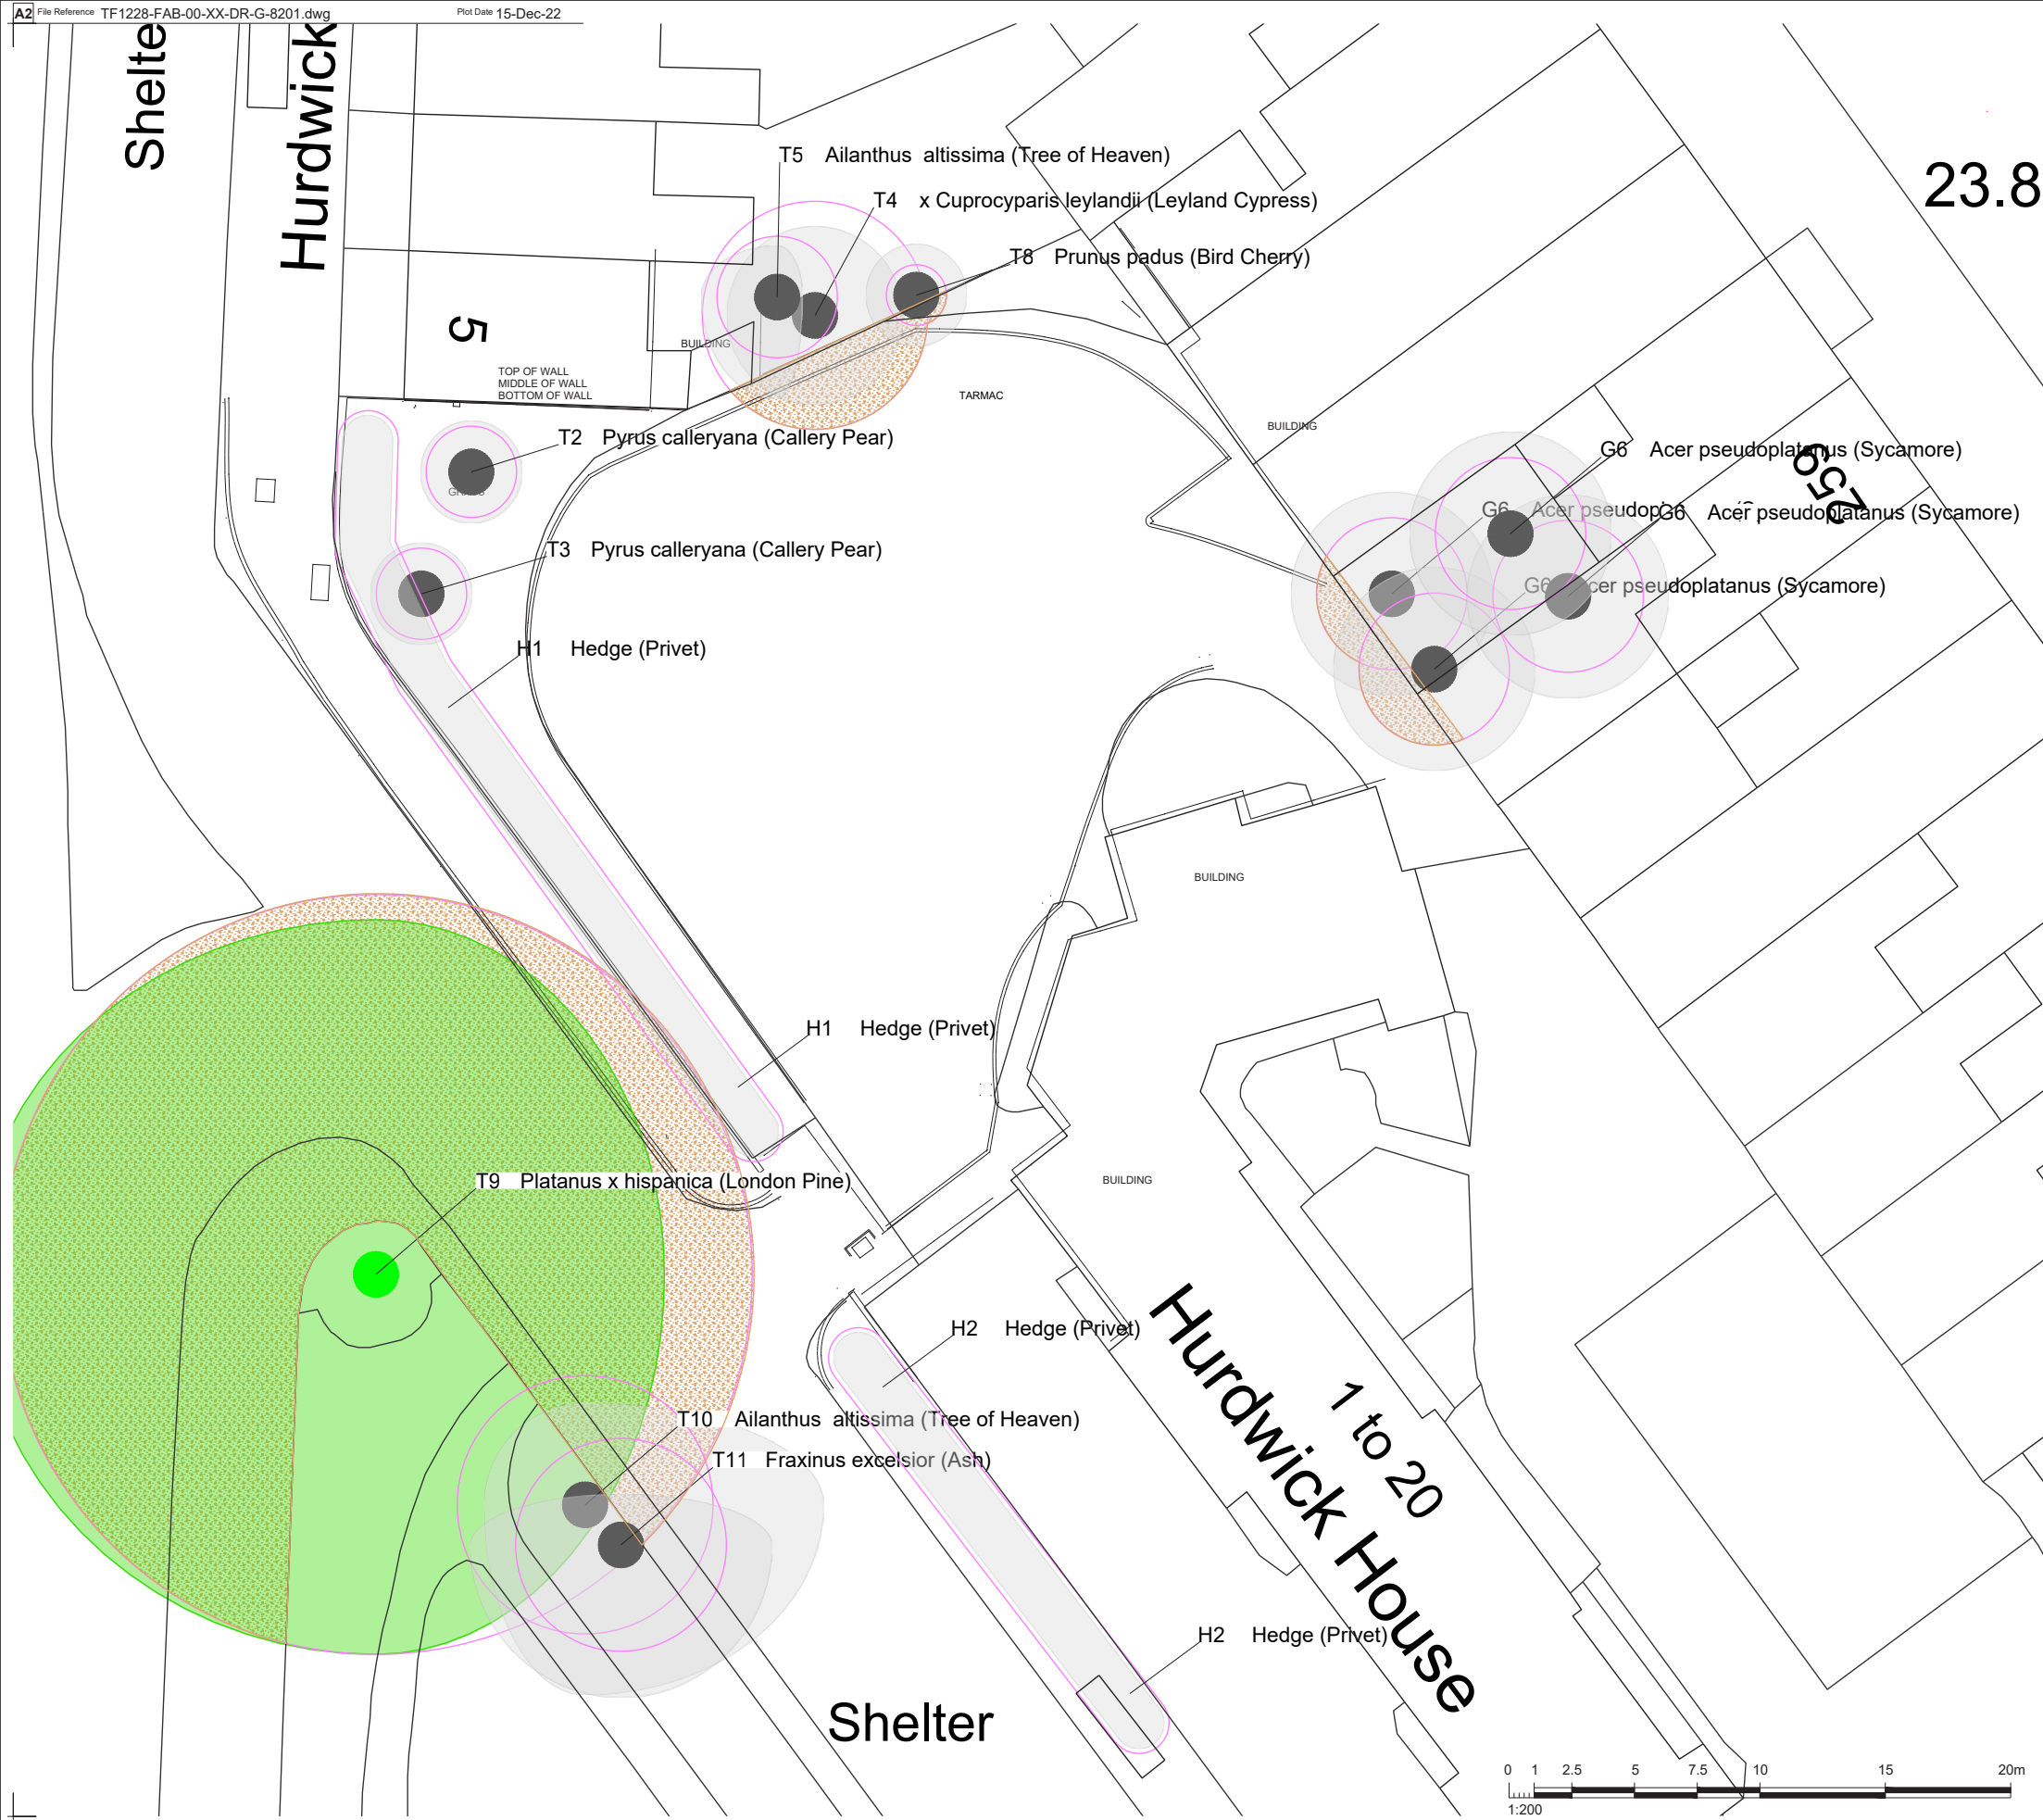
Tree Survey Reference Plan

This illustrative plan is intended to inform preliminary site layout & design and should be read in conjunction with the Tree Survey Schedule. Detailed assessment and site measurement may be required prior to final design.

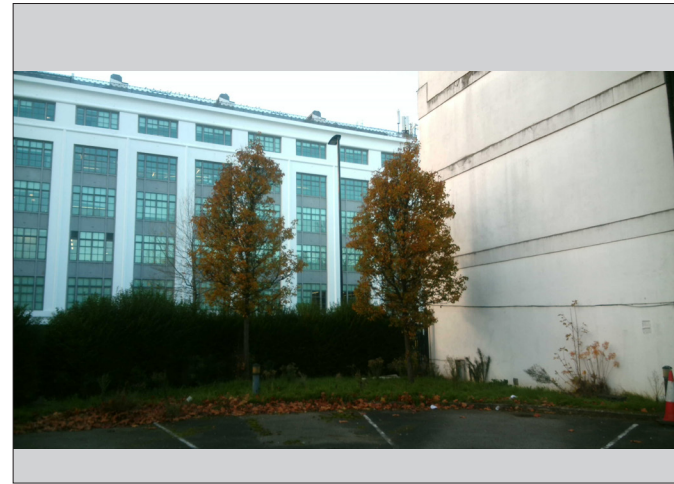
- 1 Photograph showing trees T2 and T3 adjacent to Hurdwick place. Trees shown are identified as Callery Pear. Below H1 is identified also.

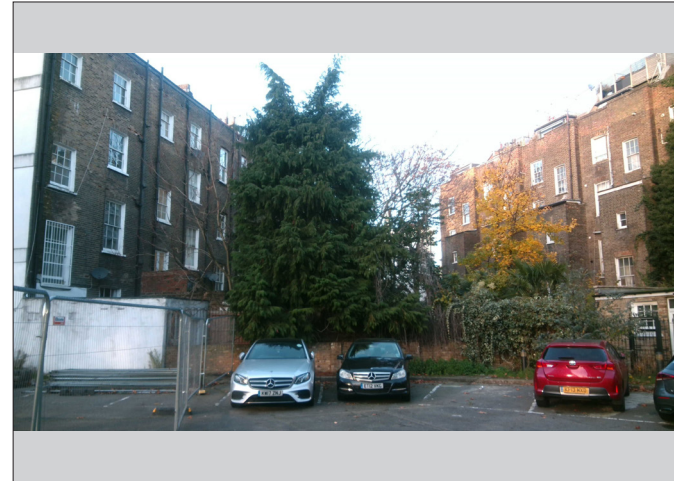
- 2 Photograph showing trees T4, T5 and T8 (Cypress, Tree of Heaven and Bird Cherry respectively) all tree located off site and behind boundary wall footings of wall may restrict root growth of trees

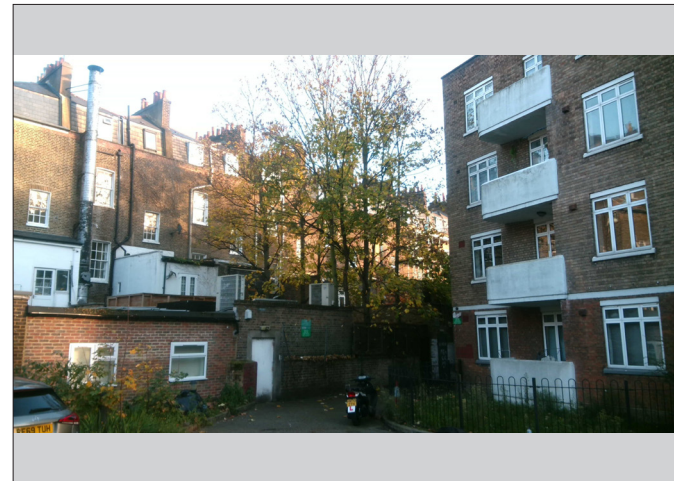
- 3 Photograph showing G6 identified as Sycamore. All trees located offsite and behind rear garden and boundary wall, also potentially restricting root growth into the site

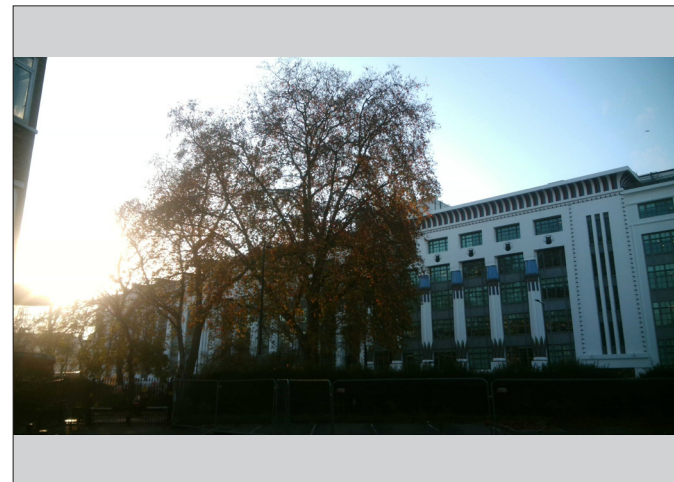
- 4 Photograph showing off site feature tree located in Harrington Square Gardens
