BASEMENT IMPACT ASSESSMENT

Ref: 23/36419-2 | Date: March 2023

Revision 1 – August 2023

**15 Howitt Road
Belsize Park
London
NW3 4LX**

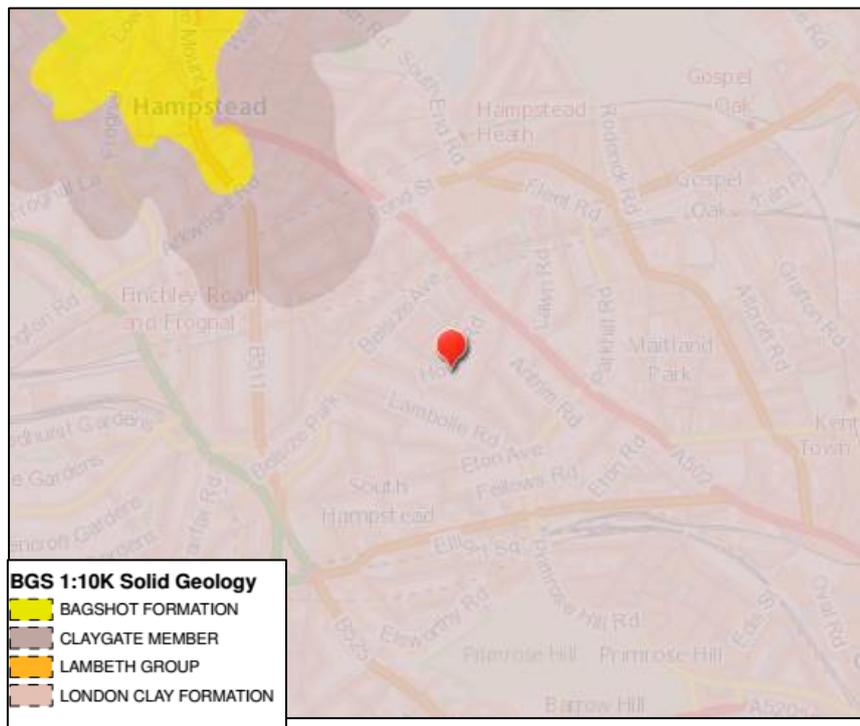
Figure 3-3. Geology of the Site (Ref. BGS Geoindex)

The 1:50000 Geological Survey of Great Britain (England and Wales) covering the area is detailed in Figure 3-3 below and indicates the site to be underlain by the London Clay Formation. Deposits of the overlying Claygate Member are indicated to be over 400m to the north-west of the site.

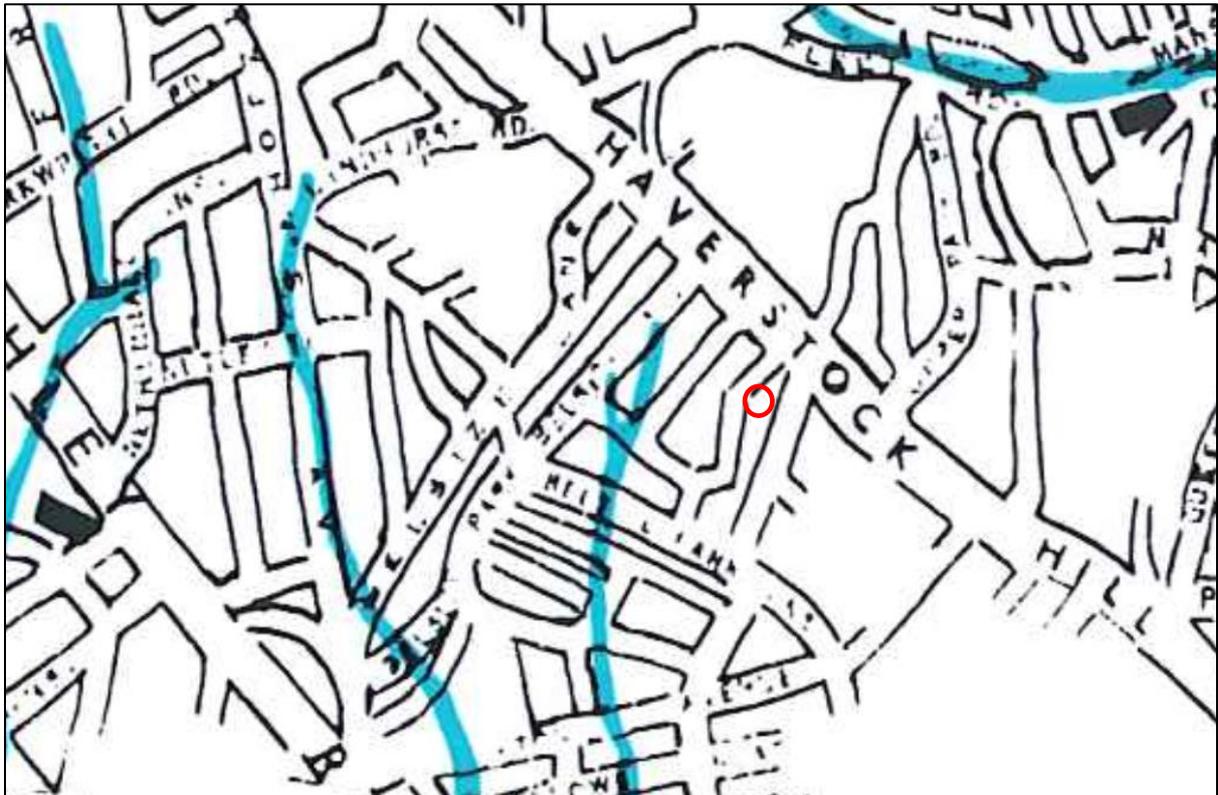
Figure 3-4. Location of site (circled) relative to the 'Lost Rivers' of London
(Source: Barton, 1992)

With reference to Camden Geological, Hydrogeological and Hydrological Study (1999), Talling (2011) and Barton (1992) a tributary of the 'lost rivers' River Tyburn was located approximately 200m west of the site (Figure 3-4).

The River Tyburn flowed in a southerly direction from Shepherds Well (or Conduit Well) located to the south of Spring Path. From the well it flowed southwards down Fitzjohn's Avenue, through Swiss Cottage and into Regent's Park, where it entered into a large lake. From the lake it flowed southwards through the West End and the City of Westminster, before issuing into the River Thames close to Vauxhall Bridge. The watercourses have since been largely lost through a culverting system as the urban extent of the borough has grown over time.

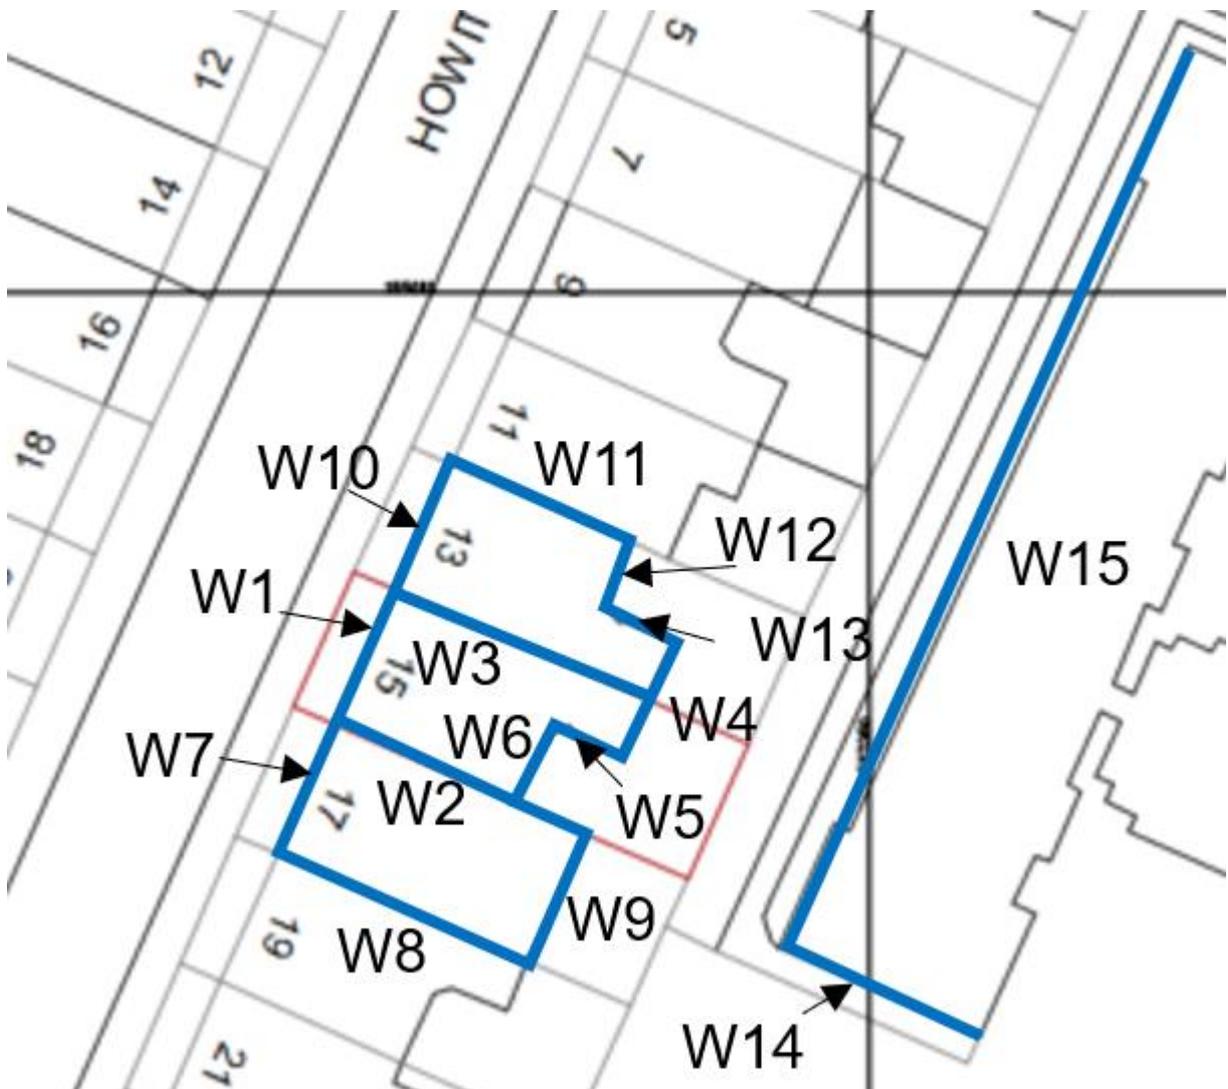
Figure 4.1: OS Map of 15 Howitt Road, with labelled walls under analysis

The properties or structures more likely to be affected by ground movements associated with the proposed basement construction, are shown in **Table 2.1**, as well as the labelled walls under analysis in **Figure 4.1** below and include the following:

- No. 13 Howitt Road (Shares party wall with No.15)
- No 17 Howitt Road (Shares party wall with No. 15)
- Holmefield Court, 12 Belsize Grove (12m southeast of No.15)
