EXPLORATORY HOLE LOCATION PLAN

PROJECT: DALEHAM GARDENSREV: 00TITLE: COLUMNS AND WALLS FOUNDATIONS ESTIMATED LOADSSKETCH No: 1803-XX-SK-01DATE: 06/03/23DRAWN BY (CHECK): EC (AC)

APPENDIX 4 – FLOOD RISK ASSESSMENT AND DRAINAGE STRATEGY REPORT

DALEHAM GARDENS, LONDON, NW3 5BU

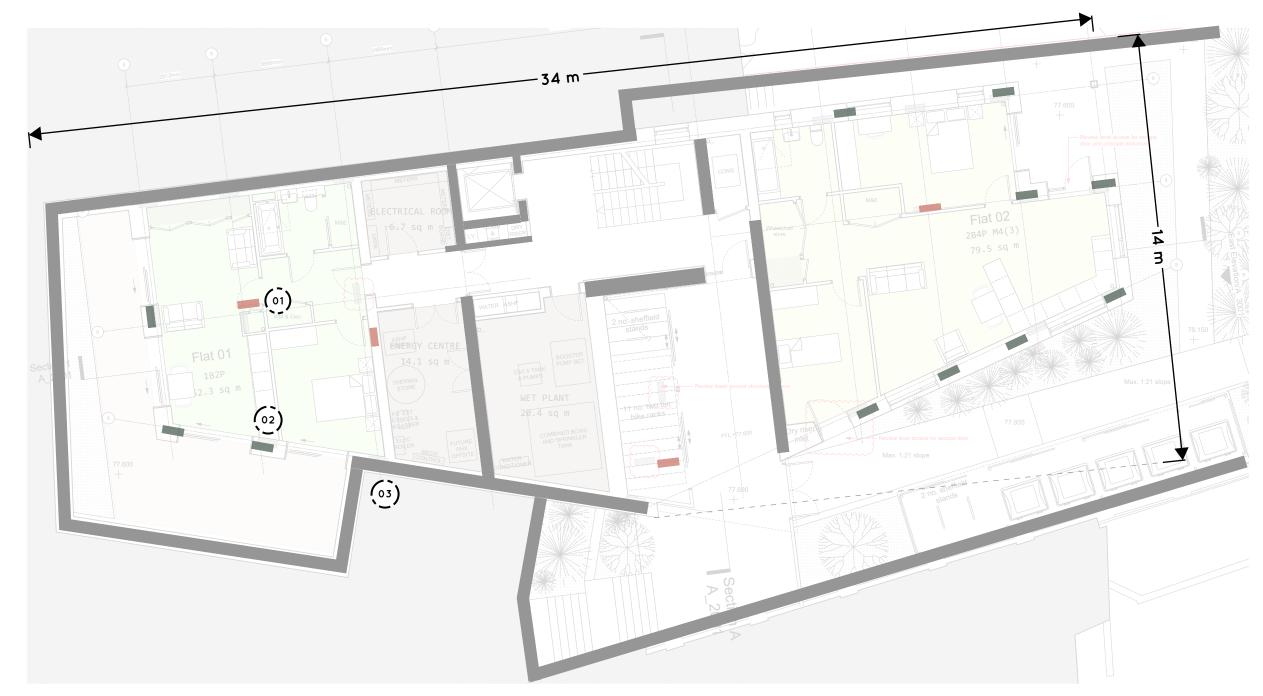
COLUMNS AND WALLS FOUNDATION ESTIMATED LOADS

FOR PILED FOUNDATIONS OR SHALLOW FOUNDATIONS (IF SUITABLE)

NOTES:	ESTIMATED LOADINGS (UNFACTORED):
ASSUMED PILE DIAMETER: 450mm U.N.O. ASSUMED PILE LENGHT: 15m TBC BY SOIL SPECIALIST PILED RETAINING WALL ASSUMED ALL AROUND	
ASSUMED DEPTH OF PILE CAPS: 1000mm	WORST CASE - INTERNAL COLUMN DL = 465 kN, LL = 210 kN
PILES ASSUMED SLEEVED TO ORIGINAL BASEMENT (DEMOLISHED) FOUNDING LEVEL	
	EXTERNAL COLUMN DL = 465 kN, LL = 115 kN

(03) RETAINING WALL DL = 111 kN/m, LL = 23 kN/m

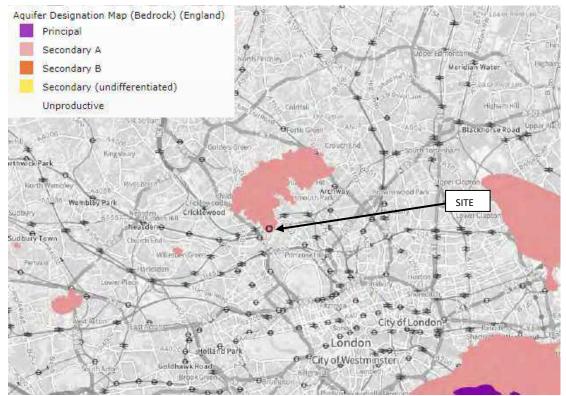
Figure 2.4.1 – Ground Water Vulnerability Zones (approximate site location marked)

Map Dataset	Designation	Comment
Groundwater Vulnerability	High	This category classifies the underlying groundwater in terms of vulnerability from activities carried out on the surface.Figue 2 1 ideti fies that the site has a Hi gh de signation ha at ei sed by the Secondary A aquifer with permeable leaching soils close to ground level, resulting in a high vulnerability to pollutants.
Aquifer Maps: Bedrock Deposits Designation	Secondary A	This category identifies the type of aquifer present in solid permeable formations.Figue 2 indiat es that the supefi i al deposits ae in the Seo nda yA designation, consisting of permeal e stata ap a le of suppoti ng water supplies at a local rather than strategic scale and in some cases forming an important source of base flow to rivers.
Ground Water Source Protection Zone	N/A	Figure 2.4.3 shows the site is not located within a source protection zone.

The geological and hydrogeological ground conditions have been investigated within section 2.3 and 2.4 of this report. Figure 2.4.1 shows a groundwater vulnerability class of High. This is likely due to the shallow nature of the Claygate Member soils to the surface. Given the nature of these soils and the existence of made ground from the demolition of the previous building, post-development surface water run-off is unlikely to utilise infiltration and will most likely discharge to sewer, thereby reducing the contamination risk to the underlying water table. As shown on figure 2.4.3, the site is not located within a groundwater protection zone.

The geological and hydrogeological conditions have been investigated within section 2.3 and 2.4 of this report. Figure 2.4.1 shows a groundwater vulnerability of high in relation to activities undertaken at surface level. This is likely due to the shallow nature of the Claygate Member soils close to the surface. Given the impermeable nature of these soils and the existence of made ground from the demolition and past use of site, it is not proposed to discharge surface water run-off via the use of infiltration or soakaways. The site also affords little space for the positioning of a below-ground soakaway due to the site of the proposed building and the buffer required between foundations and soakaways.

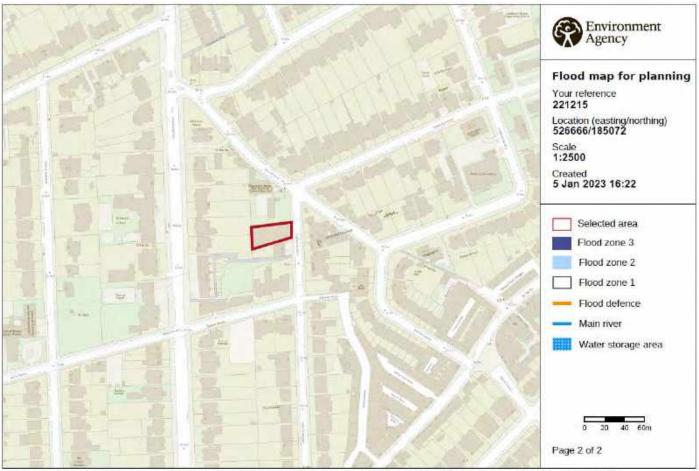
Figure 4.1.1 – Environment Agency Online Flood Map for Planning (Approximate Site Extents Edged Red)

An extract from the Ei ronmet Ag ey s online flood map published on the Government website is shown in Figure 4.1.1 below, with Flood Zone 3a & 3b denoted by dark blue hatch and Flood Zone 2 a light blue:

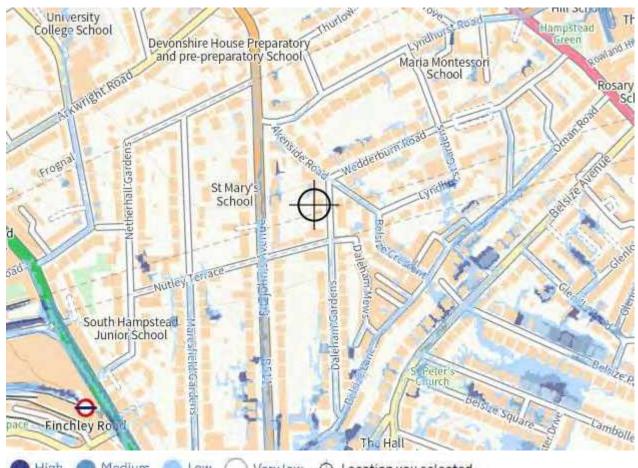
Figure 4.2.1 – Environment Agency Online Surface Water Flood Map Extract (Site Marked)

With reference to Environment Agency long term flood risk mapping, published on the Government website, the below extract shows the site in relation to indicative flood risk from surface water:

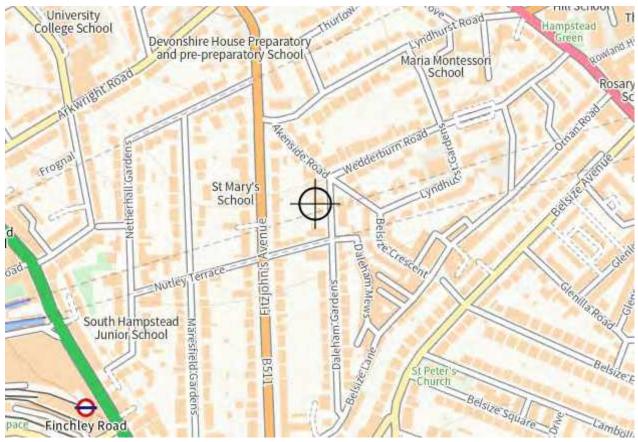
Figure 4.4.1 – Environment Agency Online Reservoir Flood Map Extract (Approximate Site Extents Edged Red)

With reference to the Environment Agency long term flood risk mapping, published on the Government website, the below extract shows the Site is not at risk of flooding from reservoirs:

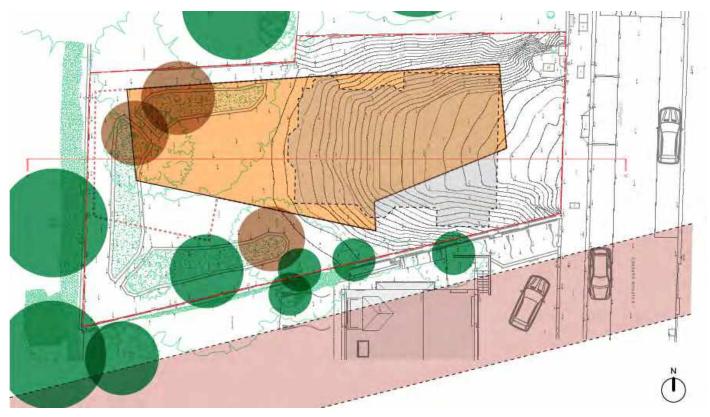
Figure 6.7.1 – Extract of Simple Works Constraints Plan (Drg 1803-XX-SK-01)

It should be noted that there is an existing Network Rail Tunnel, the Belsize Railway Tunnel, passing beneath the adjacent property. The below extract shows the proposed building footprint in orange, with the approximate alignment of the tunnel in salmon colour:

The exact alignment and depth of the tunnel is yet to be determined. The surface water drainage design on-site will need to comply with Net ok Rails asset protection guidance and requirements.

As such, it should be noted that the current drainage proposals are subject to amendment to suit any discussions yet to be held with Network Rail.
