19 APPENDIX 3 – ENVIRONMENTAL SCREENING REPORT

31 DALEHAM GARDENS, LONDON, NW3 5BU

CCTV SURVEY REPORT

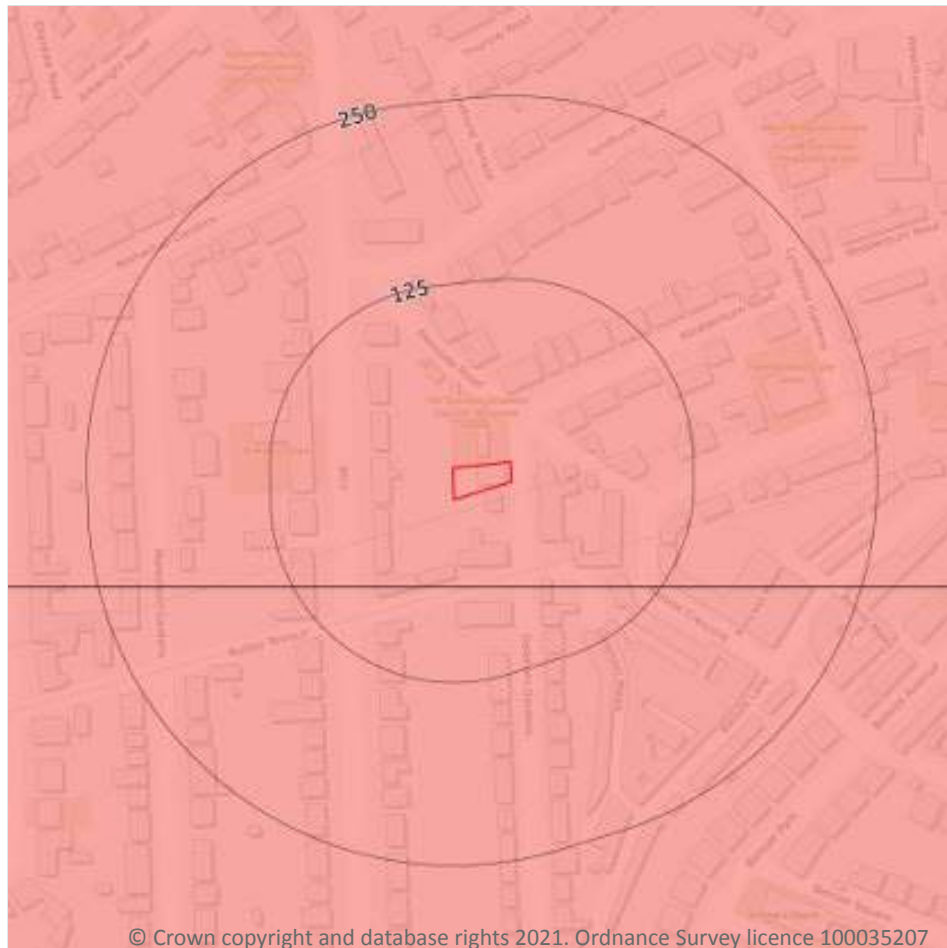
17 Natural ground subsidence - Shrink swell clays

| Location | Hazard rating | Details |
|---|---|--|
| On site | Moderate | Ground conditions predominantly high plasticity. |

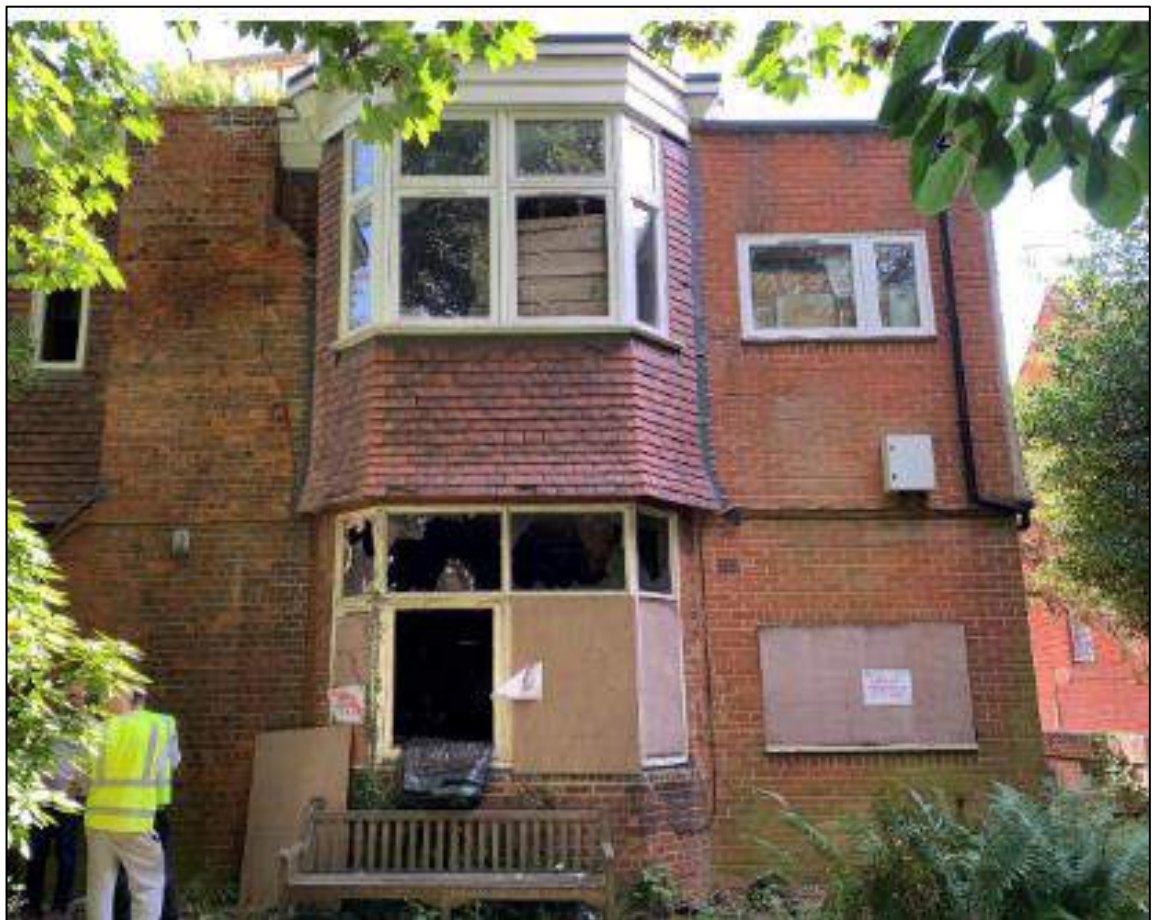
Figure 3: Rear West Elevation

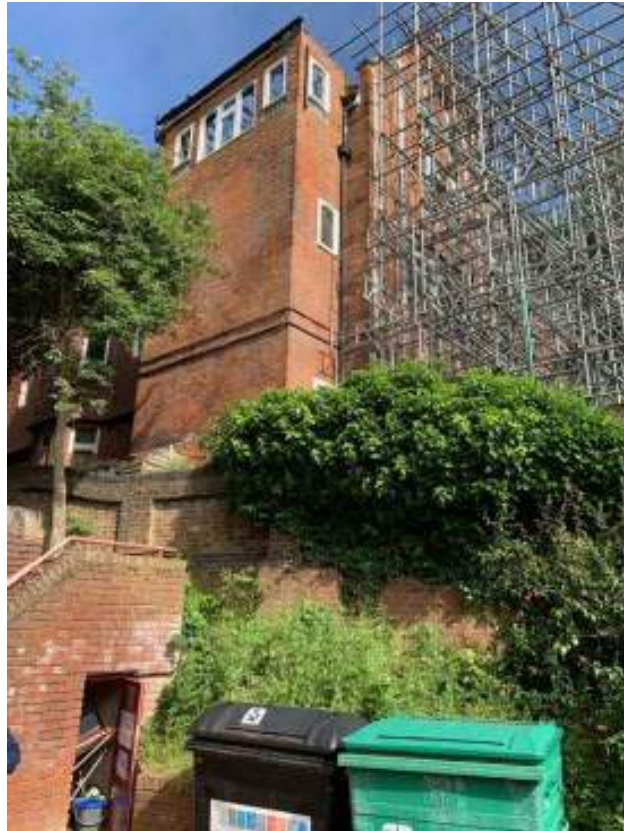
Figure 4: South Face of 31 to Roofline, Retaining Wall, 31a Brick Staircase
