PHOTO RECORD

THE CITY OF LONDON CORPORATION

**KEATS LIBRARY
10 KEATS GROVE, HAMPSTEAD
LONDON NW3 2RR**

CCTV, FIRE AND INTRUDER ALARM SYSTEMS

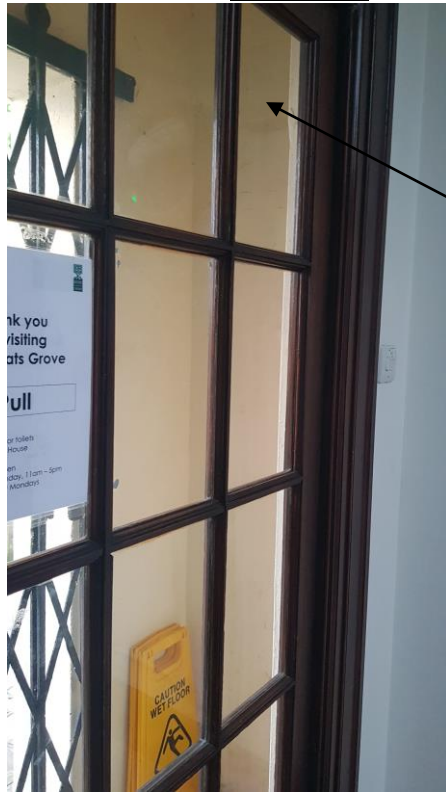
G1

External Beacon

Proposed location for a wireless external beacon.

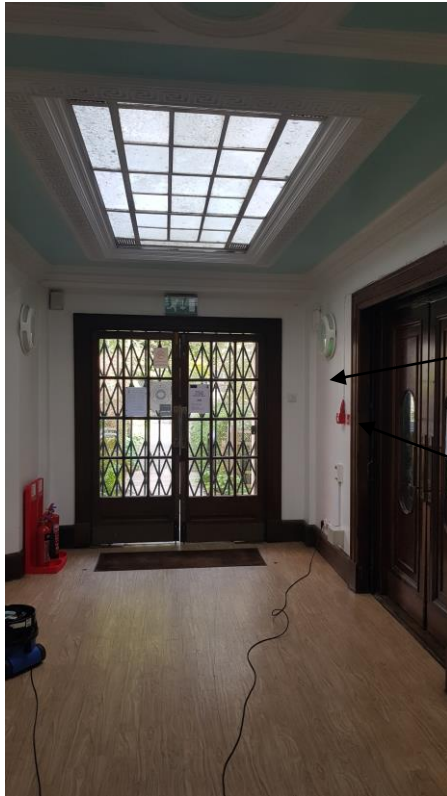
VIEW 1

New Fire Alarm Panel &
Ancillaries Location

Manual Break Glass Unit

Existing manual break glass to be replaced with a wireless type and relocated below new fire alarm panel. Cabling to be removed.

Proposed location for a new fire alarm panel, ancillaries and power supply units all housed within a white painted timber cupboard – See drawing COL/KL/68/10 for further details.

Note:- Redundant holes within the wall will be filled and painted.

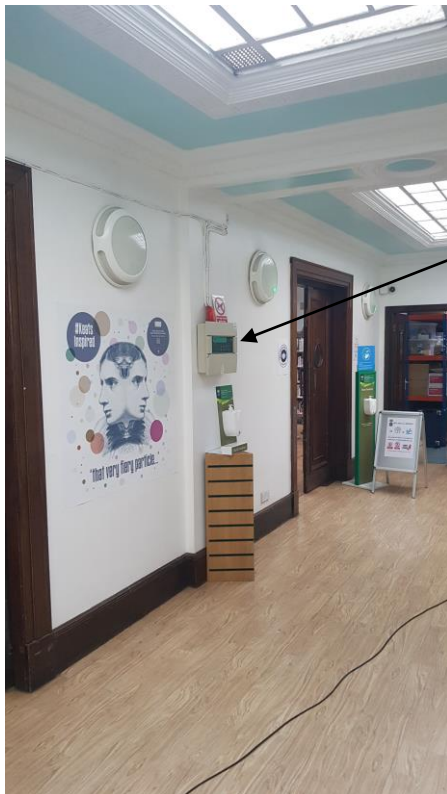
VIEW 2

Fire Alarm Panel

Existing fire alarm panel, power supply, ancillaries and cabling to be removed.

Note:- Redundant holes within the wall will be filled and painted.

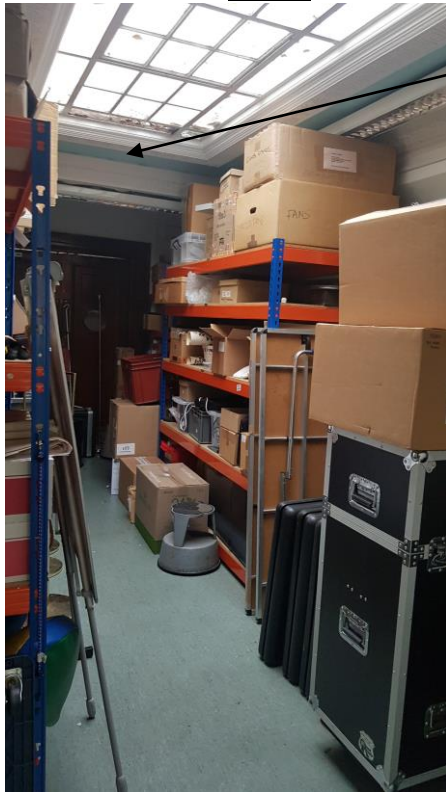
G3

Smoke Detector

Proposed location for a new wireless smoke detector mounted onto a base sounder and beacon.

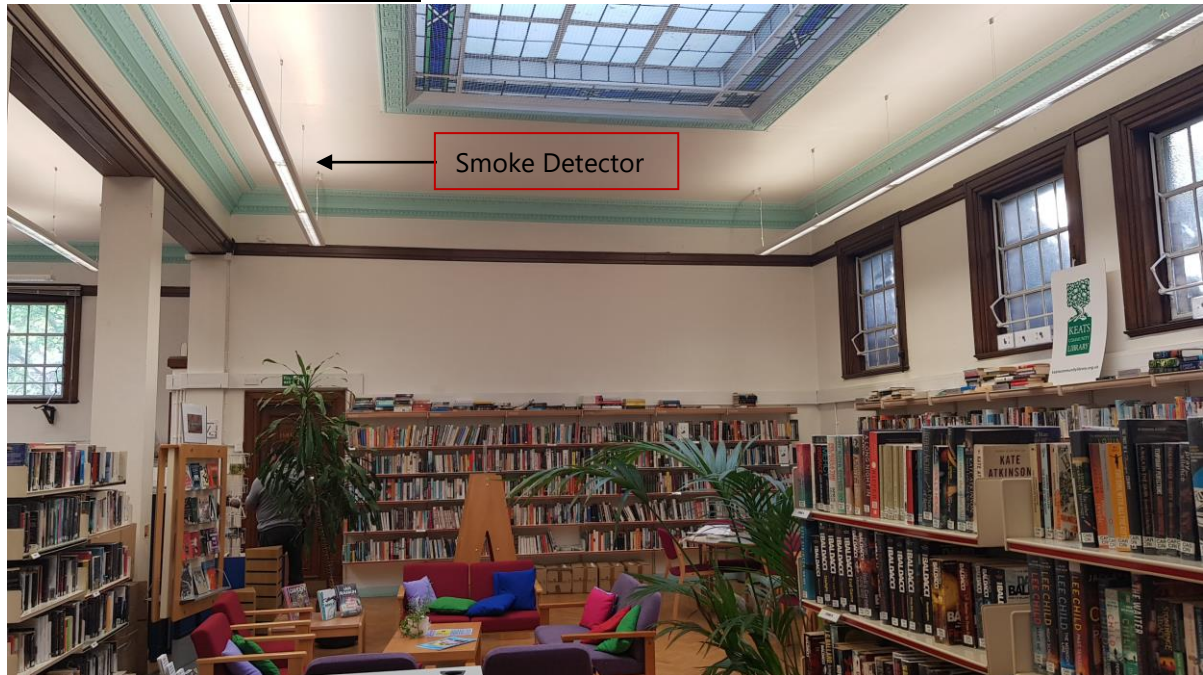
VIEW 1

Proposed location for a new wireless smoke detector mounted onto a base sounder and beacon.

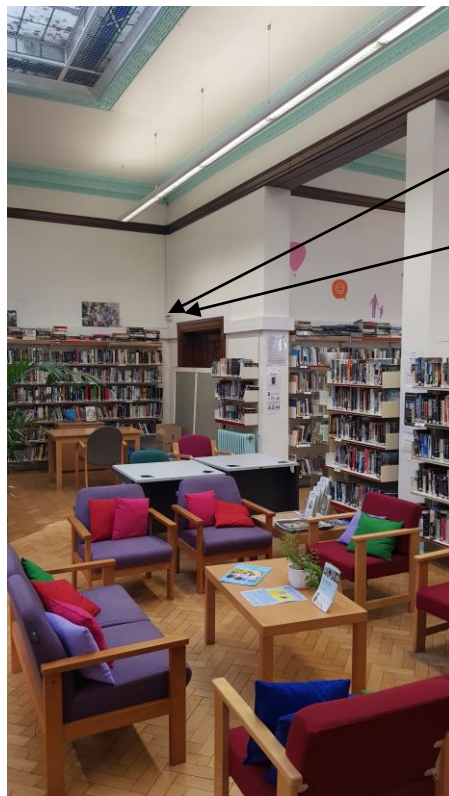
VIEW 3

Intruder Detector

Intruder Alarm Siren

Proposed location for a new intruder detector and siren.

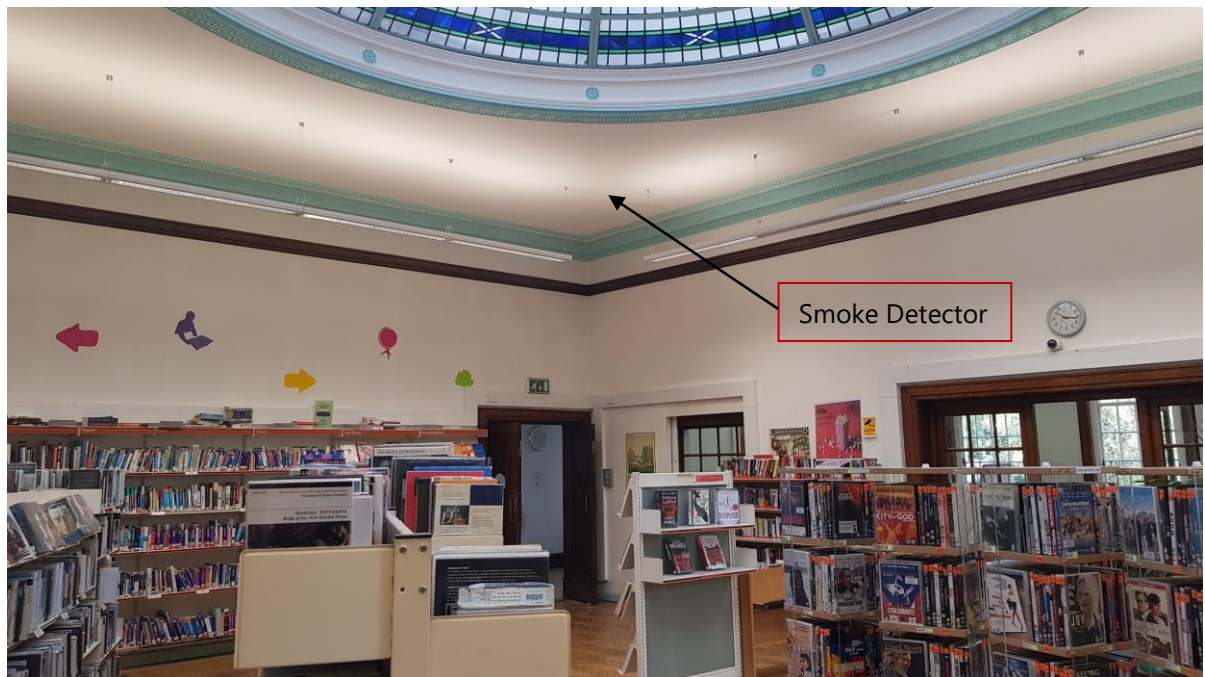
VIEW 4
LOOKING FROM MAIN LIBRARY (G5) TOWARDS
HALL DOOR (G2)

Proposed location for a new wireless smoke detector mounted onto a base sounder and beacon.

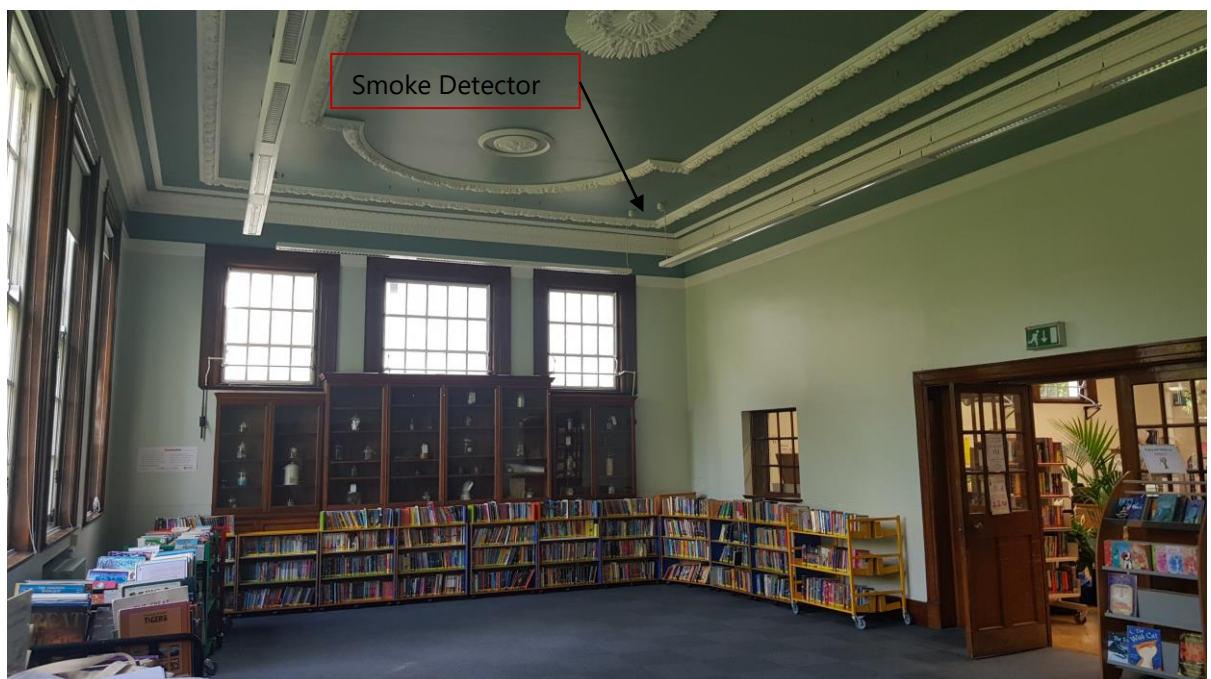
VIEW 2

Proposed location for a new wireless smoke detector mounted onto a base sounder and beacon.

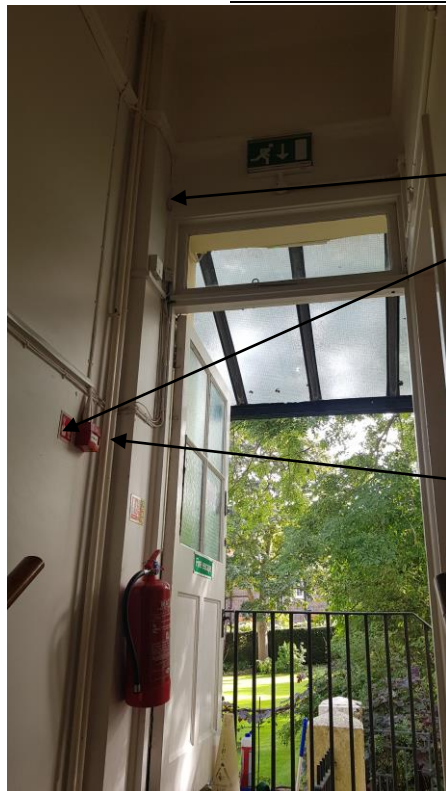
VIEW 1

Intruder Detector

Intruder Alarm Keypad

Manual Break Glass Unit

Proposed location for a new intruder detector.

Proposed location for a new keypad and mounted in-line with fire alarm manual break glass unit.

Existing manual break glass is to be replaced with a wireless type.

It is proposed to install a new wireless smoke detector mounted onto a base sounder, located onto the ceiling within this area.

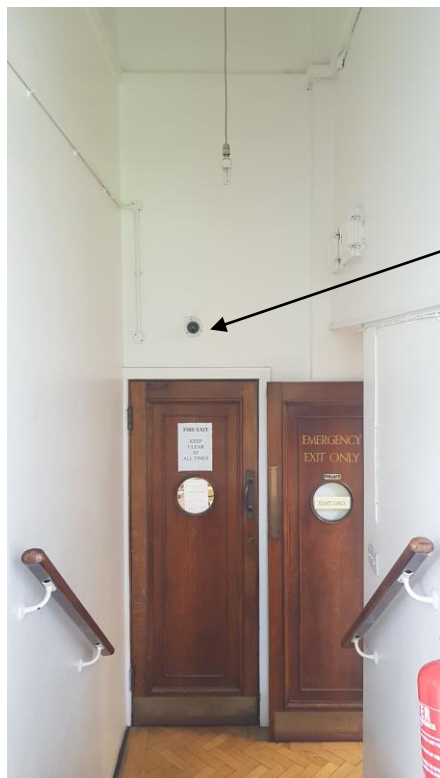
VIEW 2

CCTV Camera

New camera to be a direct replacement and connected to existing cabling.

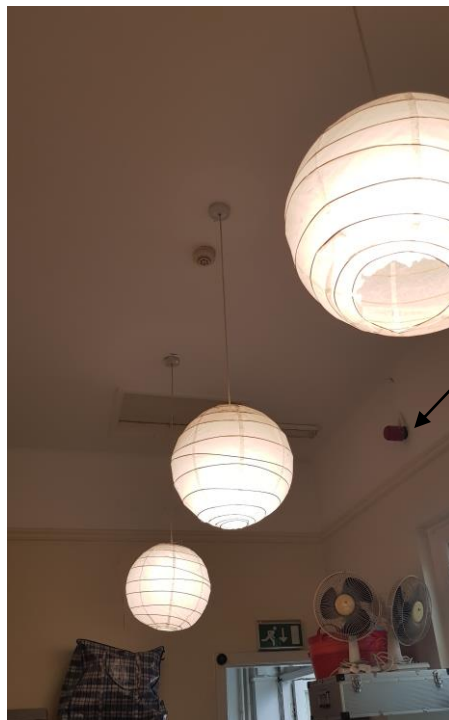
VIEW 2

Existing fire alarm sounder and cabling to be removed.

It is proposed to install a new detector within this area.

Note:- Redundant holes within the wall will be filled and painted.

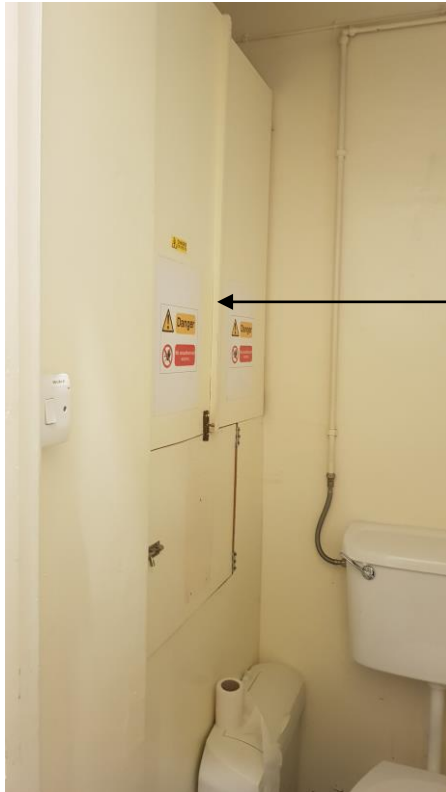
G10

Electrical Service Cupboard

It is proposed to install a new wireless smoke detector within the electrical mains cupboard.

Note:- The District Network Operators (DNO) incoming electrical service head and the libraries distribution board are housed within this cupboard.

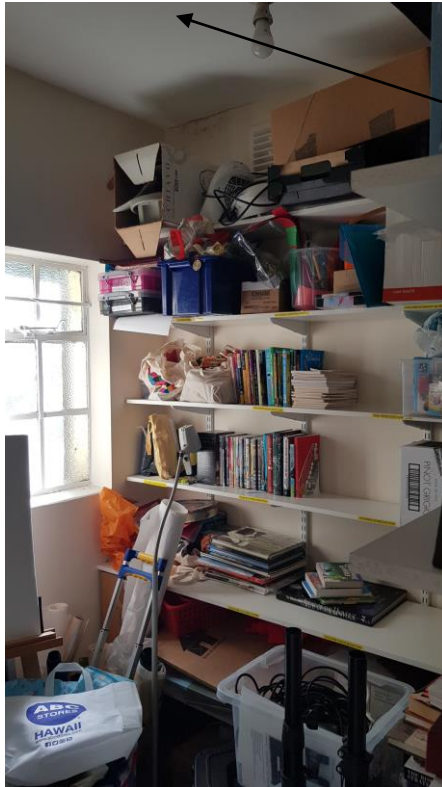
VIEW 1

Smoke Detector

It is proposed to install a new wireless smoke detector mounted onto a base sounder and located onto the ceiling within this area.

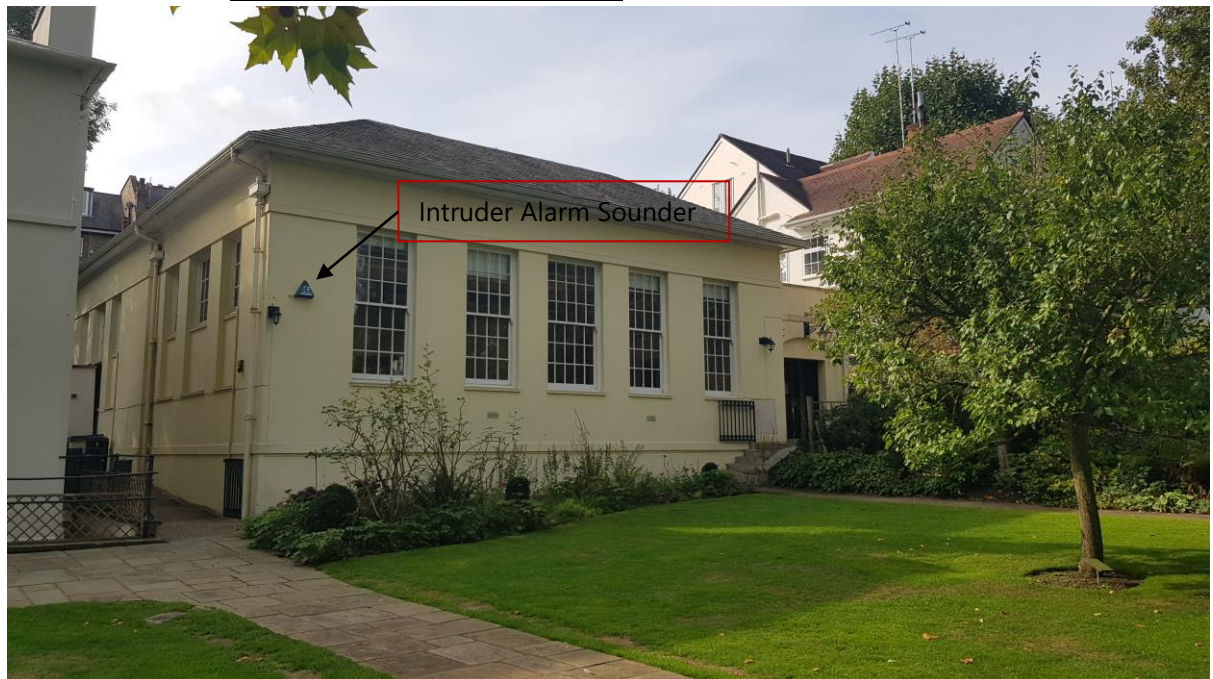
EXTERIOR – FRONT ELEVATION

Intruder Alarm Existing external sander to be replaced and relocated.
New location to be adjacent to rear staff door – See drawing COL/KL/68/11.
Note:- Redundant holes within the wall will be filled and painted.
