Project :
 KEATS HOUSE
 10 KEATS GROVE
 LONDON NW3 2RR

Drawing :
 BASEMENT & GRD FLR
 EXISTING FIRE ALARM
 SYSTEM LAYOUT

Scale at A1 : 1:50	Drawn by : S.M.C.
Des : S.M.C.	App :
Date : NOV 21	Pro code UPRN
Drawing No: COL/KH/68/00	
Revision	C

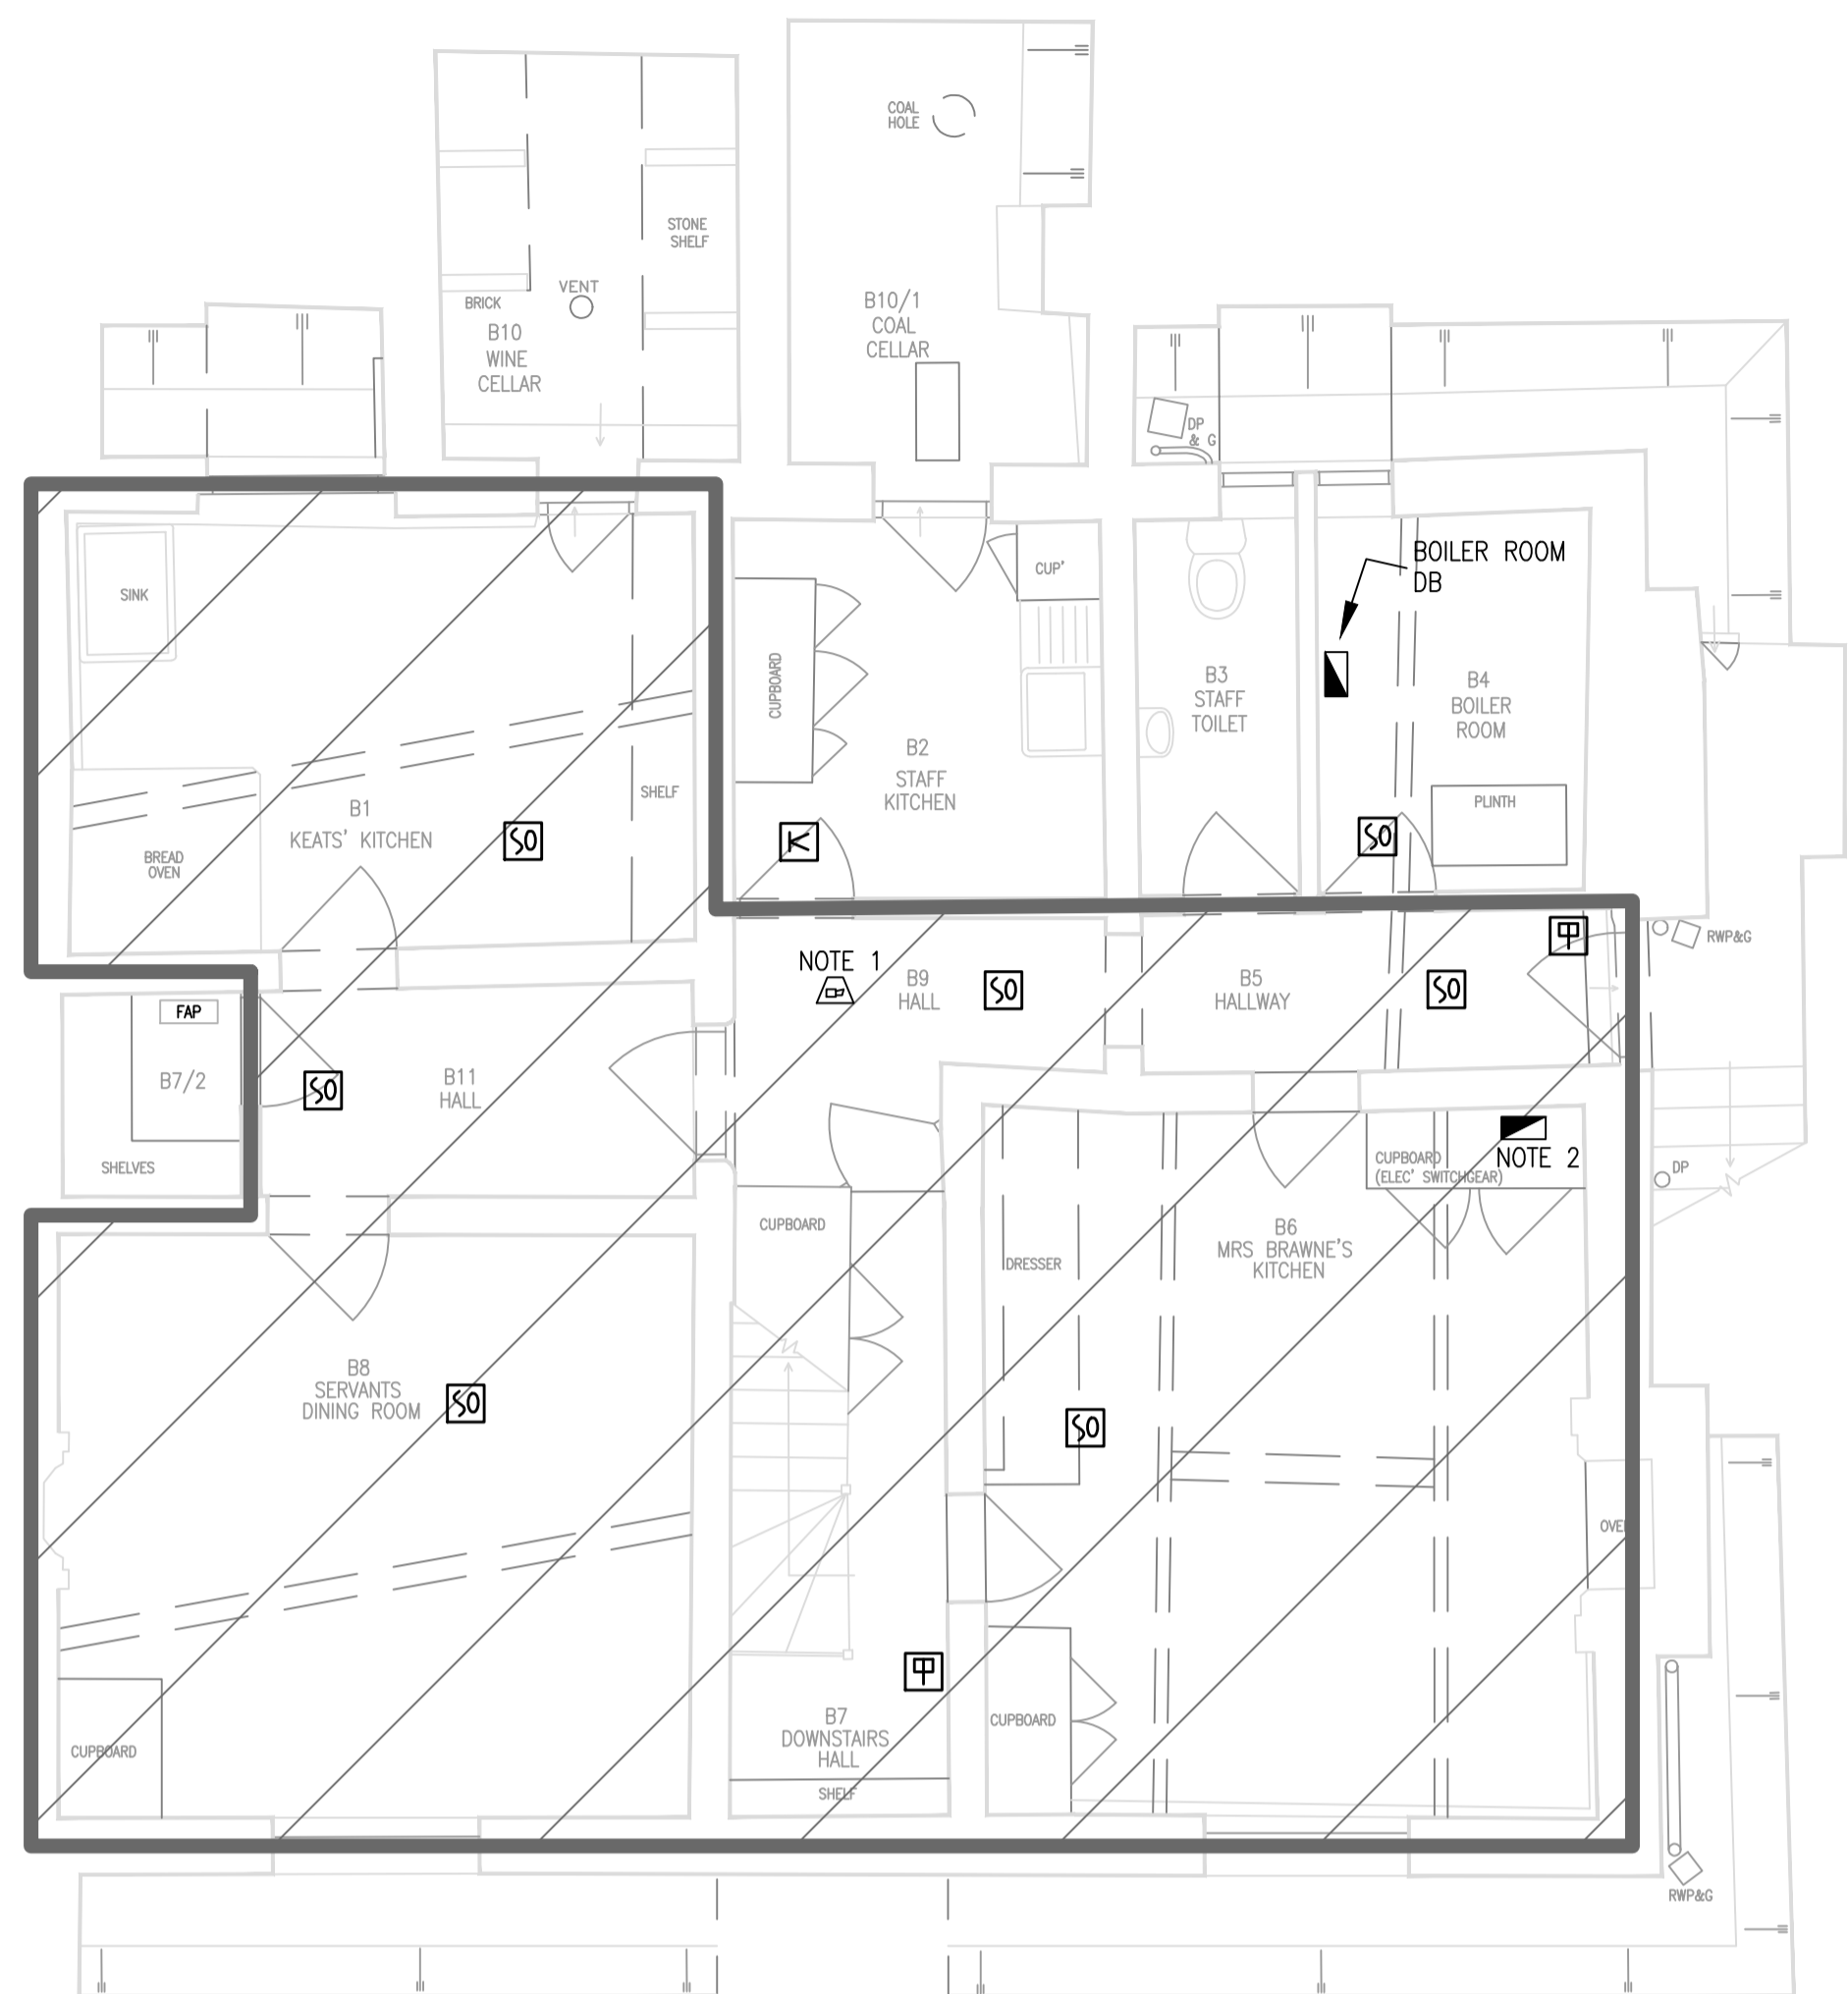
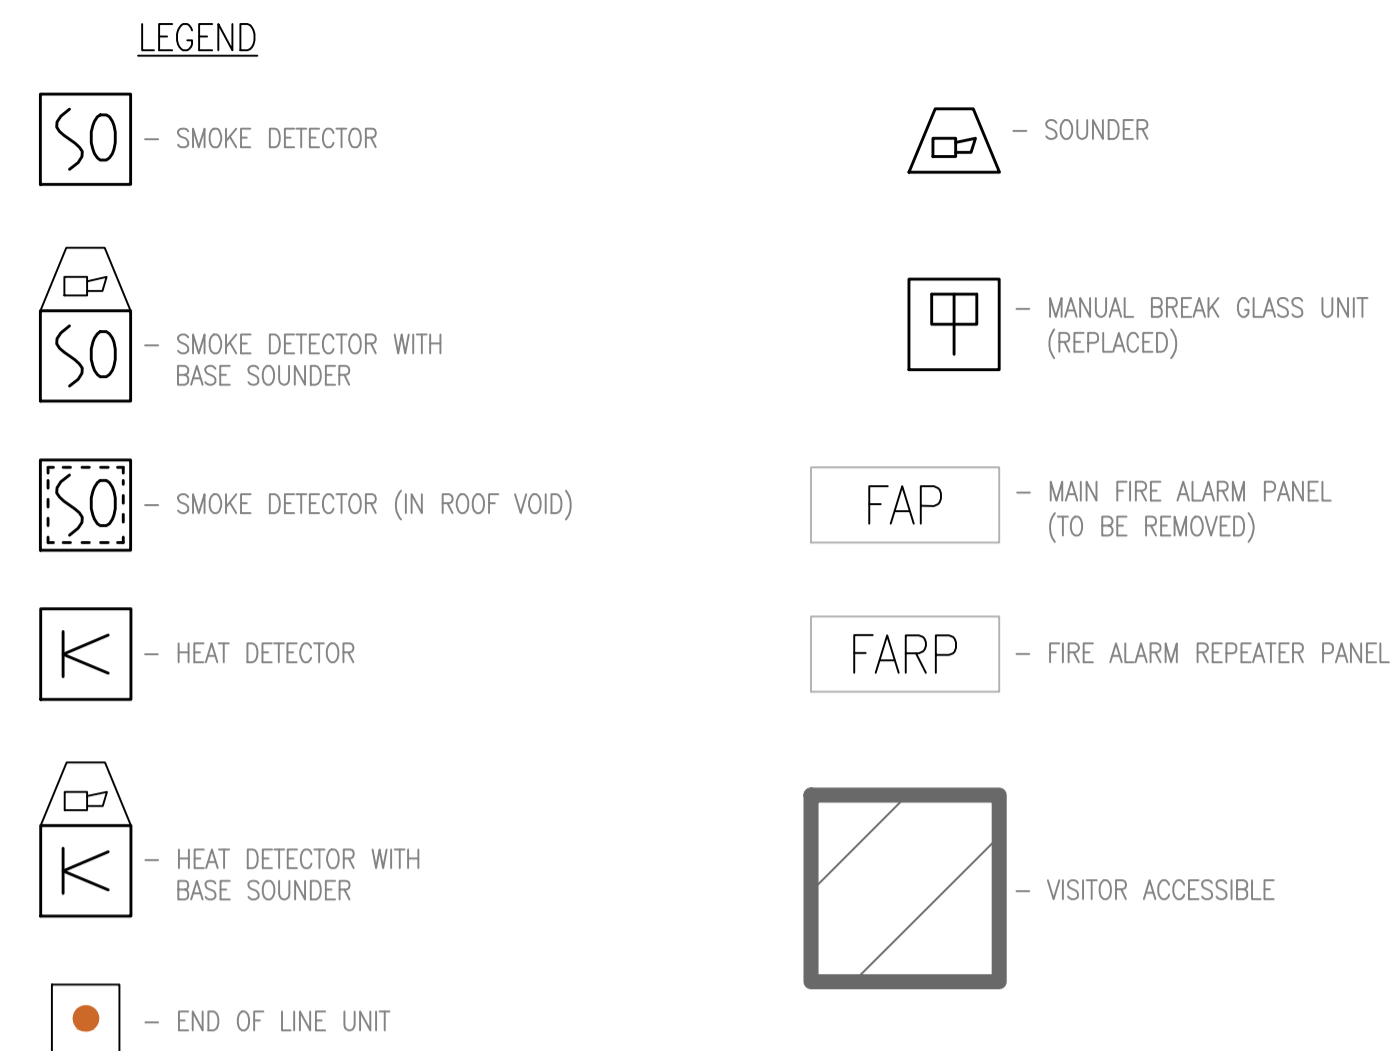
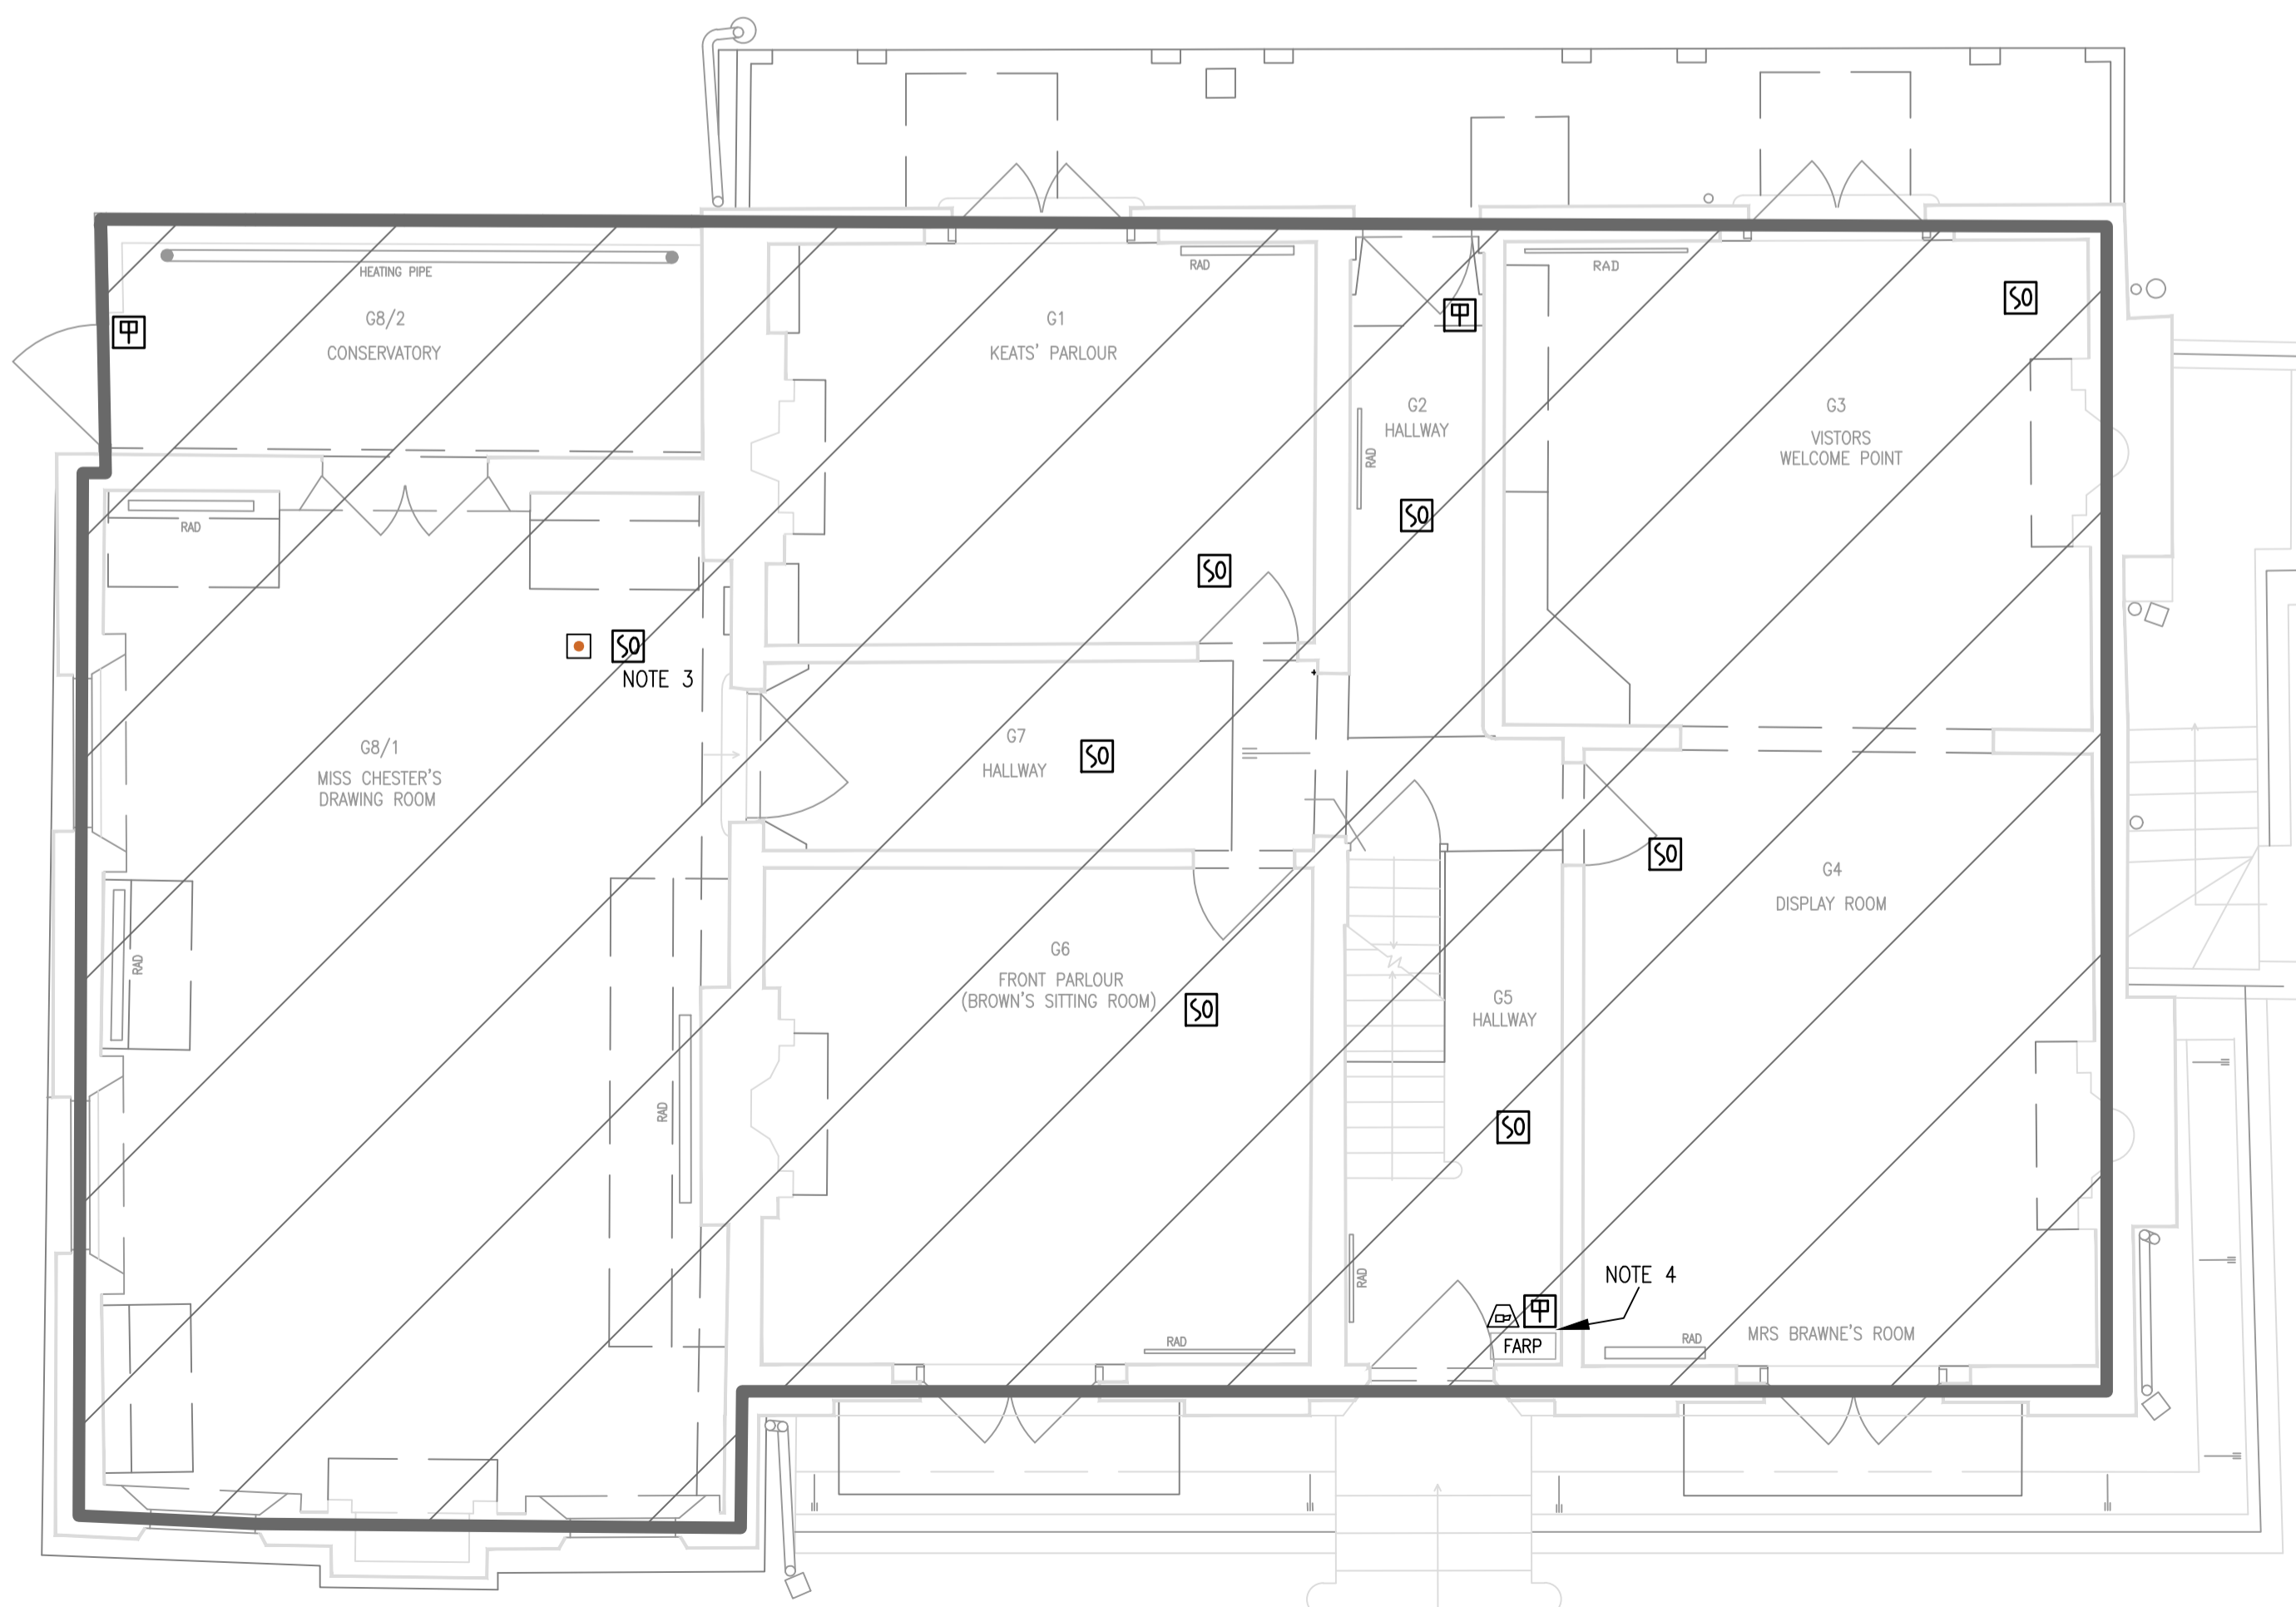
- notes
- SOUNDER HAS MISSING COVER.
 - LOCATION OF DNO TP&N SERVICE HEAD & METER ALONG WITH THE HOUSES DISTRIBUTION HEAD.
 - IT IS STRONGLY BELIEVED THIS DETECTOR HAS A FAULT IN ITS SUPPLY CABLE AND HENCE DOES NOT WORK.
 - LOCATION OF A SIMPLE INDICATOR PANEL WITH 4 NO. ZONE INDICATORS, A FAULT INDICATOR AND 4 NO. PUSH BUTTONS.
 - SIGNAGE IS UNAFFECTED BY THIS PROPOSAL.
 - WHERE PRACTICAL AND IT DOES NOT IMPAIR ITS OPERATION, ALL NEW & EXISTING DEVICES/EQUIPMENT ARE TO BE PAINTED (EVENLY & WITHOUT RUNS) SO AS TO MATCH THE SURROUNDING WALL/CEILING SURFACE TO WHICH IT IS FIXED.
 - ALL REDUNDANT CABLING IS TO BE REMOVED AND ANY SURFACES MADE GOOD.
