BUILT HERITAGE STATEMENT

13-15 Bonny Street, Camden

JCH02017
13-15 Bonny Street
September 2023

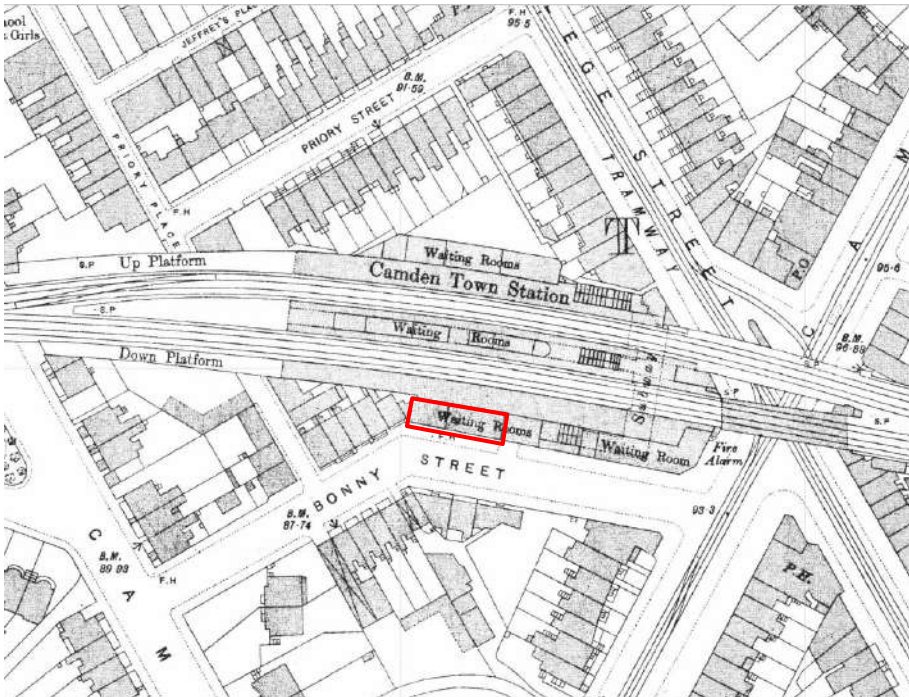
Figure 8: 1896 OS map

The 1896 Ordnance Survey map (Figure 8) shows the renaming of the street to Bonny Street. The Site is identified as 'waiting rooms' for the Camden Town Station, therefore the dividing walls are likely to correspond to this, rather than the separation on the ground and first floors. Residential terraces have been established on the southern side of Bonny Street and in the local area, Great College Street has been widened to accommodate the new infrastructure.

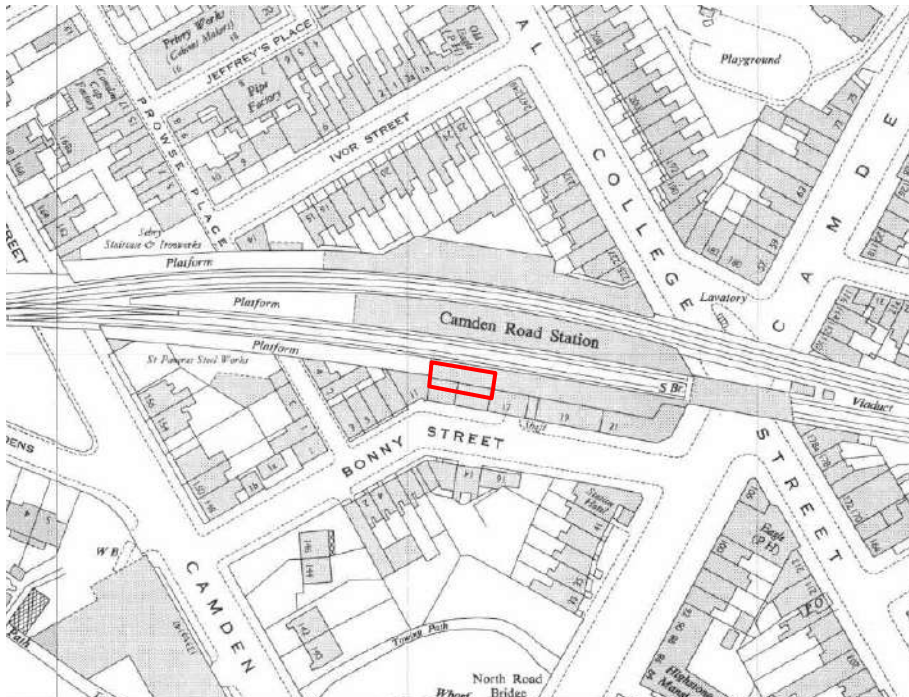
Figure 9: 1952 OS map

The division of the lower floors of Camden Road Station is visible in the 1952 Ordnance Survey map (Figure 9, page 9) and corresponds to the existing layout. The station is marked as Camden Road, after being renamed in September 1950. There is little change in the local area, demonstrating that it is unlikely that any bomb damage affected this immediate area.

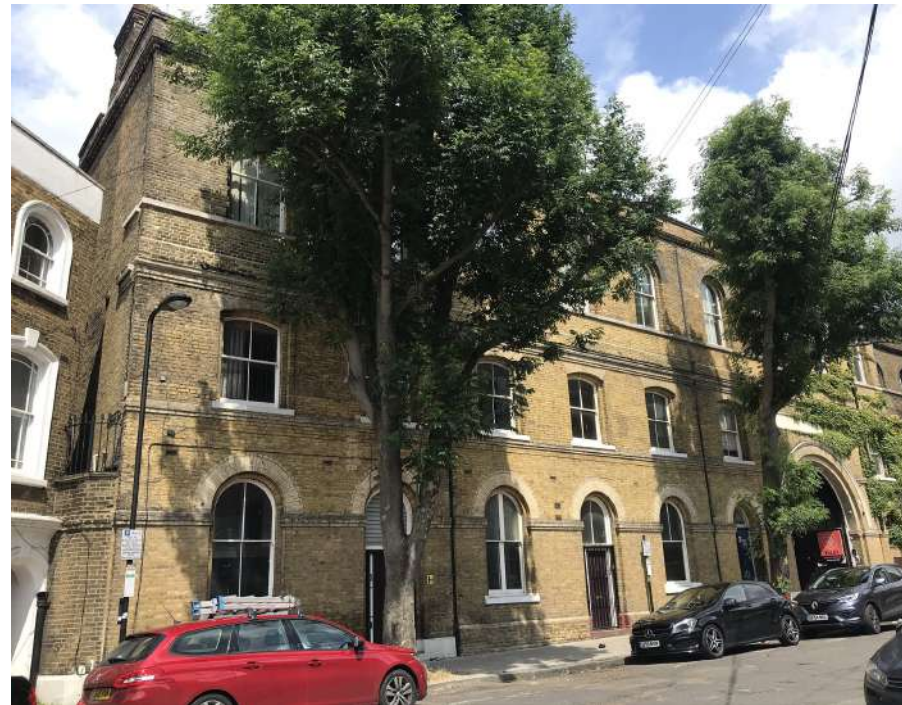
Figure 13: 13 (to left) and 15 (to right) Bonny Street

The ground floor external window between No.13 and No.15 has been divided to separate the dwellings; the wider glazing bar to accommodate this can be noted on the exterior. The No.13 ground floor window is two-over-two sash, however No.15 is two-over-one sash. There are two-over-two sash windows throughout the first floor of No.13 and No.15. They appear to retain the same profile and detailing.

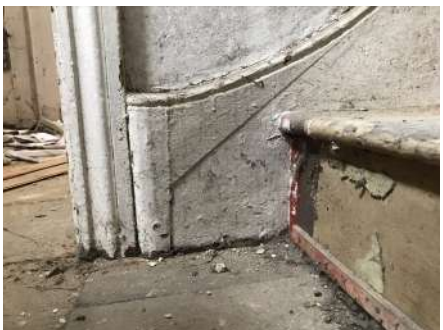
Images 1&2: Staircase details

Floor: Timber floorboards. Skirting up the staircase only (Images 1 and 2)

The staircase in No.13 and the half flight in No.15 were likely to have been established at the same time, when the building was separated, indicated by the similarities of the metal rail found in both (Images 1, 2, 3 and 26, pages.

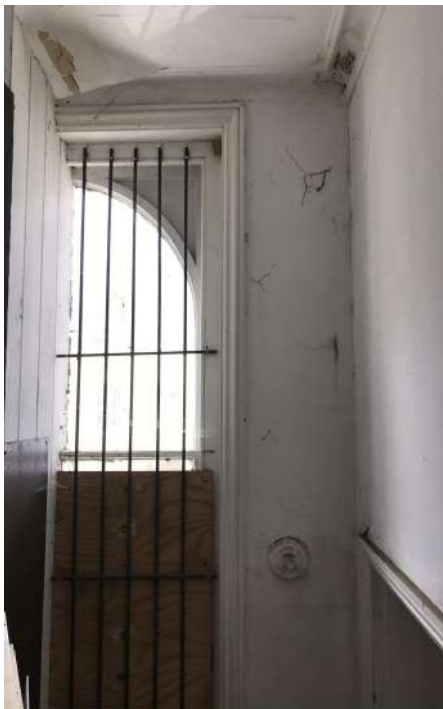
Image 4: 13GF.1

Doors: Architrave (Image 4). Modern door at bottom of stair, off the hinges.

Windows: architrave around door matches detail around window (Image 4)

Additional comments: metal detail on wall also seen on first floor and in No. 15 (Image 4)

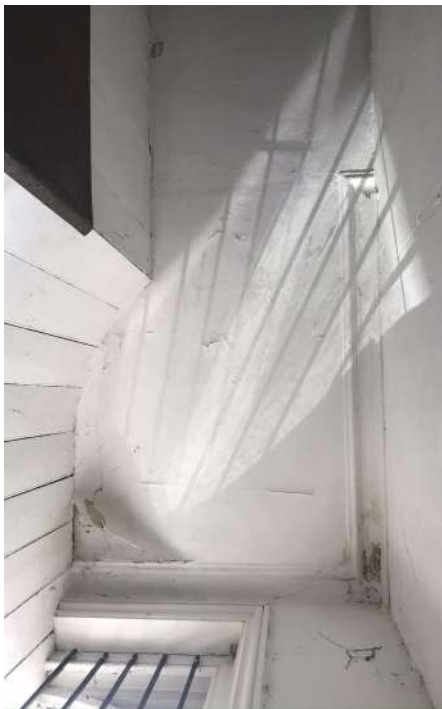
Image 5: 13GF.1 Ceiling

Ceiling: Assumed lath and plaster. Cornicing in one corner only (Image 5)

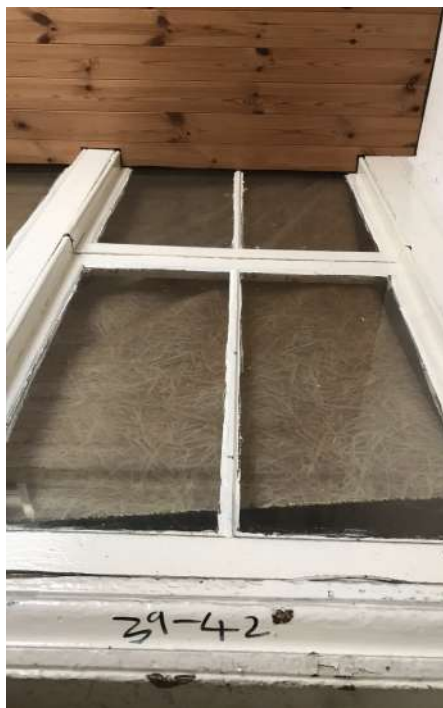
Image 8: 13GF.2

The internal windows on the ground floor appear to have been installed at the same time as the timber panelled walls. The profiles of these windows in No. 15 and 13GF.2 and 4 (see images 6, 7 and 8 are similar a. The internal window for 13GF.3 and 5 (see image 14) is a modern replacement.

Doors: Architrave on all doorways (Image 8 example).

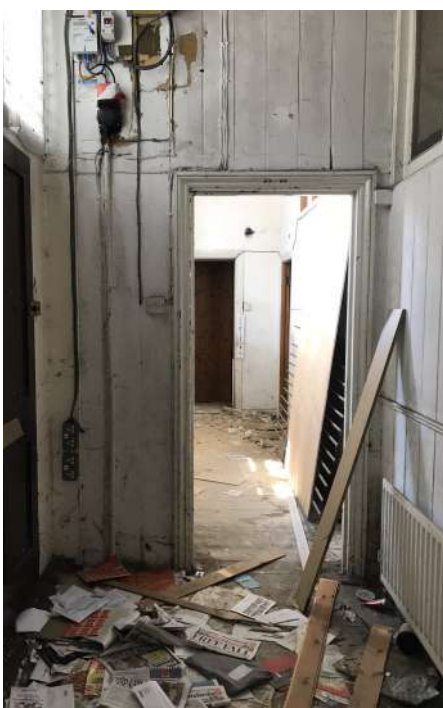
Image 9: 13GF.2

Floor: Timber floorboards. No skirting (Image 9)

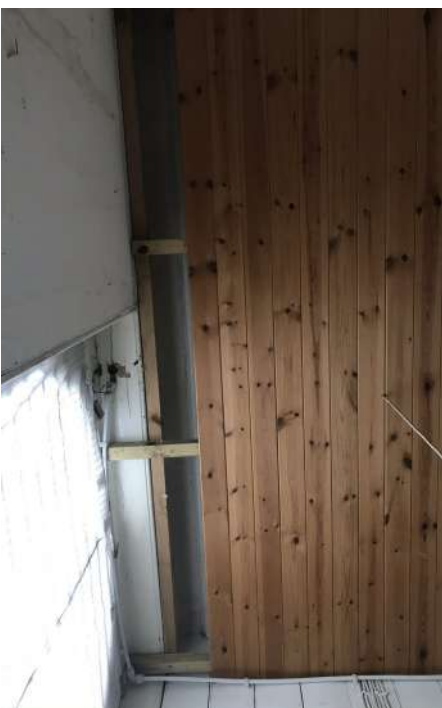
Image 10: 13GF.2 Ceiling

Ceiling: Modern, poorly detailed around internal window (Images 8 and 10). There may be cornicing and historic ceiling underneath evidenced by the gap (Image 10).

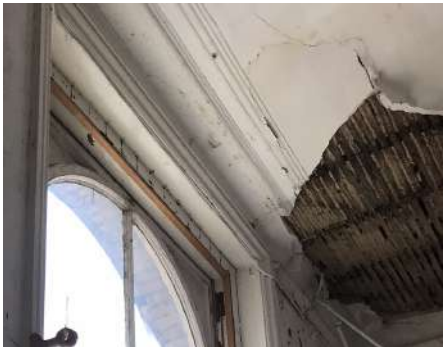
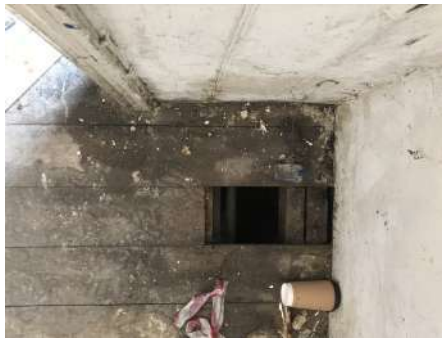
Images 11&12: 13GF.3

Floor: Timber floorboards. No skirting (Image 12)

Windows: One large sash window (Image 11).

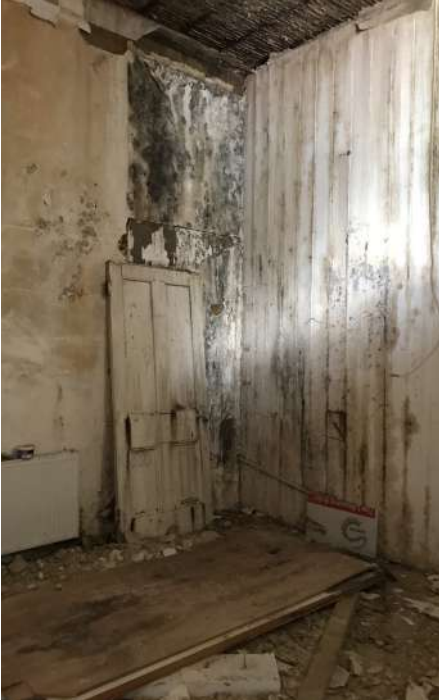
Image 19: 13GF.5

Additional comments: Chimneybreast in situ. Modern fireplace. Four panelled door propped in corner. Potential blocked up door on northern wall, outline visible (Images 17&19).

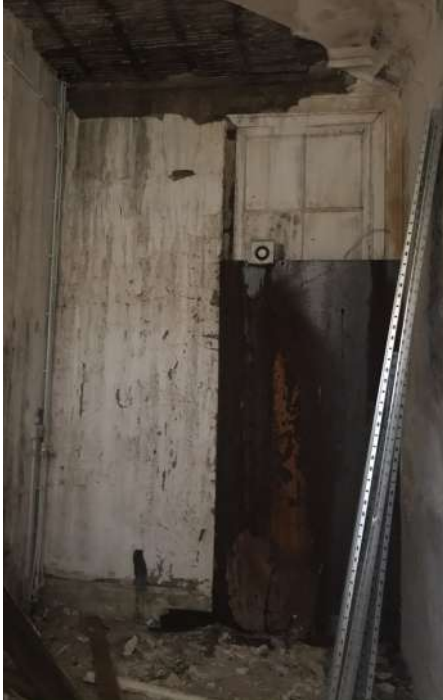
Image 20: 13GF.4

Windows: Blocked/painted window on northern wall (Image 20).

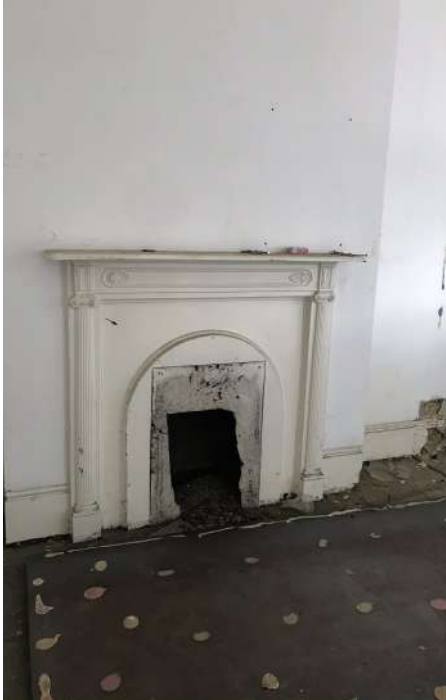
Image 30: 13FF.3

Additional comments: Chimneybreast in situ. Fireplace similar to the one found in 15FF.2 (Image 30/Image 63).

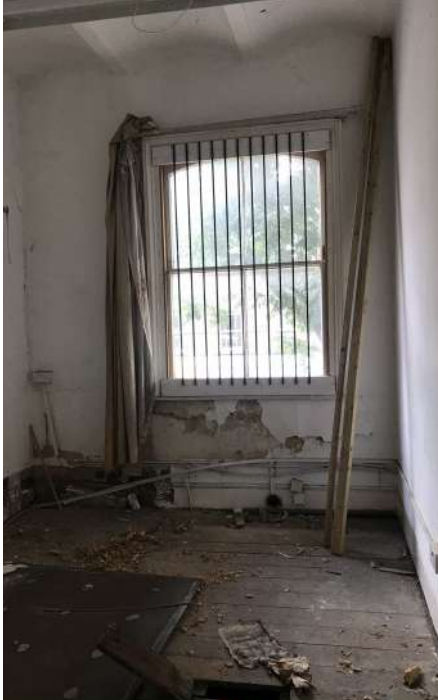
Image 31: 13FF.3

Walls: Damage in south eastern corner reveals lath and plaster (Image 31).

Windows: Two-over-two sash window (Image 31).

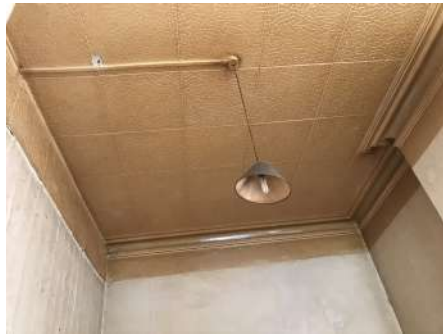
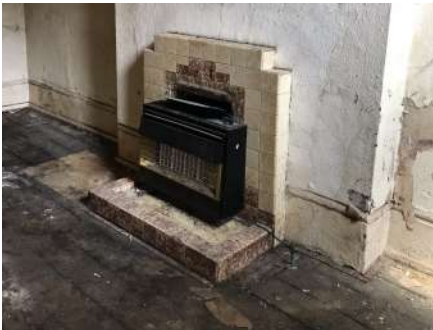
Images 32&33: 15GF.1

Additional comments: Chimneybreast in situ. Modern fireplace (Image 33).

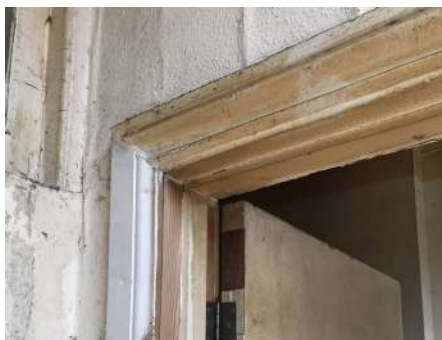
Images 39&40: 15GF.2

Doors: Architrave on all doorways, patch repair on doorway through to 15GF.1 (Image 39).

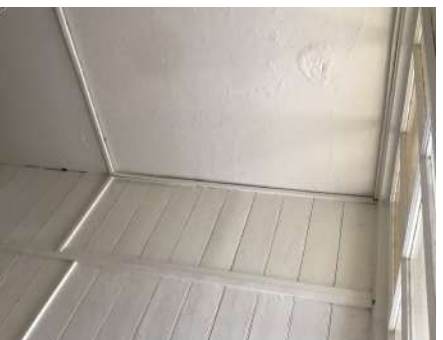
Images 41&42: 15GF.3

No. 15 has modern kitchen and bathroom facilities. (images 41, 42 and 43) There is also evidence of modern suspended ceilings (images 29 and 61 and 62) .

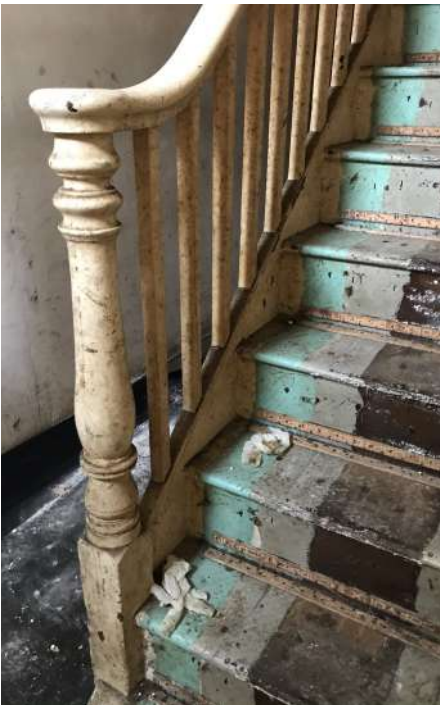
Image 48: Staircase details from 15GF.4

Additional comments: Staircase splits to serve 15FF.2/15FF.3 and 15FF.4 separately. Staircase serving 15FF.4 is a return staircase with timber panelling underneath (Image 47 15GF.4). Handrail serving 15FF.2/15FF.3 (Image 56) is similar to No.13 (Image 24&26).

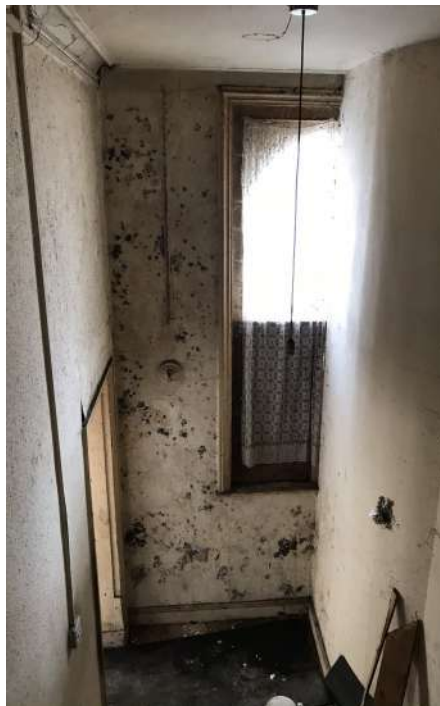
Image 50: 15GF.4 from stair

Doors: Architrave on doorway, no door into 15GF.4 from 15GF.2 (Image 50).

Windows: Sash window divided with No. 13 (Image 50).

Additional comments: metal detail on wall also seen on in No. 13 (Image 50). Timber panel from the stair has been removed and left propped against the wall, historic nails revealed (Image 52).

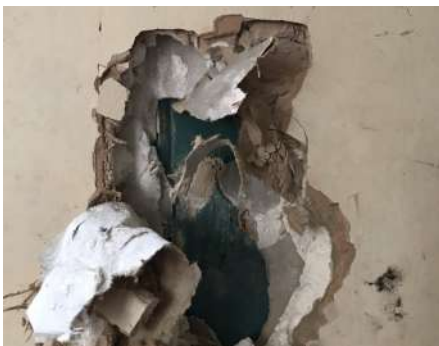
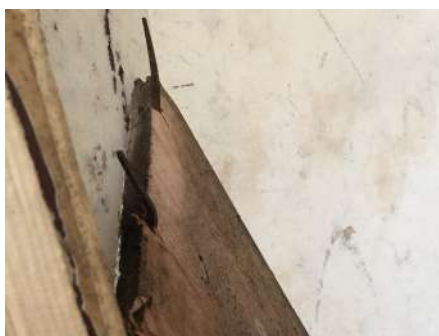
Images 51&52: Detail of curved wall 15GF.4. Detail of nails from timber panel from stair

Walls: Curved dividing wall timber panelled (Image 51).

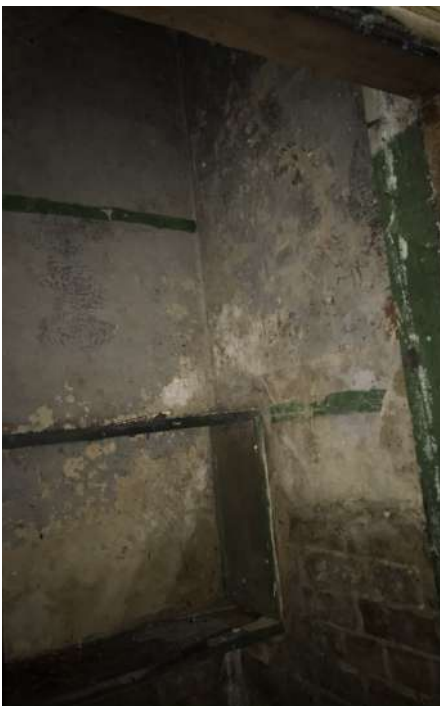
Image 53: 15GF.5

Walls: Brickwork at lower levels on northern and western wall (Image 53)

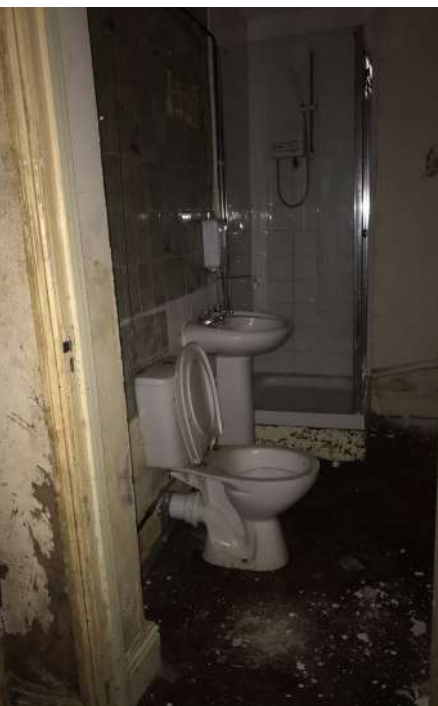
Figure 54: 15GF.6

Walls: Modern tilling (Image 54).

Doors: Four panelled door. Architrave on doorway (Image 54).

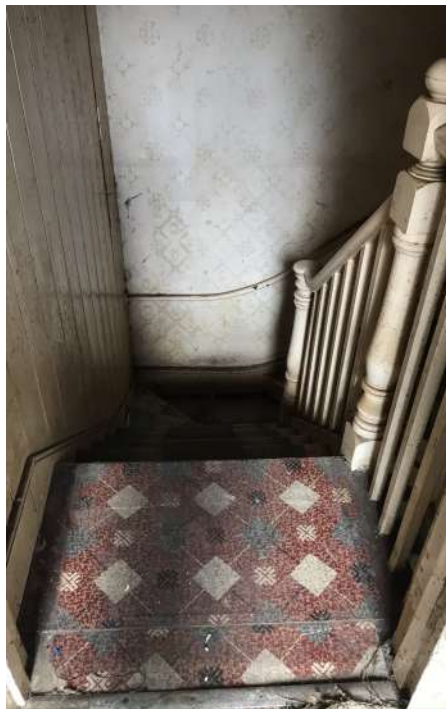
Image 55: 15FF.1

Floor: Timber floorboards. Skirting throughout (Images 55,56&57).

Walls: Timber panelled western dividing wall (Images 55&56), lath and plaster found on hallway southern wall (associated with 15FF.3, Image 59).

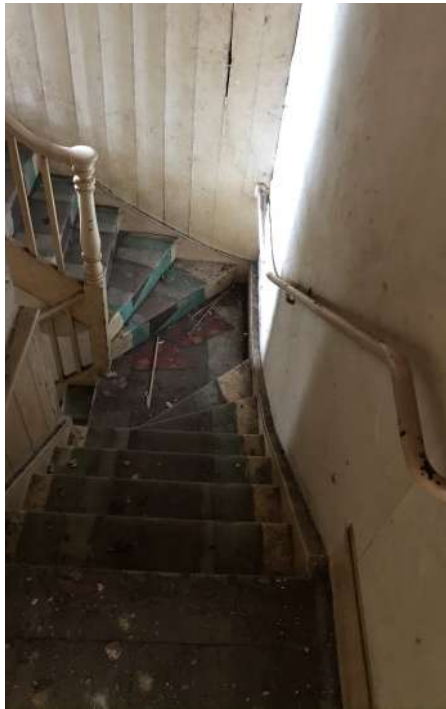
Image 56: 15FF.1

Ceiling: Assumed lath and plaster due to rest of the building. Cornicing on southern wall over staircase, not on western wall or rest of hallway (Images 56&58).

Additional comments: Evidence of blocked up doorway at the top of the staircase from cornicing detail and outline. Stair handrail goes over this area (Figure 24). Hand rail is similar to that found in 15FF.1 (Image 56). Metal detail on wall, similar to that found in 13GF.1 (Image 4) and 15GF.4 (Image 54).

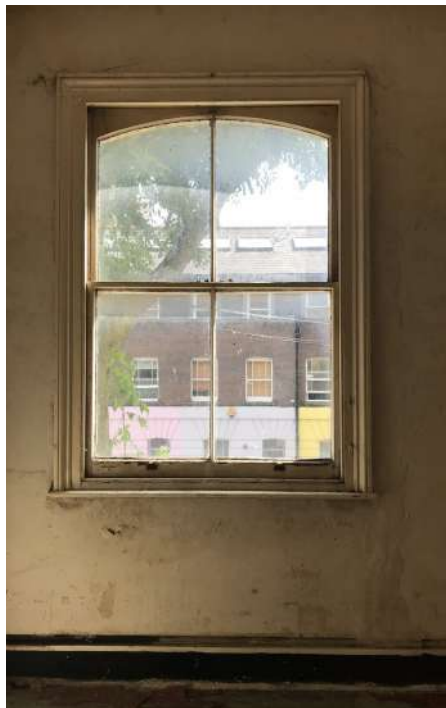
Image 60: 15FF.2

Windows: Sash window. Same profile as 15FF.3 and 15FF.4 (Image 60).

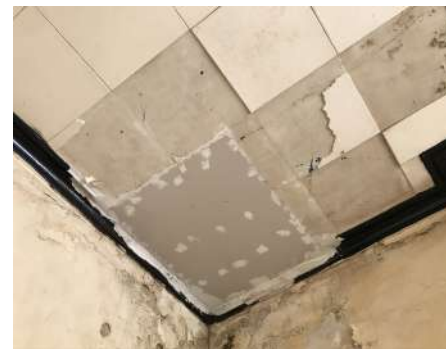
Images 61&62: 15FF.2

Ceiling: Polystyrene-like ceiling tiles. No evidence to suggest what is underneath, except a poor patch repair in the north eastern corner with plaster board (Image 61). Cornicing throughout, appears to be the same profile throughout (Image 61).

Walls: Lath and plaster found on the western wall (Image 62)

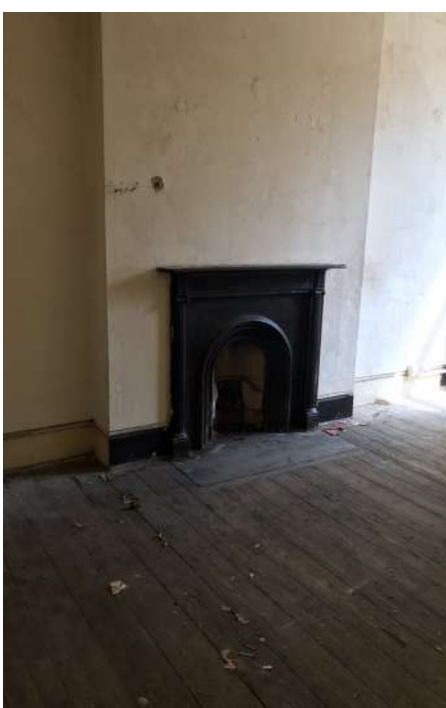
Image 63: 15FF.2

Floor: Timber floorboards. Skirting throughout, appears to be the same profile (Image 63).

Additional comments: Chimneybreast in situ. Fireplace similar to the one found in 13FF.3 (Image 30/Image 63).

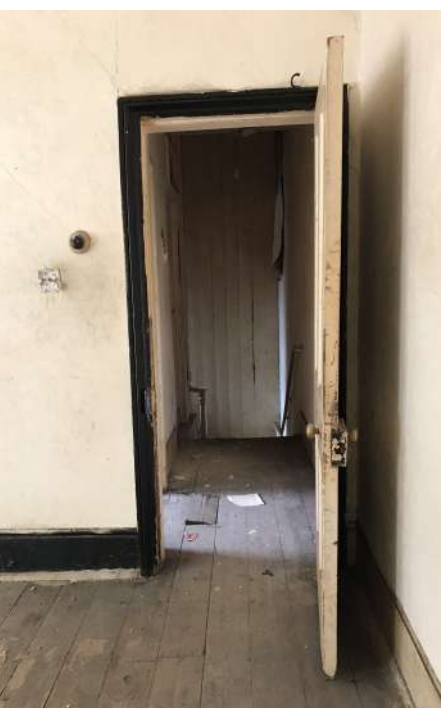
Image 64: 15FF.2

Doors: Four panelled door. Architrave on doorway (Image 64).

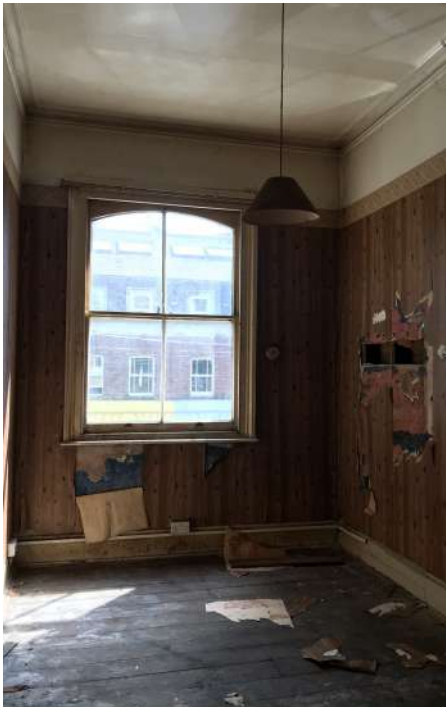
Image 65: 15FF.3

Floor: Timber floorboards. Skirting throughout, appears to be the same profile, partly removed in south western corner (Image 65).

Windows: Sash window with modern blind rail above. Same profile as 15FF.2 and 15FF.4 (Image 65).

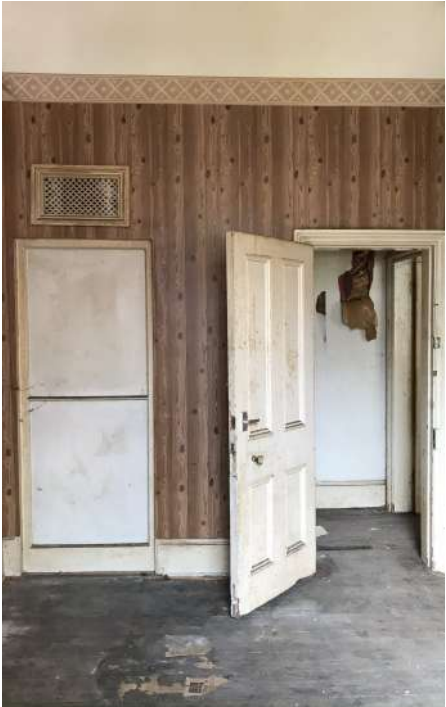
Image 66: 15FF.3

Doors: Blocked up door with vent over, no architrave. Architrave round existing doorway. Four panelled door (Image 66).

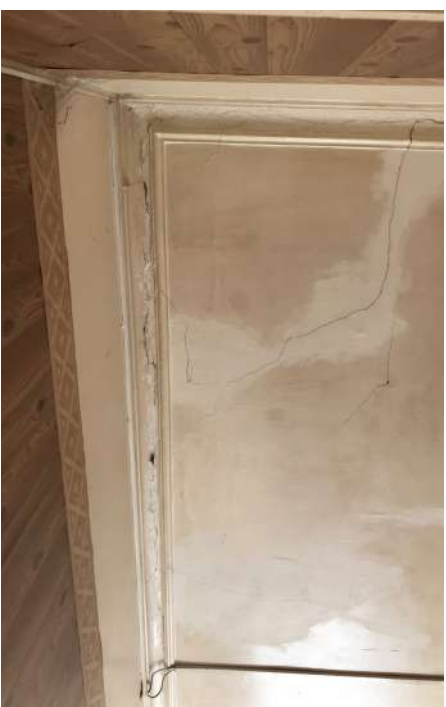
Image 67: 15FF.3 ceiling

Ceiling: Assumed lath and plaster due to rest of the building. Cornicing throughout, appears to be the same profile (Image 67).

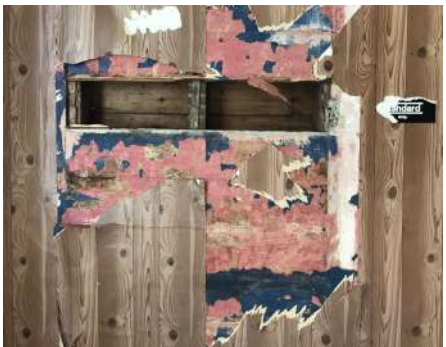
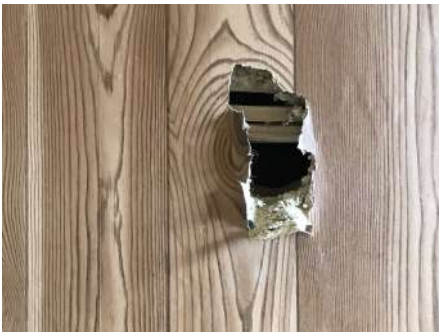
Images 68&69: 15FF.3

Walls: Wallpapered. Lath and plaster identified on western and eastern walls (Images 68&69).

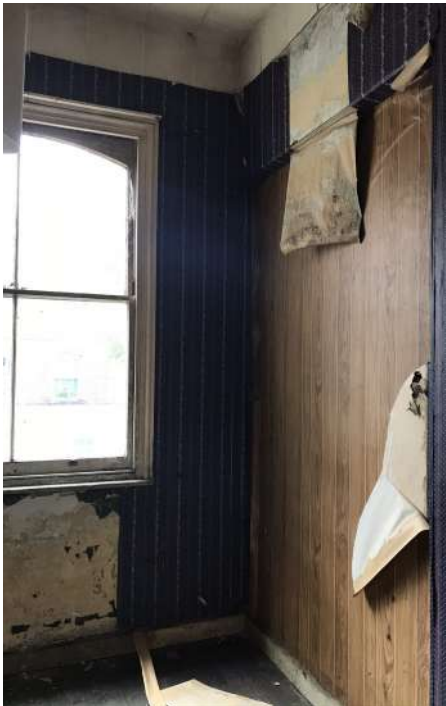
Image 70: 15FF.4

Walls: Wallpapered. Lath and plaster found on western dividing wall (Image 70).

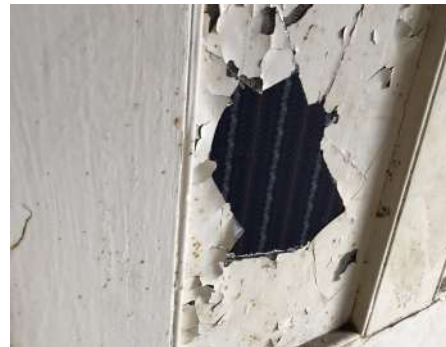
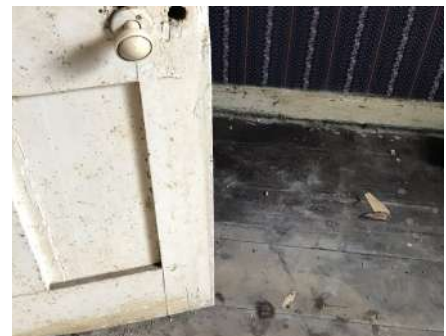
Images 71&72: 15FF.4 door

Floor: Timber floorboards. Plain skirting throughout differs to skirting found in 15FF.2 and 15FF.3 (Images 70&72)

Doors: Painted glass panelled door, Architrave on doorway (Images 71&72)

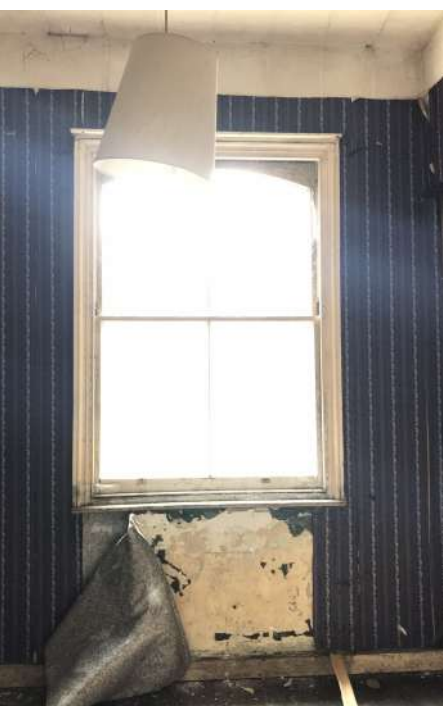
Image 73: 15FF.4

Windows: Sash window with modern blind rail above. Same profile as 15FF.2 and 15FF.3 (Image 73).
