**Hampstead Hill School
St Stephen's Hall
Pond Street
London NW3 2PP**

Proposed Repair of Grade II Listed Boundary Wall

Design & Access and Heritage Statement
October 2023

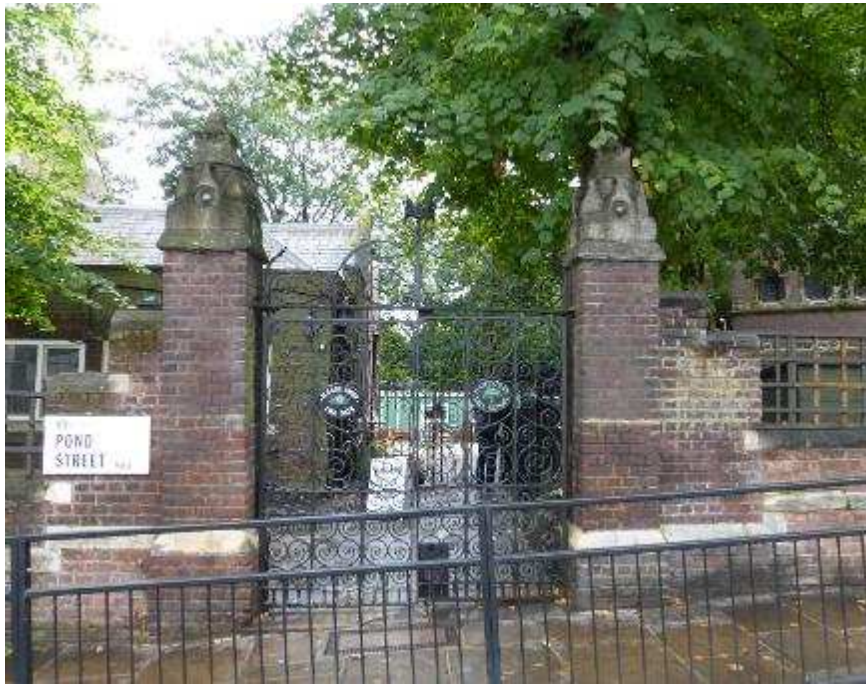
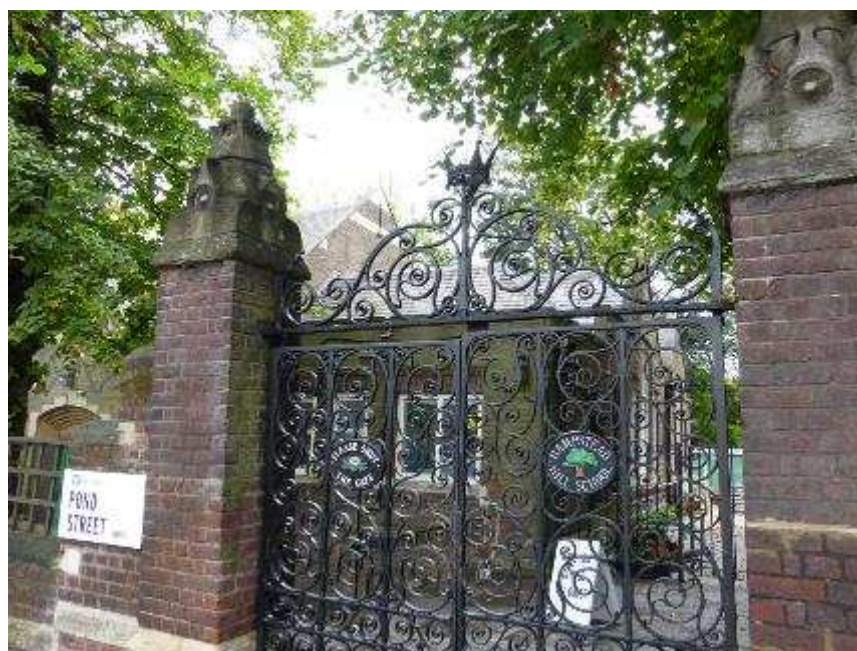
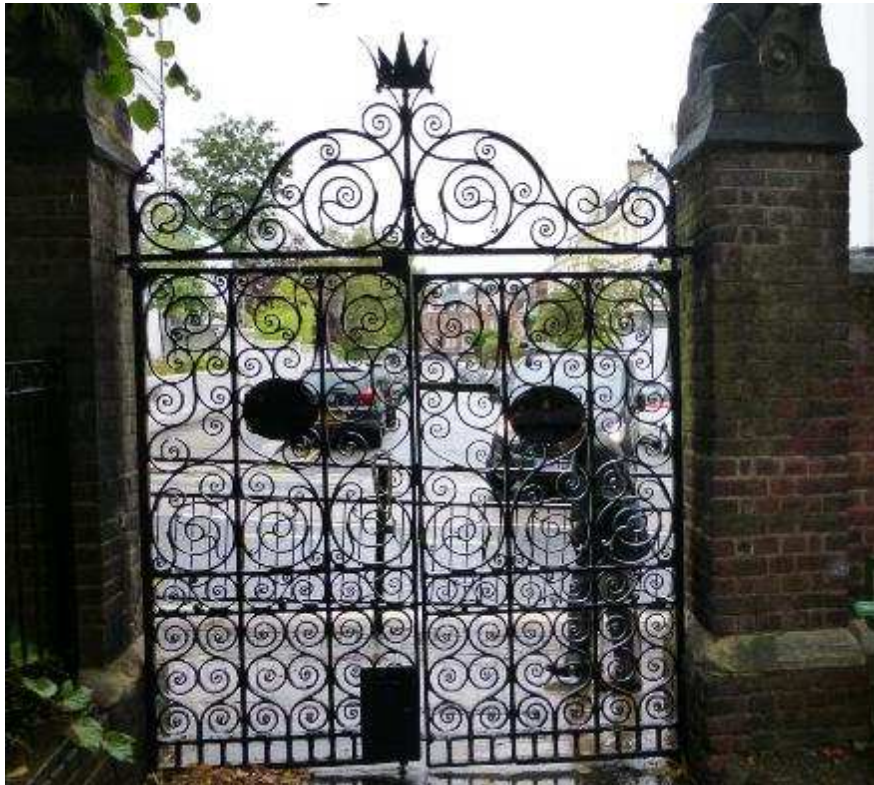
2 Description of Character and important Features

The proposed works relate to part of the boundary wall Asset at the location of the pedestrian entrance to the hall along Pond Street. The Asset comprises a pair of ornate cast iron gates with piers either side constructed red stock bricks and dressed stone coursing and caps, set predominantly in lime:sand mortar.

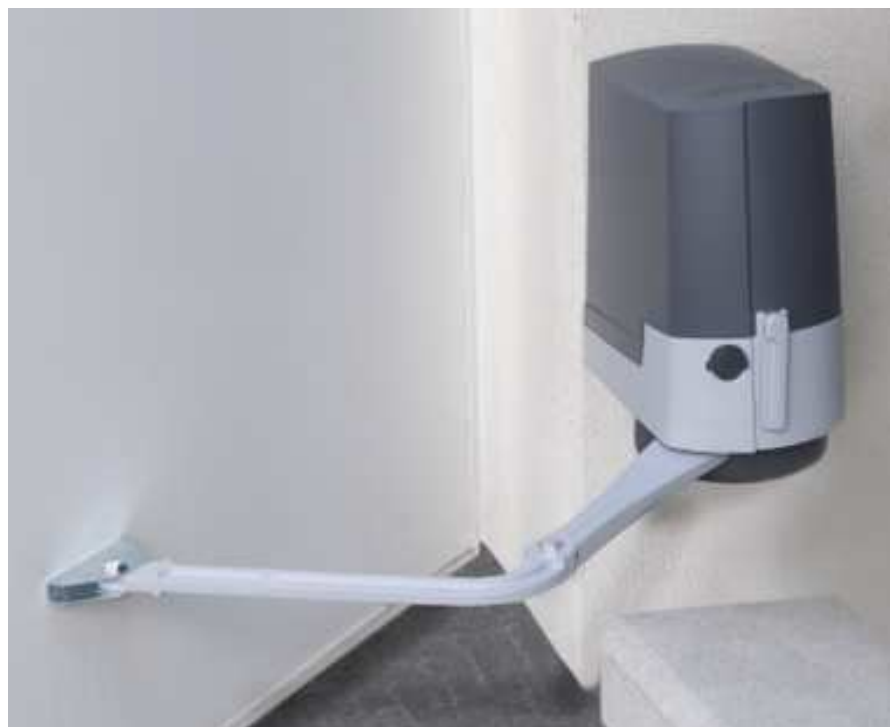
The design of the articulated arm gate closers has been carefully considered so as to have a minimal appearance on the gate and piers. The body of the device is proposed to be installed at low level on the internal face of the brick piers and the projecting arm bolt secured to the bottom rail of the gates. The fittings will be finished in black paint. The fixing of the body will be into the mortar joints and not brickwork.

The expected impact on the significance will be minimal and not have a significant impact on the gate design. The proposed structural remedial works

to the piers will not be visible and the repointing of the brickwork would be undertaken using matching lime:sand mortar.
