PROJECT: 64-65 Guilford Street

TITLE:
Existing windows
Type9

DWG NO. ST-GU-189	REVISION A	
----------------------	---------------	--

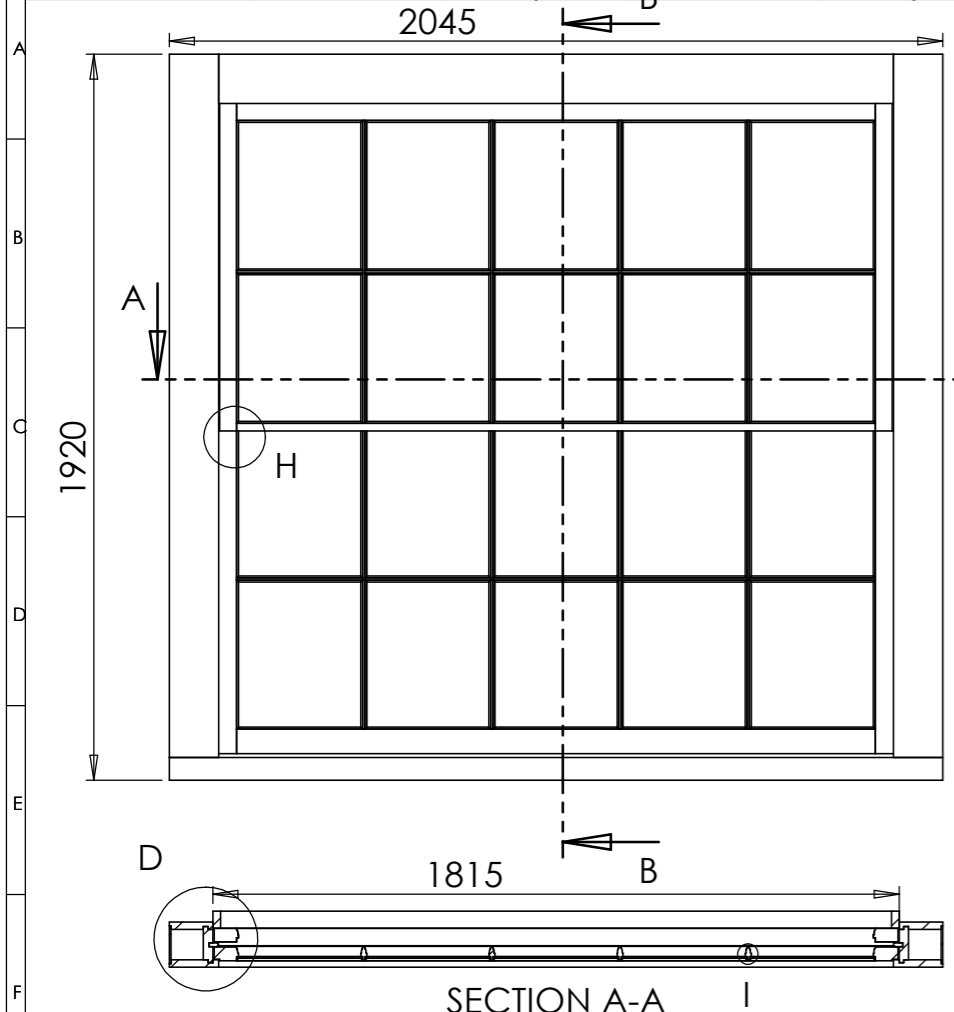
SECTION A-A

staff bead has been replaced to accommodate thicker casement

casements have been replaced and are thicker than original

external plaster reveal depth must be maintained
