# 64 - 65 Guilford Street

Schedule ST-GU-182 Rev: D Page 1

TITLE:  
Window Schedule Front Elevation

TITLE:  
Window Schedule Rear Elevation

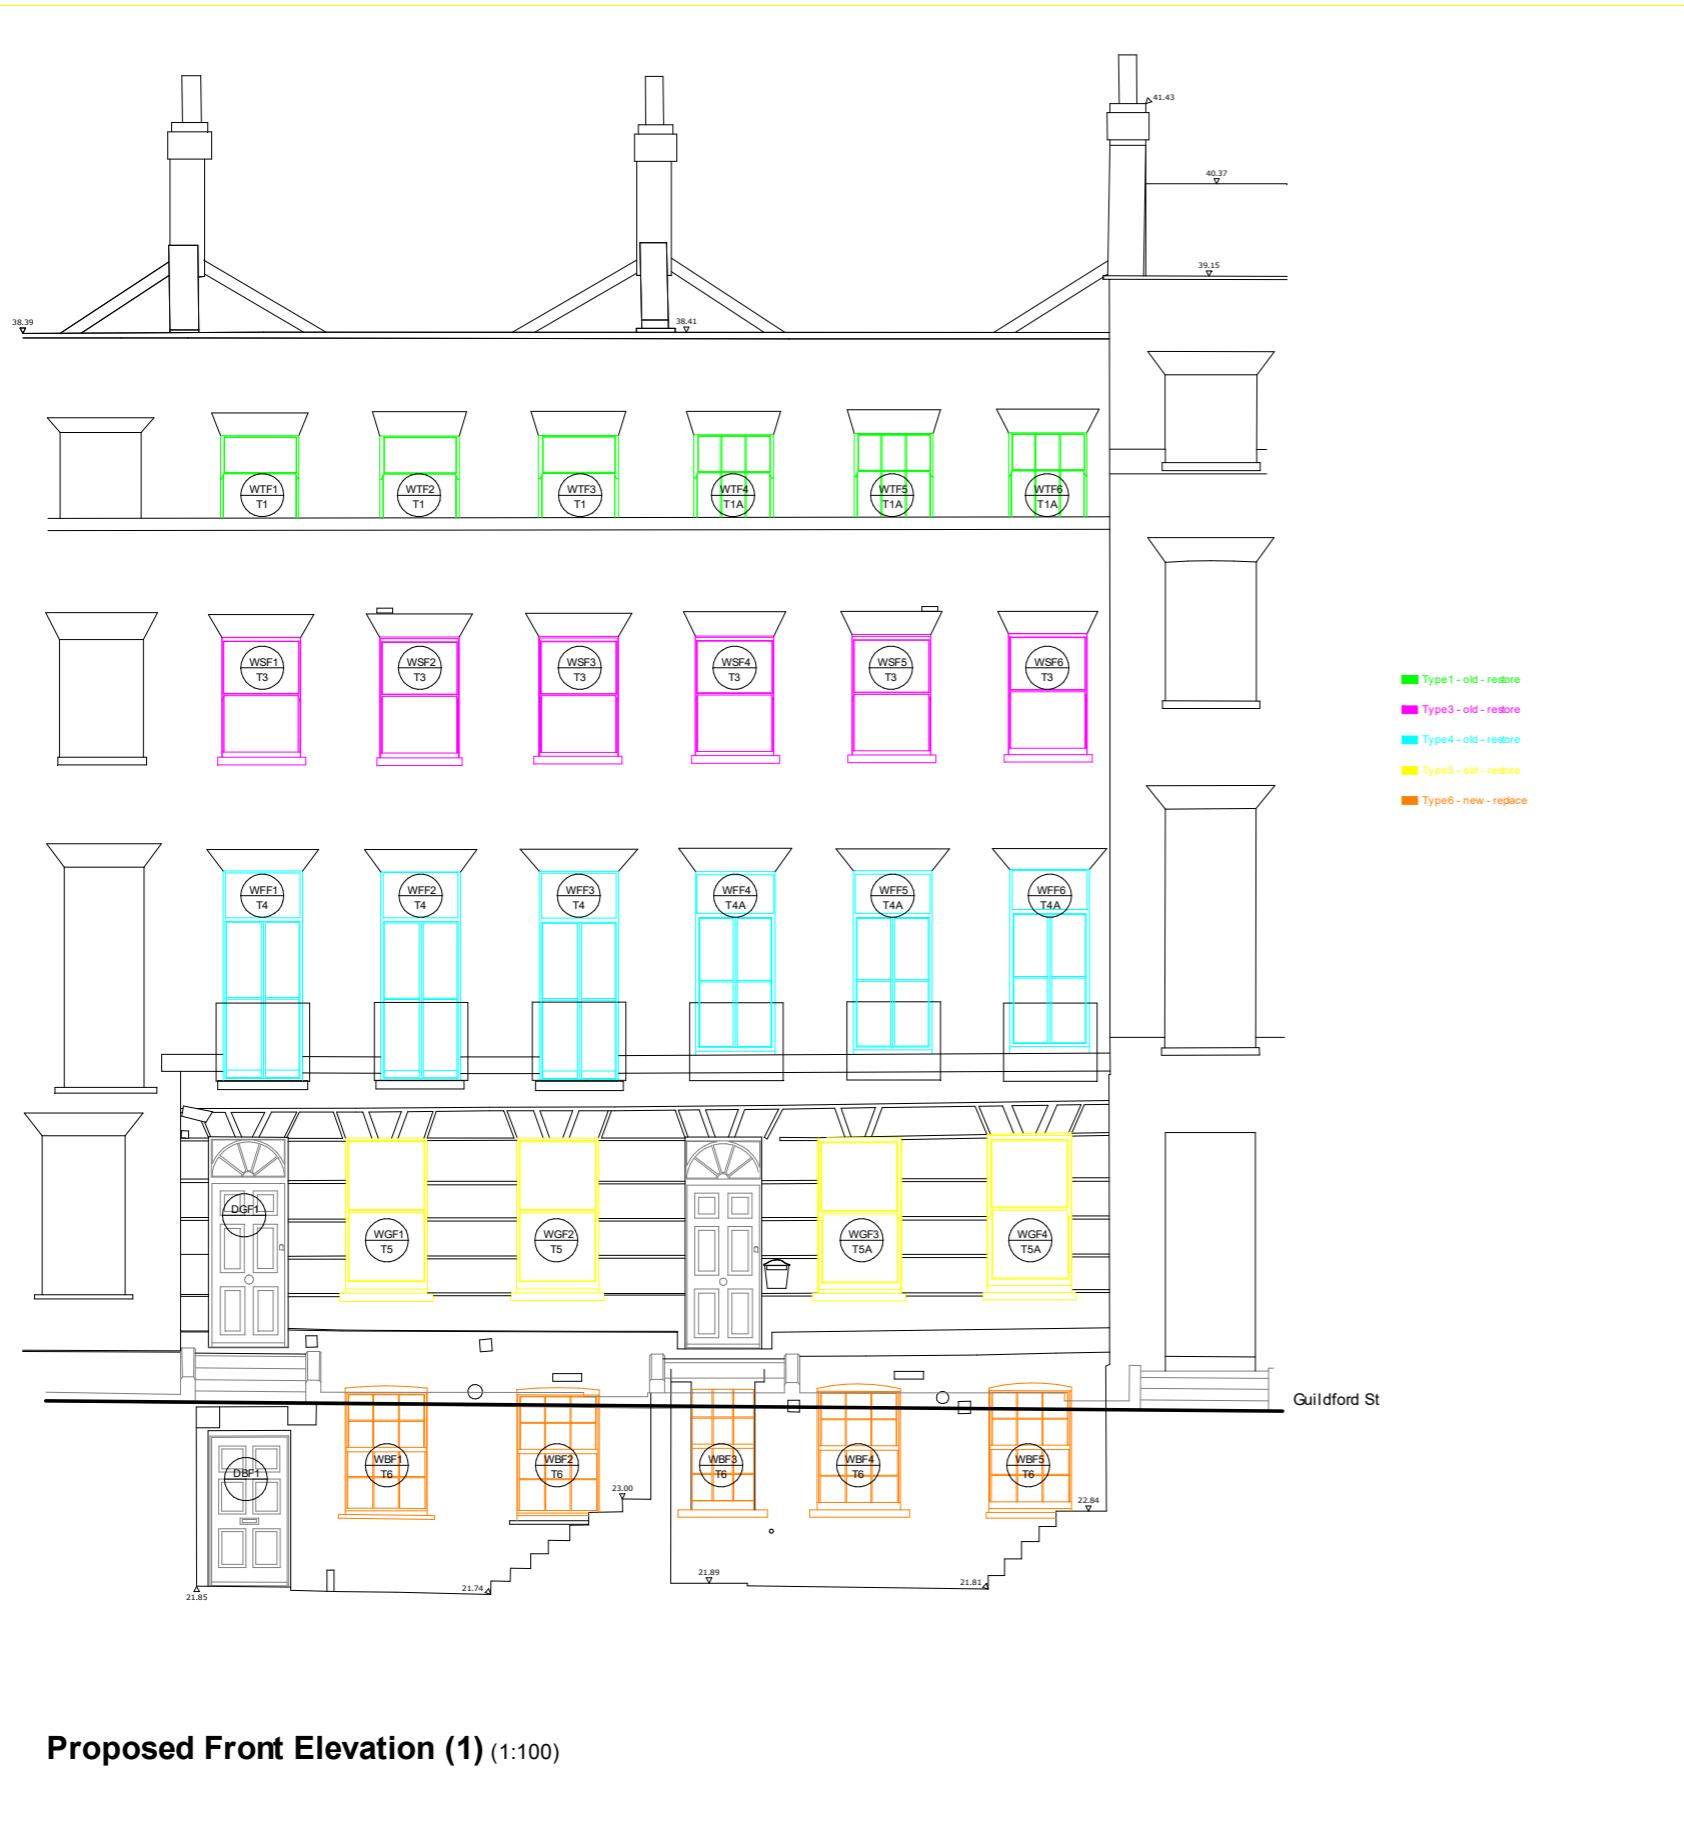
**Proposed Front Elevation (1) (1:100)**

- 1 Both properties are Grade2 Listed
- 2 All original timber sash windows to be overhauled and made good to original condition. Modern windows to be replaced to match period existing in accordance with Conservation & Heritage best practice.

- 3 WBF1, WBF2, WBF3, WBF4 and WBF5 are modern and should be replaced. It should be agreed with the conservation officer whether glazing bars are required.

- 4 Actions on remaining windows should be agreed with the conservation officer and recorded on schedule ST-GU-182.
- 5 Windows Type1, Type3 and Type4 are old but probably not original. It should therefore be agreed with the conservation officer which Type should be used as a model for replacement of the basement windows.

- 6 It should be confirmed that modern float glass can be used where any replacement glass is required.
- 7 It should be confirmed whether trickle ventilation is required in the new basement windows.

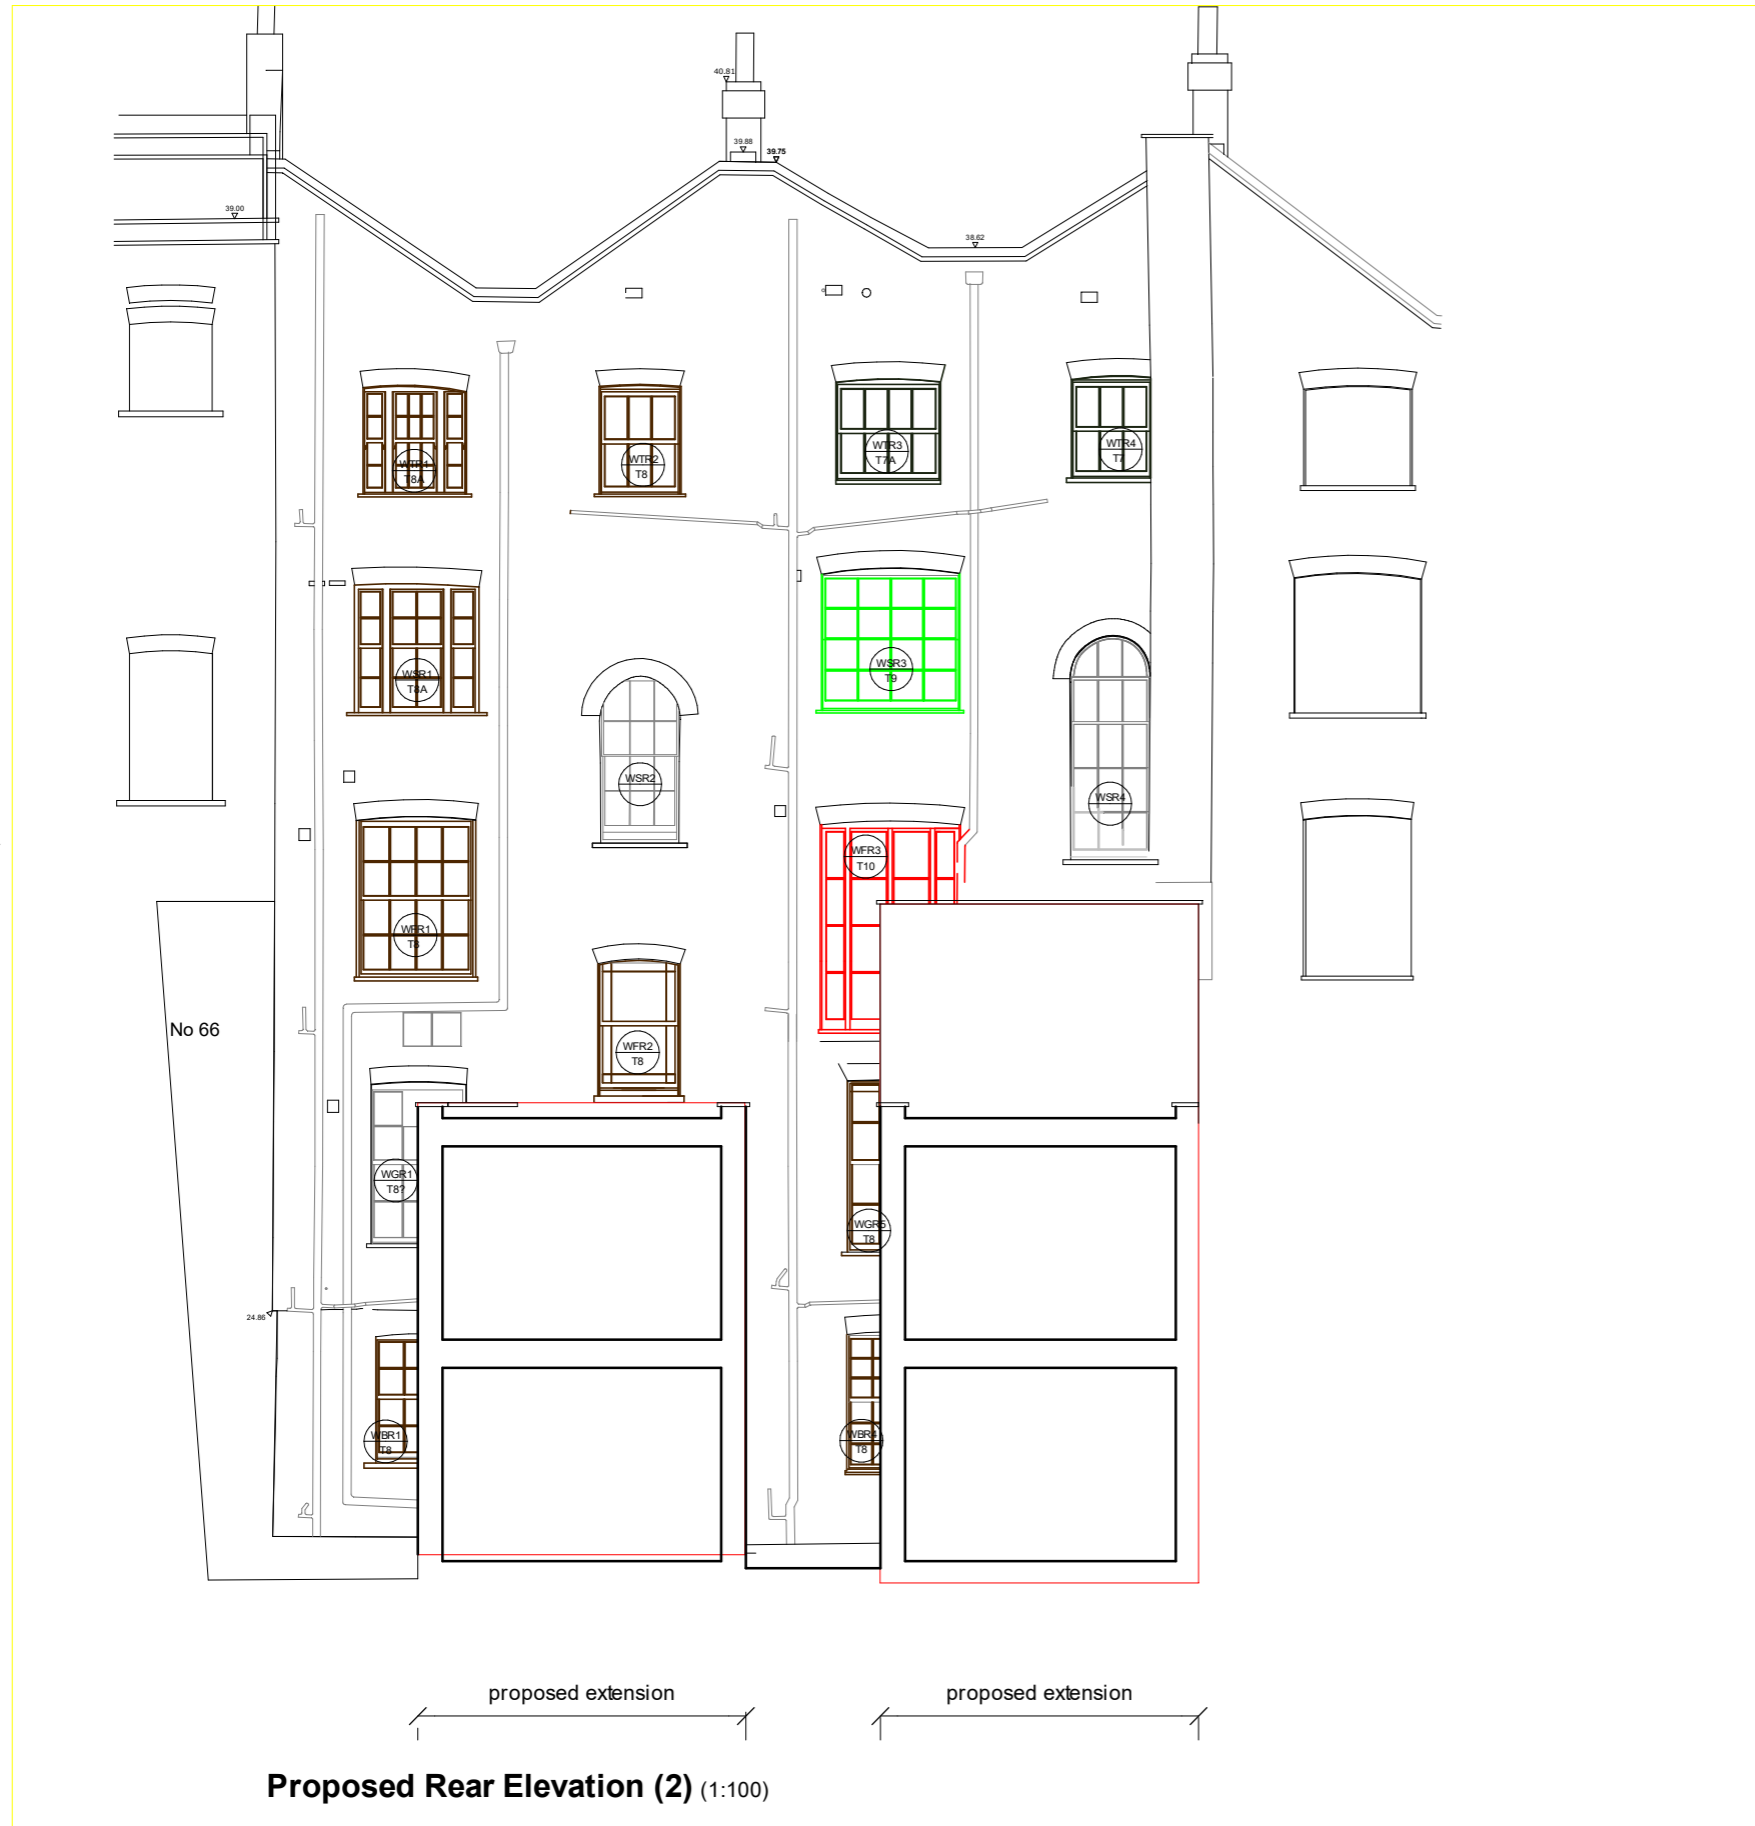
**Proposed Rear Elevation (2) (1:100)**

- 1 Both properties are Grade2 Listed
- 2 All original timber sash windows to be overhauled and made good to original condition. Modern windows to be replaced to match period existing in accordance with Conservation & Heritage bestpractice.
- 3 WBR1,WBR4,WGR5,WFR1,WFR2,WSR1,WTR1 and WTR2 are modern and should be replaced. It should be agreed with the conservation officer whether glazing bars are required.
- 4 Actions on remaining windows should be agreed with the conservation officer and recorded on schedule ST-GU-182.
- 5 Window WSR3 is possibly original.
- 6 It should be confirmed that modern floatglass can be used where any replacement glass is required.
- 7 It should be confirmed whether trickle ventilation is required in the new windows.
- 8 It should be confirmed that it is acceptable to use Type 3 as a model for all replacement windows.
