# Maria Fidelis Old School Building

## Precautionary Method of Works

Document No. 1CP01-MDS\_ARP-EV-REP-SS08\_SL20-990054  
Work Package No.

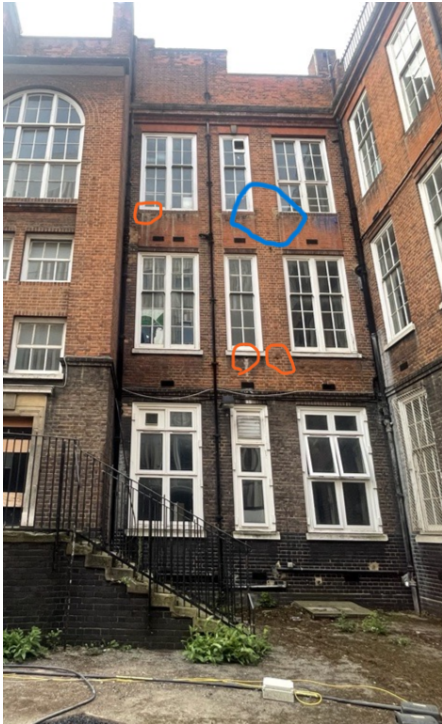
Photograph 1 – External brickwork cavities, including the confirmed roost locality (blue circle) and possible additional roosting features (orange circles).	Photograph 2 – 3 of the total 17 roof vents present throughout the roof top. All roof vents are recorded as possible roosting features.

- 1.4.4 The external inspection of the school building found features suitable for bats, including vents within the roof area, holes in brickwork and damage to wooden soffits on the annex building connected to the school building. Overall, no direct evidence of bats was recorded and given that the Site is within a highly urbanised environment and is directly adjacent to the HS2 Euston active construction site, the main school building and its connecting annex building was assessed to have low suitability for bats.

- 1.4.7 One common pipistrelle bat was recorded emerging from the northern elevation of the main school building during the dusk emergence survey on 13<sup>th</sup> September 2023 at 19:38 hours. The exact location of where the bat emerged could not be determined however the bat emergence point was localised to the 3<sup>rd</sup> floor windows on the western side of the northern elevation (see Photograph 1 in Table 4; Appendix A). It is likely the bat emerged from one of the holes in the brickwork, present within this area.
