**Broxwood View
(Previously 29 Barrie House)**

**Appendix 4
Programme**

**Appendix 5
Site Investigation Data**

BARRIE HOUSE, 29 ST EDMUND'S TERRACE, LONDON NW8 7QH

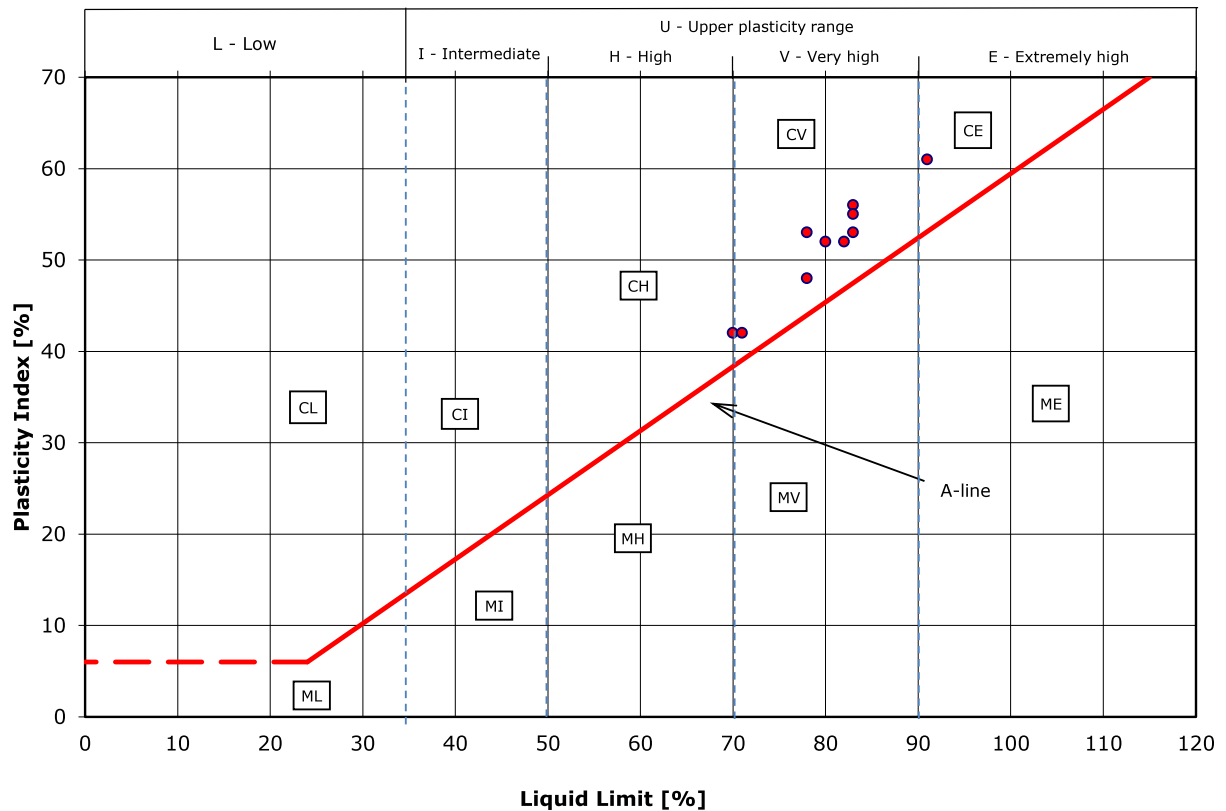
PLASTICITY CHART - BS5930 classification

M - Silt [M-soil] plots below the A-line
C - Clay plots above the A-line

Classification based upon BS5930:1999 'Code of practice for site investigations'
