**BASIC GEOTECHNICAL  
ASSESSMENT &  
BASEMENT IMPACT ASSESSMENT  
REPORT**

15 Belsize Park Mews

**Report Title:** Ground Investigation & Basement Impact Assessment for 15 Belsize Park Mews,  
Camden NW3 5BL

**Job No:** P5188J2818/SC

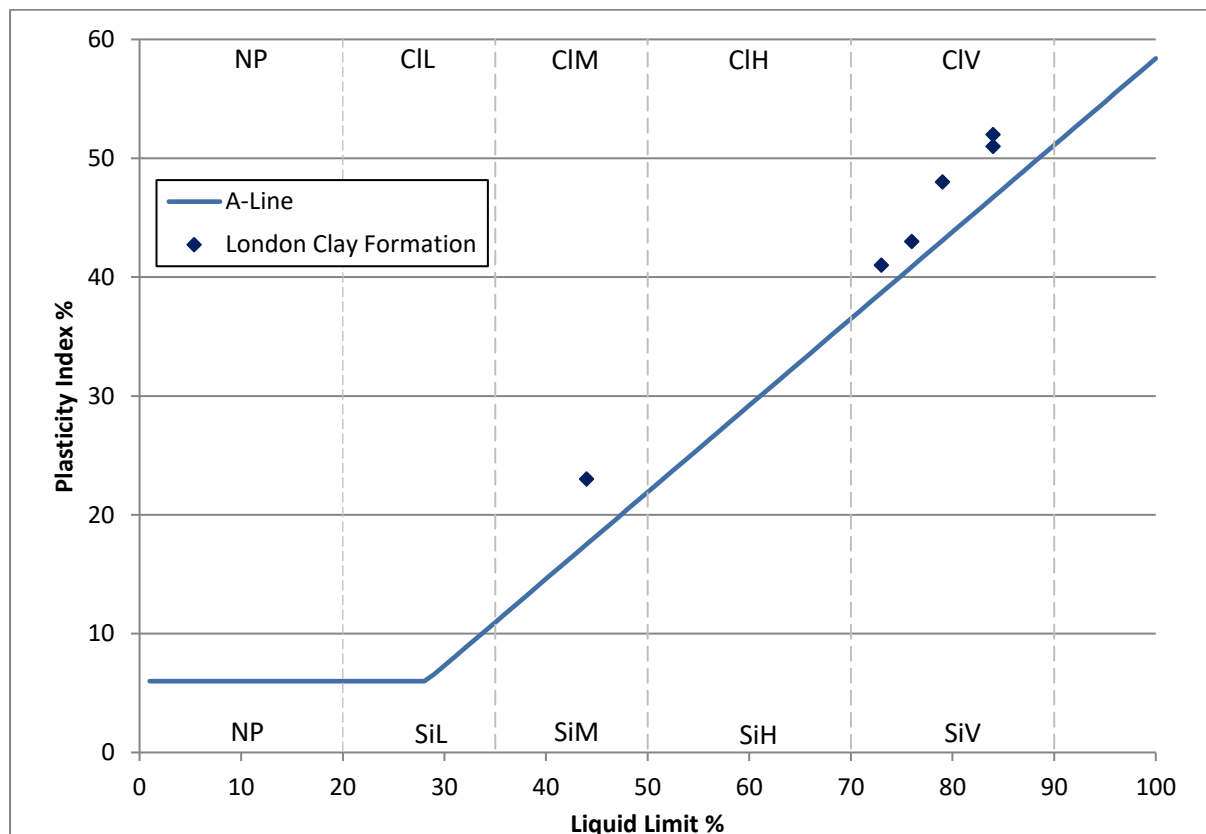
**Figure 5.1: Plasticity Chart**

5.2.3 Modified Plasticity Index values in these strata ranged from 21.9% to 52%, indicating soils with medium to high volume change potential.

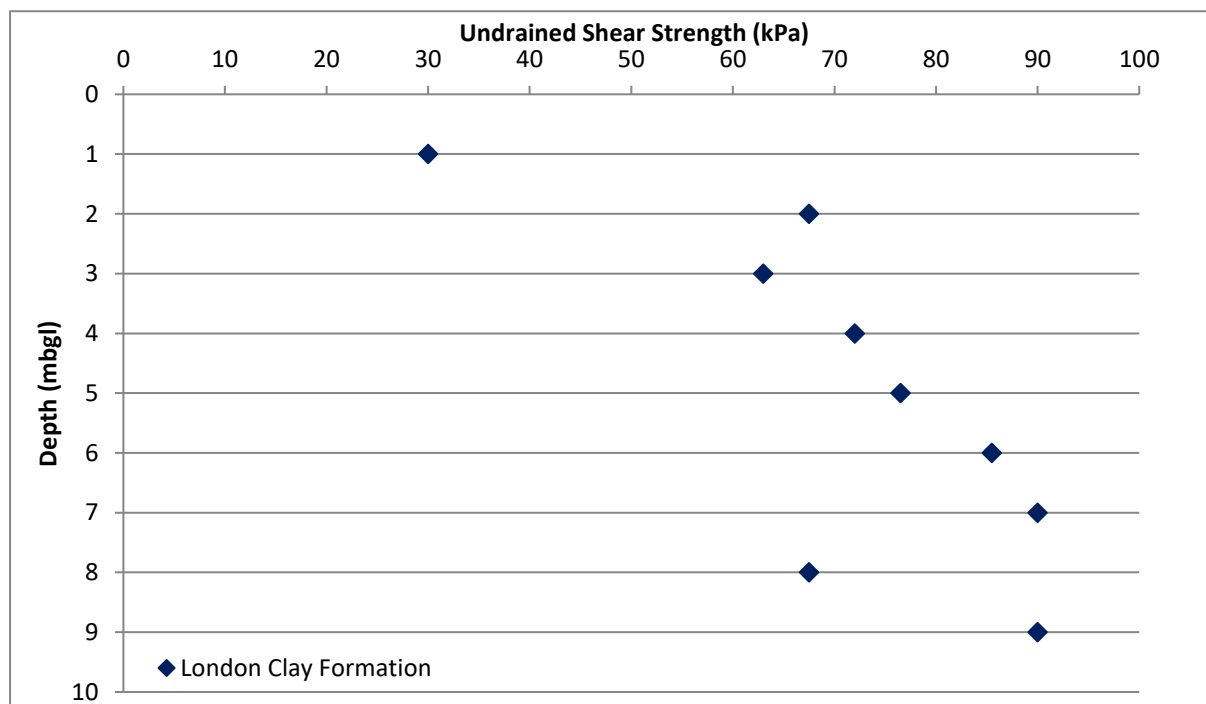
**Figure 5.2: Undrained Shear Strength v Depth**

- 5.3.3 The graph below shows the shear strength profile of the encountered cohesive materials at the site, based on the SPT to shear strength correlation described above.

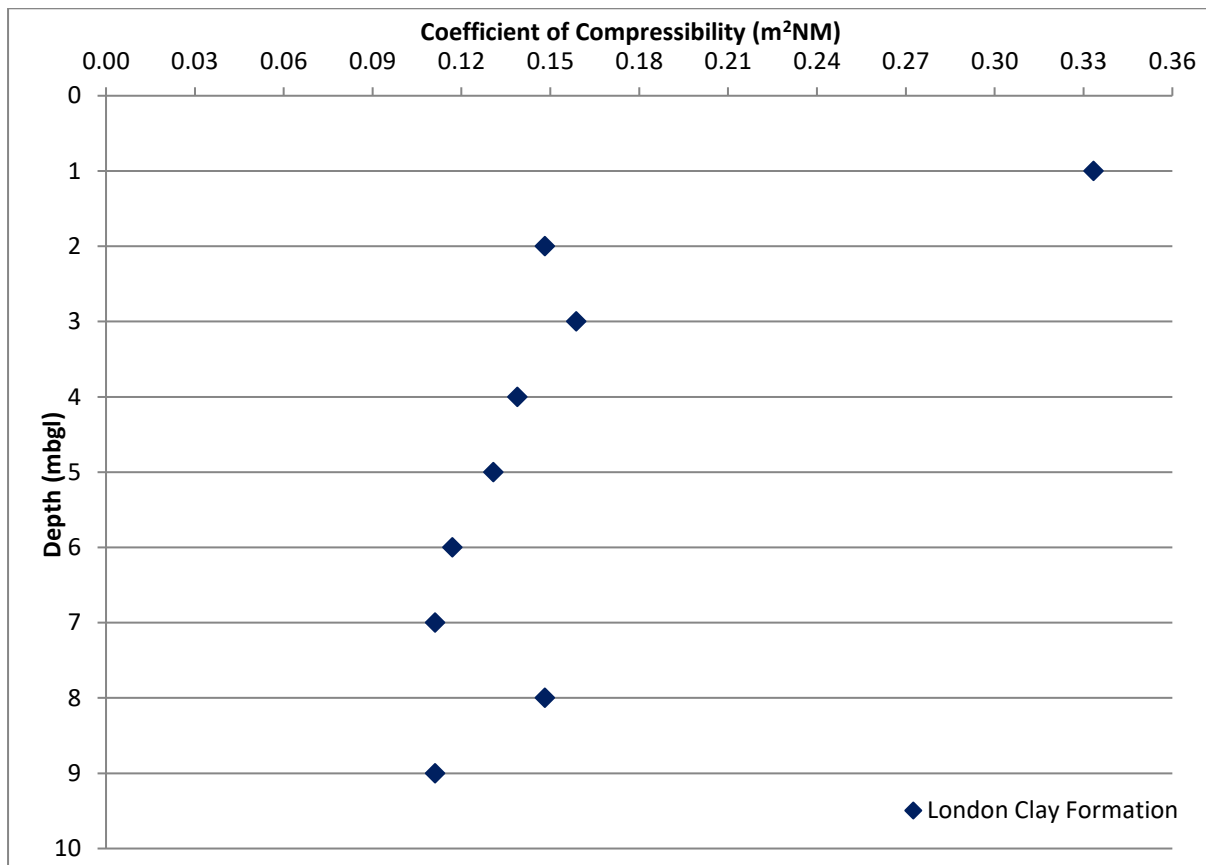
**Figure 5.3: Coefficient of Volume Compressibility ( $m_v$ ) v Depth**

5.4.2 Using the plasticity indices obtained and the graphs provided in Tomlinson (2001) a value of  $f_2$  of 0.45 has been taken and used with the SPT N-values to infer coefficient of compressibility ( $m_v$ ).

5.4.3 The results from of the London Clay Formation are generally of “medium compressibility”.

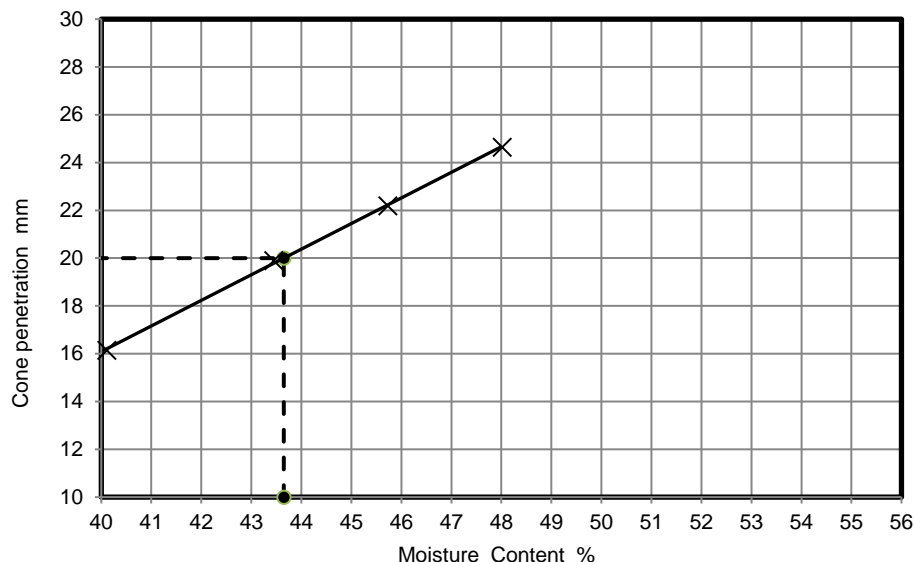
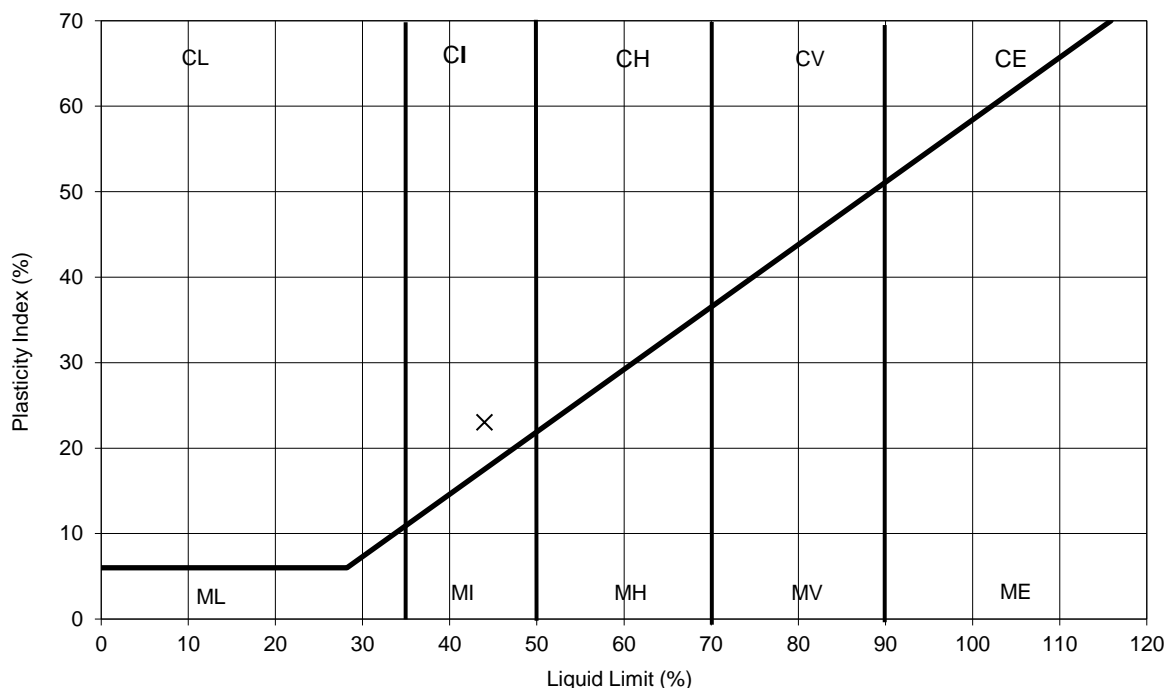
Orangish brown slightly mottled bluish grey slightly gravelly slightly sandy silty CLAY (gravel is fm and sub-angular to rounded)

NATURAL MOISTURE CONTENT	32	%
% PASSING 425µm SIEVE	95	%
LIQUID LIMIT	44	%
PLASTIC LIMIT	21	%
PLASTICITY INDEX	23	%

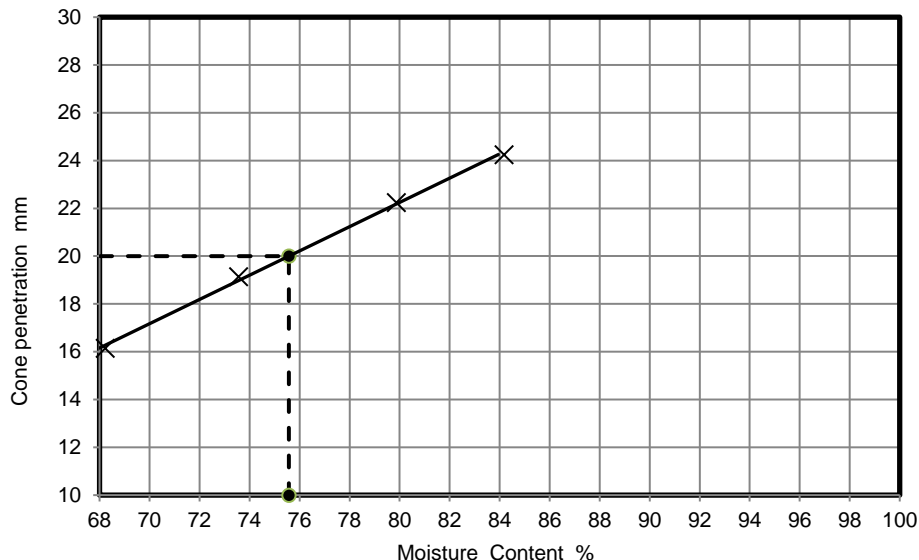
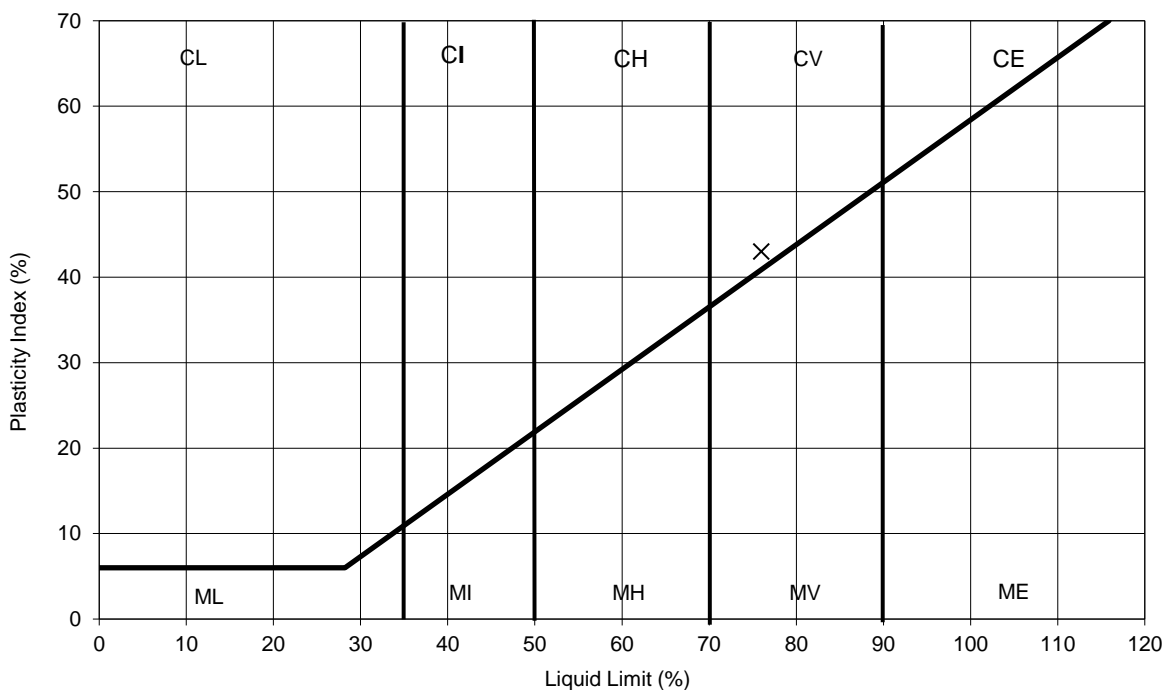
Soil Description Orangish brown slightly mottled grey silty CLAY with scattered selenite crystals

NATURAL MOISTURE CONTENT	32	%
% PASSING 425µm SIEVE	100	%
LIQUID LIMIT	76	%
PLASTIC LIMIT	33	%
PLASTICITY INDEX	43	%

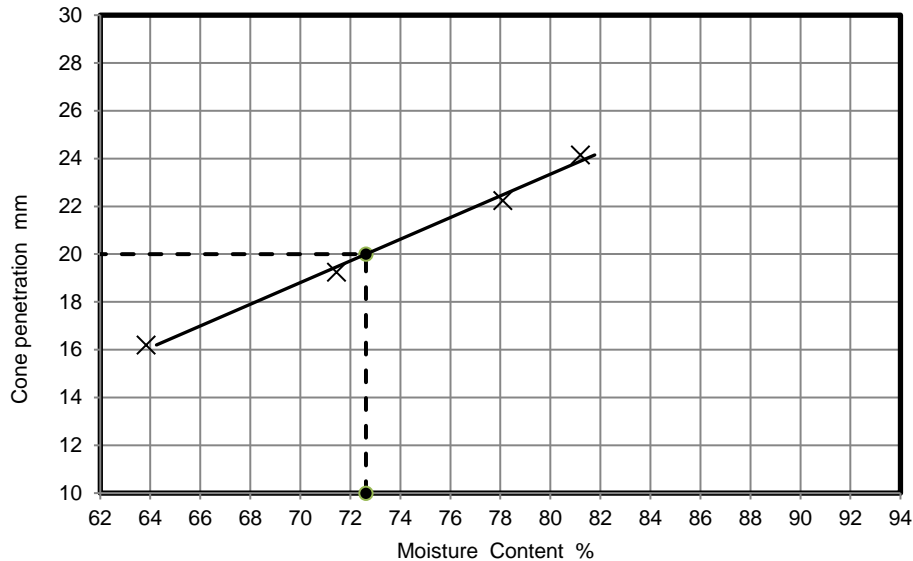
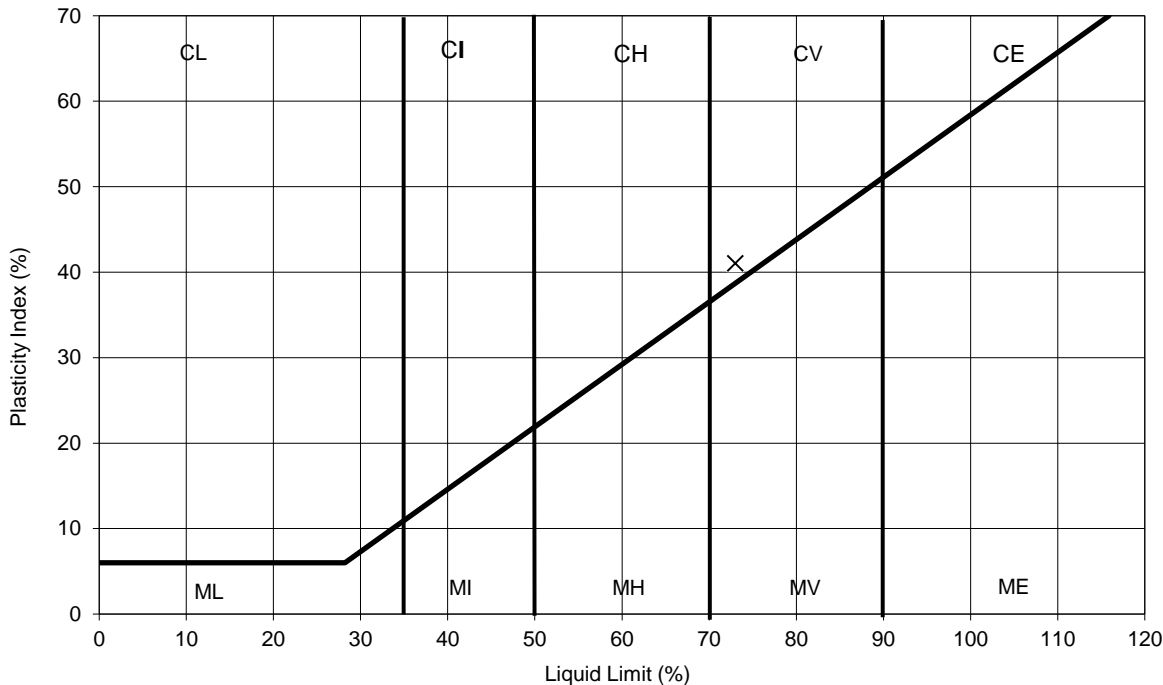
Job No.	34289
Borehole/Pit No.	WS1
Sample No.	-
Depth Top	4.50 m
Depth Base	- m
Sample Type	D
Samples received	30/10/2023
Schedules received	30/10/2023
Project Started	30/10/2023
Date Tested	10/11/2023

Site Name	15 Belsize Park Mews, Camden, NW3 5BL		
Project No.	-	Client	Jomas Associates
Soil Description	Orangish brown slightly mottled grey silty CLAY with scattered selenite crystals

NATURAL MOISTURE CONTENT	30	%
% PASSING 425µm SIEVE	100	%
LIQUID LIMIT	73	%
PLASTIC LIMIT	32	%
PLASTICITY INDEX	41	%

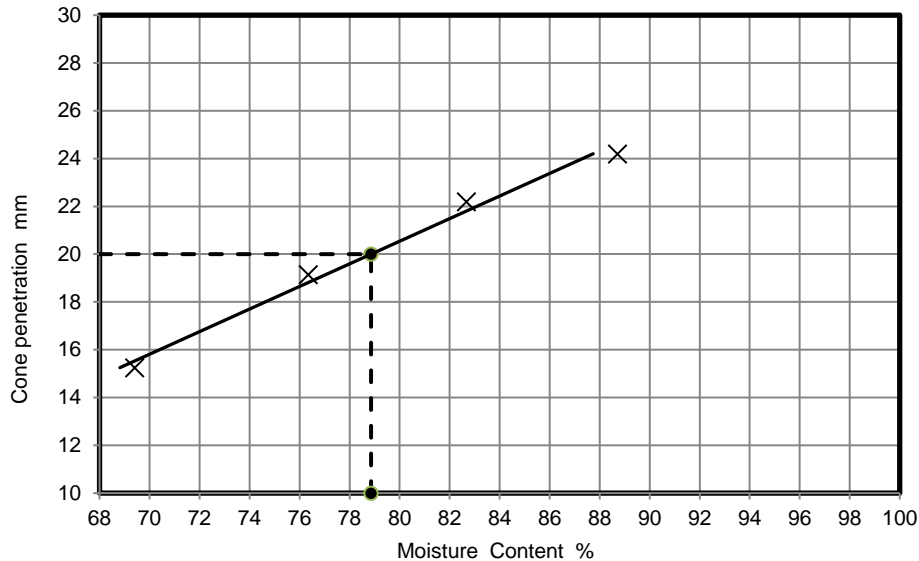
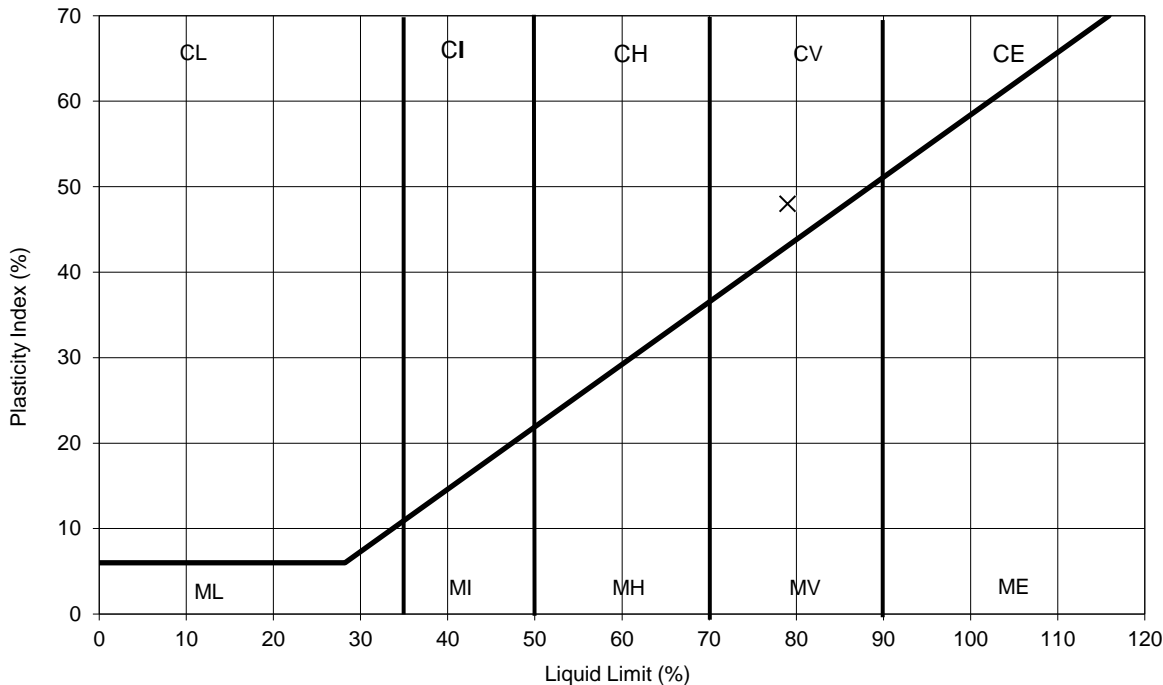
Job No.	34289
Borehole/Pit No.	WS1
Sample No.	-
Depth Top	6.50 m
Depth Base	- m
Sample Type	D
Samples received	30/10/2023
Schedules received	30/10/2023
Project Started	30/10/2023
Date Tested	10/11/2023

Site Name	15 Belsize Park Mews, Camden, NW3 5BL		
Project No.	-	Client	Jomas Associates
Soil Description	Dark grey silty CLAY with scattered selenite crystals

NATURAL MOISTURE CONTENT	32	%
% PASSING 425µm SIEVE	100	%
LIQUID LIMIT	79	%
PLASTIC LIMIT	31	%
PLASTICITY INDEX	48	%

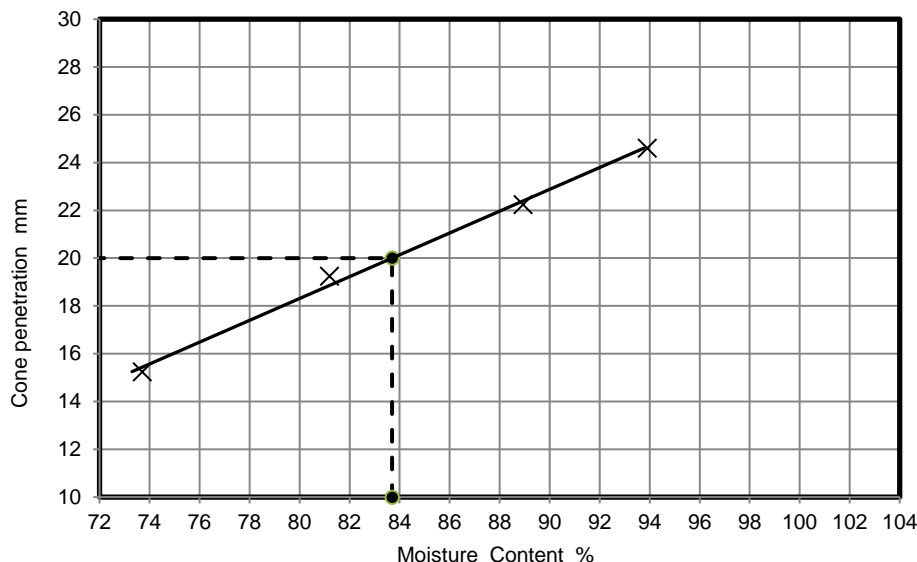
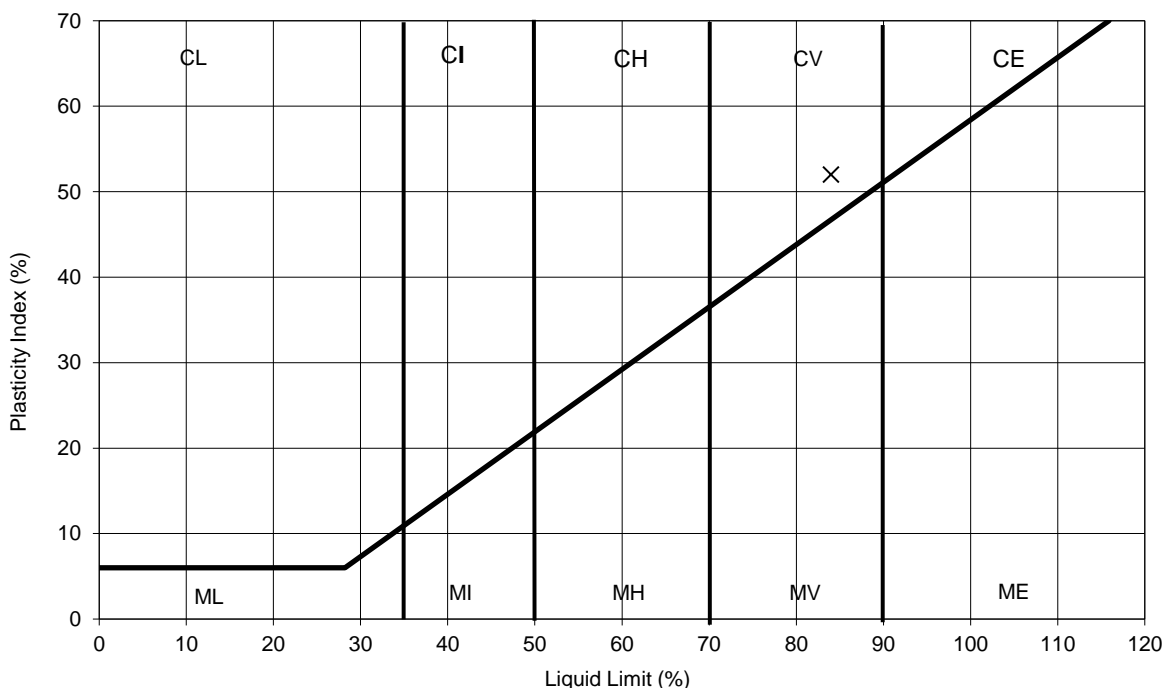
Job No.	34289
Borehole/Pit No.	WS1
Sample No.	-
Depth Top	8.50 m
Depth Base	- m
Sample Type	D
Samples received	30/10/2023
Schedules received	30/10/2023
Project Started	30/10/2023
Date Tested	10/11/2023

Site Name	15 Belsize Park Mews, Camden, NW3 5BL		
Project No.	-	Client	Jomas Associates
Soil Description	Dark grey silty CLAY

NATURAL MOISTURE CONTENT	30	%
% PASSING 425µm SIEVE	100	%
LIQUID LIMIT	84	%
PLASTIC LIMIT	32	%
PLASTICITY INDEX	52	%
