Entire Houze Ltd.

Verification Report

11-12 Grenville Street

Report No: 23-10-12

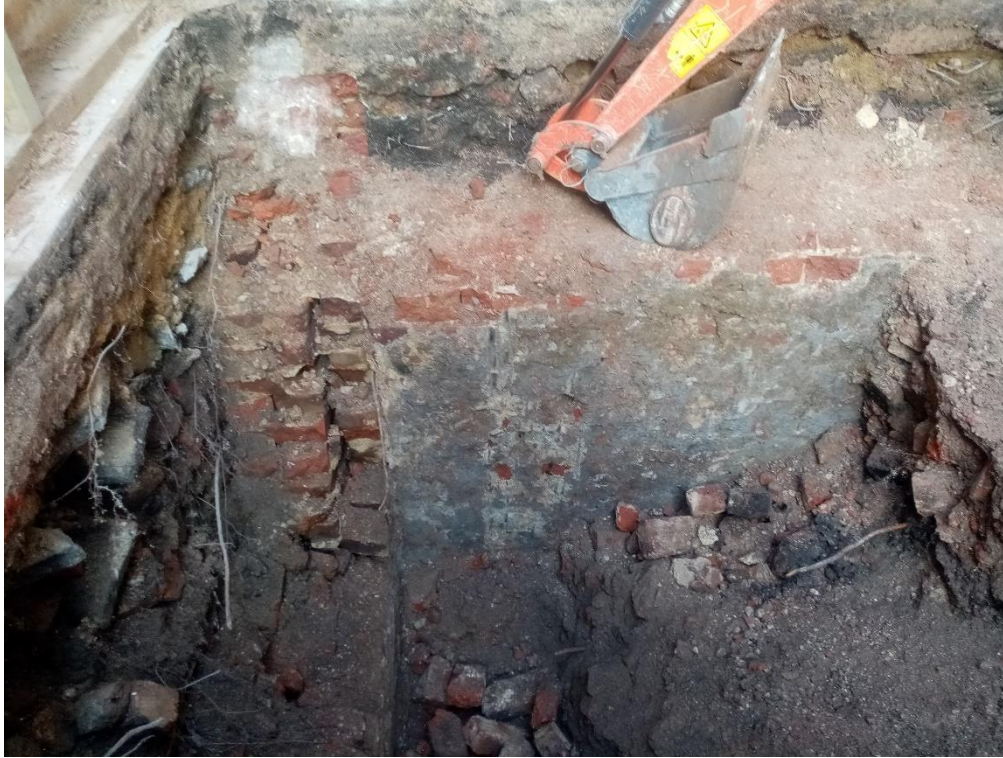
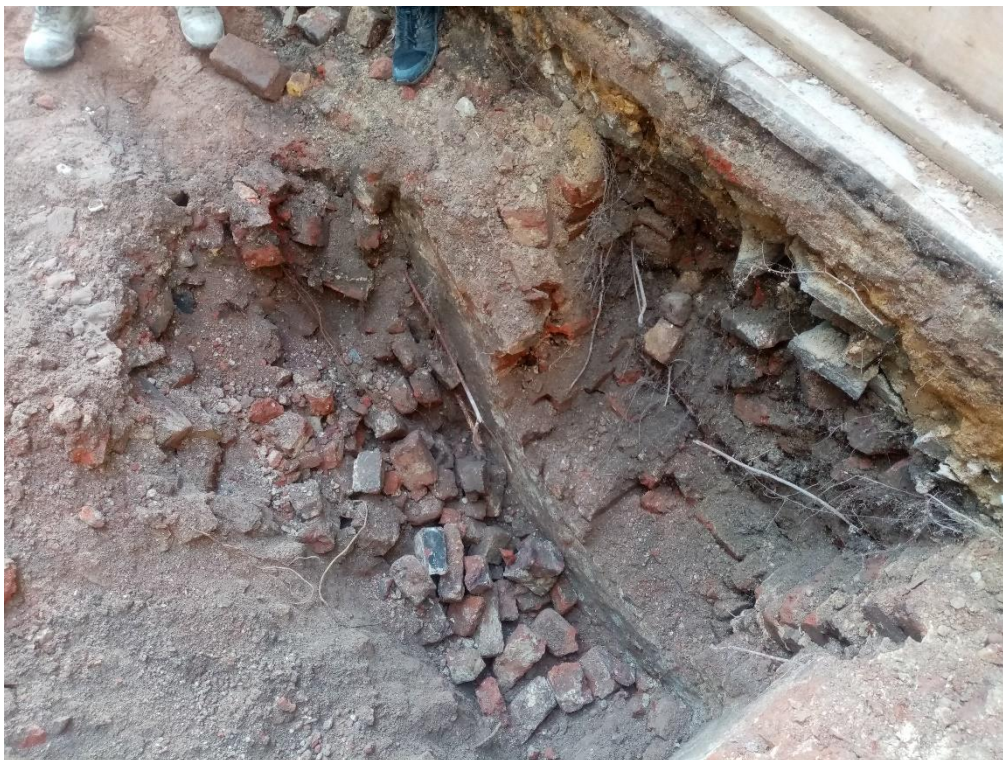
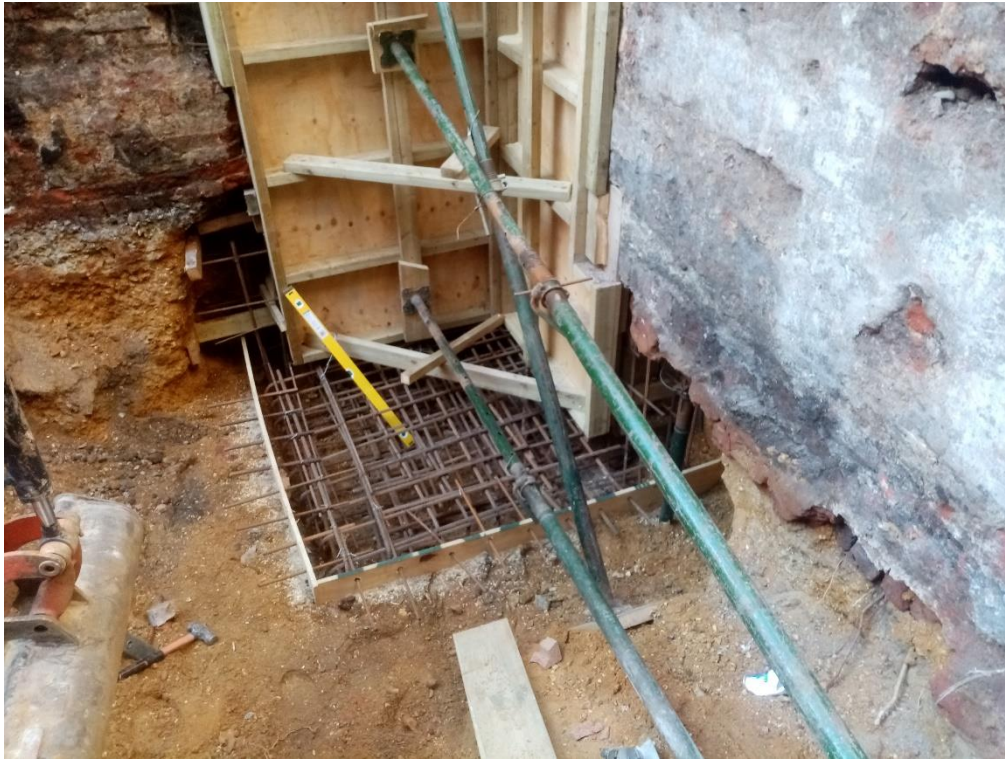
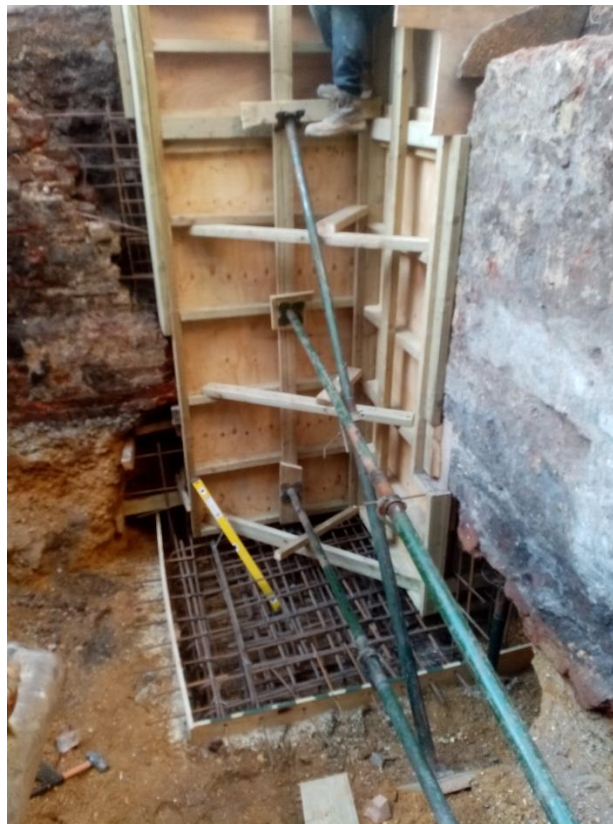
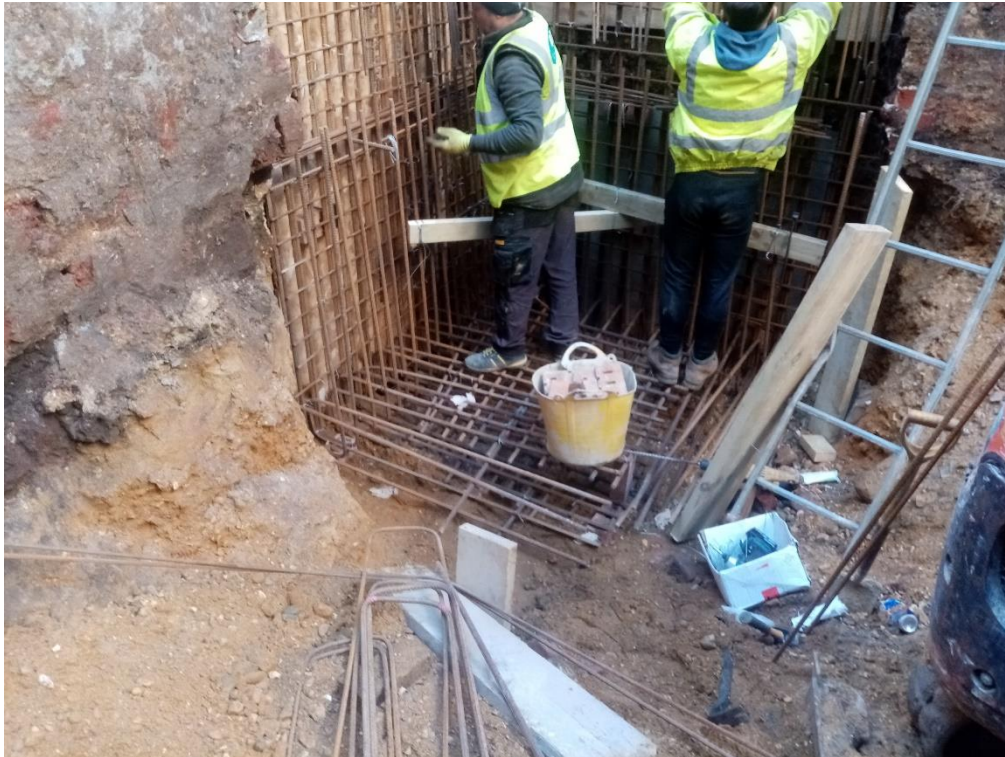
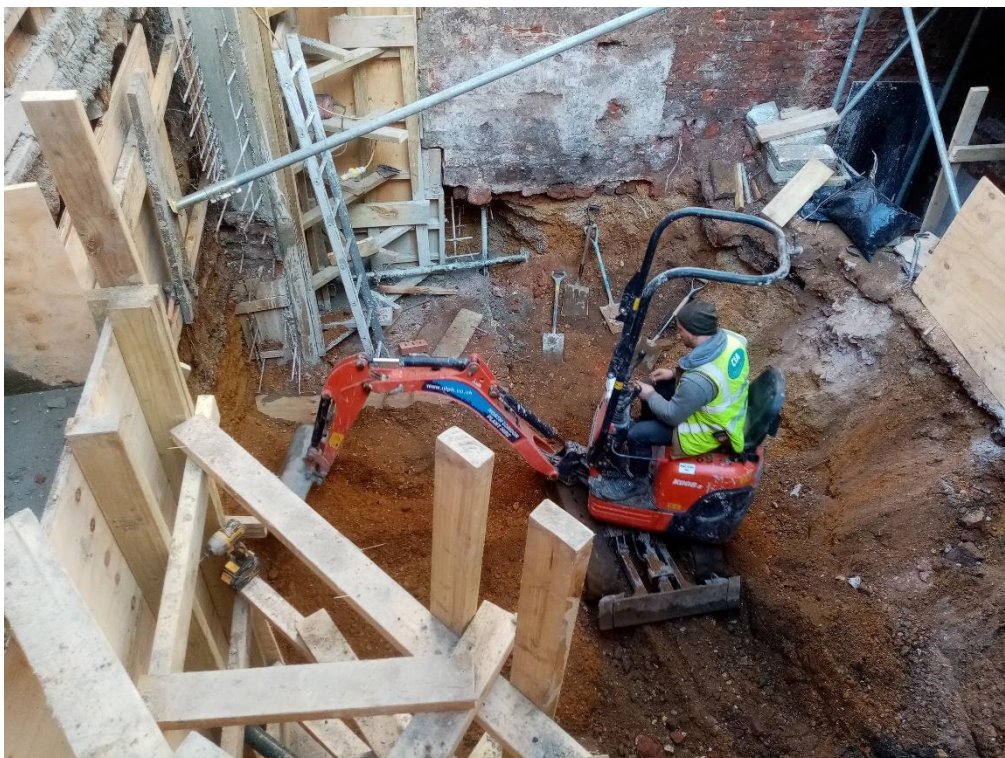
Photographic Record of the Formation Level Soil

The photographic record is shown in Appendix A. The photographs indicate the presence of Made Ground comprising visible fragments of brick and metal, overlying natural sand and gravel deposits interpreted to be the Lynch Hill Gravel Member. No obvious visible staining or odour was reported.

During the excavation of the basement a photographic record was taken of the nature of the formation level soil.
