**REPORT 72418/F-K**

**EUSTON TOWER**

**TESTING OF CONCRETE CORES**

**REPORT ON THE PETROGRAPHIC EXAMINATION  
OF FOUR CONCRETE CORES  
(Client Ref: ETF149 – Euston Tower Foundation Investigation Works)**

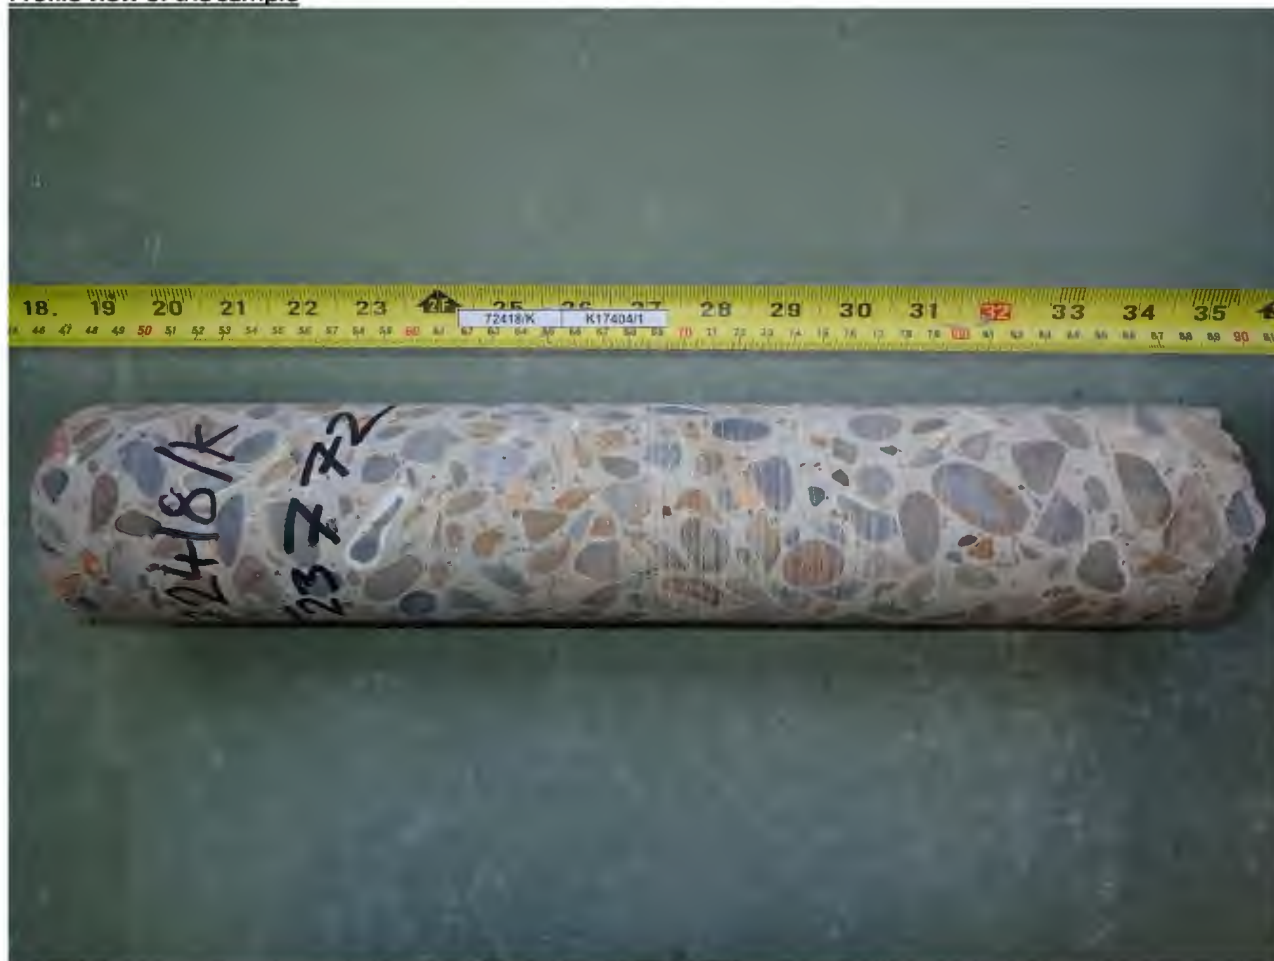
Laboratory Ref: K17404/1  
Client Ref: H1-P4/02

Profile view of the sample

View of the outer surface

View of the inner surface

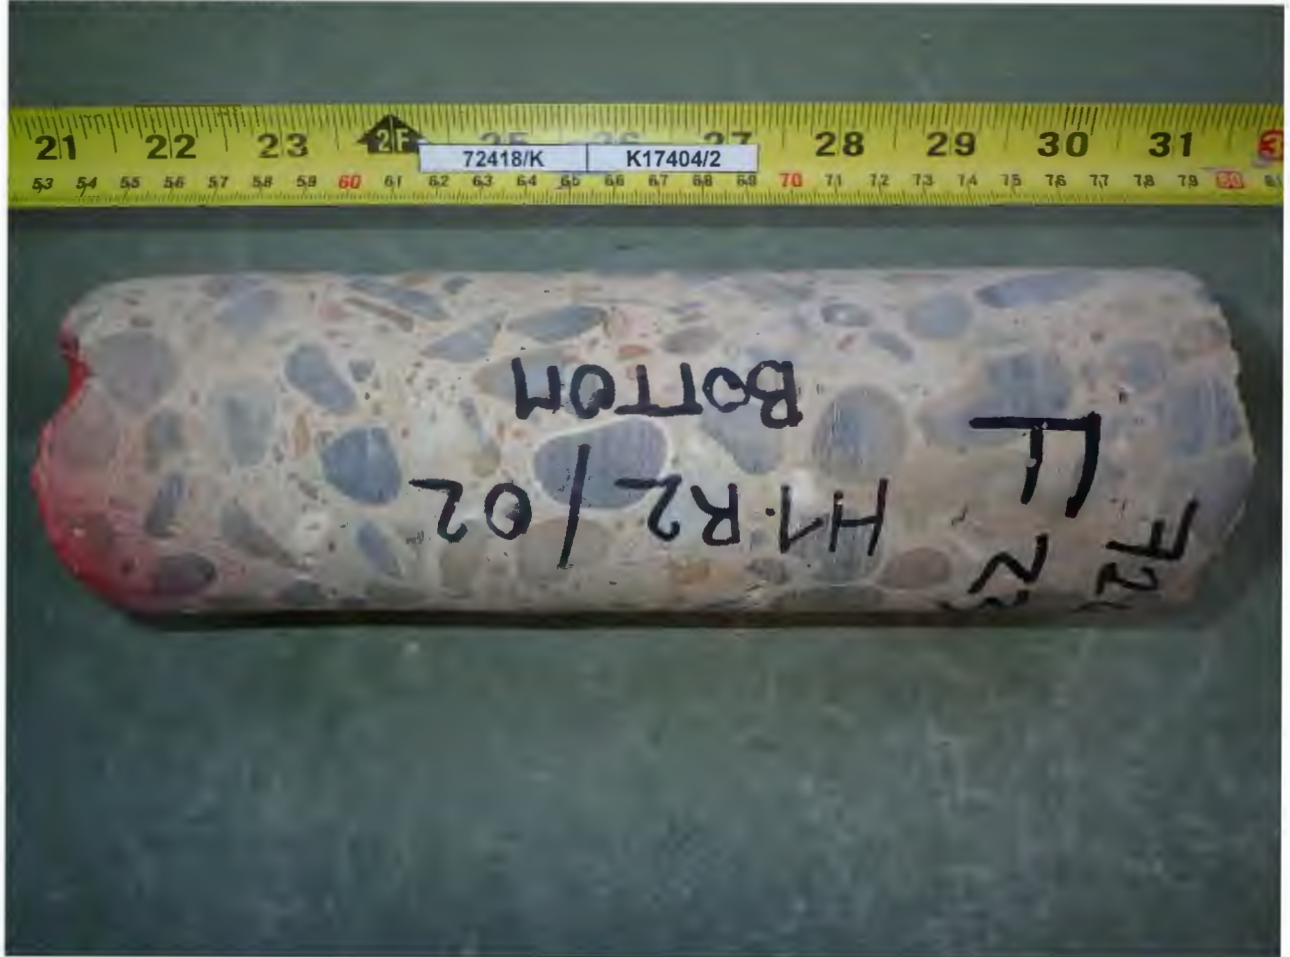
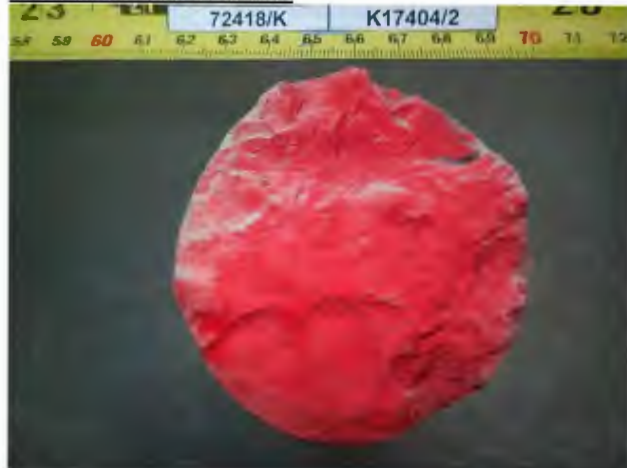
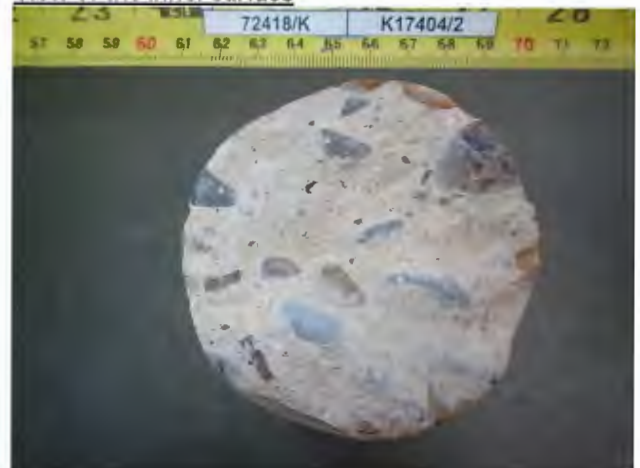
Figure B2

Profile view of the sample

View of the outer surface

View of the inner surface

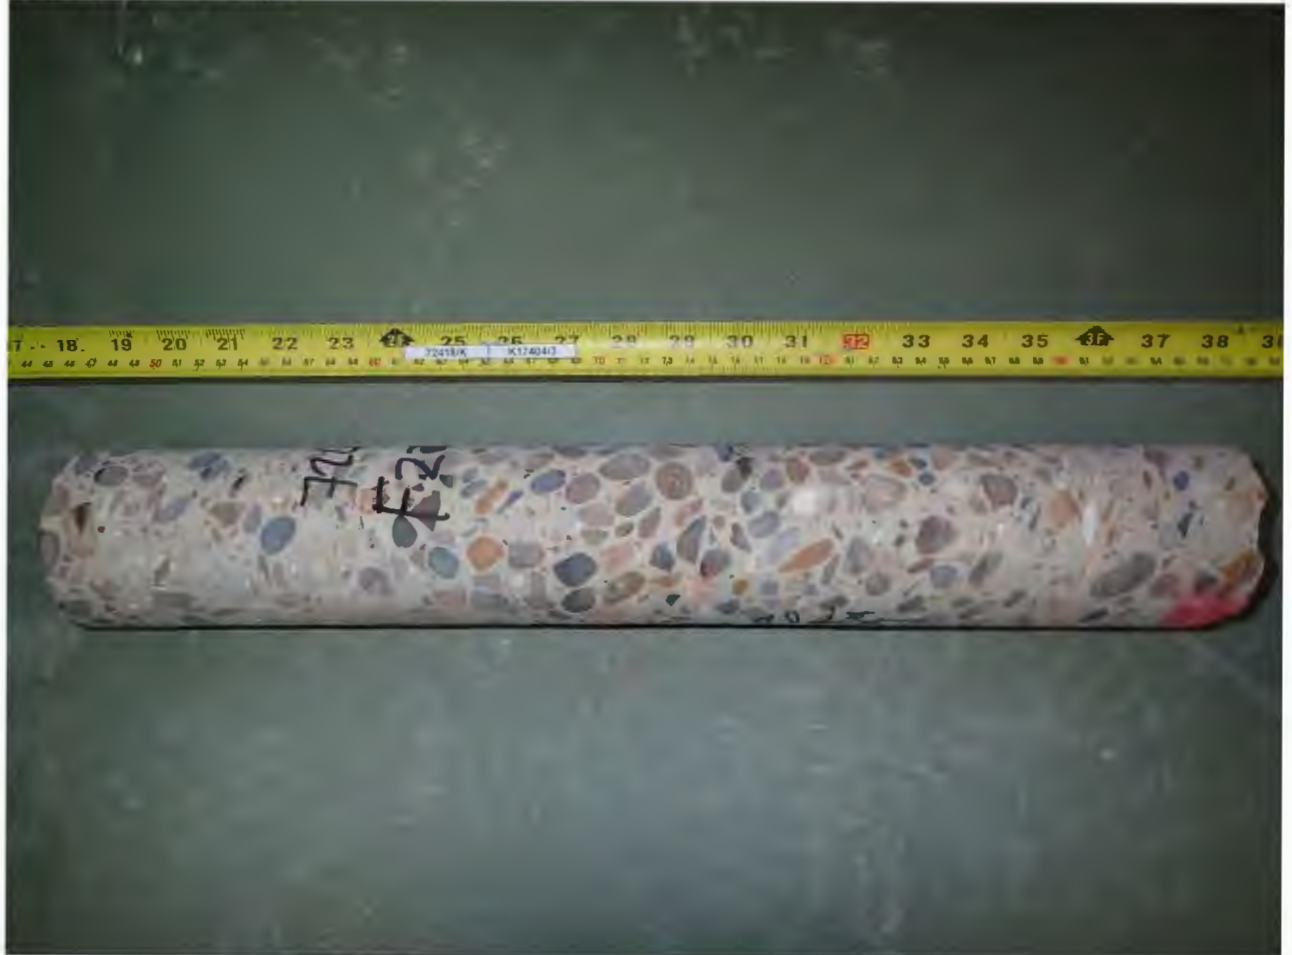
Figure B3

Profile view of the sample

View of the outer surface

View of the inner surface

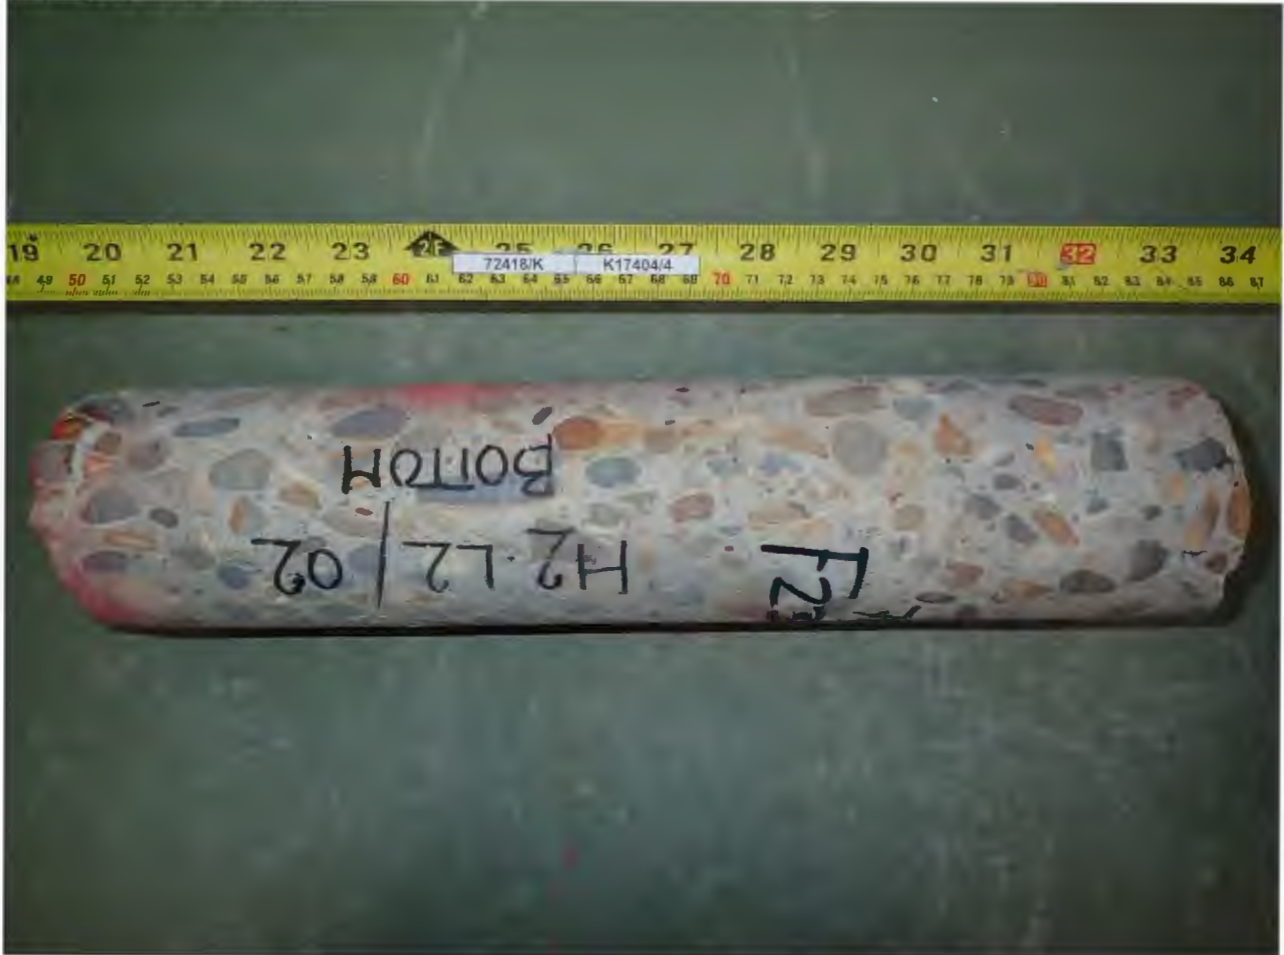
Figure B4

Profile view of the sample

View of the outer surface

View of the inner surface

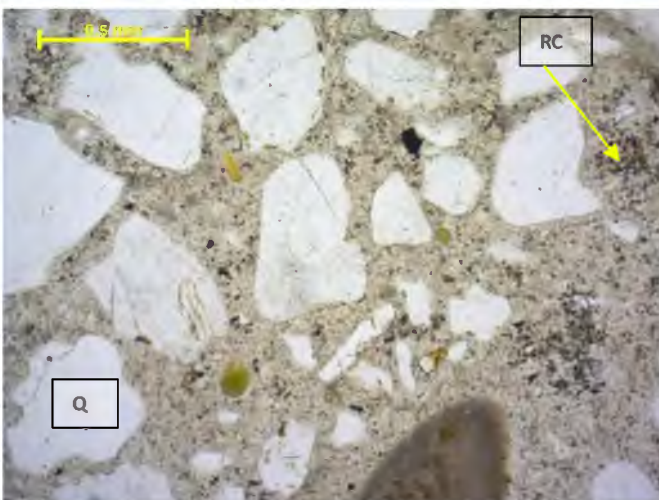
Photomicrograph C:

View of the concrete, showing quartz (Q) fine aggregate particles, bound by uncarbonated Portland-type cement matrix, which includes relict unhydrated cement grains (RC).

x50, Plane-polarised light
