Ground Movement & Damage Impact Assessment

BRITISH MUSEUM
EAST ROAD BUILDING REDEVELOPMENT
BUILDING DAMAGE ASSESSMENT

Rev 1

December 2023

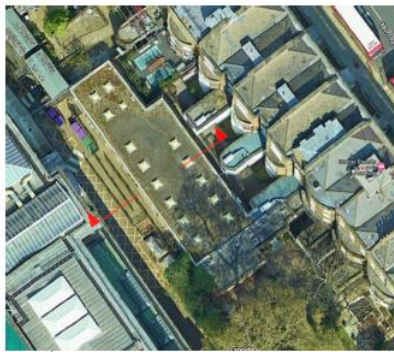
Figure 2

1910/41 EXISTING SECTION
BN RB A-A 1:50

British Museum
East Road Building redevelopment
Existing East Road Building
From Alan Baxter, Reference [1]

The site is currently occupied by the existing East Road Building (ERB), which is a single-storey workshop building that is to be demolished. The building is a load-bearing masonry structure supported on mass concrete strip foundations around 0.8m to 2.3m below ground level, corresponding to a foundation level of approximately +23.7mOD (see Figure 2).

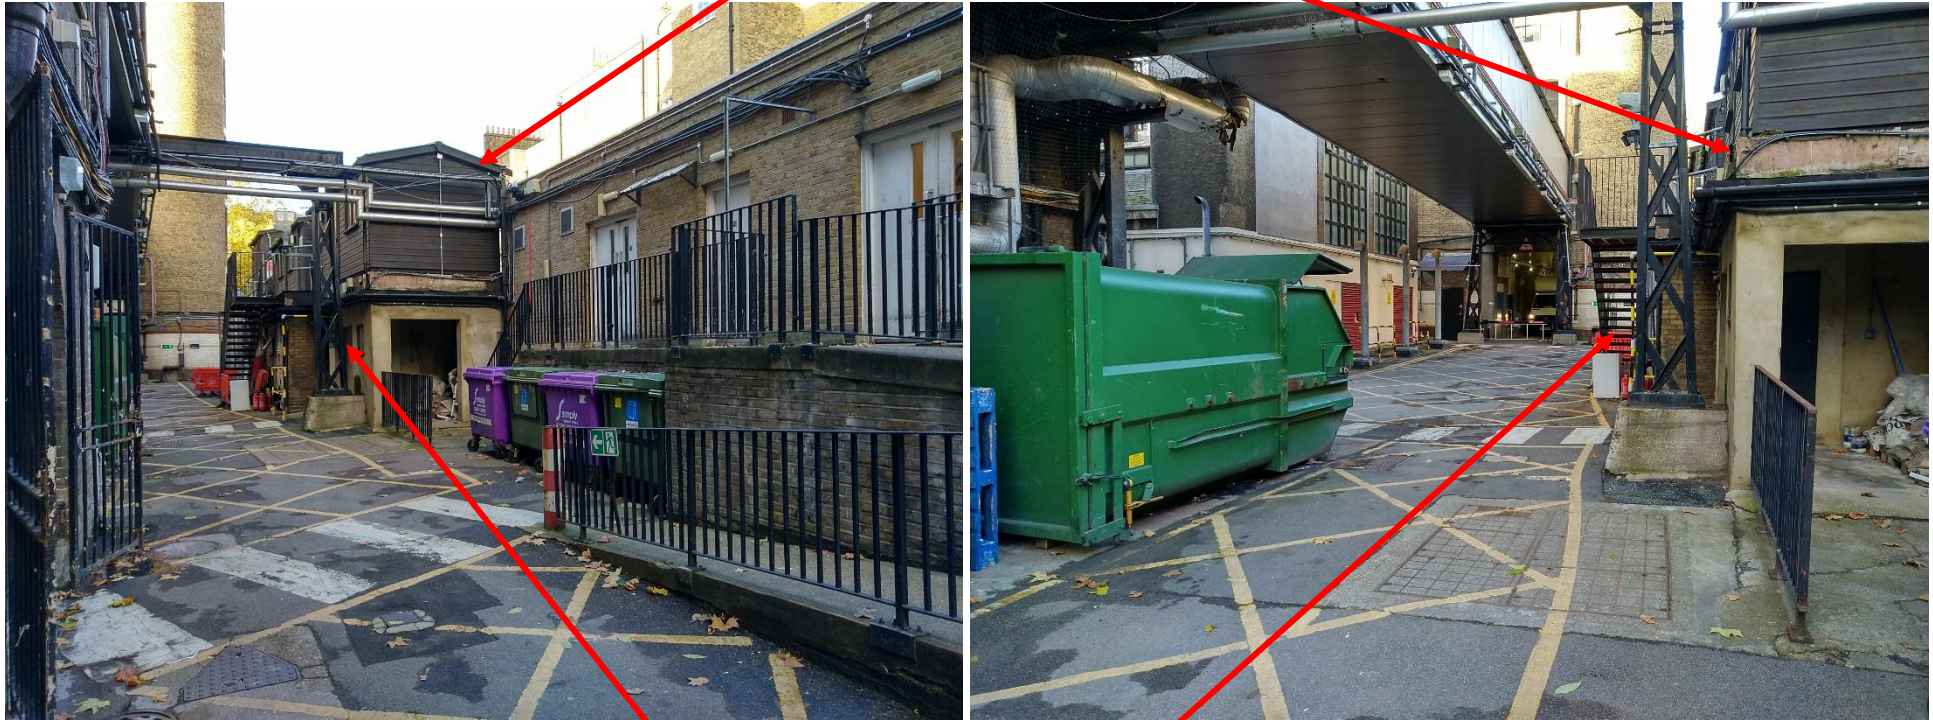
Figure 5

Structures to the north-west corner of East Road Building

Stanchion on concrete pad foundation

Photos of frame supporting the Jade Gallery and structures to the north-west corner of the East Road Building

The column located to the north-west of the ERB (see Figure 5) is part of a goalpost frame with a top beam that runs under the Jade Gallery tunnel and supports it and a second column present next to the museum East Wing. This column is founded on a concrete pad located at a level of approx. +23.8mOD.

rendered brick walls (see Figure 5) and appear to be founded at approx. 0.6m bgl, i.e. at a level of approx. +24.2mOD. It is proposed to demolish these building prior to the redevelopment of the East Road Building.

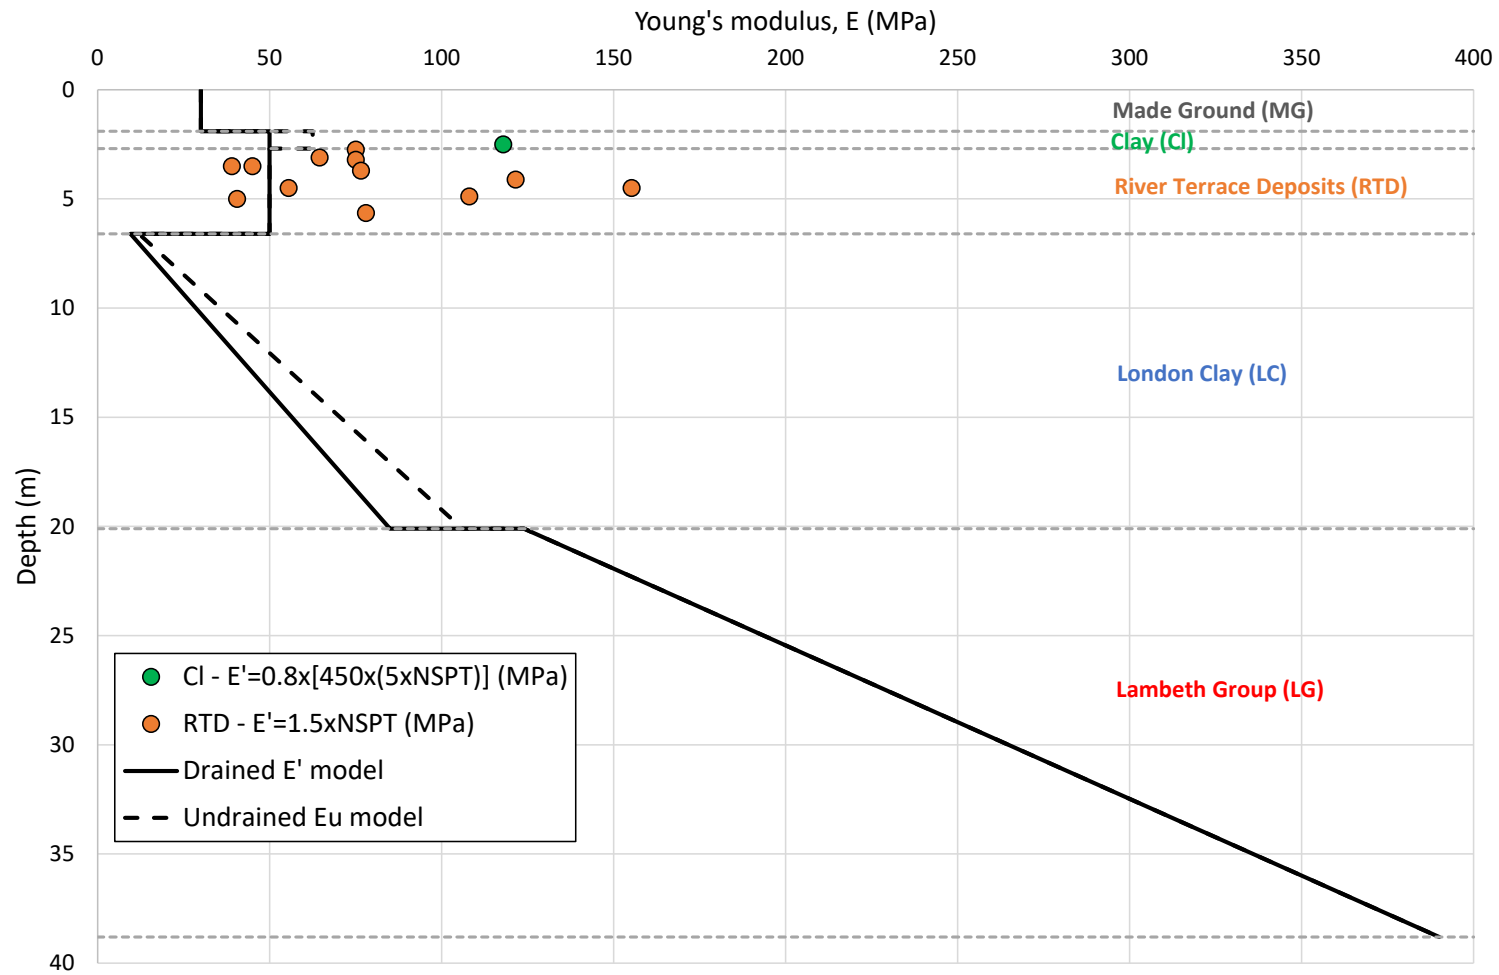
Figure 12

Young's Modulus profile adopted for elastic analyses
