Entire Houze Ltd.

Verification Report

11-12 Grenville Street

Report No: 23-12-03

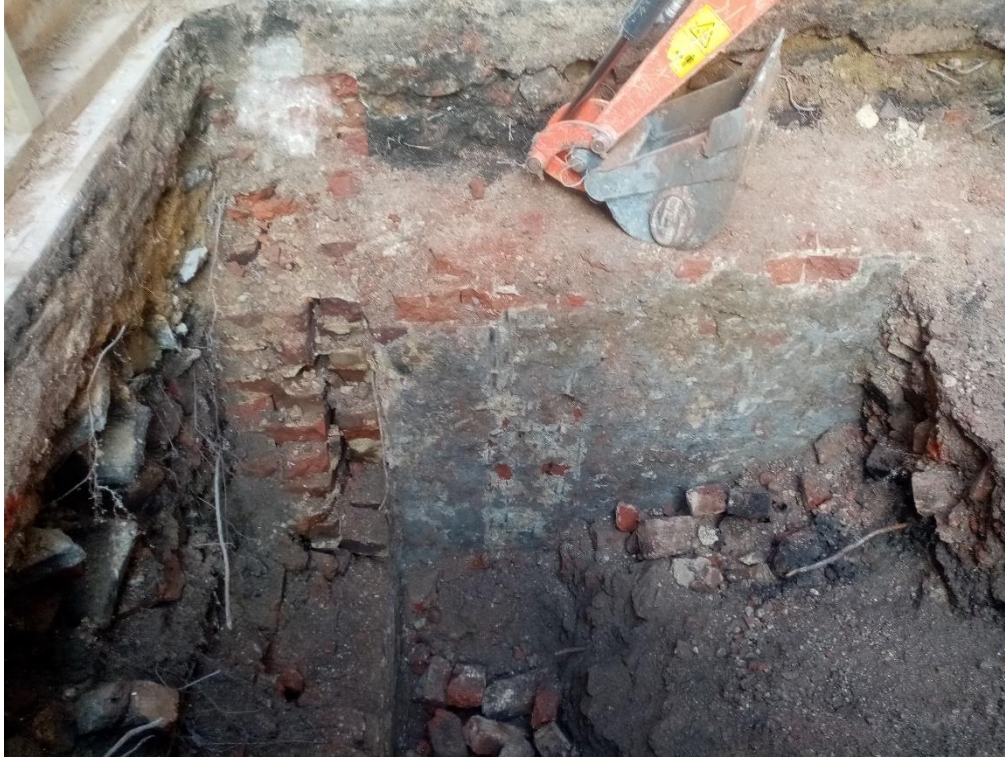
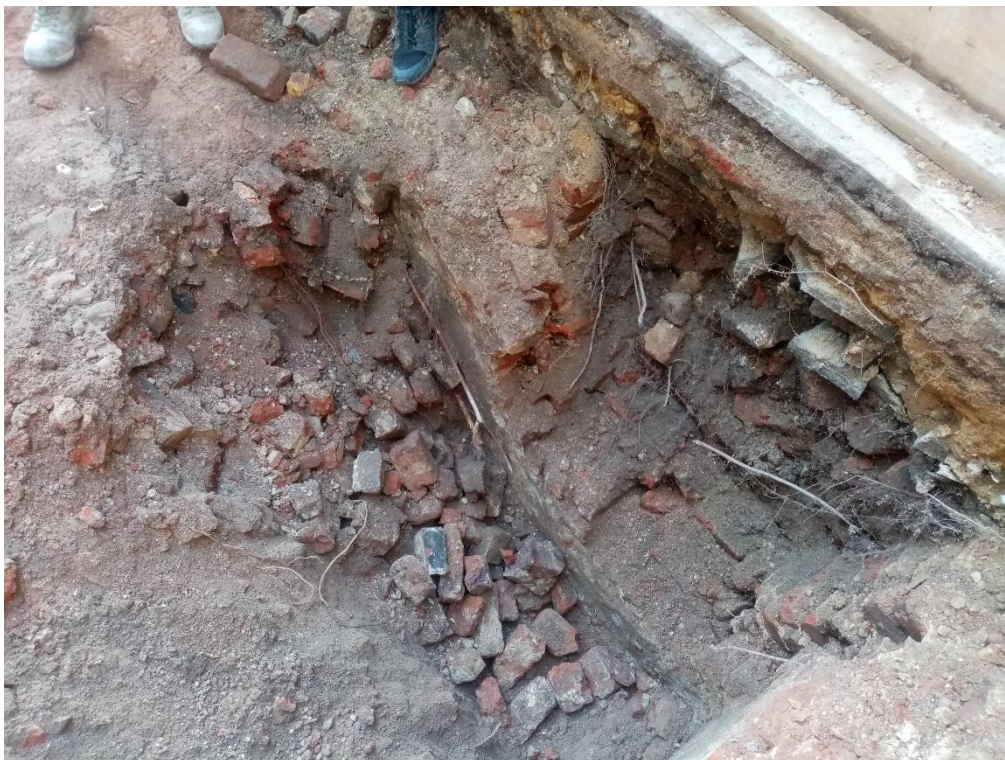
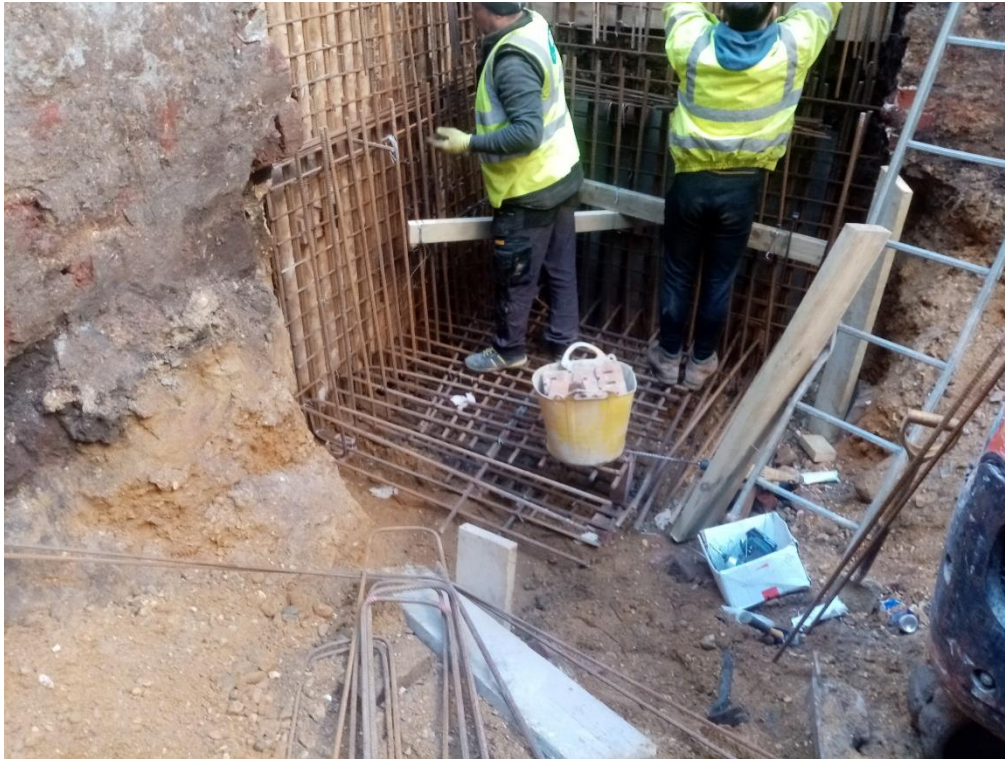
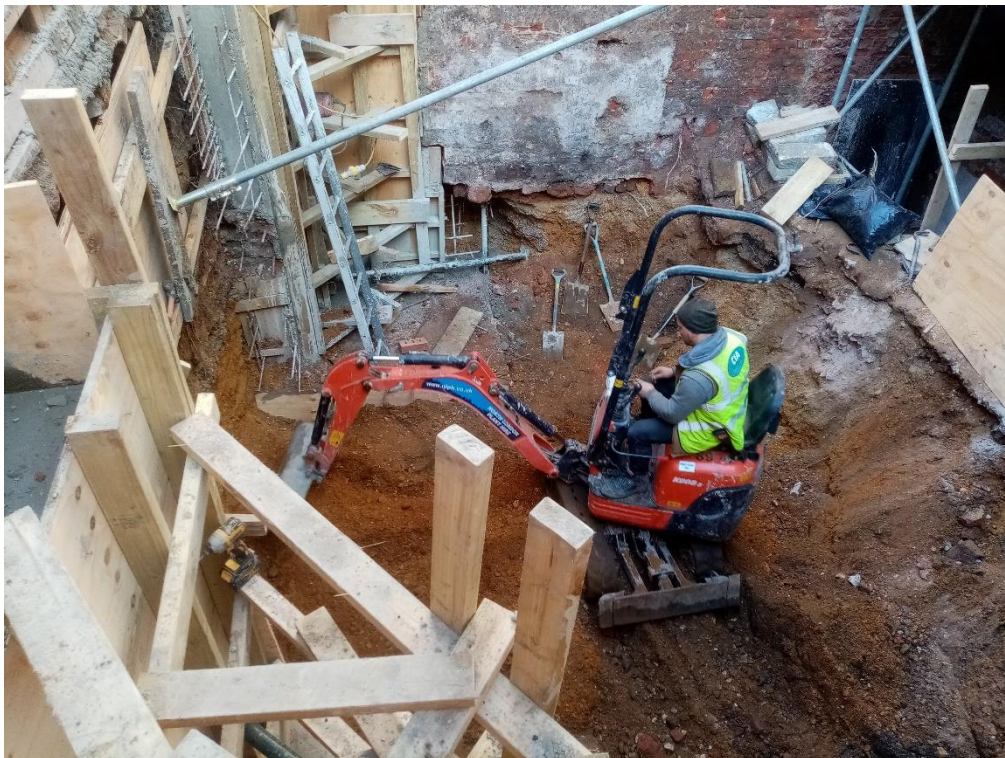
Photographic Record of the Formation Level Soil

The photographic record is shown in Appendix A. The photographs indicate the presence of Made Ground comprising visible fragments of brick and metal, overlying natural sand and gravel deposits interpreted to be the Lynch Hill Gravel Member. No obvious visible staining or odour was reported.

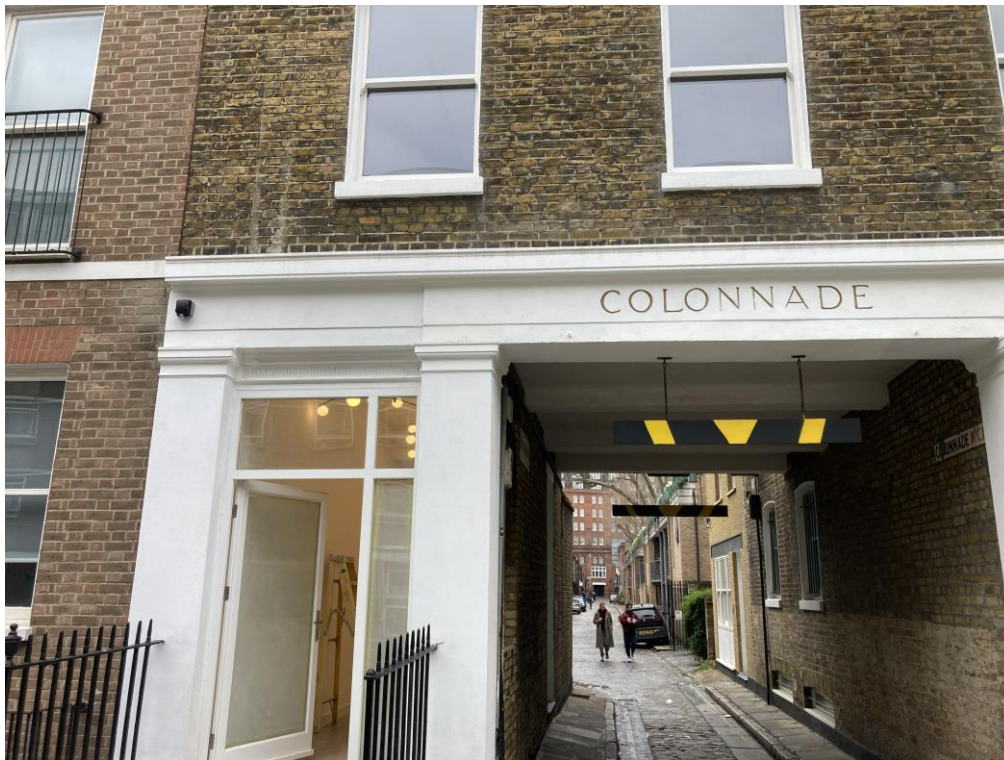
Photo showing 11-12 Grenville Street

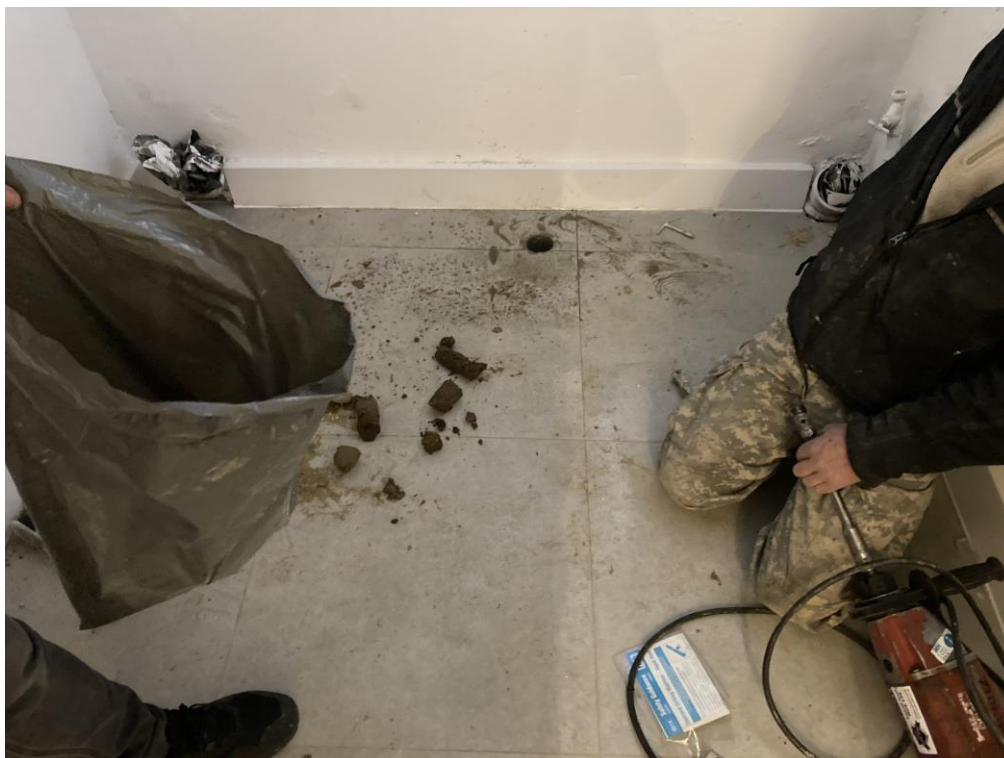
On the 7th of December 2023 a hand auger borehole was put down using an electric corer adjacent to the basement within the basement of 12 Grenville Street. Drilling through the basement of 11 Grenville Street was not possible due existing tanking however ground conditions are anticipated to closely match those of the adjacent basement at 12 Grenville Street, including the risk of vapour ingress. A log of the ground conditions was undertaken and two samples collected from the formation level soils (Logs and photographs are included within Appendix A).

The ground conditions encountered were concrete down to 0.15m bgl, overlying granular fill down to 0.45m bgl, overlying Reworked Ground comprising soft, brown, silty, slightly gravelly clay down to the base of the exploratory hole in excess of 0.95m bgl.

Photo showing the borehole

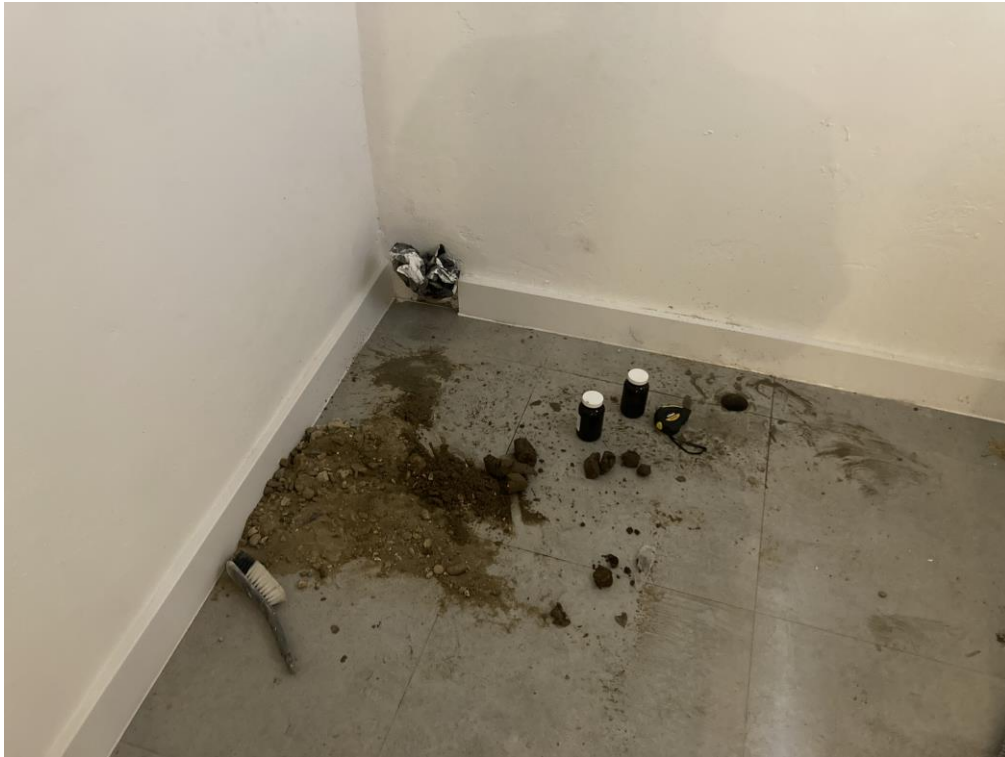
Geo-environmental laboratory testing was undertaken on the two selected samples within the formation level soils underlying the concrete and granular fill at depths of 0.50m and 0.90m bgl. The testing was carried out at a MCERTS and UKAS accredited laboratory. The results are presented in the Appendices.

Photo showing the samples taken.
