In September 2023 Ed Toovey Architects commissioned Middlemarch to undertake a Preliminary Bat Roost Assessment at University College School, Hampstead. This assessment is required to inform a planning application associated with the development of new teaching accommodation.

To fulfil the above brief to assess the potential for the existing buildings and trees on site to support roosting bats, a Preliminary Bat Roost Assessment was undertaken on 24<sup>th</sup> October 2023.

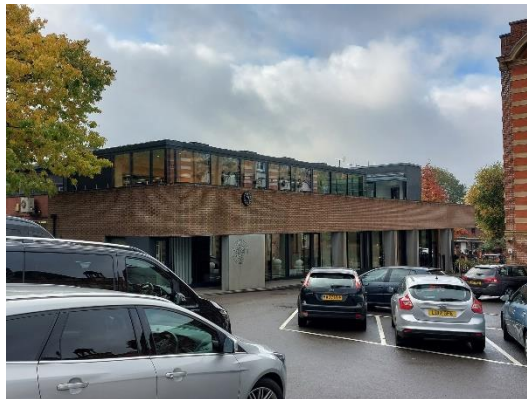
**Plate 4.1: Building 1 overview, western elevation**

Building B1, the Kents Building, comprises of a reception, sports centre, and drama theatre. The building has 2-3 storeys, has large windows throughout, and substantial sections of red brick frontage. The structure had a flat roof that was found to be in good condition (Plate 4.1). There were no bat roosting features identified at the time of the survey.

The building had negligible potential to support roosting bats due to an absence of suitable features.

- R1 Buildings B1, B3, B4, B5, B6 and B7:** These buildings have been assessed as having negligible potential to support roosting bats. The survey data obtained for the site is valid for 12 months from the survey date. If works to the surveyed buildings have not commenced within this timeframe it will be essential to update the survey effort to establish if suitable features have developed and if bats have colonised buildings in the interim. In the unlikely event that a bat is found during demolition works all works must immediately cease and a suitably qualified ecologist should be contacted.

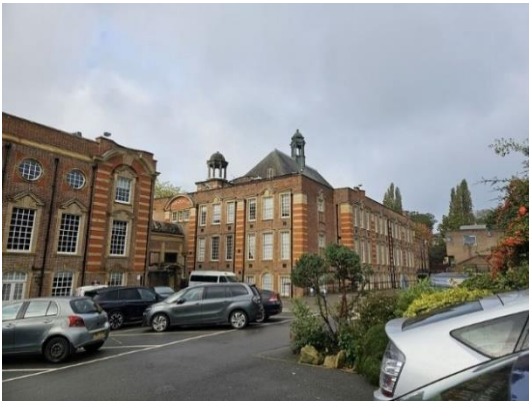
**Plate 4.2: Building B2**

Building B2 consists of three separate buildings, the north block, the centre block, and the south block, all interconnected by tunnels. It is a listed baroque Edwardian-style red brick building (Plate 4.2) with sections of steep pitched roofs and carved stone on the walls (Plate 4.3). The building was three storeys with large windows on all aspects.

All external brickwork and carved stone looked in good condition with no potential roosting features observed. There were weepholes covered with mesh on all aspects of the building preventing possible access for roosting bats.

- R2 Building B2:** Building B2 has been assessed as having high potential to support roosting bats, due to the presence of an old roof on the middle section which was not fully inspected. This building is not to be impacted by the proposed works therefore no further survey work is required at this stage. Should the proposed works change, an inspection of the roof and likely bat emergence surveys will be required to determine presence/absence of roosting bats.

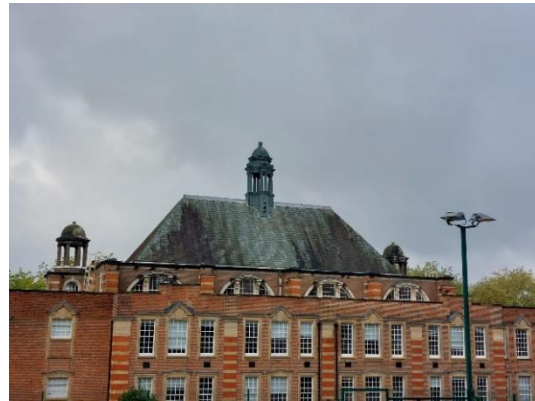
**Plate 4.3: Building B2 Roof**

The building's roof has high potential to support roosting bats, due to its size, the age of the building, and generally suspected suitability. The building is however outside of the scope of works.

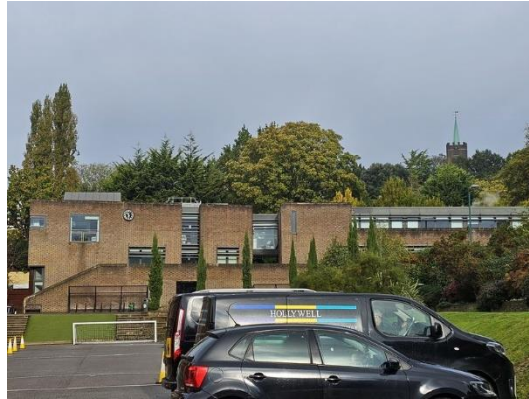
**Plate 4.7 Building B3 overview.**

B3 comprises of 2 separate buildings, the Bentham Building to the west and the Modern Language Centre to the east. Both buildings are connected via a corridor constructed from glass and metal

(Plate 4.7). The building comprised two storeys with brick walls and a flat roof. Overall, the external areas of the building were tightly fitted and in good condition with no suitable features for roosting bats. An internal assessment of the building was not undertaken.

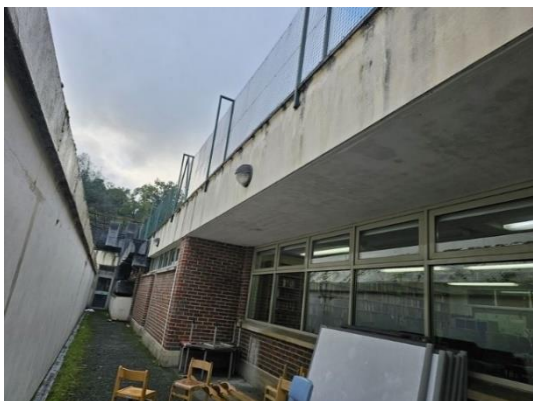
Building 4, the Giles Slaughter building, is a single storey brick-built building with an overhanging feature at ground level (Plates 4.9 & 4.10). The building’s roof is flat and used as a tennis court (Plate 4.11). The tennis courts can be accessed via a concrete built staircase with metal handrails on the eastern elevation of the building, which has signs of water damage (Plate 4.12). Overall, the building was modern and in good condition, with no suitable features for roosting bats recorded.

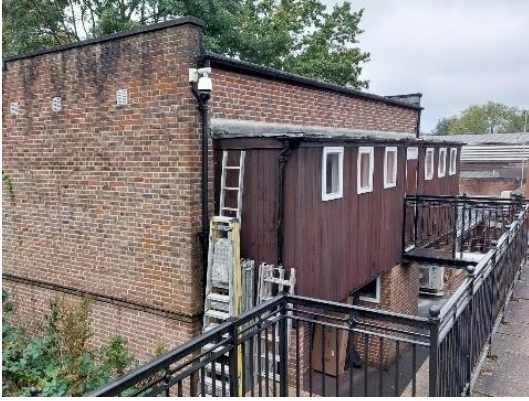
**Plate 4.14: Building B5**

Building B5 is a single storey brick structure with a flat roof. It is faced with timber cladding on the northern aspect (Plate 4.14). The fascia board was tight and flush, providing no roosting opportunities (Plate 4.15).

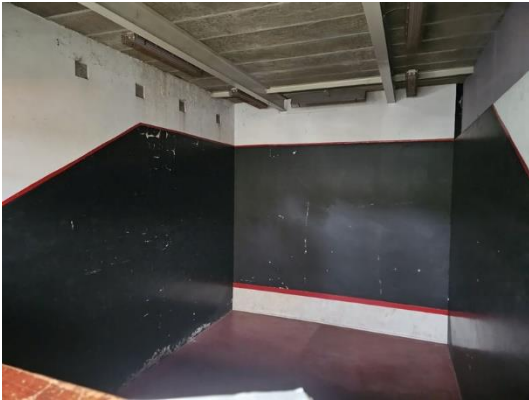
**Plate 4.16: Squash Court**

Building B5 is used as a squash court and had high concrete ceilings with no concealed void (Plate 4.16).

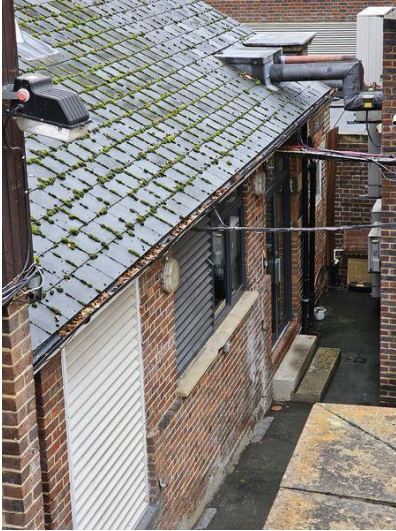
**Plate 4.17: Building B6**

B6, the facilities building, is a single storey brick-built structure. It has a gable slate tiled roof which appeared in good condition, with no slipped, lifted or missing tiles that might provide crevice features for roosting bats (Plate 4.17). There was lead flashing on the base of the chimney with no gaps noted. There were several metal flue pipes coming out of the roof, again with no gaps noted (Plate 4.18).

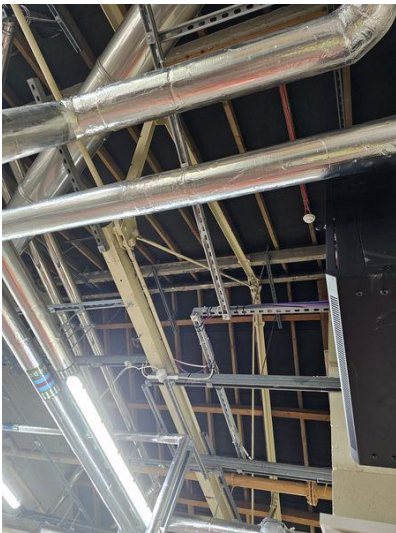
**Plate 4.19: Boiler Room**

The majority of the building is used as a boiler room with no concealed roof space (Plate 4.19). The remainder of the building is a used office space and was unsuitable for roosting bats (Plate 4.20).

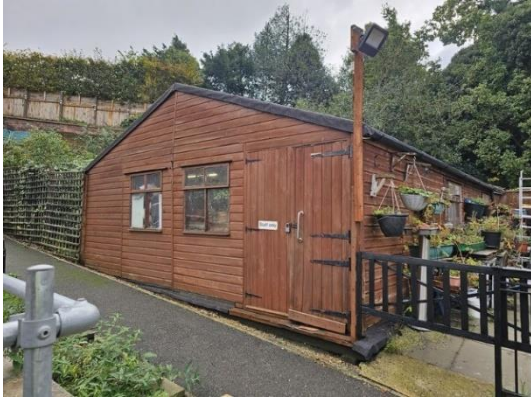
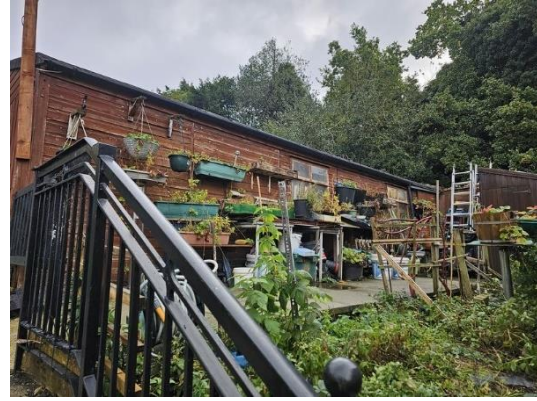
Building 7 is a small single storey hut with tightly fitted timber walls and a felt gable roof which is in good condition (Plate 4.21 and 4.22). There were no gaps noted between the roof and the timber beams (Plate 4.23), allowing no potential roosting opportunities for bats.

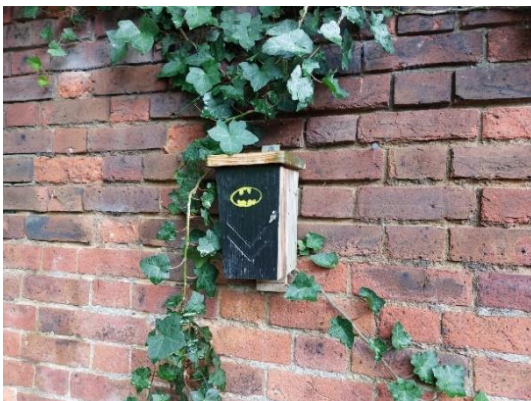
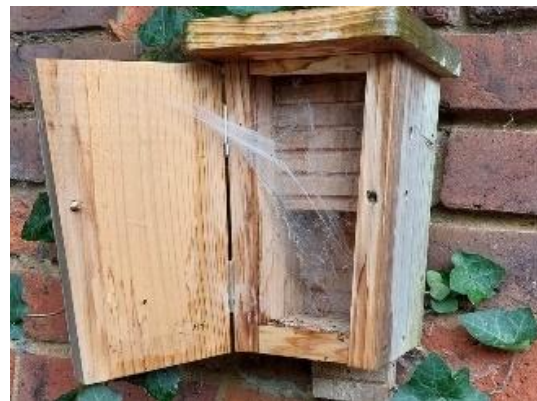
One bat box was located in the northeastern corner of the survey area. It was inspected and found to be unused and heavily cobwebbed. The bat box is not to be impacted by the proposed works.

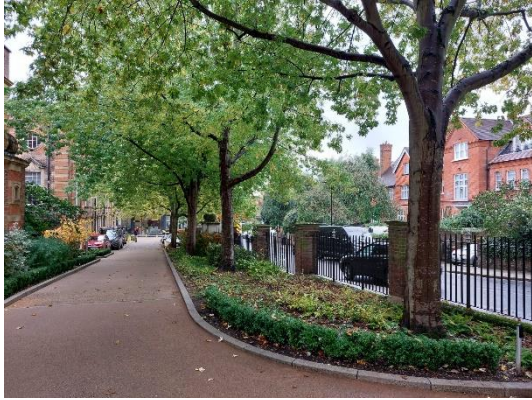
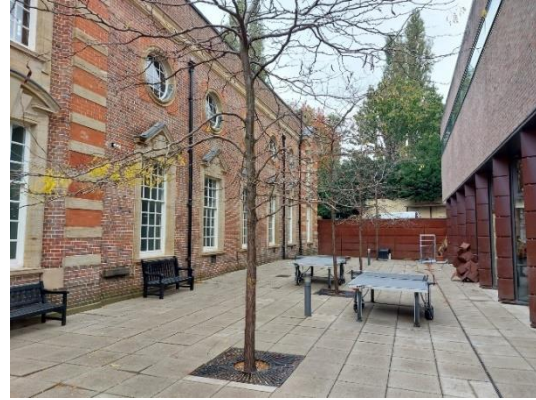
The site's trees were primarily situated at its boundaries (Plate 4.26), with some smaller scattered trees present between the buildings (Plate 4.27). Species present during the survey were Turkey oaks *Quercus cerris*, pear *Pyrus* sp., cherry *Prunus* sp., birch *Betula* sp., apple *Malus* sp., cypress

The age of the trees ranged from sapling to semi mature, and presented no features for roosting bats (e.g. knotholes, woodpecker holes). The trees are therefore classified as having negligible potential for roosting bats due to the absence of features.

- R3 Trees:** All trees on site were considered to have negligible potential to support roosting bats. The survey data obtained for the site is valid for 12 months from the survey date. If proposed site works have not commenced within this time frame it will be essential to update the survey effort to establish if the trees have developed features that could be used by roosting bats in the interim. In the unlikely event that a bat is found during works to the trees all works must immediately cease and a suitably qualified ecologist should be contacted.
