Bat Survey Report

Fox Court

Clare Real Estate (14 Gray's Inn Road) Ltd

October 2023

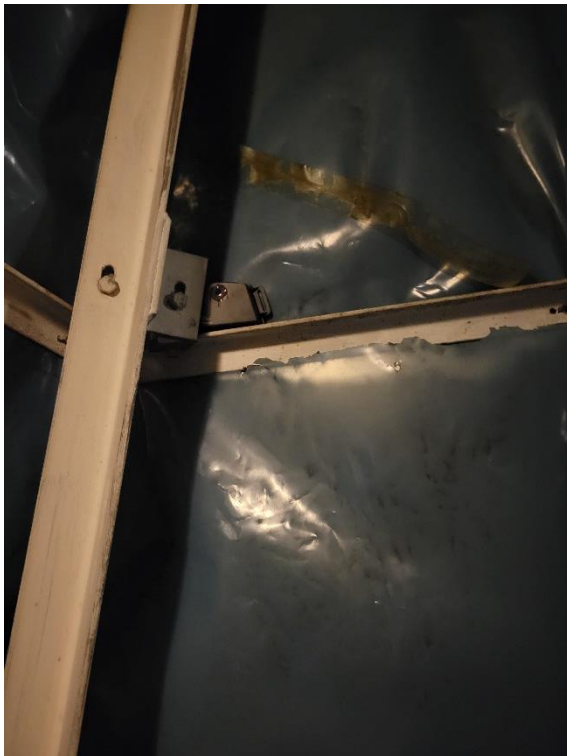
Photograph 2: Static detector deployed within the parapet/roof voids

Two static detectors were placed within the parapet/roof voids on the 7th floor of the building, along the southern and eastern elevations, on 21st August, prior to the dusk emergence survey; the locations of the static detectors are shown on Figure 1, Appendix 4. The detectors were set to record bat activity from 15 minutes before sunset until 15 minutes after sunrise and were left in place to record for a period of nine days.

Gaps around/between the sloping metal panels forming the walls of the parapet/roof voids, as well as along the uncovered drainage ducts between the brick wall and the metal cladding, offered potential access points for bats to the void within, providing roosting opportunities for void-dwelling bat species.

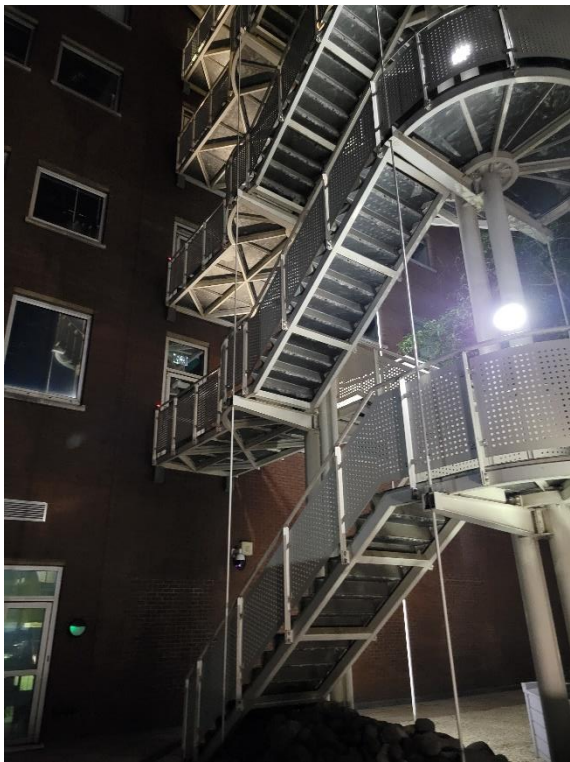
Photograph 3: High levels of lighting in the courtyard at night

No bat roosts were identified on the Site, and no bats were recorded during the emergence/activity survey. The high artificial light levels in the courtyard and surrounding streets would potentially act as a deterrent to bats.

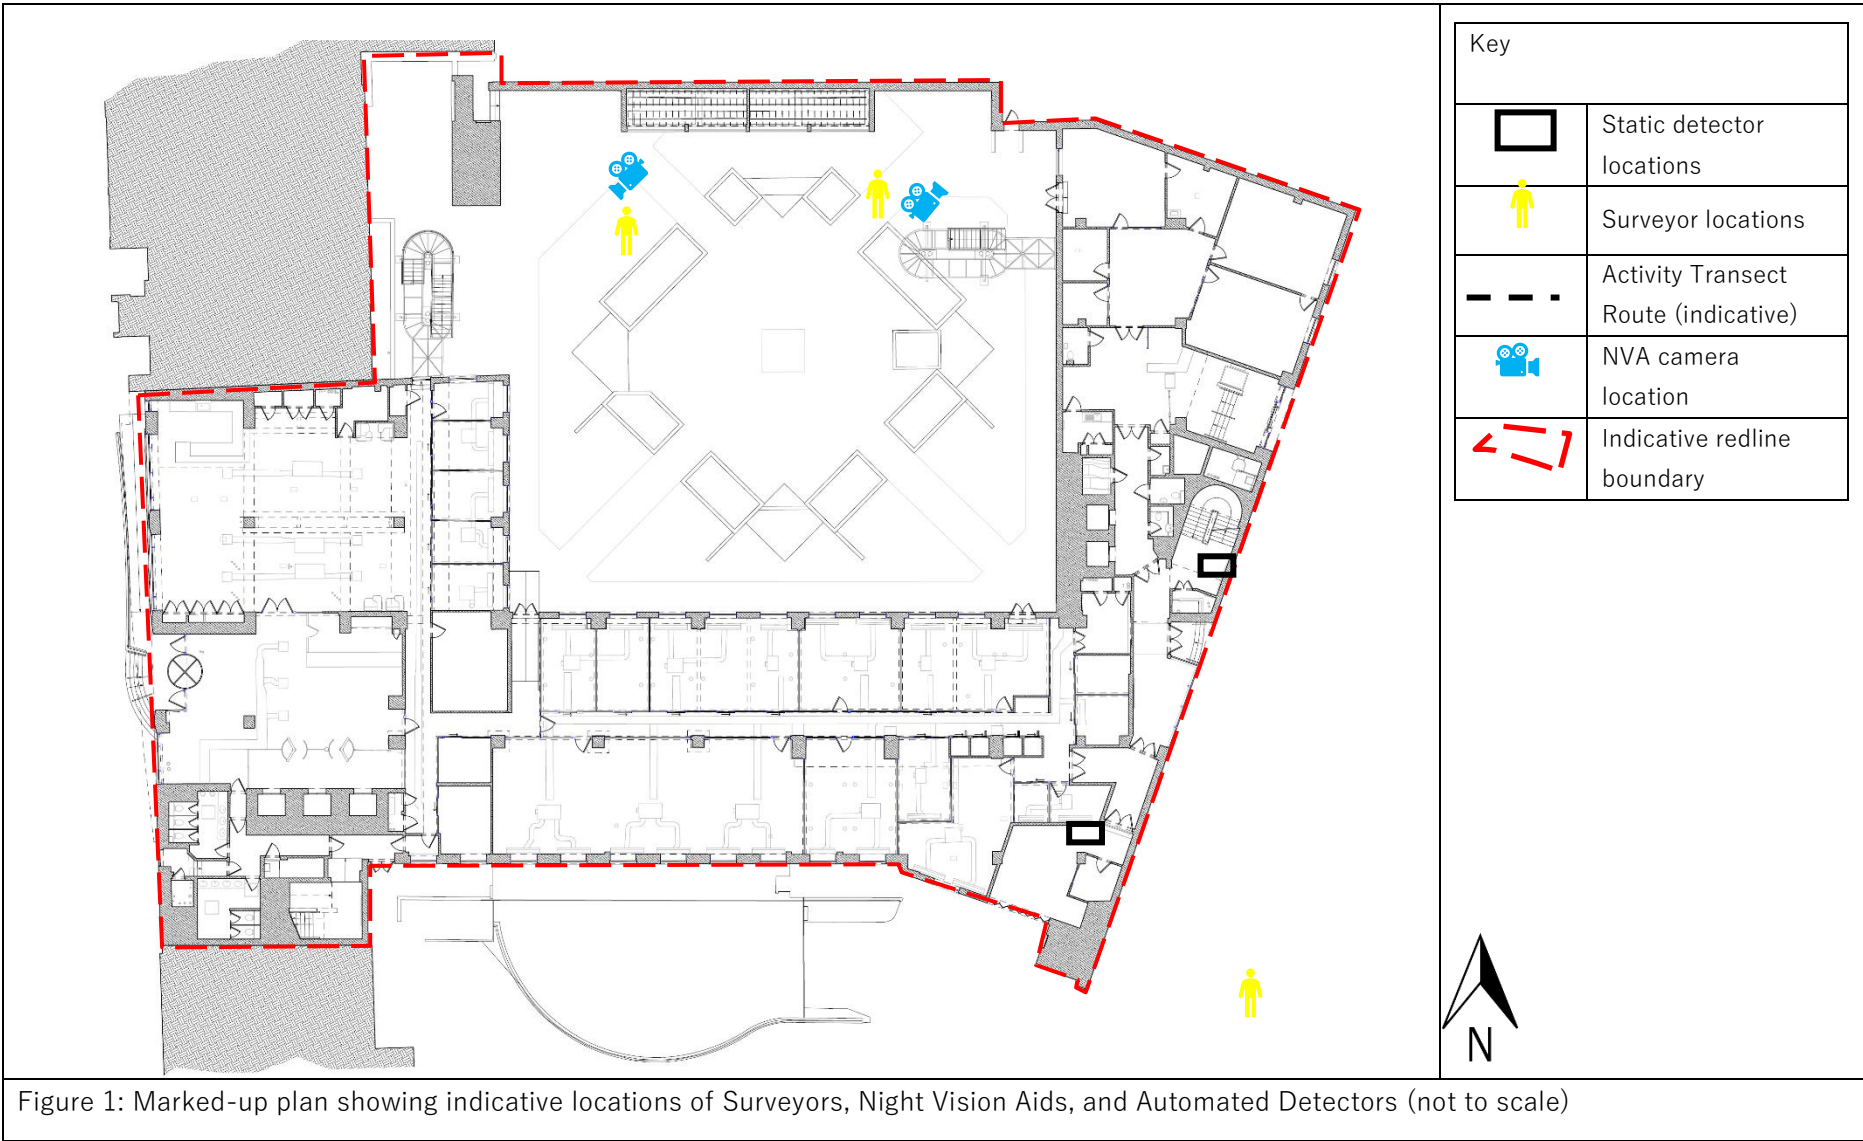
Figure 1: Bat Survey Results – Surveyor and Night Vision Aid camera locations

Two infra-red cameras and a thermal imaging camera were used to support the surveyors during the survey. The cameras were positioned to record bat activity within the courtyard stairwells and shed (see photographs in Appendix 3 and Figure 1, Appendix 4); recorded footage was subsequently analysed in conjunction with recorded bat calls.

A description of the survey findings is provided below, and a figure showing the indicative locations of the surveyors is provided in Figure 1, Appendix 4. Infra-red photographs from the camera(s) are included in Appendix 3. Information regarding the species recorded on Site is included in Appendix 2. The raw survey data is available on request.
