Our Ref: 27755342 1922663 Hampden Close

APPENDIX E SITE INVESTIGATION PHOTOGRAPHS

TRIAL PIT DRAWINGS

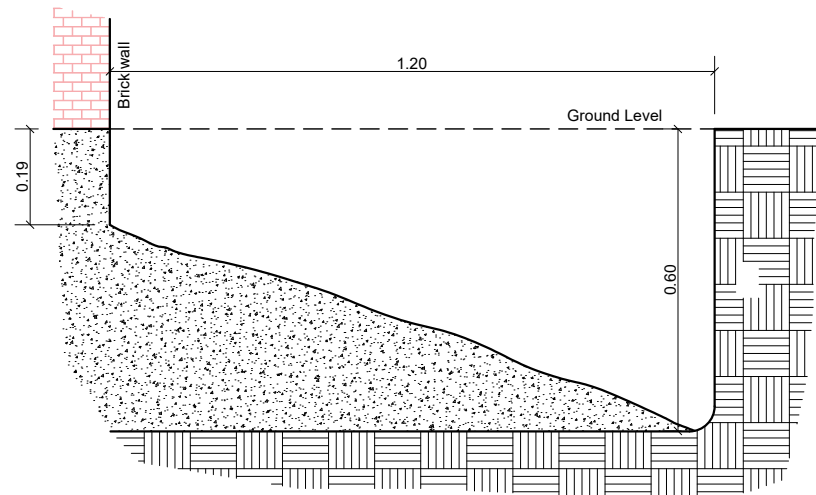
Description
Foundation Pit Sketch FP1b

Plan view
Scale 1:15

Section view
Scale 1:15
