GROUND INVESTIGATION & BASEMENT IMPACT ASSESSMENT REPORT

15 Belsize Park Mews

Report Title: Ground Investigation & Basement Impact Assessment for 15 Belsize Park Mews,
Camden NW3 5BL

Job No: P5188J2818/SC

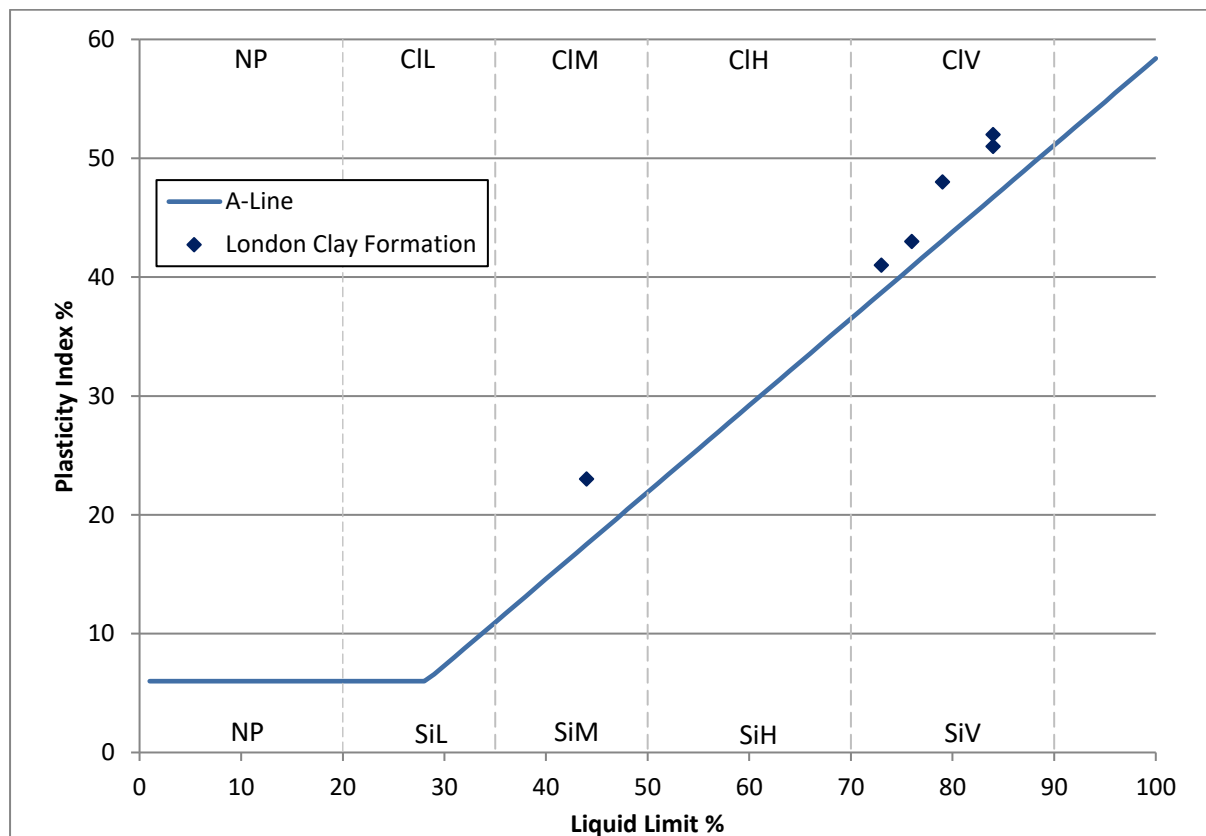
Figure 5.1: Plasticity Chart

5.2.3 Modified Plasticity Index values in these strata ranged from 21.9% to 52%, indicating soils with medium to high volume change potential.

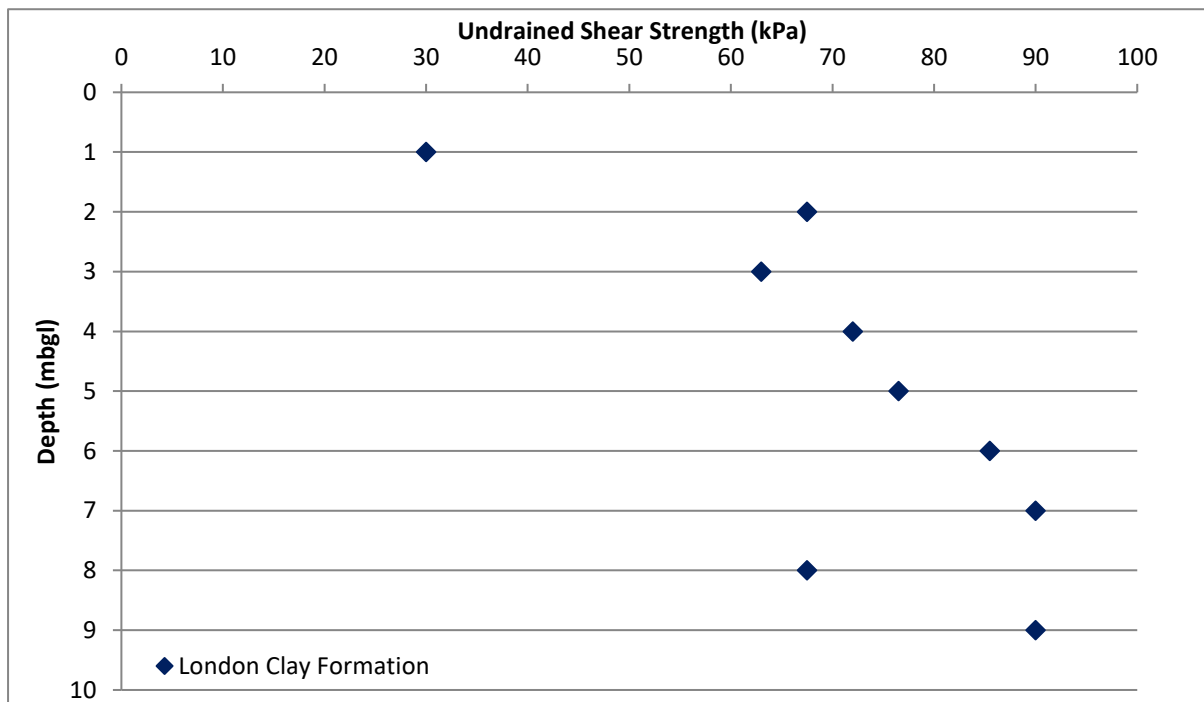
Figure 5.2: Undrained Shear Strength v Depth

- 5.3.3 The graph below shows the shear strength profile of the encountered cohesive materials at the site, based on the SPT to shear strength correlation described above.

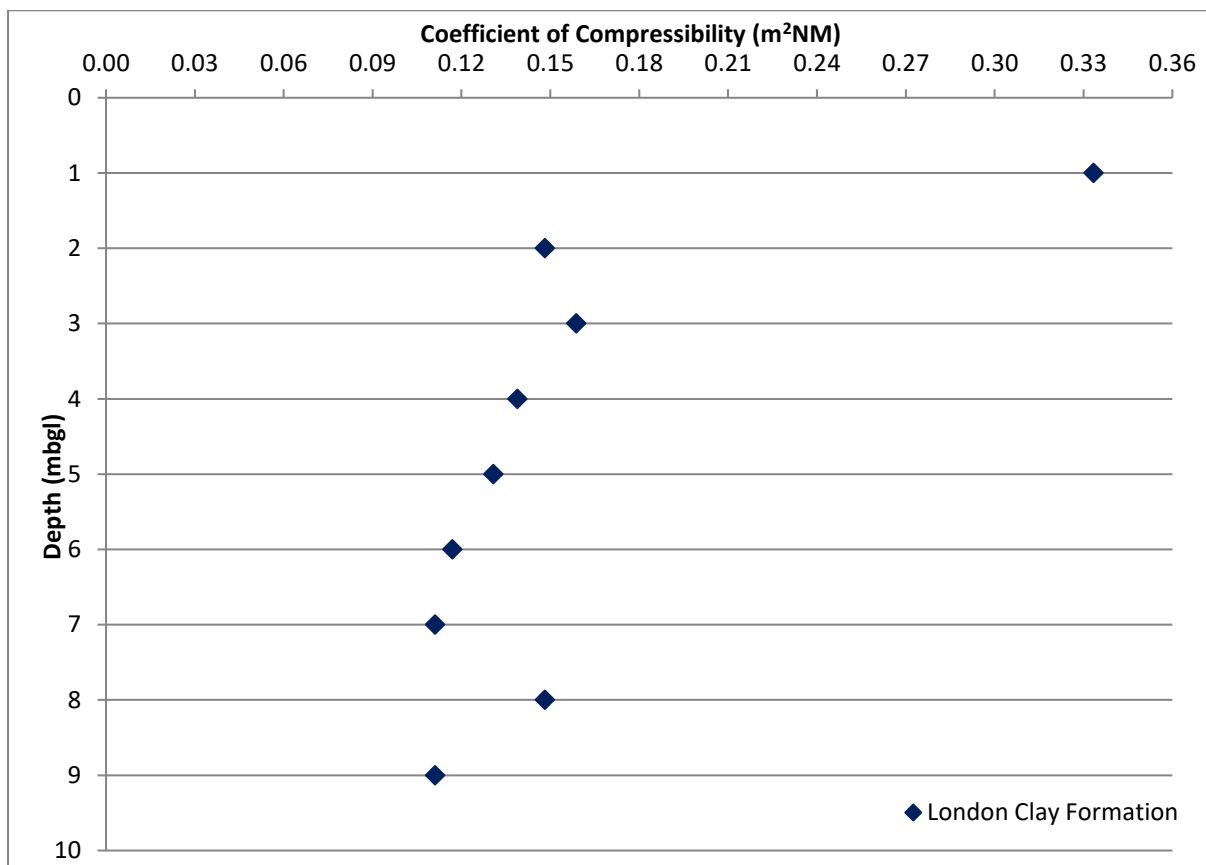
Figure 5.3: Coefficient of Volume Compressibility (m_v) v Depth

5.4.2 Using the plasticity indices obtained and the graphs provided in Tomlinson (2001) a value of f_2 of 0.45 has been taken and used with the SPT N-values to infer coefficient of compressibility (m_v).

5.4.3 The results from of the London Clay Formation are generally of “medium compressibility”.

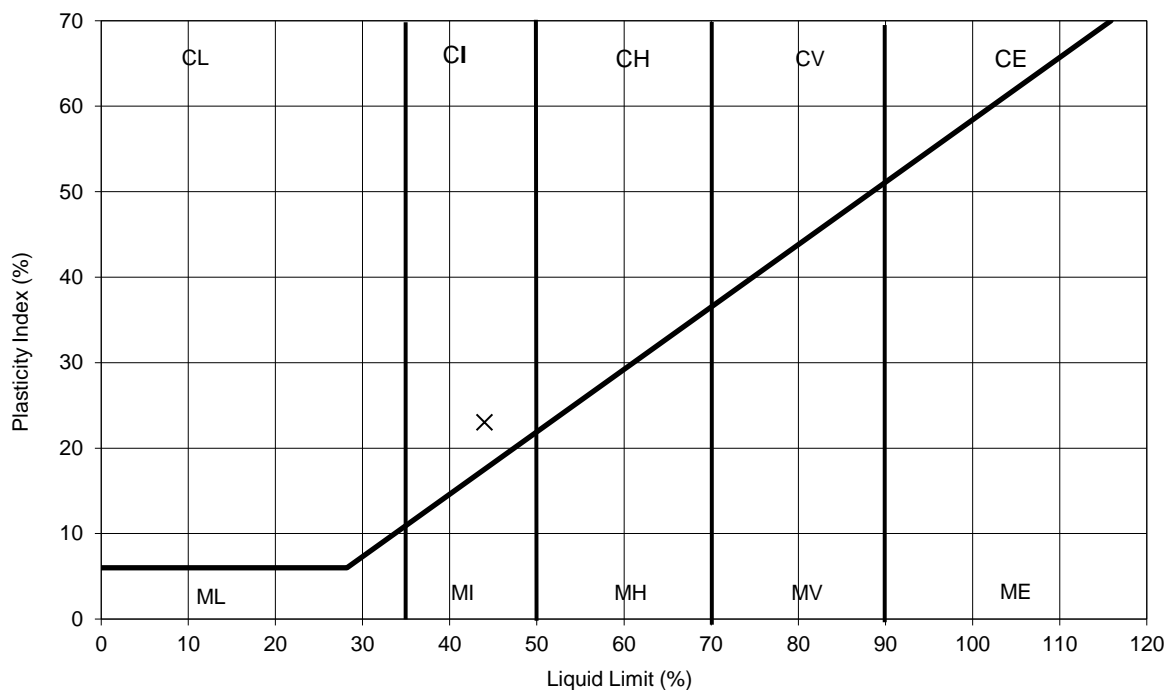
PLASTICITY INDEX

Orangish brown slightly mottled bluish grey slightly gravelly slightly sandy silty CLAY (gravel is fm and sub-angular to rounded)

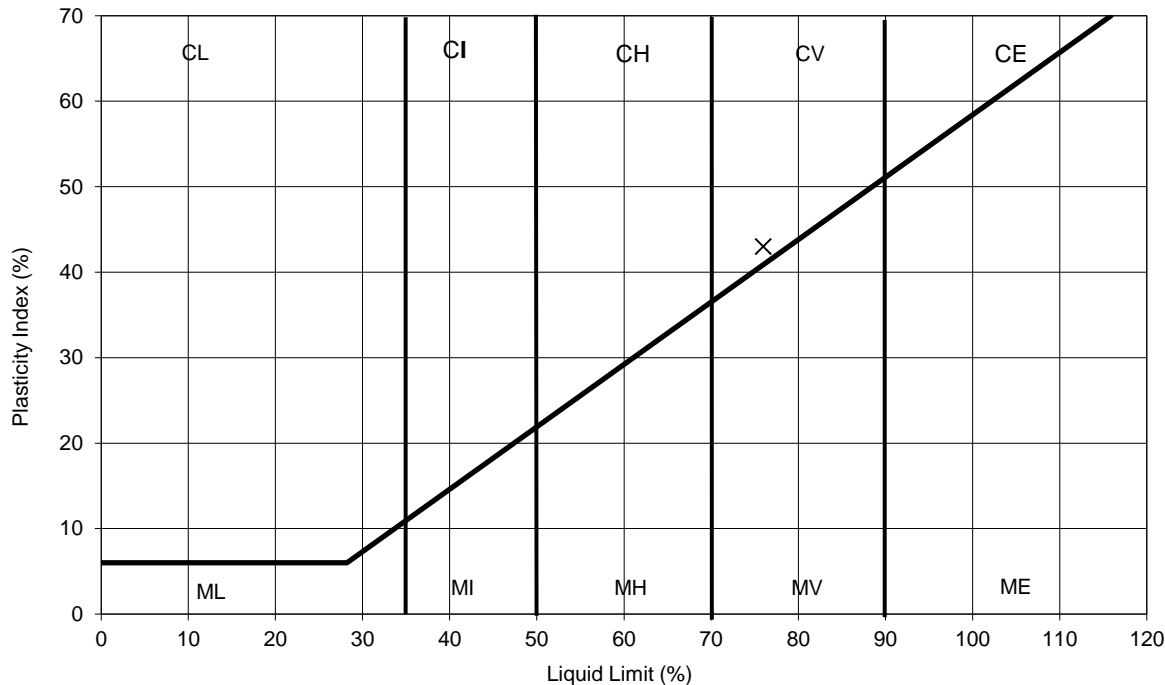
PLASTICITY INDEX

**NATURAL MOISTURE CONTENT****32****%****% PASSING 425µm SIEVE****100****%****LIQUID LIMIT****76****%****PLASTIC LIMIT****33****%****PLASTICITY INDEX****43****%****Remarks**
