Site Investigation Report

Job Information	
Client	Allianz
Client ref	
Visit date	05/04/2023
Report date	15/05/2023

Job Summary	
	1 trial hole undertaken. Read more.
	Unable to locate footing in TH1 Read more.

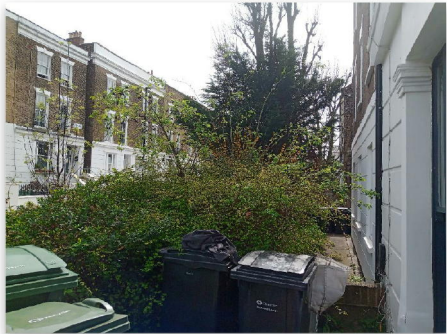
Fig 1.1: Trial Hole 1 Location Fig 1.2: Trial Hole 1 Footing

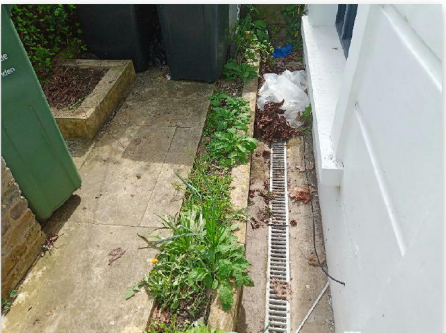
Trial Hole Findings We could not excavate the TH in the proposed location due to a ACO drain which spans across the front of the property. See evidence below figure 2.1. We excavated a Remote BH in front garden to reach the required depth (3m) and collect soil and root samples. Bore Hole measurements shown in Trail Hole Log below.

Fig 2.1: ACO Drain

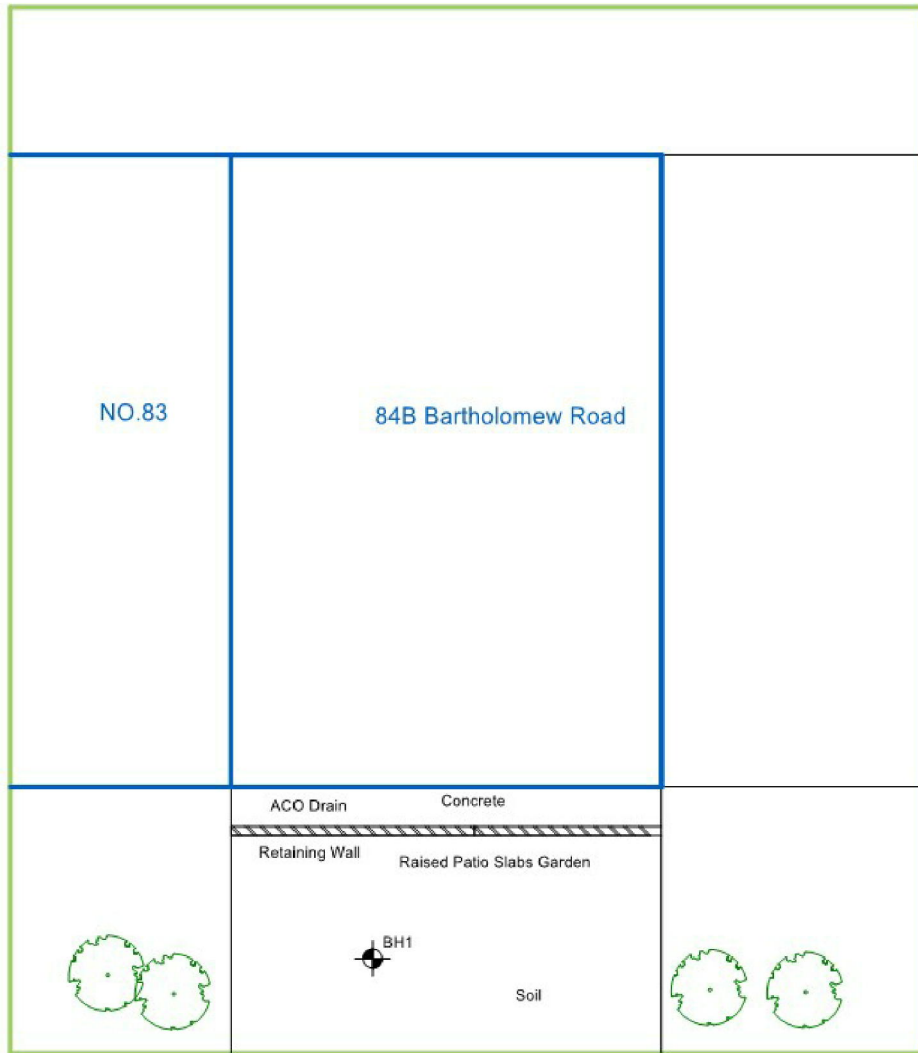
FRONT OF PROPERTY

Location: Raised garden area front garden

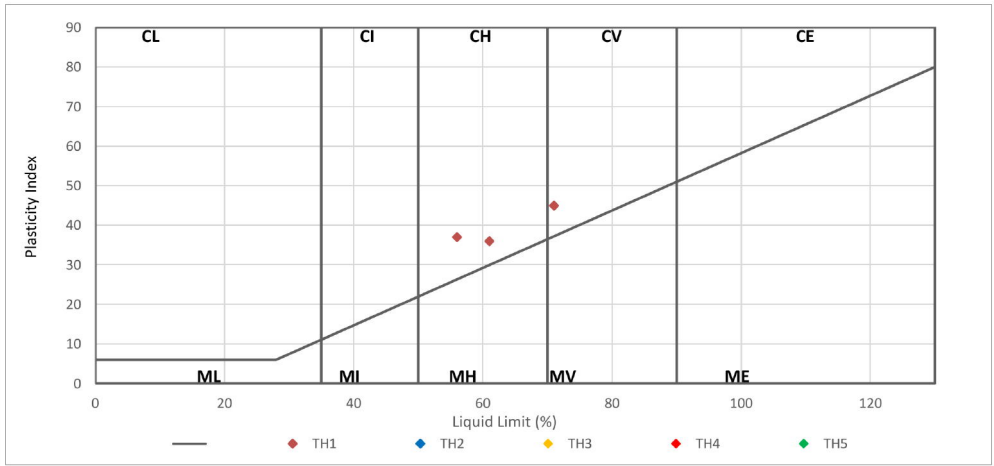
PLASTICITY CHART FOR CASAGRANDE CLASSIFICATION
BS 5930:1999+A2:2010

Modified Plasticity Index (PI) <10 : Non Classified
 Modified PI = 10 to <20 : Low volume change potential (LOW VCP)
 Modified PI = 20 to <40 : Medium volume change potential (Med VCP)
 Modified PI = 40 or greater : High volume change potential (HIGH VCP)

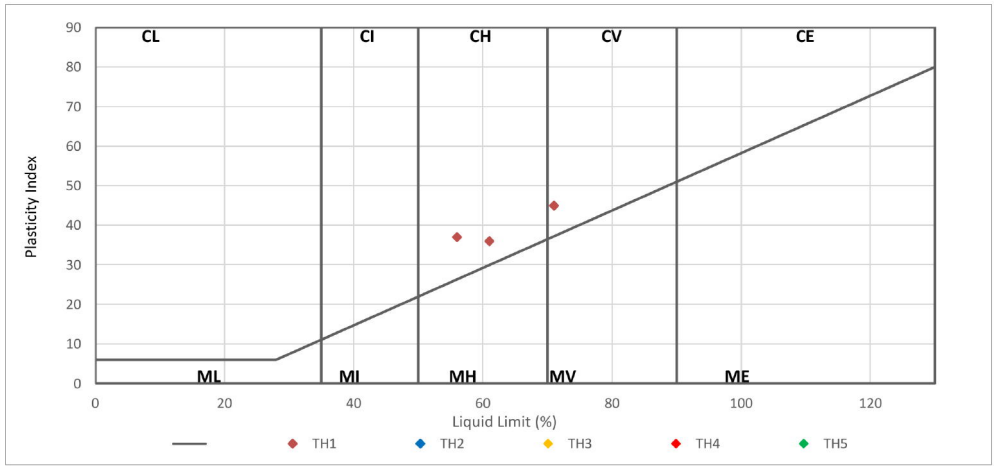
PLASTICITY CHART FOR CASAGRANDE CLASSIFICATION
BS 5930:1999+A2:2010

Modified Plasticity Index (PI) <10 : Non Classified
 Modified PI = 10 to <20 : Low volume change potential (LOW VCP)
 Modified PI = 20 to <40 : Medium volume change potential (Med VCP)
 Modified PI = 40 or greater : High volume change potential (HIGH VCP)
