# 100 Chalk Farm Road

## Heritage Engineering Report

Pell Frischmann

January 2024

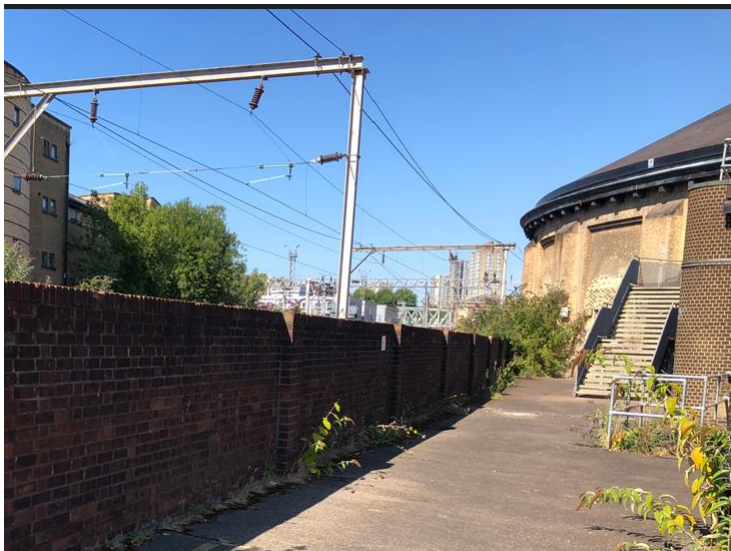
Figure 10 - Existing steel escape staircase.

The steel staircase is supported on a steel frame bearing on the existing ground near the southern boundary of the site. The steel posts of the frame adjacent to the Roundhouse are laterally restrained by the Roundhouse walls with steel angle cleats and bolts (Figure 11).

The existing connections of the steel beams and the steel staircase are shown in Figures 5 to 12.
