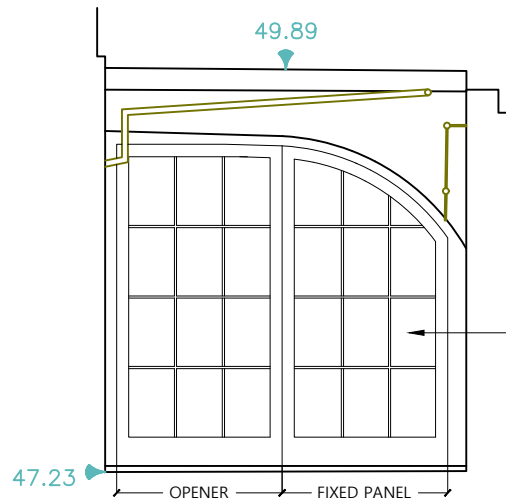
2 - Side Elevation

Existing solid doors removed and replaced with side hung casement windows in style to match existing windows

Existing doors removed and replaced with new timber door set comprising of double door and fixed side light
