# ITR- Repair To Heritage Railing

Document No. 1CP01-MDS-SE-REP-SS08\_SL31-000001

## 1.3 Summary of the proposed work

# Specification and methodology for cast iron repair and welding

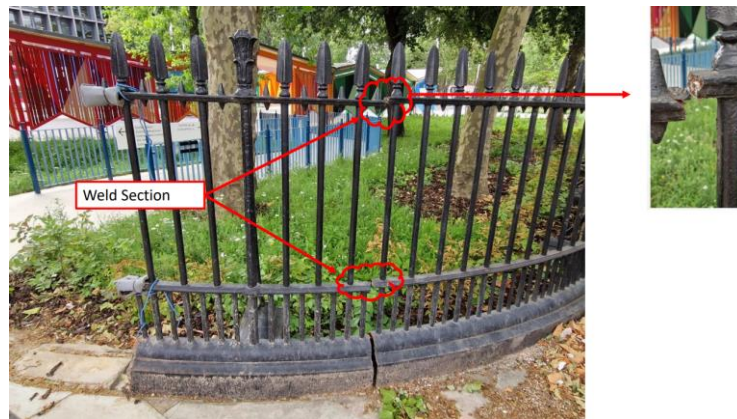
Figure 1. Panel E/28 showing locations for repair.

- 2.1.6 The railings which are the subject of this HAMS (E/27 and E/28) are noted as being in good overall condition but with extensive failure and loss of the protective paint coating. Open joints on the bottom were likely caused by previous re-locations and minor movement or ground settlement due to insufficient foundations. Historic repairs had failed and were visible.
- 2.1.7 Panel E/27 has a missing and lost spearhead finial. The railing surface is chipped and pitted in many places. In some cases, this kind of relatively superficial damage has apparently occurred due to general 'wear and tear' within a heavily used public garden. Where surface pitting is visible underneath paint, this may be the result of minor, past surface corrosion. Surface pitting and small voids may also result from the casting process.

3.1.2 Prior to re-instatement of Panel E/27 in situ, the appointed contractor will repair identified locations of railings (Panel E/28) by doweled cold repair, and if necessary, by welding. This work will take place on site and the location for these repairs are indicated on the location plan in Appendix 2.

- 3.1.3 The appointed contractor will move the existing fractured section of railing (Panel E/28) from location to expose bedding substrate. The railing will be placed safely to one side in order to establish the base material and prepare the ground as necessary, to ensure a level surface and to allow panels to be butt jointed together at the base.

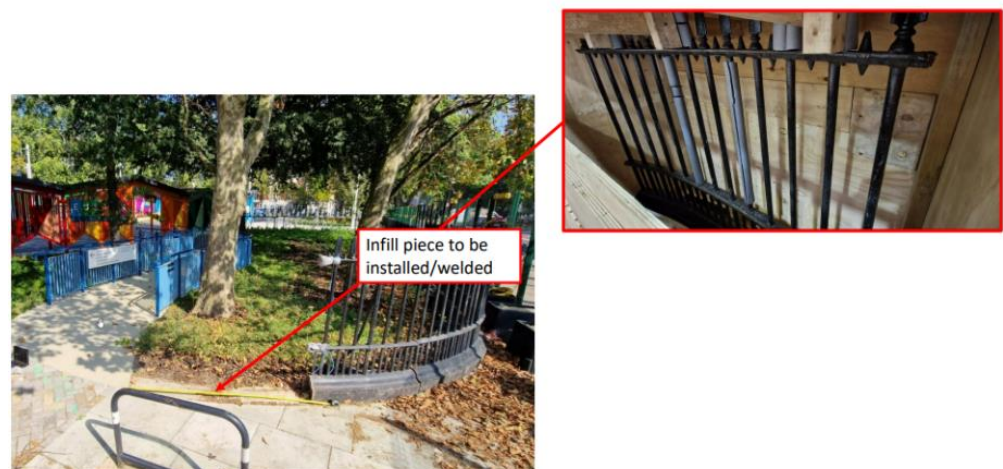
Figure 2. Location of missing railing (E/27) to be reinstated.

- 1.3.1 The proposed work includes the reinstatement of 1no. section of railings currently in storage (Panel E/27). It is proposed that this reinstatement may be achieved via cold repair (dowel) only, but localised welding repairs to 4no. separate locations may be required if dowel jointing is insufficient for strength and stability of the railing. These works have been discussed with London Borough of Camden, Historic England and HS2 as part of pre-app consultation in January 2024.
- 1.3.2 This method statement is to be applied within the proposed locations only, as indicated in the location plan in Appendix 2. However, if other repairs are to be undertaken at other locations on the railings, this method statement may be reviewed for suitability of the

- 3.1.4 The following methodology will be applied to panels E/27, E/28 and E/29.
- 3.1.5 The existing surface rust to the exposed ends of railing bars will be cleaned using a wire wheel attachment for a handheld drill, to ensure a surface free from dirt and surface debris prior to repair.

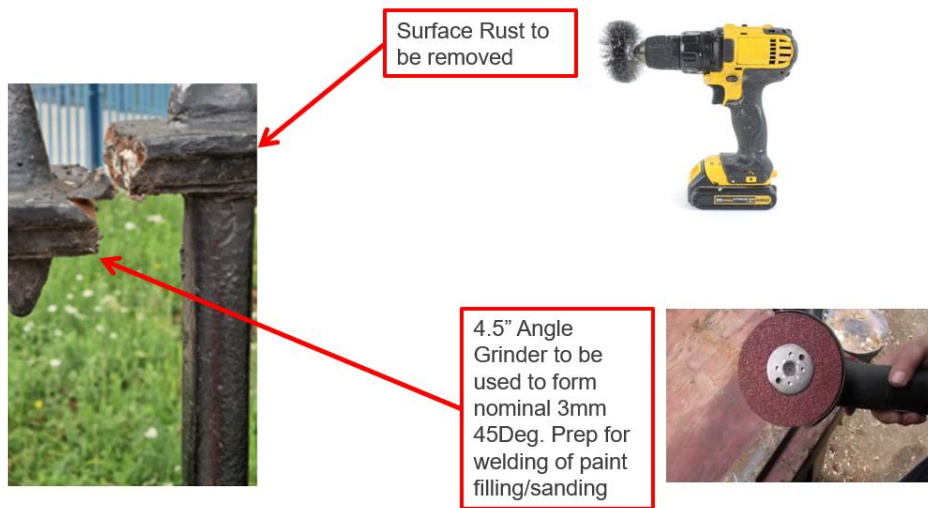
Figure 3. Preparation method for repair

- 3.1.6 Contract operatives will use an angle grinder to remove any existing finishes and prepare a 3mm 45degree 'V' (chamfer) into the bar for the preparation of either weld or paint finishes in the event of a cold repair.

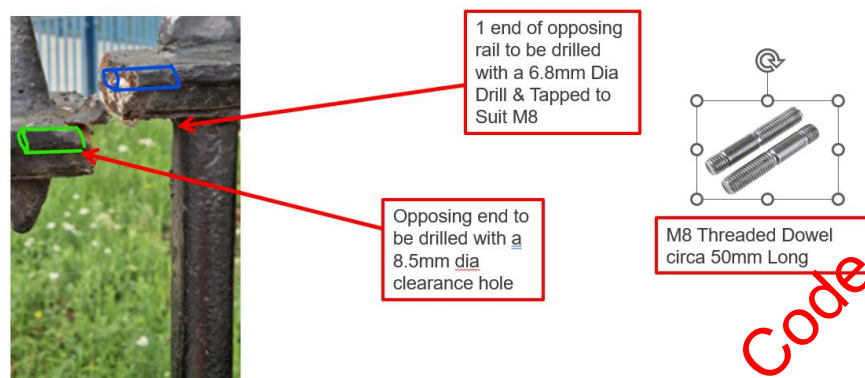
Figure 4. Methodology for cold dowel repair

- 3.1.7 The joints will then receive a steel dowel to reattach the railings.
- 3.1.8 The dowel will be a size M8 threaded dowel circa 50mm long. One end of the rail to be drilled with a 6.8mm diameter drill to allow the dowel to be tapped into position. The opposing end will be drilled with an 8.5mm diameter clearance hole. This will allow the dowel to be pushed into the socket, bringing the two sections together, with the use of epoxy resin and clamps as necessary to secure the railings in situ.

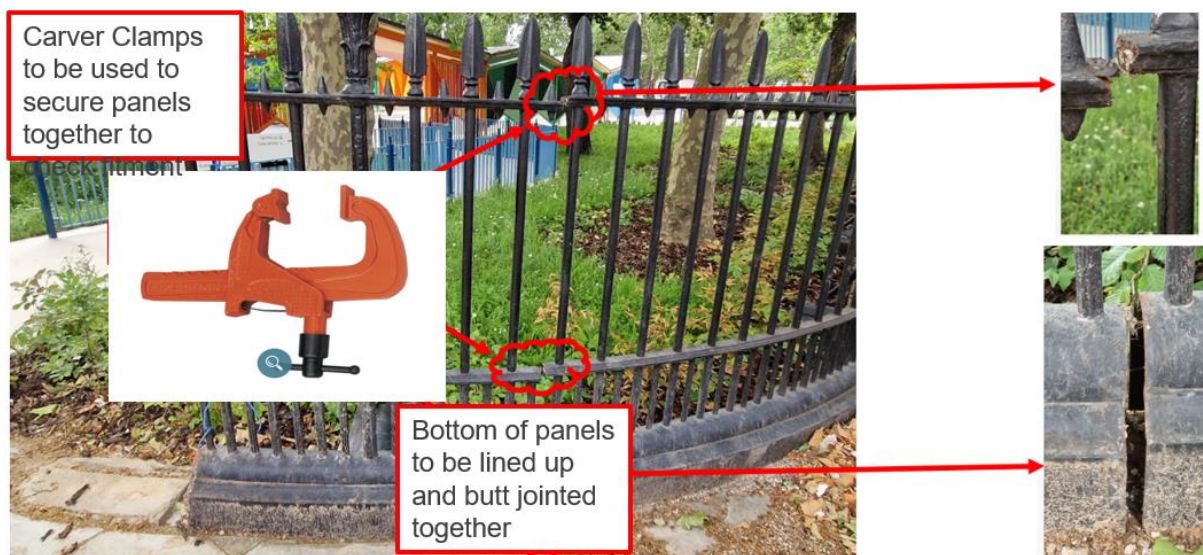
Figure 5. Methodology for clamping

- 3.1.9 Once the dowel is installed the panels will be offered into position and alignment checked. The bottom of the panels will be lined up and butt jointed together. The panels will be secured in situ using the dowel and clamps in the first instance, with the use of epoxy resin (Araldite) where deemed necessary.

- 3.1.10 Rigidity of the fix is to be inspected at this stage. If the reinstatement is successful, the panel will be bedded at base, and handed to the lead contractor for final finishing and painting.
- 3.1.11 If repair by dowel and resin has not sufficiently conserved or stabilised the railings then welding will be deemed necessary, and joints to be welded following the methodology outlined below.

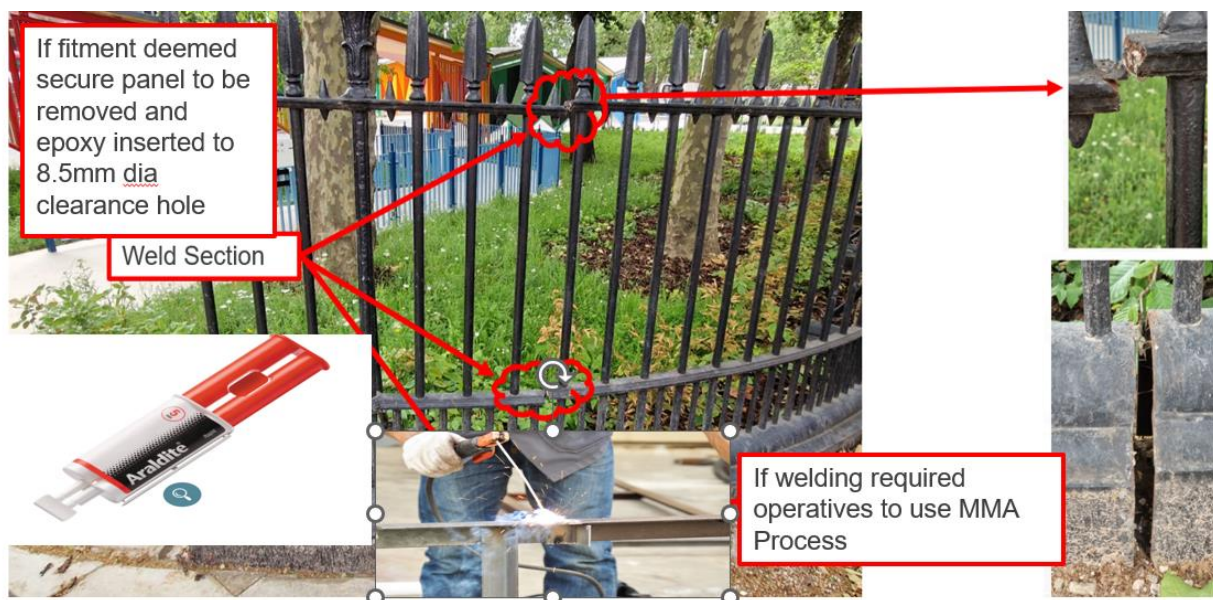
Figure 6. Hot weld methodology

- 3.2.1 Ends of existing cast iron railings to be gradually pre heated using manual propane torch to prevent risk of fracture from thermal shock.
- 3.2.2 Materials to be pre-heated to a nominal 300 degrees Celsius. This will be verified by thermal imaging camera.

- 3.2.3 The welding rod is proposed to be a High Nickel content weld, due to the limited thermal expansion of nickel, with cast iron electrodes.

- 3.2.4 Once the weld is complete, the area will be wrapped with a ceramic fibre blanket to control cooling in order to minimise the risk of fracture from thermal shock.
- 3.2.5 The blanket will remain in situ for a minimum period of 1 hour, then removed and the weld inspected. The thermal imaging camera will be utilised to monitor the rate of cooling and temperature prior to removal of blanket to minimise risk of thermal shock.
- 3.2.6 Surface welds will then be dressed smooth with an angle grinder or filing sander and any imperfections to be re-welded.
- 3.2.7 The railings will then be handed to lead contractor for final finishing and painting.

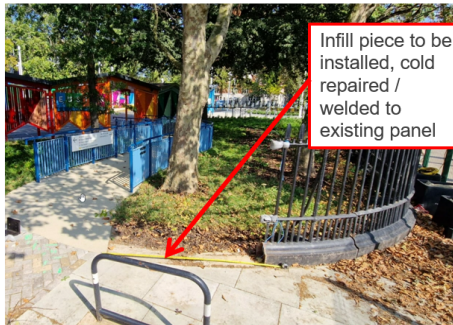
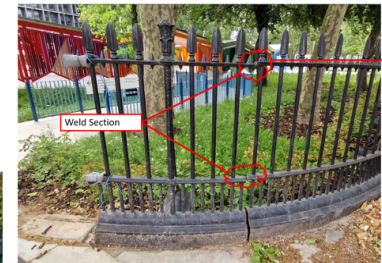
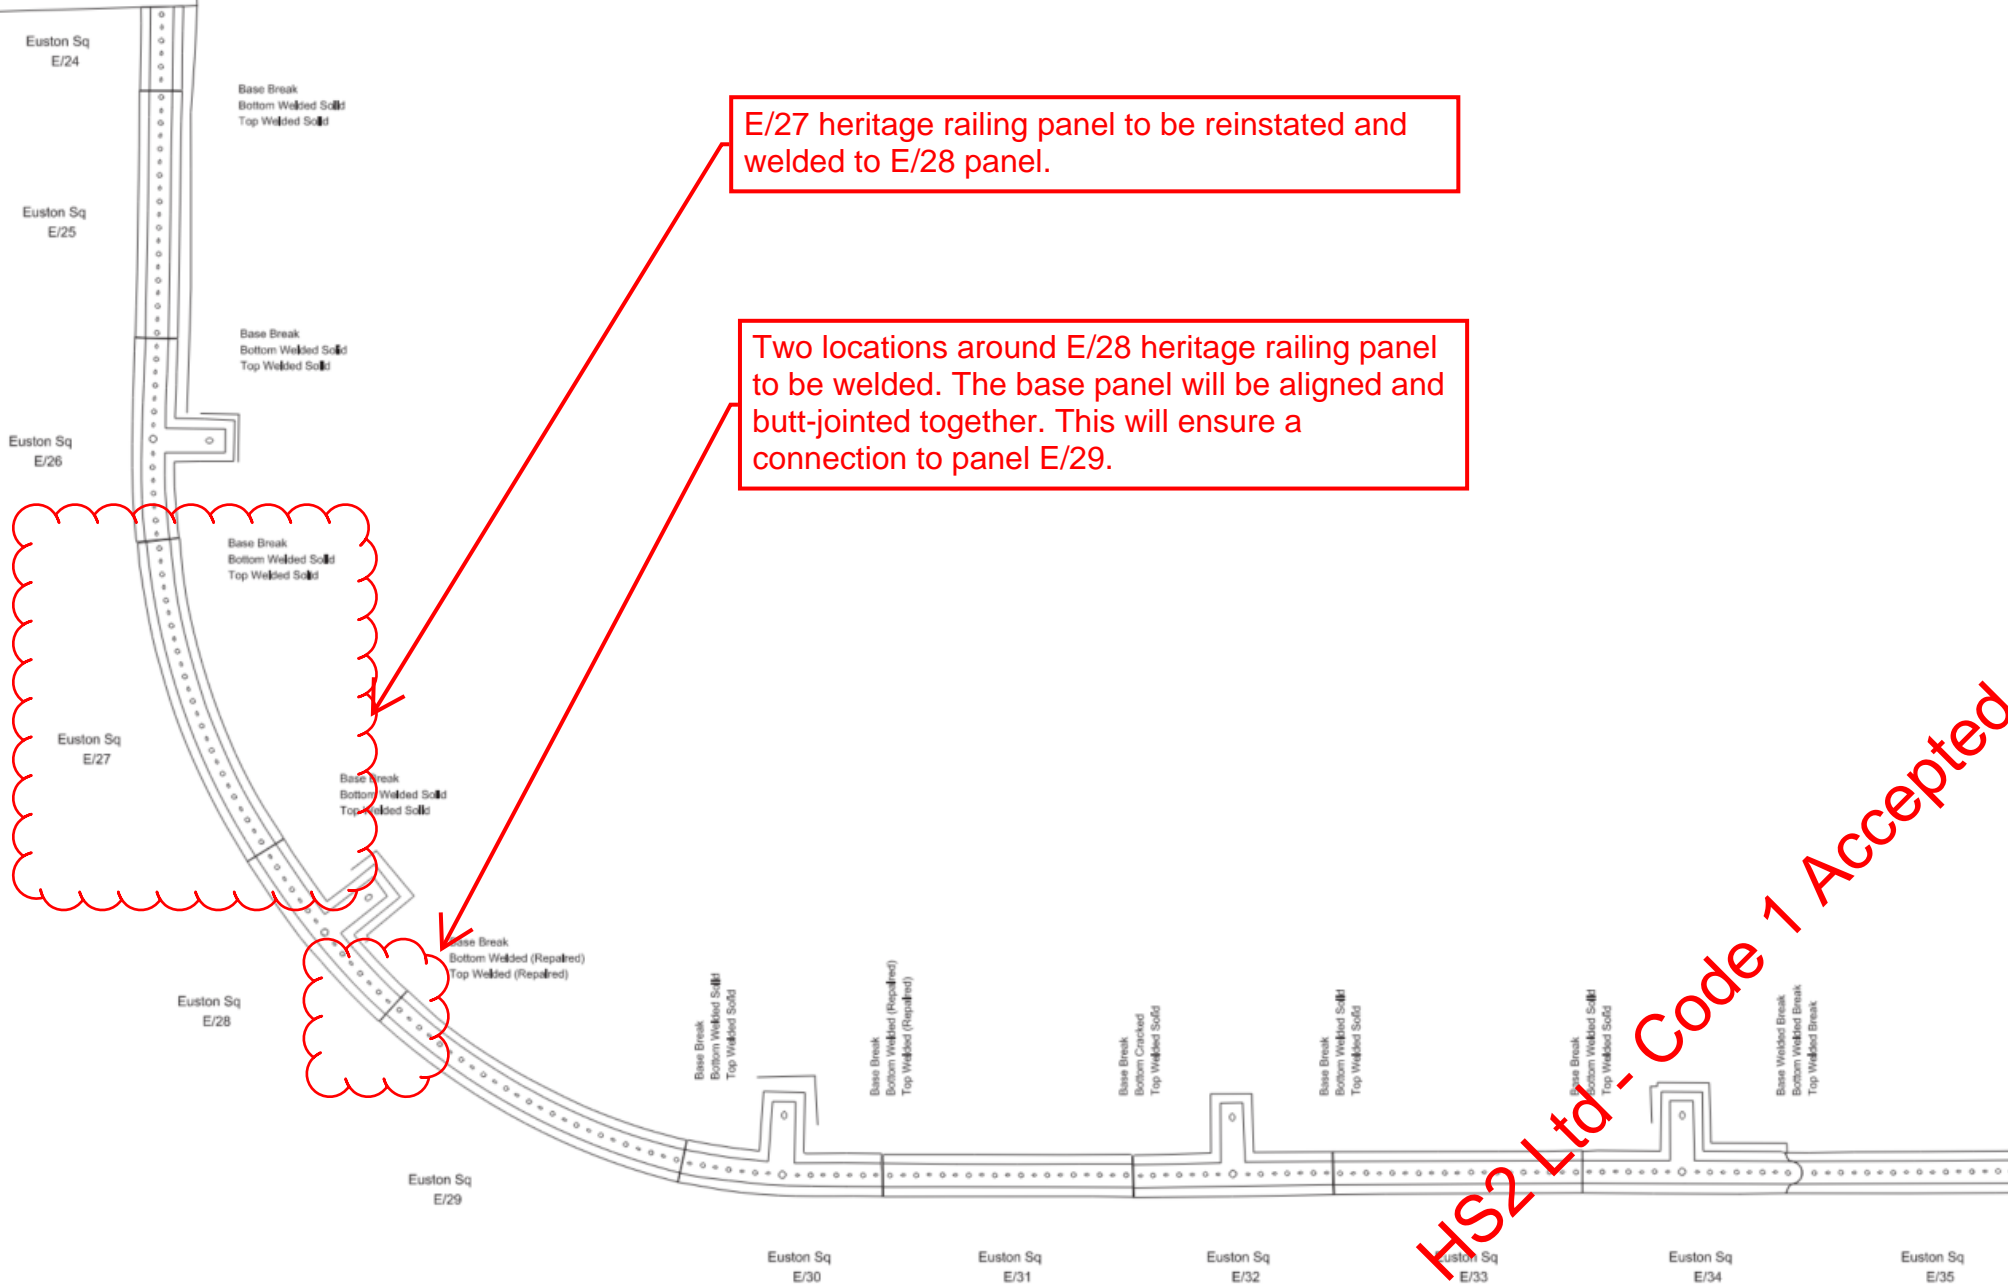
# Location Plan of Railing To Be Reinstated

Section of Grade II listed railing to be reinstated and repaired. These are E/27 and E/28.

Infill piece to be installed, cold repaired / welded to existing panel

Weld missing panel section
