Location Plan of Railing To Be Reinstated

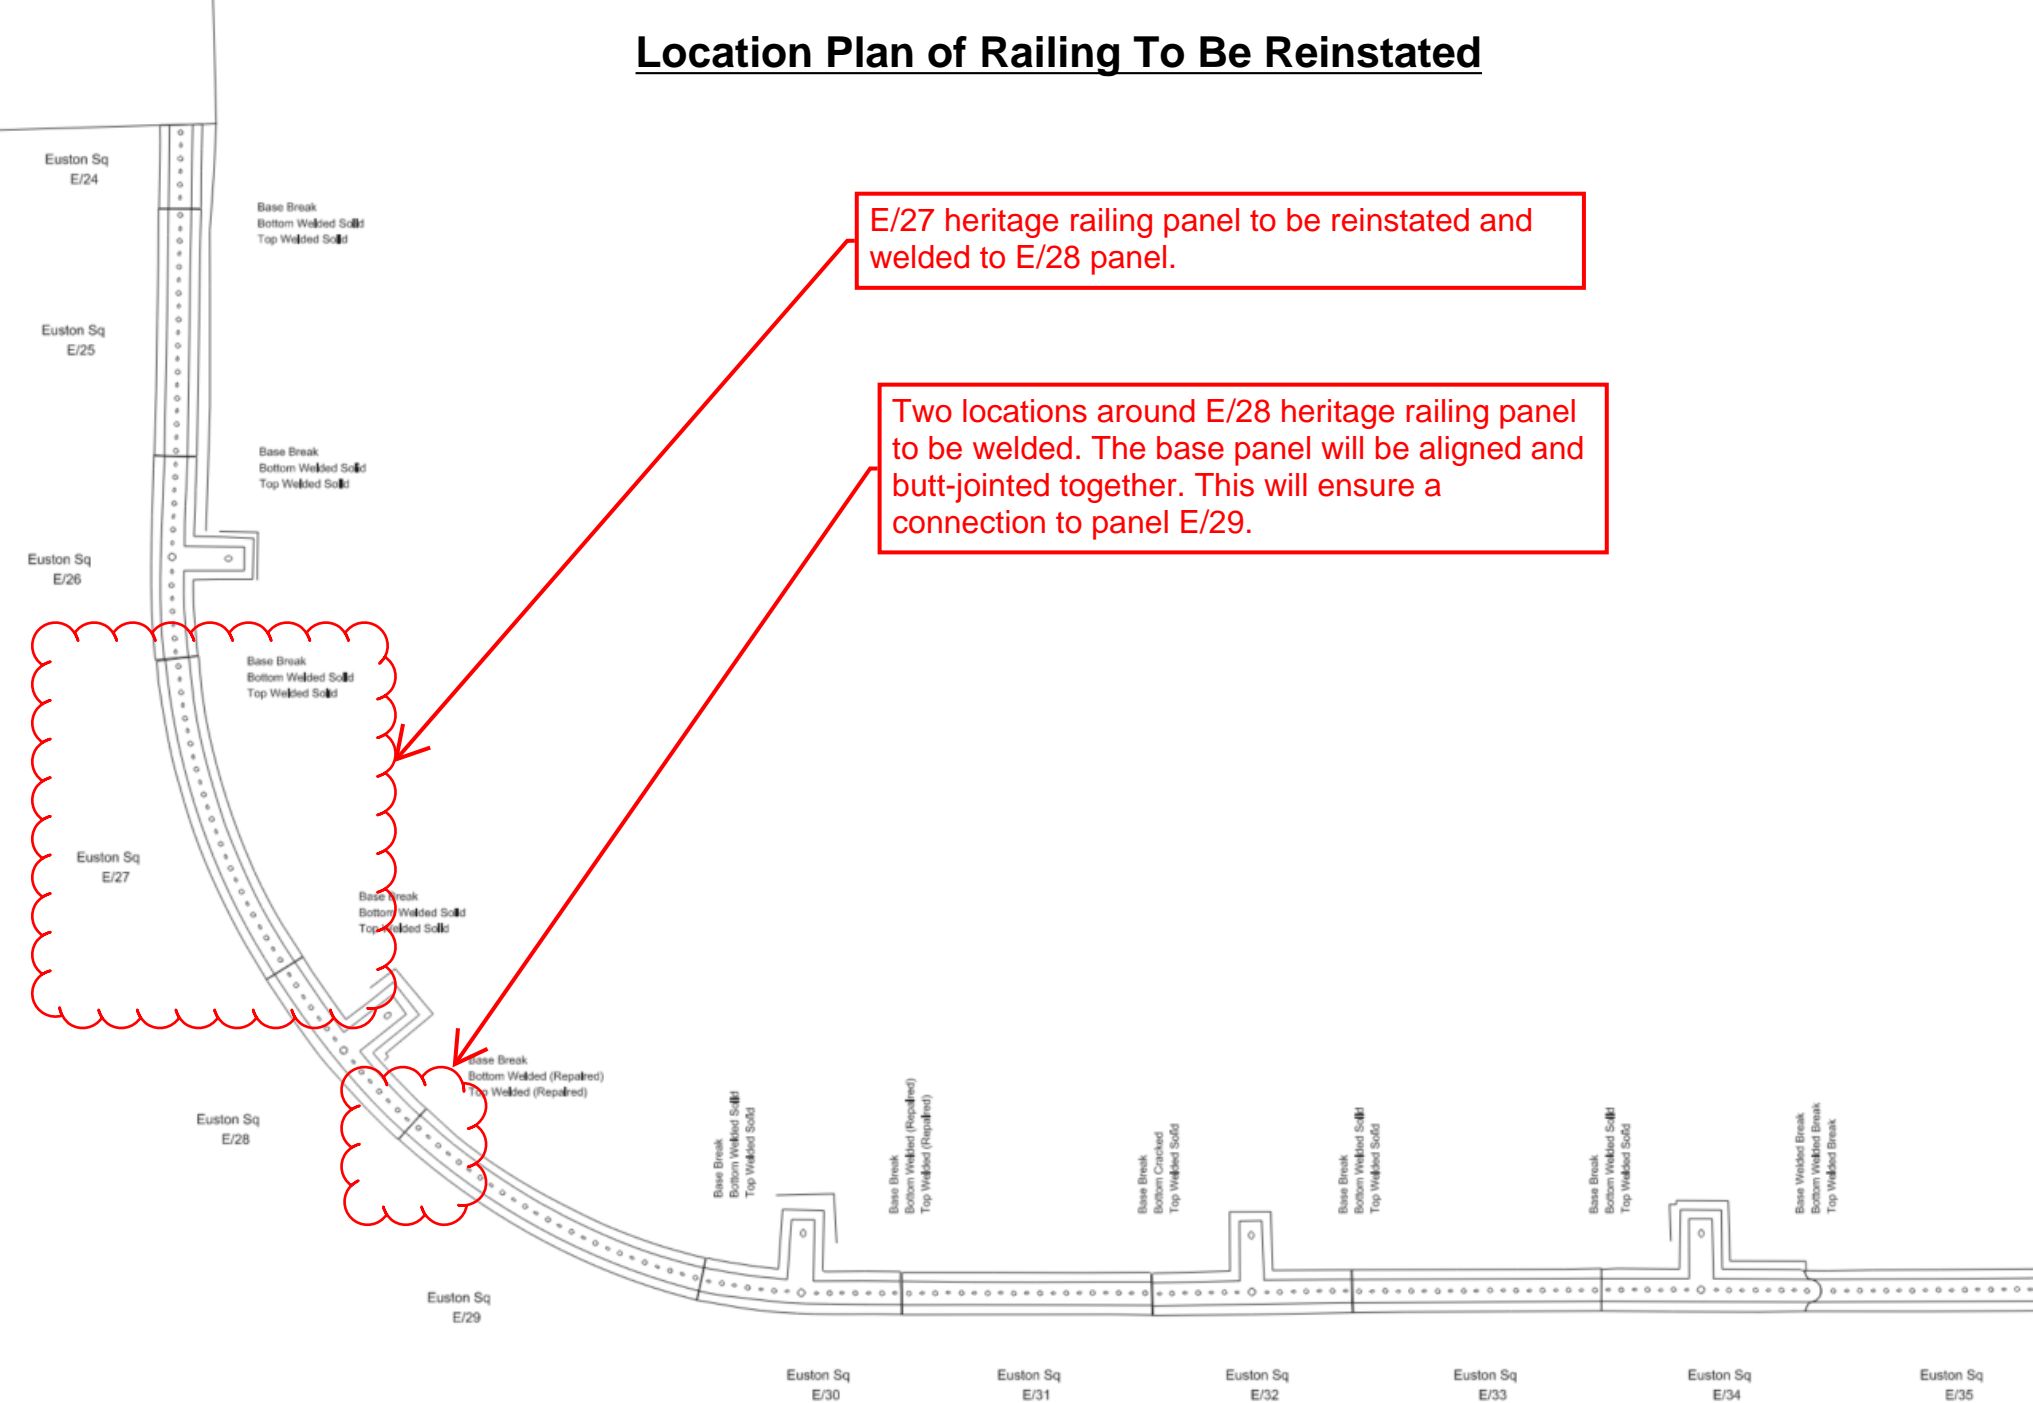
Two locations around E/28 heritage railing panel to be welded. The base panel will be aligned and butt-jointed together. This will ensure a connection to panel E/29.

Base Break
Bottom Welded Solid
Top Welded Solid

Base Break
Bottom Welded (Repaired)
Top Welded (Repaired)

Base Break
Bottom Cracked
Top Welded Solid

Base Welded Break
Bottom Welded Break
Top Welded Break

E/27 heritage railing panel to be reinstated and welded to E/28 panel.
