Schedule of Works

4 Sandwich Street, London, WC1H 9PL

29th February 2024

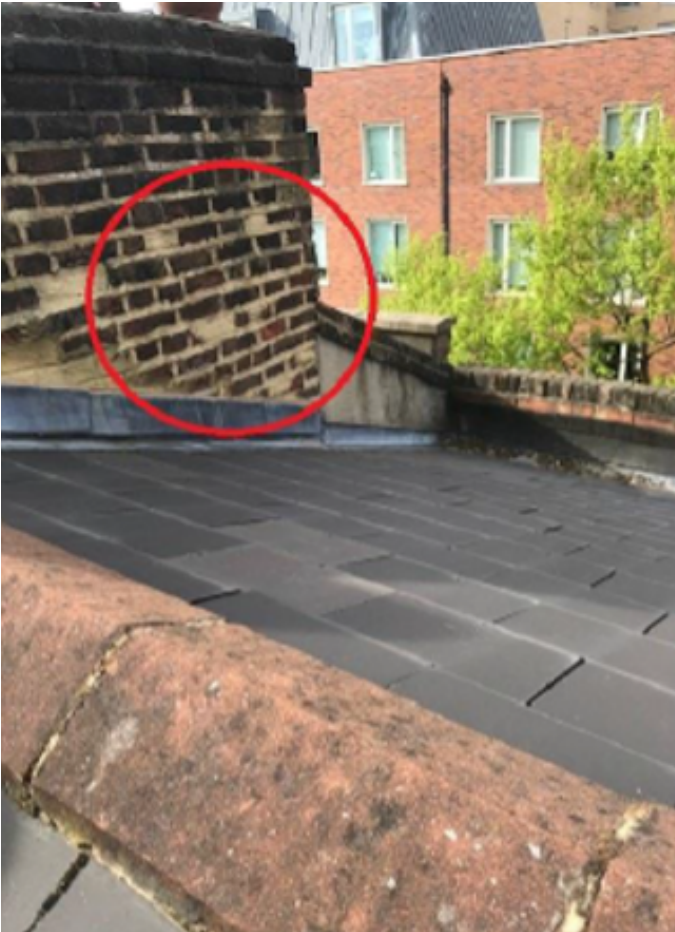
Photo 01 Prior to construction

Photo by contractor showing roof before works including: fibre cement man-made tiles, concrete ridge tiles, lead lined gutter behind parapet to front of building, and chase cut lead flashings. (Red circle added by contractor to highlight pointing)

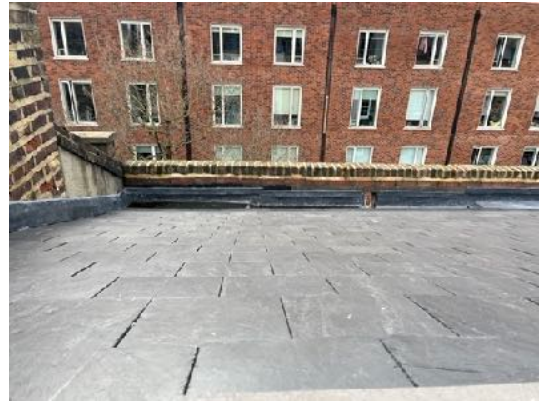
Photo 02 As built

Roof following works showing: Natural slate roof covering; repaired lead lined gutter behind parapet; restored chase cut lead flashings to chimney and party walls.

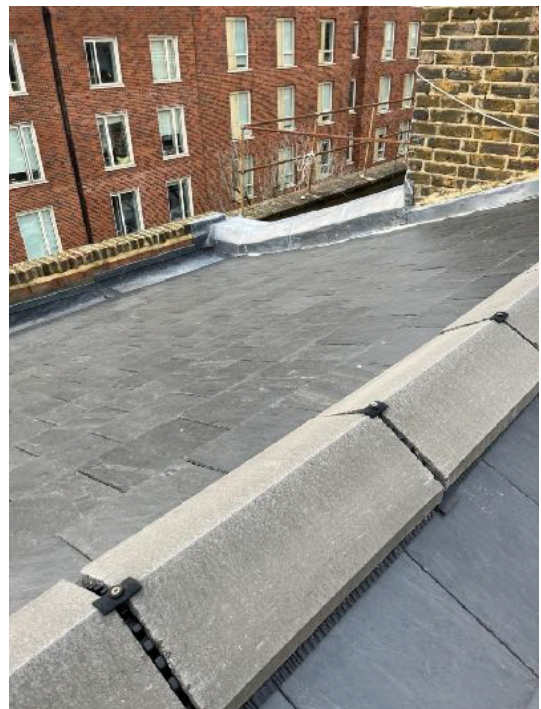
Photo 03 As built

Roof following works showing: Mechanically fixed ventilated ridge tiles; restored lead lined gutter to parapet of front facade, natural slate roof covering.

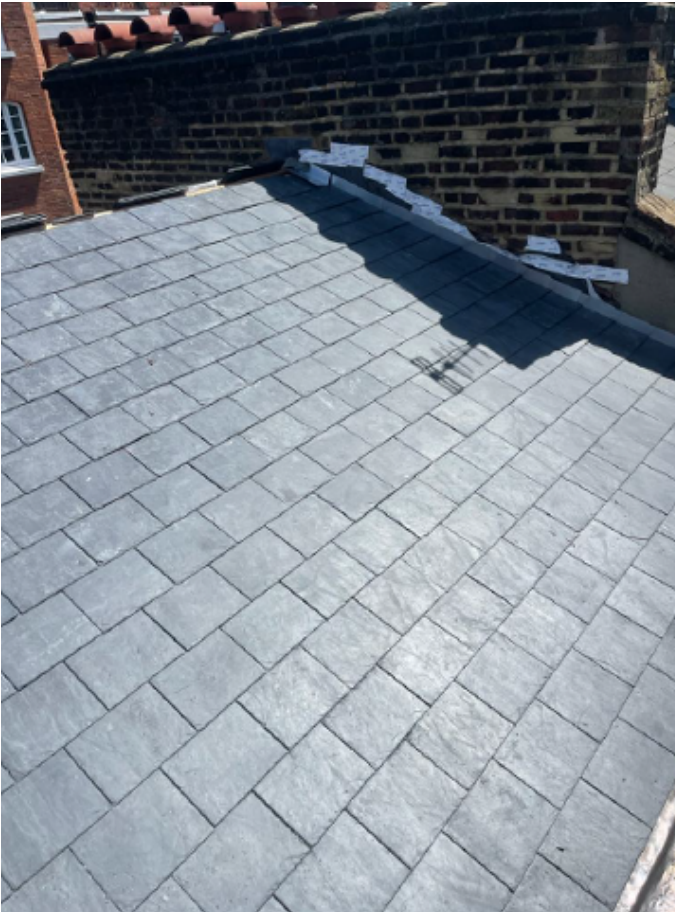
Photo 04 During construction

Contractor's photo showing roof during works including: new installed natural slate roof covering, concrete ridge tiles have been removed, chimney ready for repair and new lead flashing.

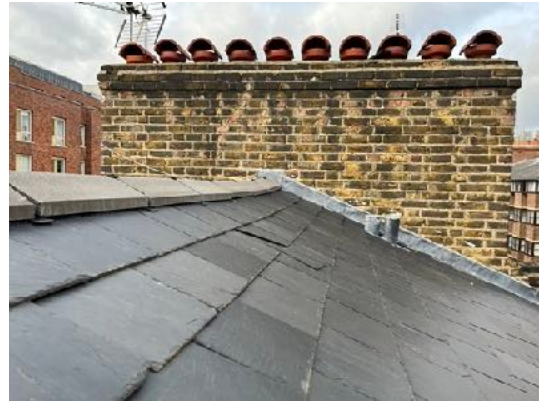
Photo 05 As built

Roof following works showing: Natural slate roof covering; mechanically fixed ventilated ridge tiles; new lead pipe penetrations for roof ventilation, and restored chase cut lead flashings to chimney and party walls.

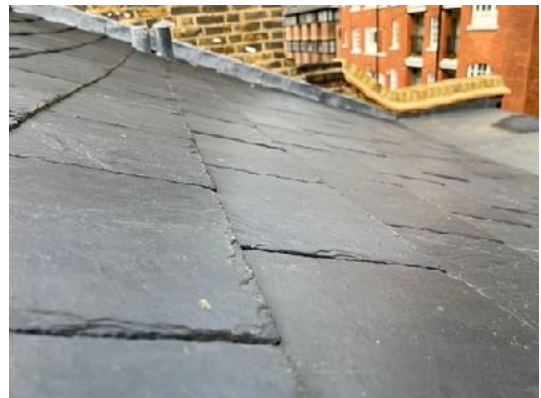
Photo 06 As built

Detail photograph showing the natural slate roof covering; lead pipe penetrations and felt flat roof beyond.

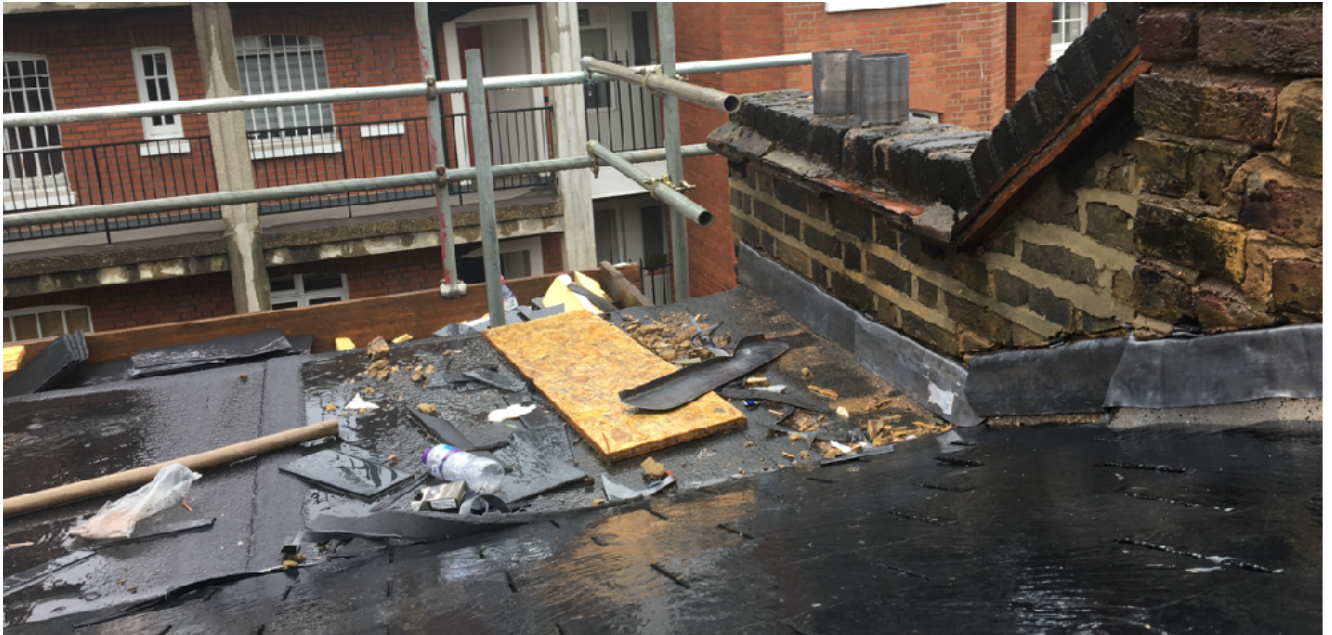
Photo 07 during construction

Contractor's photo showing rear flat roof during works including: new installed natural slate roof covering, existing chase cut lead flashings have not been repaired yet, new roof felting system is being installed with waterproofing.

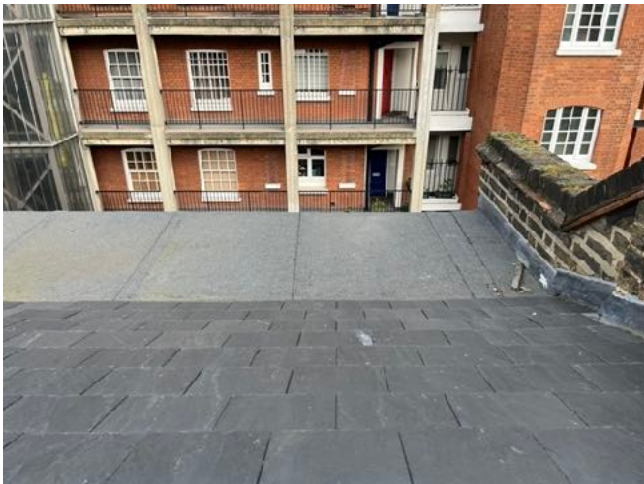
Photo 08 As built

Like for like new roof felting system installed to flat roof which drains to gutter below, natural slate roof covering, chase cut lead flashings to party wall.

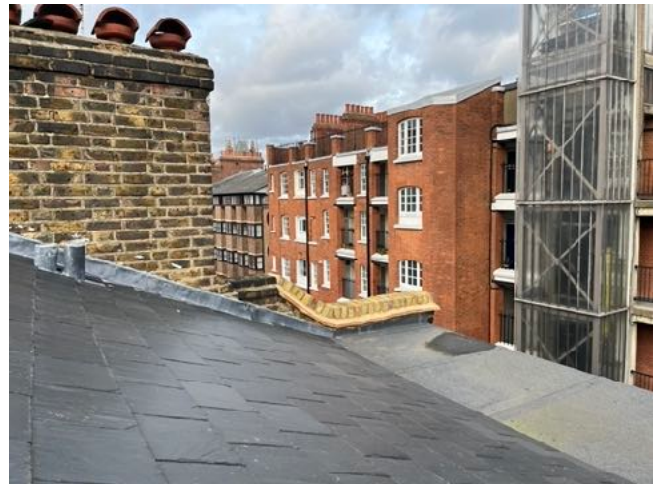
Photo 09 As built

Like for like new roof felting system installed to flat roof which drains to gutter below, natural slate roof covering, lead pipe ventilation penetrations, chase cut lead flashings to repaired party wall parapet.

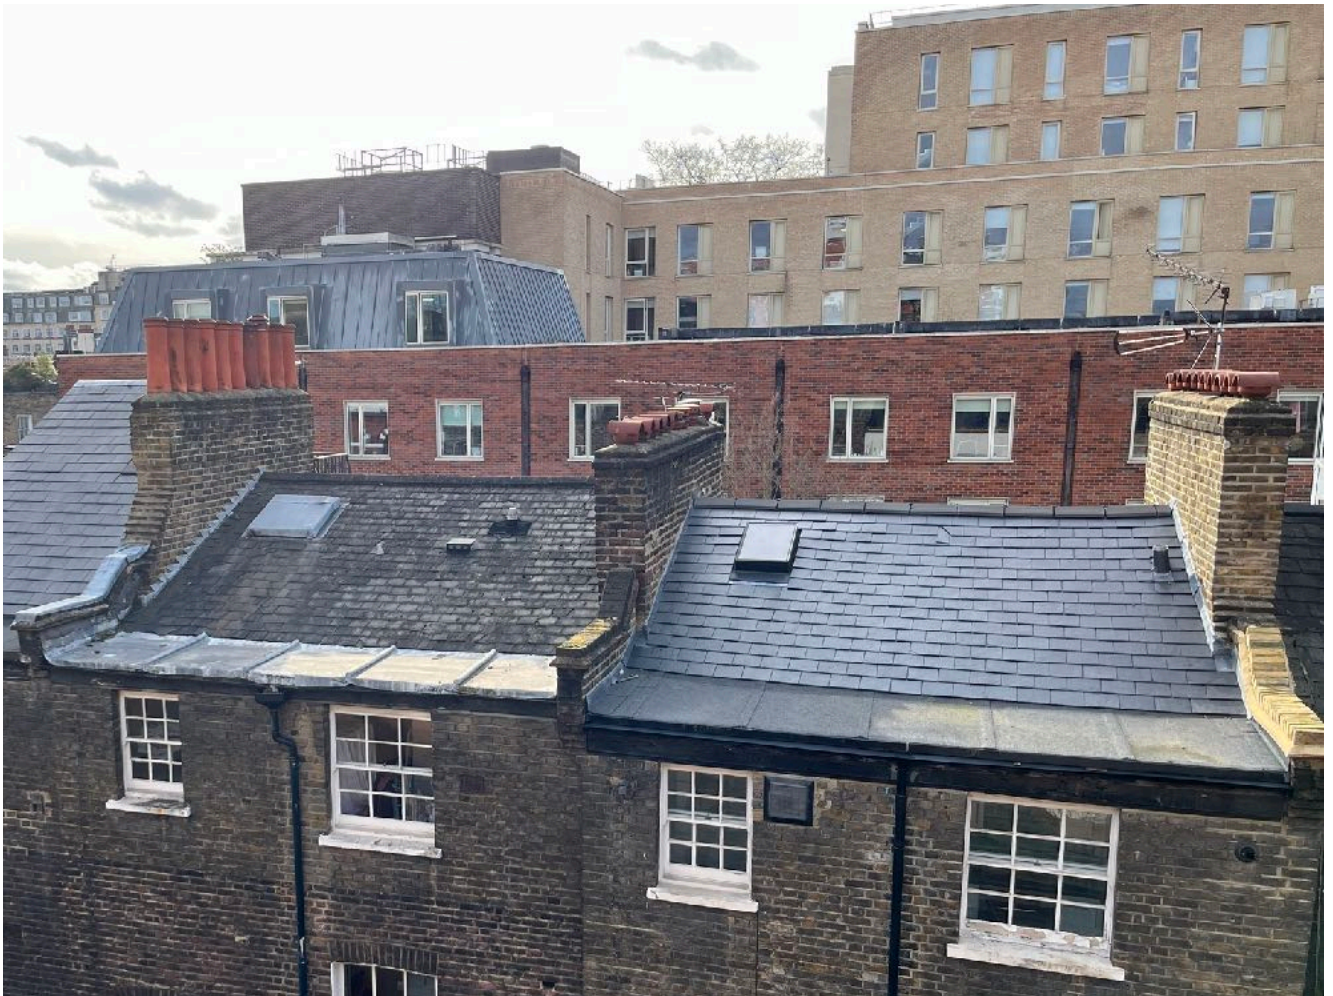
Photo 10 As built

Photo taken of rear of building showing: new natural slate roof covering, like for like roof felting system to rear flat roof draining to gutter below, small black openable rooflight hatch replacing raised lead roof access hatch (similar shown on 3 Sandwich Street to left hand side of photo).
