SAVILLE THEATRE

135 SHAFTESBURY AVENUE

LAND CONTAMINATION RISK MANAGEMENT - PRELIMINARY RISK ASSESSMENT
105465-PEF-ZZ-XX-RP-GG-600001_P02 SAVILLE THEATRE PRA

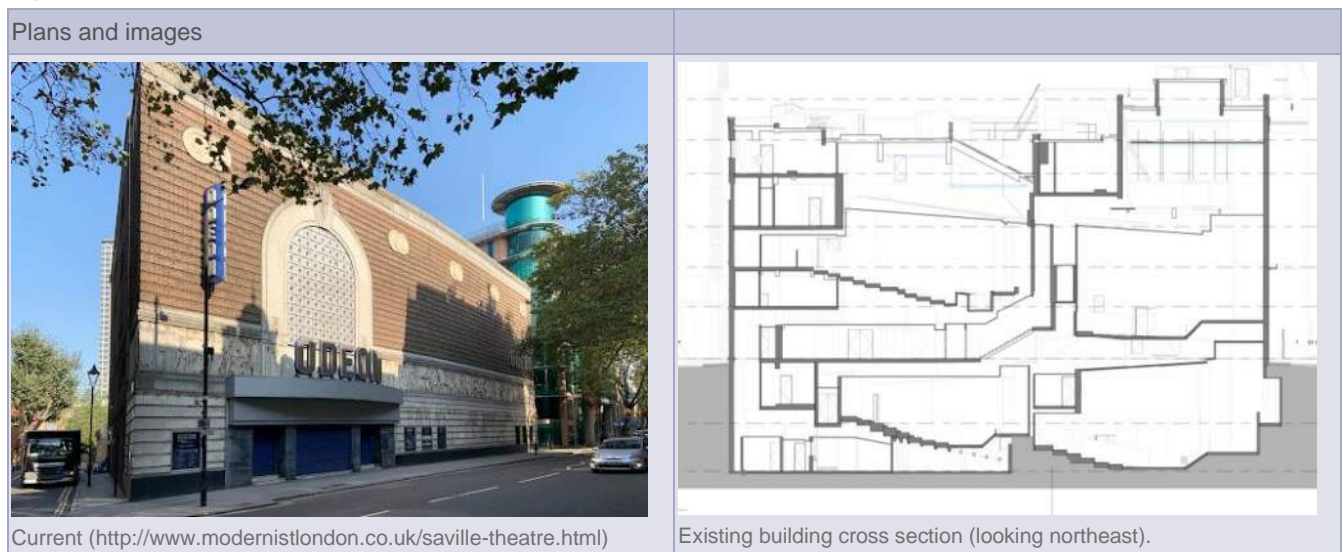
Figure 1-2 Development proposals

The proposed redevelopment includes demolishing the internal walls/structure, removing and reinstating the north façade whilst retaining the remainder of existing external façades and extending/deepening the existing basement (from two to four storeys) to facilitate the construction of a new multi-storey hotel and performance auditorium area with associated front of house facilities for both. Masterplan extracts are included in Figure 1-2 and Appendix A.

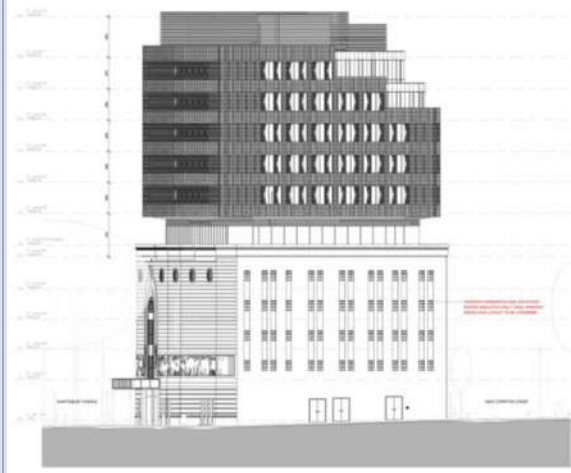
Proposed Northeast Elevation -St Giles Passage (extracted from SPPARC drawing 2111-SPP-ST-ZZ-DR-A-25-3004- P0.01 dated January 2024).

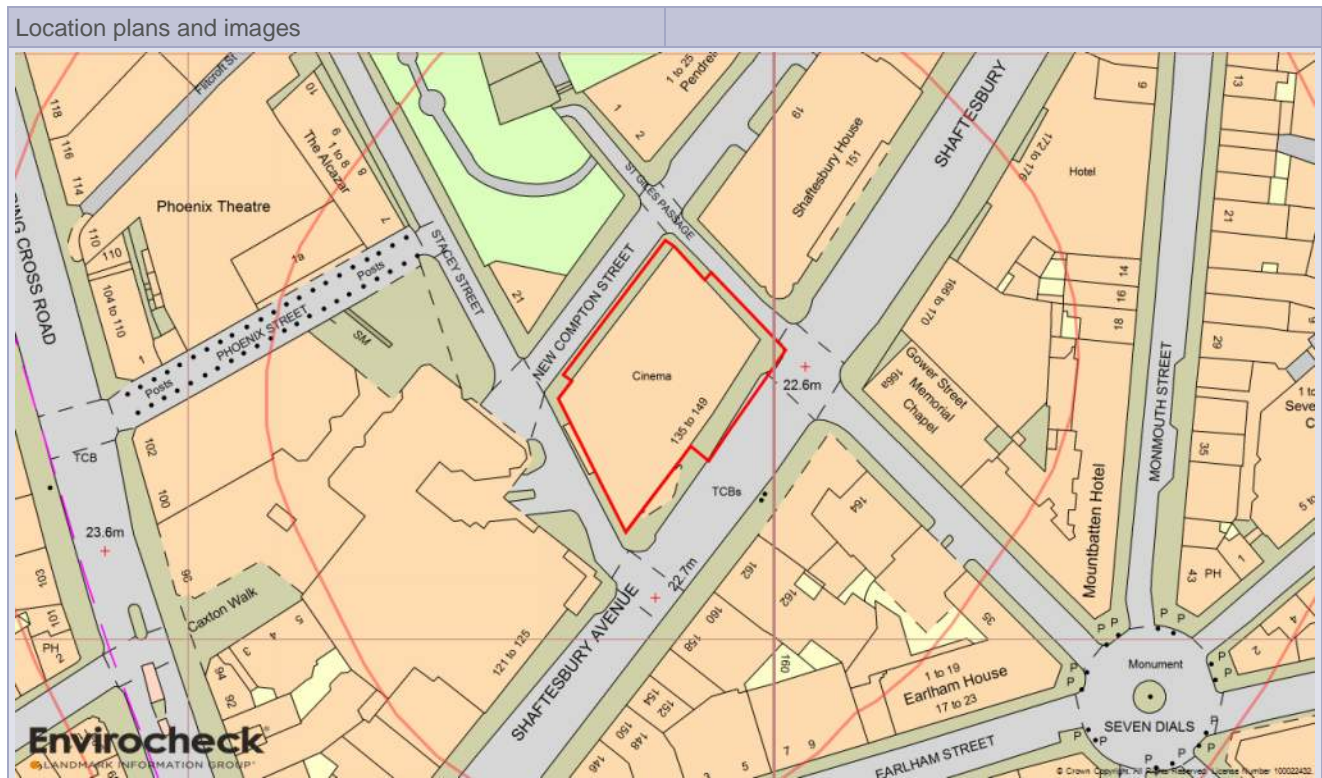
Figure 2-1 Site location and description

The site is bound by the following roads New Compton Street (northwest), St Giles Passage (northeast), Shaftesbury Avenue (southeast) and Stacey Street (southwest) and mainly surrounded by commercial buildings except for the park to the northwest (beyond New Compton Street); as shown in Figure 2-1. The site is in the London Borough of Camden, London.

The 'Odeon Convent Garden' cinema onsite comprises a seven-storey building (including a double storey basement) which occupies the entire site area. Ordnance Survey (OS) mapping indicates that Shaftesbury Avenue lies at an elevation of between 22.6 and 22.7m AOD (above Ordnance Datum) adjacent to the site.

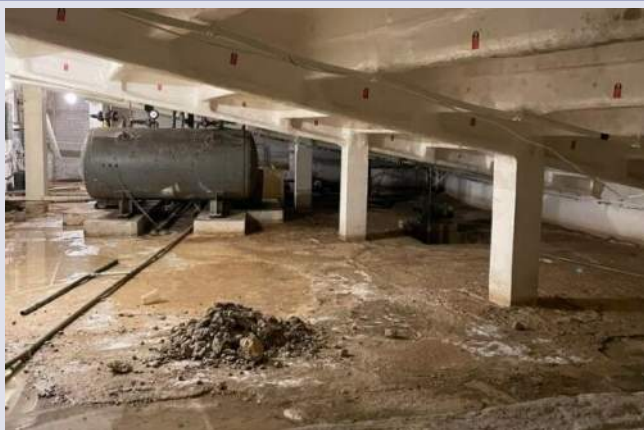
Fuel tank in basement (above and right)

Note 1: the fuel tank, boiler room and battery storage identified in this report were located within the basement and building above the substantial concrete floor slab so the potential for ground contamination is considered highly unlikely.

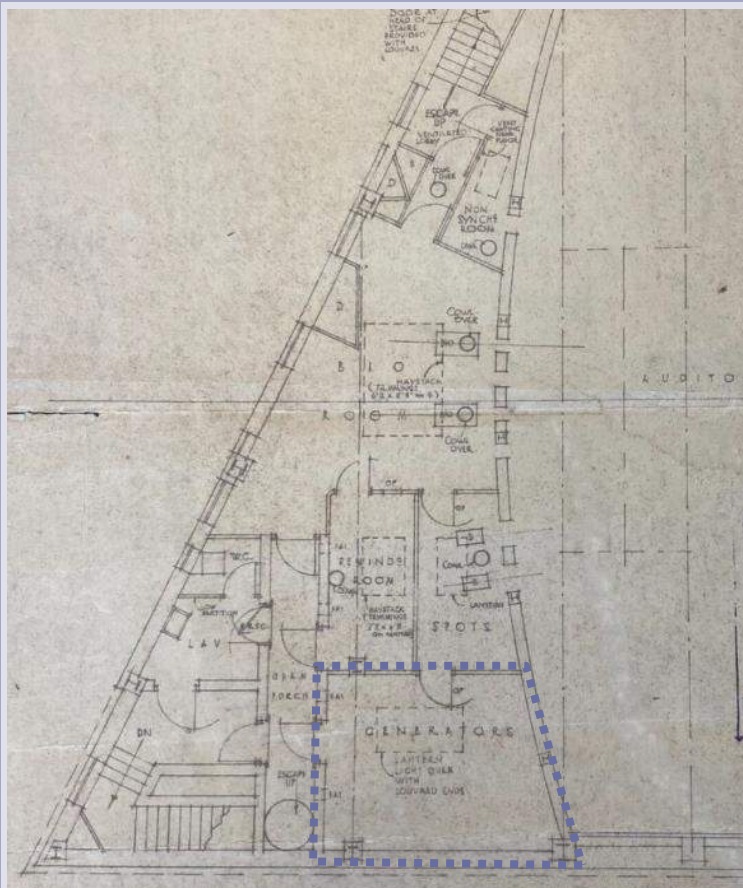
Bioscope and rewinding rooms, indicating a generator (13 Sept 1930)

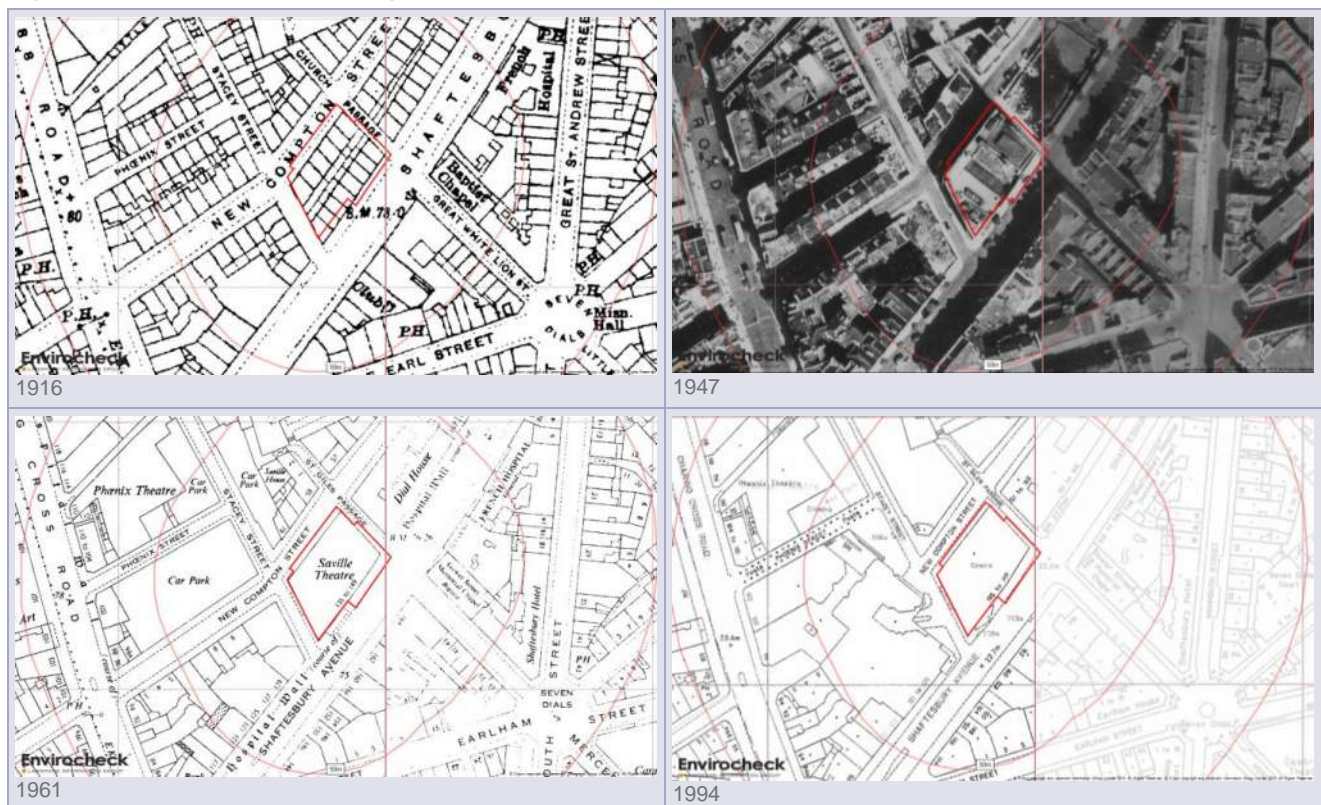
Figure 3-1 Historic maps and images

A selection of historic maps and aerial photograph extracts are presented in Figure 3-1. In summary, the historic information indicates the following:

Onsite: The present-day cinema occupies the former Saville Theatre building (which includes a double-storey basement). Saville Theatre opened in October 1931, the former theatre is listed as a Grade II Listed Building for its architectural and historic interest. Reference to the listing details and historicengland.org.uk indicates that the theatre was built between 1930 and 1931 and comprised a three-tiered auditorium with a stage, designed to accommodate a total capacity of 1,530, making it one of the largest theatres in the West End when opened. The conversion of Saville Theatre into a cinema was carried out in 1970.

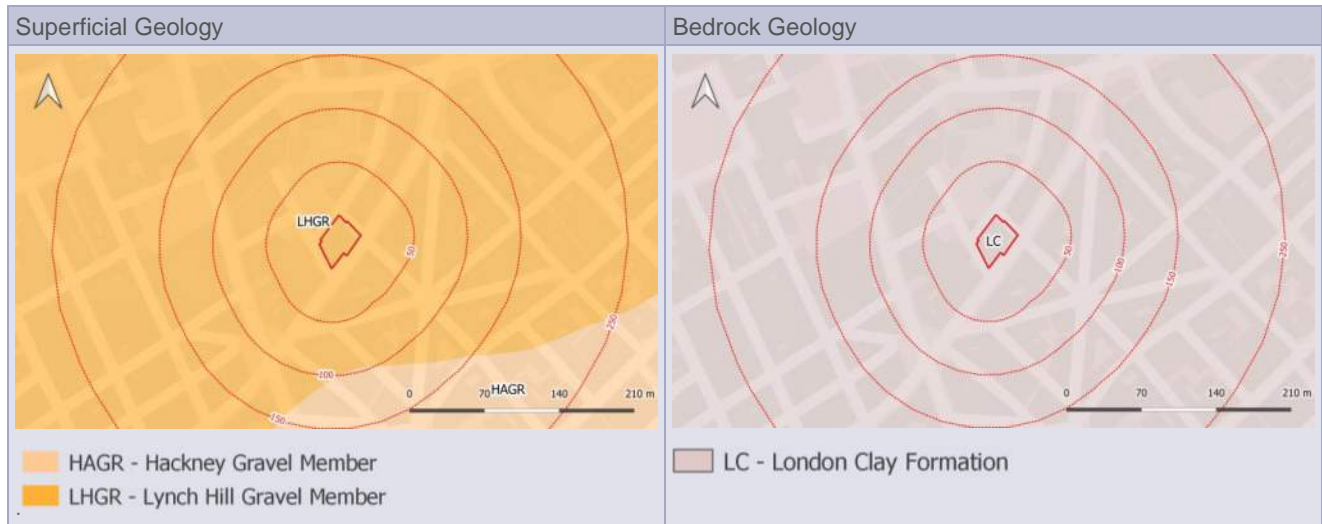
Figure 3-2 Published geology

The published geology of the area is shown on the geological map for North London (Sheet 256, scale 1:50,000), published by the British Geological Survey (BGS), the digital BGS maps are shown Figure 3-2. Derivatives of the BGS mapping are included in the Geology Report (Landmark) and further geological information has been obtained from the BGS website.

The geological mapping indicates that the site is underlain by the following sequence of superficial deposits and bedrock strata (the descriptions for each stratum are taken from the BGS):

- **Lynch Hill Gravel Member** (superficial): Sand and gravel, locally with lenses of silt, clay or peat.
- **London Clay Formation** (bedrock): bioturbated or poorly laminated, blue-grey or grey-brown, slightly calcareous, silty to very silty clay, clayey silt and sometimes silt, with some layers of sandy clay.

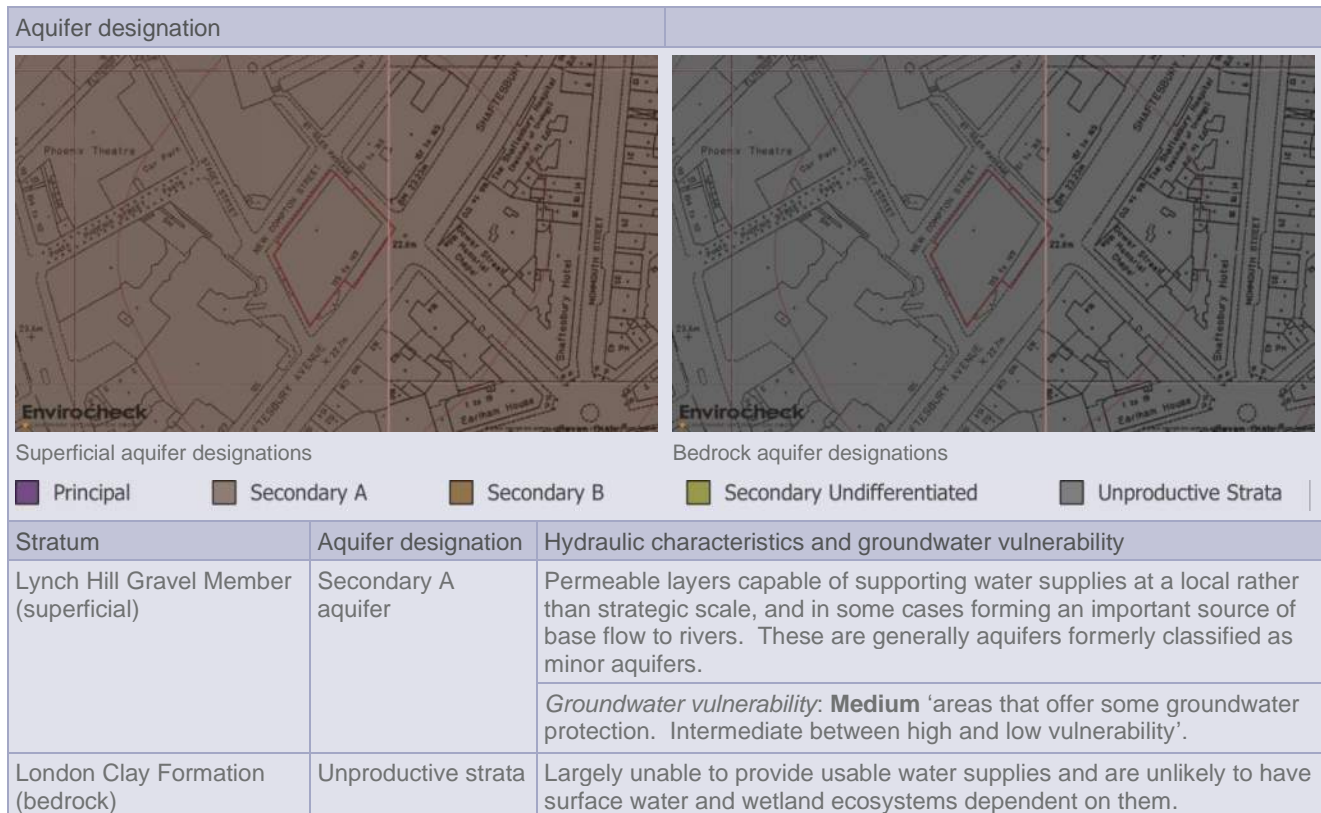
Figure 3-4 Aquifer designations and groundwater vulnerability mapping

The Environment Agency aquifer designations for the underlying superficial deposits and bedrock, and the associated groundwater vulnerability classifications for these strata are summarised in Figure 3-4.

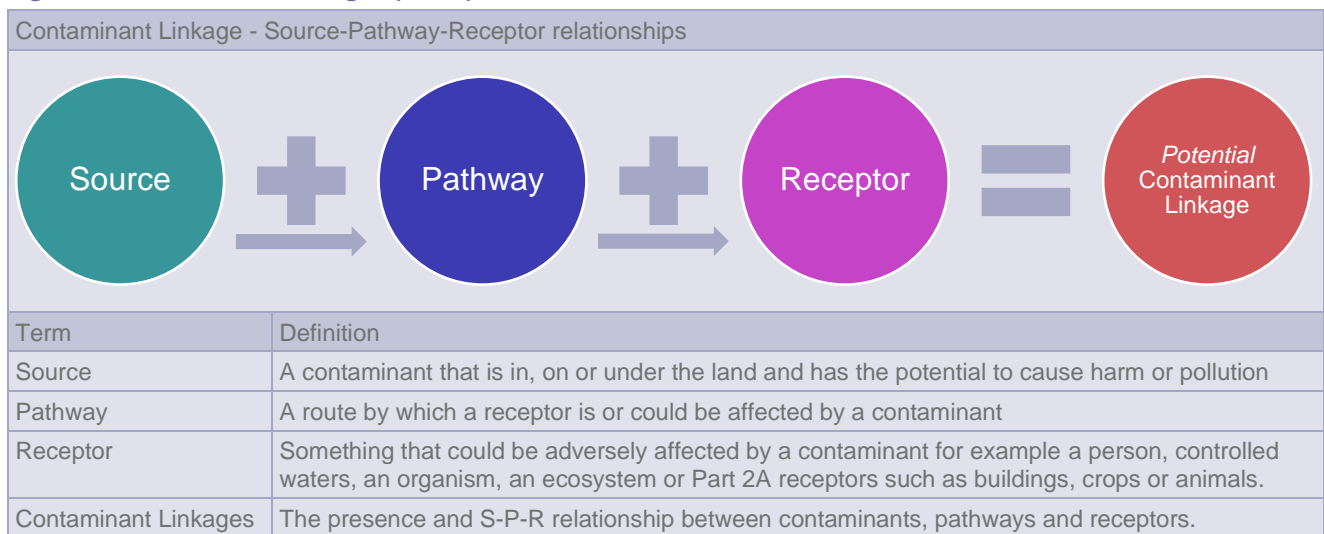
Figure 4-1 Contaminant Linkages (S-P-R)

The preliminary risk assessment (PRA) includes the development of an ‘outline’ or preliminary conceptual site model (CSM) for the proposed development. A conceptual site model shows the possible relationships between contaminants, pathways and receptors based on the source-pathway-receptor (S-P-R) approach, as shown in Figure 4-1.

All three elements (S-P-R) of a contaminant linkage must be present for a land contamination risk to exist, i.e. even if a contaminant has been identified but there is no receptor or no pathway then the S-P-R linkage is incomplete and there is not a risk - *“A contaminant linkage must be present for there to be a S-P-R relationship. Without a linkage, there is not a risk – even if a contaminant is present”* (LCRM, 2020).
