**GODWIN AND CROWDALE
ESTATE**
PHASE II GEOTECHNICAL AND
GEO-ENVIRONMENTAL
INVESTIGATION
LONDON BOROUGH OF CAMDEN
28/06/2019

Site:	GODWIN AND CROWDALE ESTATE	
Title:	PHASE II GEOTECHNICAL AND GEO-ENVIRONMENTAL INVESTIGATION	
Project:	CONSTRUCTION OF 10NO. RESIDENTIAL DWELLINGS	
Client:	LONDON BOROUGH OF CAMDEN	
Date:	28/06/2019	
Reference:	LS 4257	
Version:	V1.0	
Prepared by:

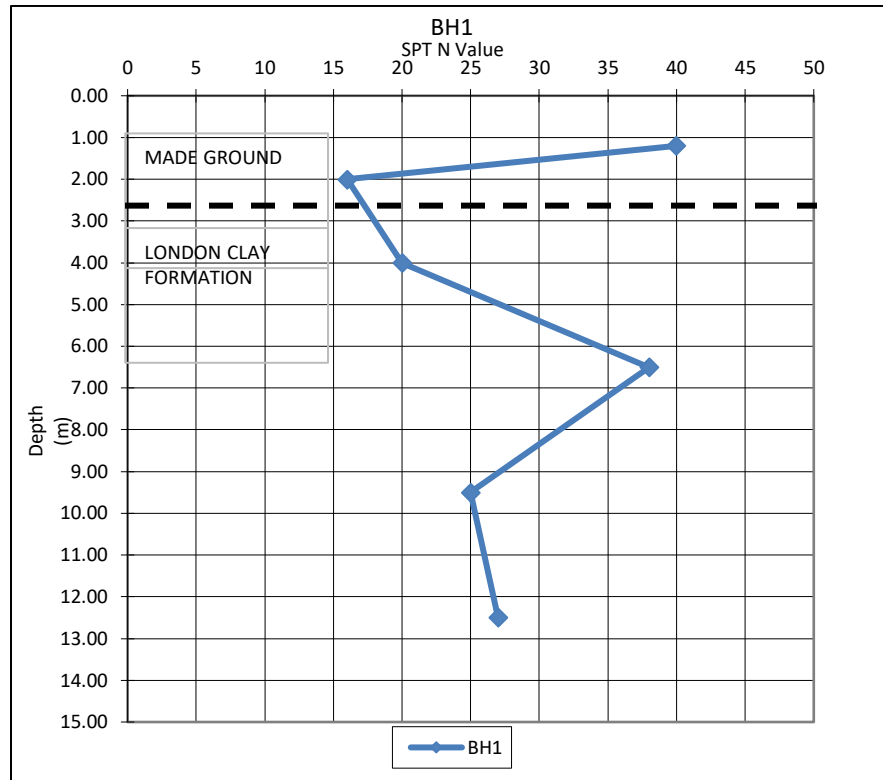
5.1 Standard Penetration Testing (SPT's)

In-situ standard penetration tests (SPT's) were undertaken within CP1, in order to assess the relative density of the materials encountered. The blow count (N) to drive the cone 300mm after any seating blows is recorded, and is used as a measure of the relative density of granular soils (as defined in BS5930:2015). The results may also be used to estimate the consistency of cohesive soils, using an empirical correlation. The results are summarised below.

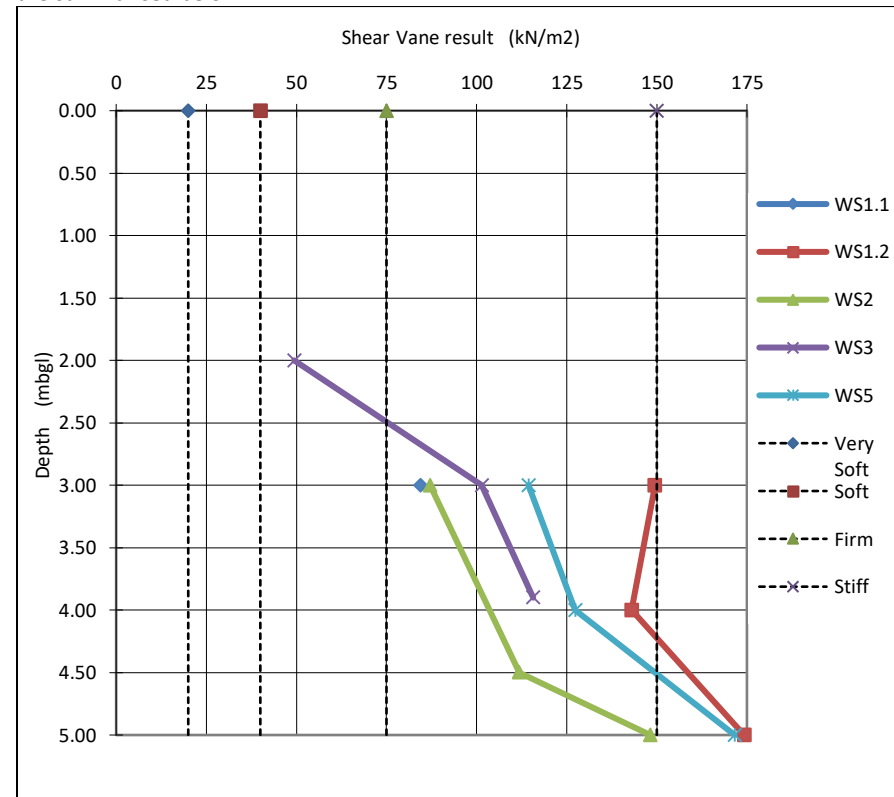
5.2 Shear Vanes

Laboratory shear vane tests were performed on samples of cohesive materials recovered within the boreholes. The test provides a direct estimate of undrained shear strength, and in turn may be used to give an indication of consistency as defined in BS5930. The results are summarised below.

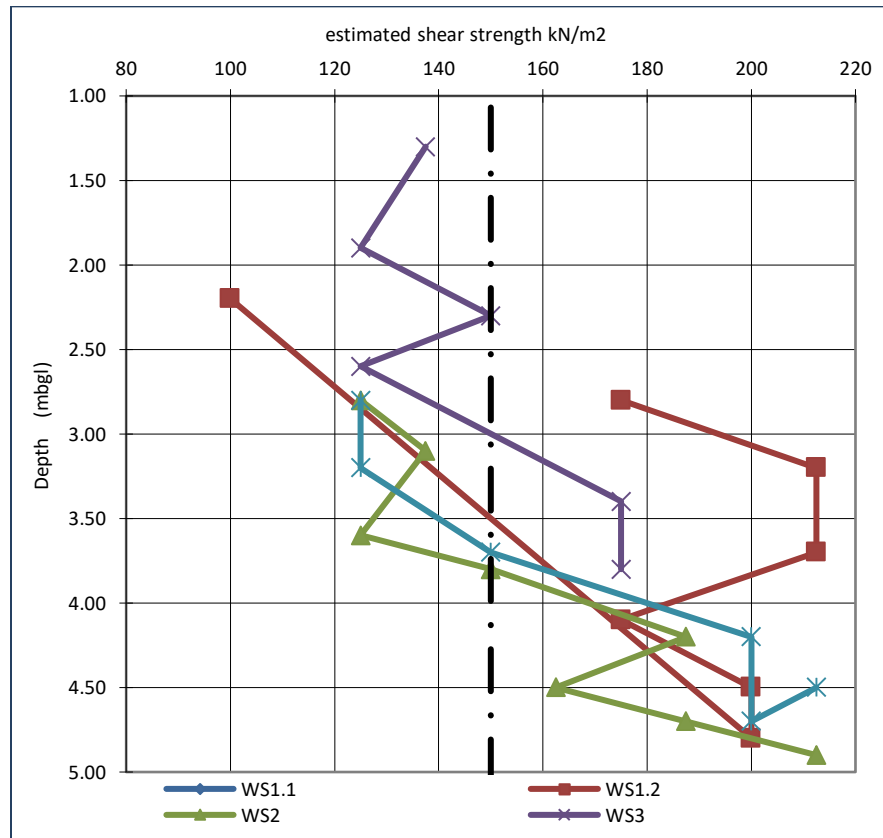
5.3 Penetrometers

Hand penetrometer tests were performed on samples of cohesive materials recovered within the boreholes. The test is used to approximate undrained shear strength and in turn has been used to give an indication of consistency as defined in BS5930. The results are summarised below.

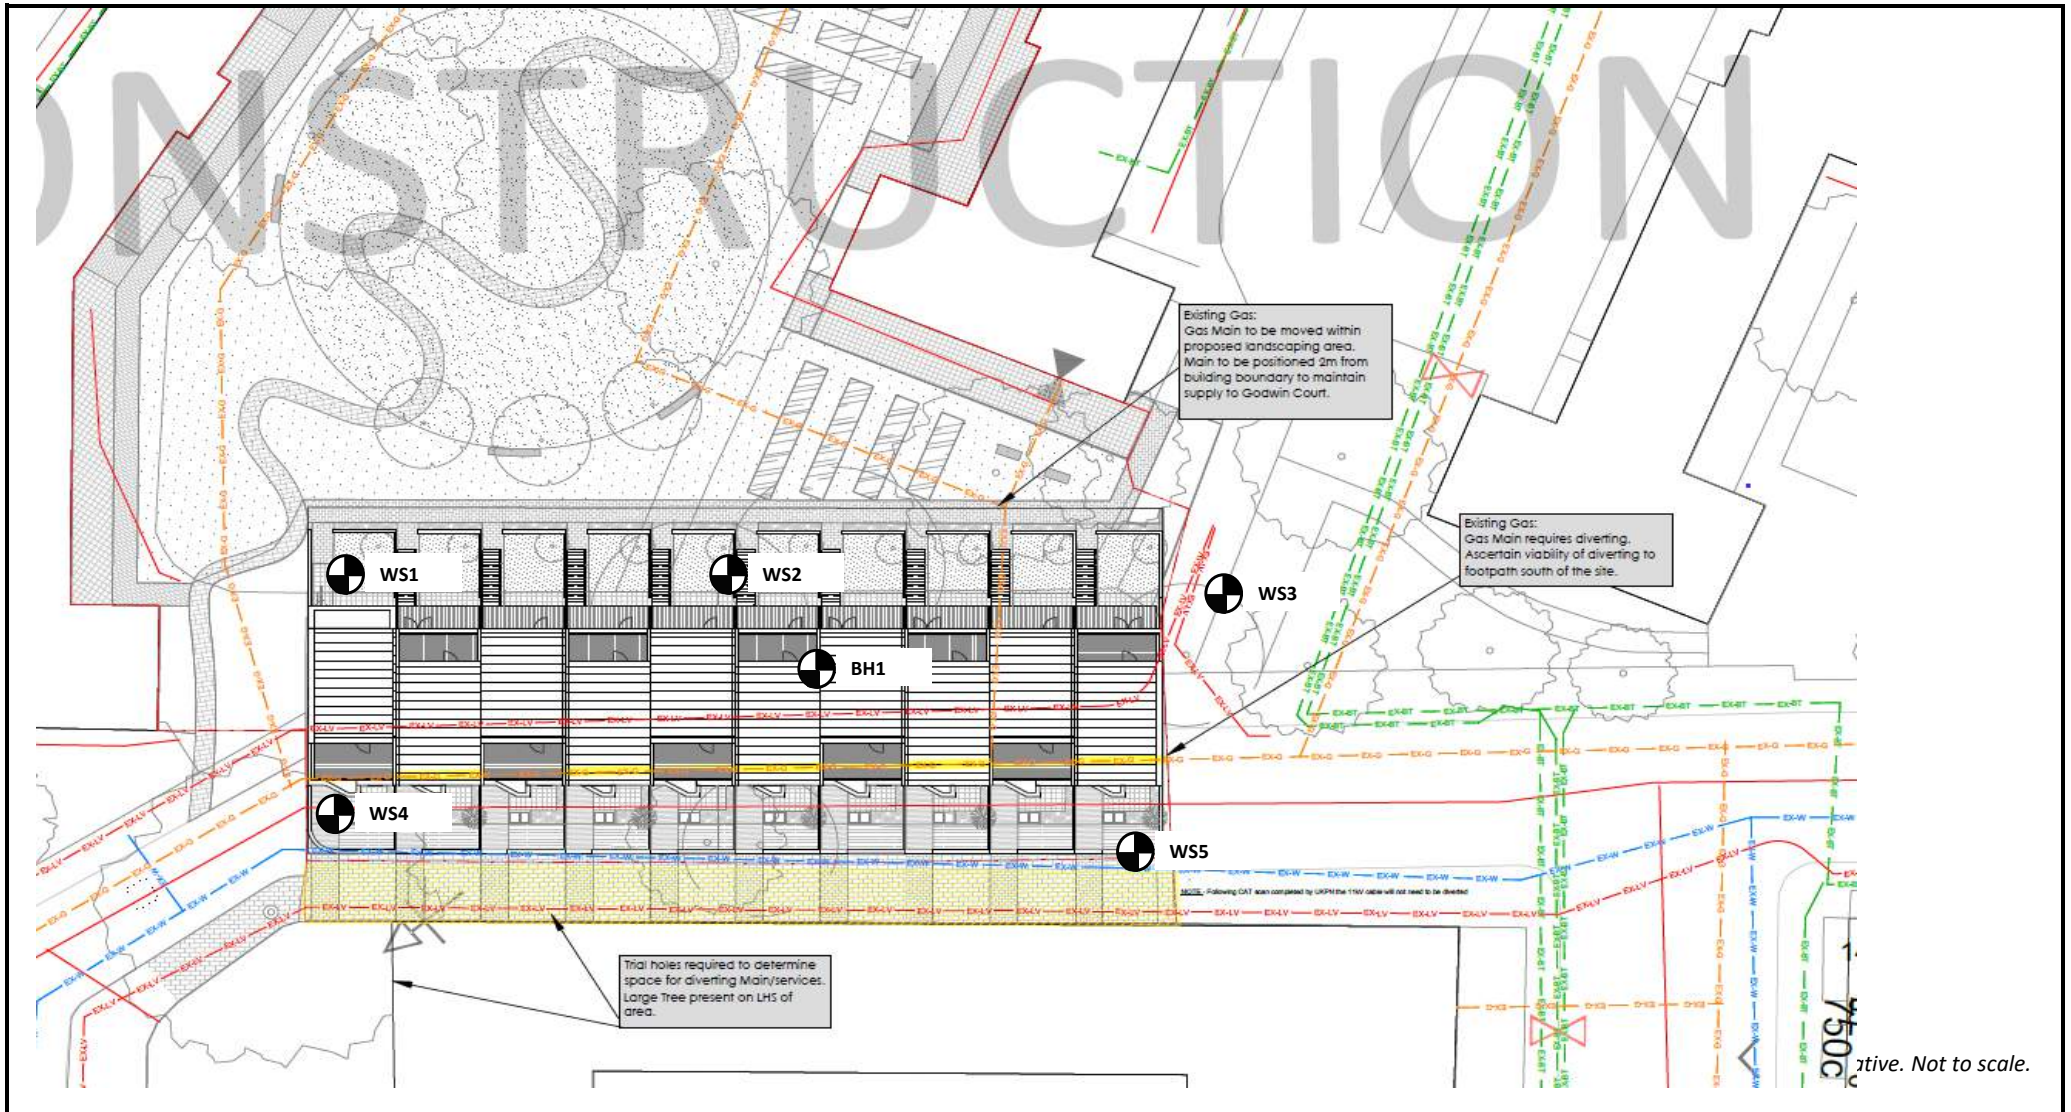
TITLE:	Existing Site / Investigation Layout	REF:	LS4257	PREPARED:	TK
	PROJECT:	Godwin & Crownsdale Estate, Crowndale Rd, London NW1 1NW	FIGURE:	3	CHECKED:	ET
	CLIENT:	Camden Council	DATE:	11/06/2019	VERSION	V1

The layout of the existing site is indicated on Figure 2, and a walkover survey is presented in section 3.0. The area was approximately 1.20 hectares. It was understood that the Client was in ownership of the site, and that this investigation was not a pre-purchase appraisal.

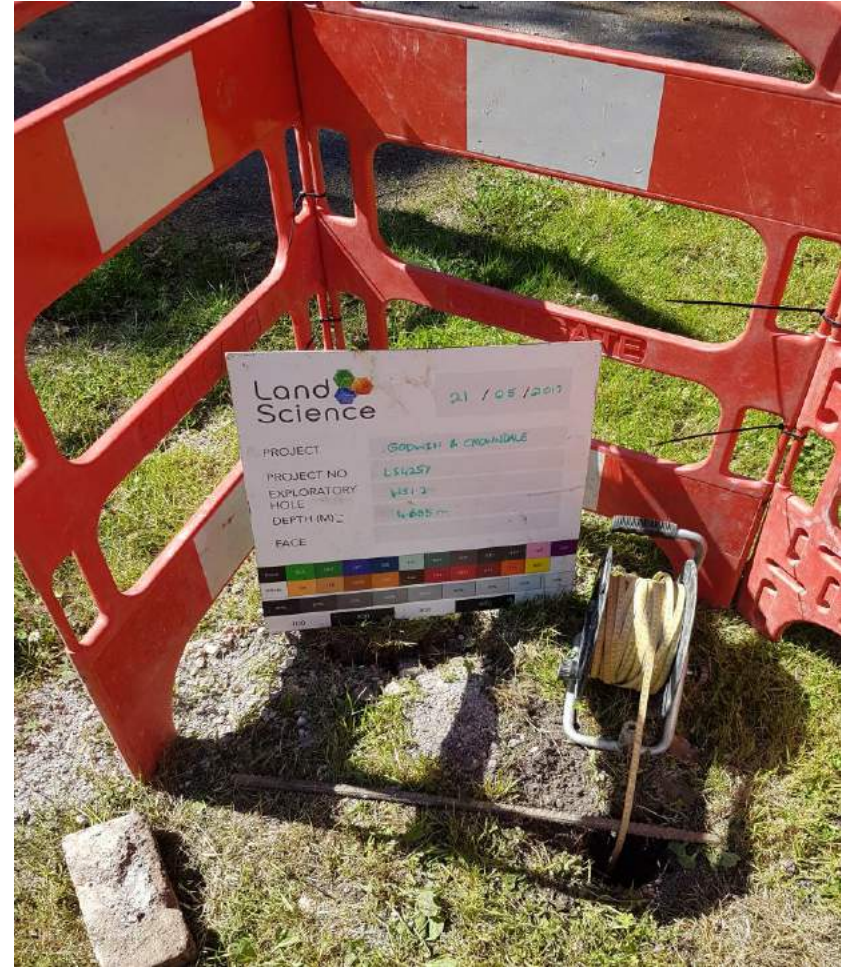
WS1.2 Soakage Test

A falling head soakage test was undertaken in WS1.2. The water level fell 0.075m in 135mins. The readings were insufficient to calculate a soil infiltration rate.

A preliminary falling head soakage test was undertaken within WS1.2. However, the percolation was extremely poor and a soil infiltration rate could not be calculated.

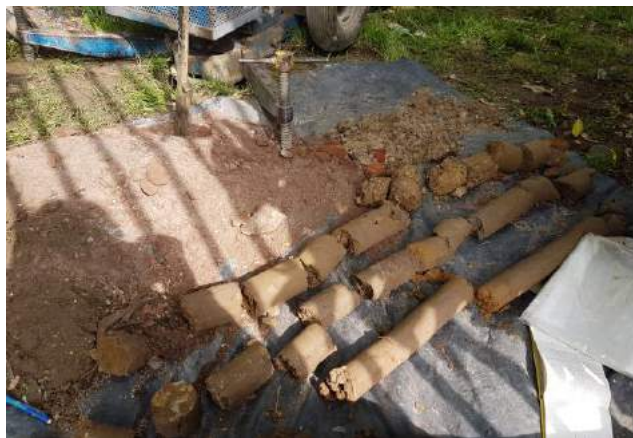
WS3 was terminated at 3.00m on an obstruction, possibly a very large root. WS4 could not be drilled due to a number of services encountered. Attempts were made to move this position, but the estate committee expressed concerns with the potential damage to the Multi Use Games Area (MUGA) surface.

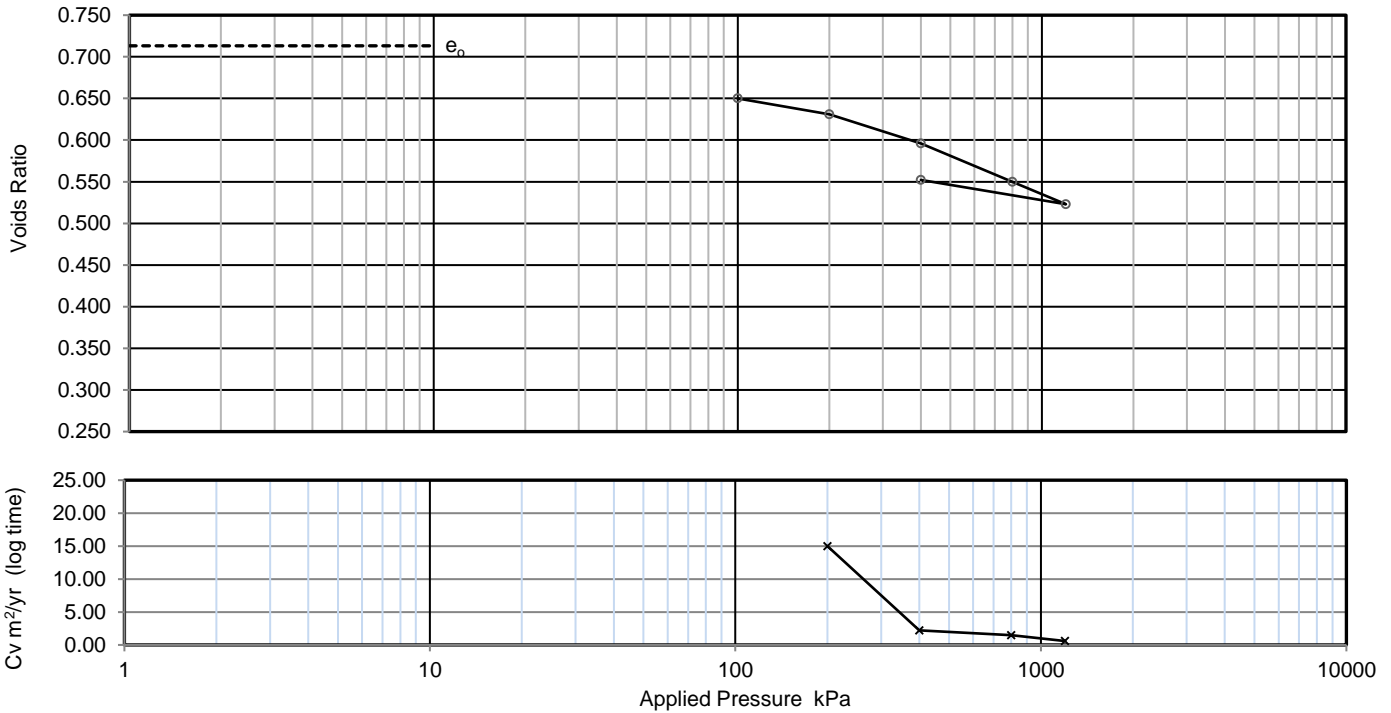
Laboratory Reference: 1229525
Hole No.: BH1
Sample Reference: Not Given
Sample Description: Brown CLAY

Applied Pressure kPa	Voids ratio	Mv m2/MN	Cv (t50, log) m2/yr	Cv (t90, root) m2/yr	Csec
0	0.713	-	-	-	-
100	0.650	0.37	N/A	N/A	N/A
200	0.631	0.12	15	N/A	N/A
400	0.596	0.11	2.2	3.6	0.0019
800	0.550	0.072	1.5	2.6	0.0013
1 200	0.523	0.044	0.59	2.2	0.0019
400	0.552	0.024

Initial	Final	
Diameter	50.00	-	mm
Height	20.00	18.11	mm
Moisture Content	26	26	%
Bulk density	1.95	2.15	Mg/m3
Dry density	1.55	1.71	Mg/m3
Voids Ratio	0.713	0.552	
Saturation	96	125	%
Avg. temperature for test	22.0		°C
Swelling Pressure	Not measured		kPa
Settlement on saturation			%

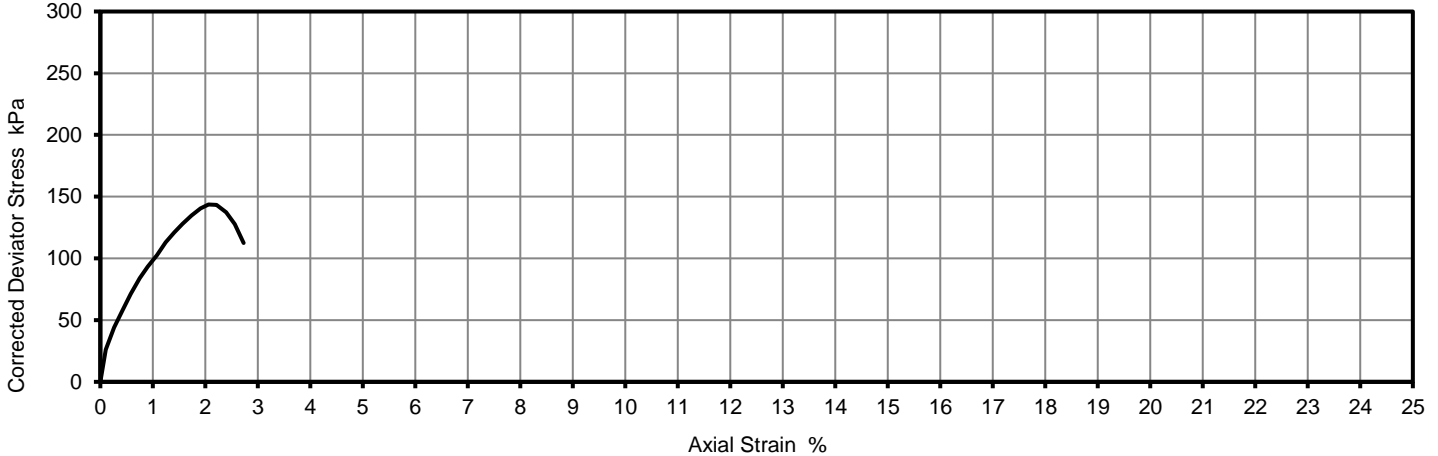
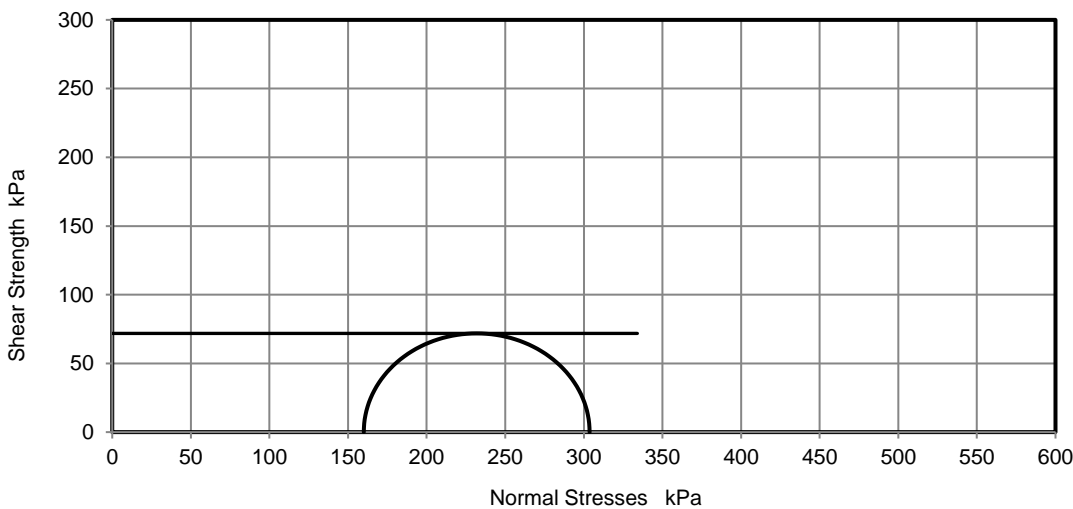
Deviator Stress v Axial Strain

Test Number	1
Length	197.87 mm
Diameter	103.29 mm
Bulk Density	1.97 Mg/m ³
Moisture Content	26 %
Dry Density	1.57 Mg/m ³
Membrane Correction	0.11 kPa

Rate of Strain	2.00 %/min
Cell Pressure	160 kPa
Axial Strain at failure	2.1 %
Deviator Stress, ($\sigma_1 - \sigma_3$) _f	144 kPa
Undrained Shear Strength, c_u	72 kPa $\frac{1}{2}(\sigma_1 - \sigma_3)_f$
Mode of Failure	Brittle
Membrane thickness	0.21 mm

Strata	Depth	Bulk density (Mg/m ³)	Dry density (Mg/m ³)	Undrained Shear strength (kPa)	Mode of Failure
London Clay Formation	8.00-8.45	1.97	1.57	72	Brittle
	11.00-11.45	2.07	1.65	197	Compound
	14.55-15.00	1.92	1.55	160	Brittle

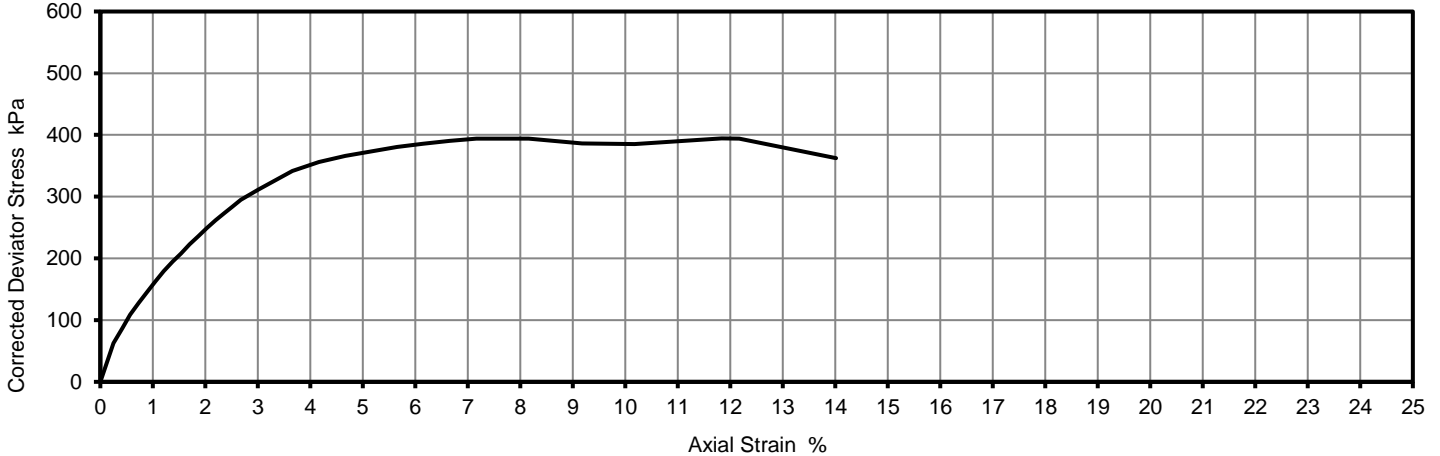
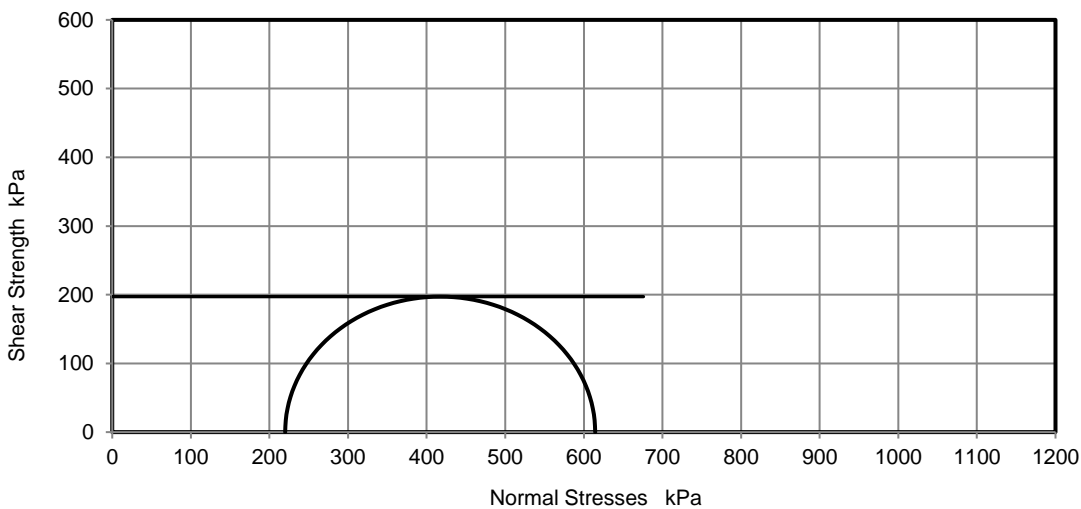
Deviator Stress v Axial Strain

Test Number	1
Length	200.24 mm
Diameter	101.86 mm
Bulk Density	2.07 Mg/m ³
Moisture Content	26 %
Dry Density	1.65 Mg/m ³
Membrane Correction	0.50 kPa

Rate of Strain	2.00 %/min
Cell Pressure	220 kPa
Axial Strain at failure	11.8 %
Deviator Stress, (σ ₁ - σ ₃) _f	394 kPa
Undrained Shear Strength, c _u	197 kPa ½(σ ₁ - σ ₃) _f
Mode of Failure	Compound
Membrane thickness	0.20 mm

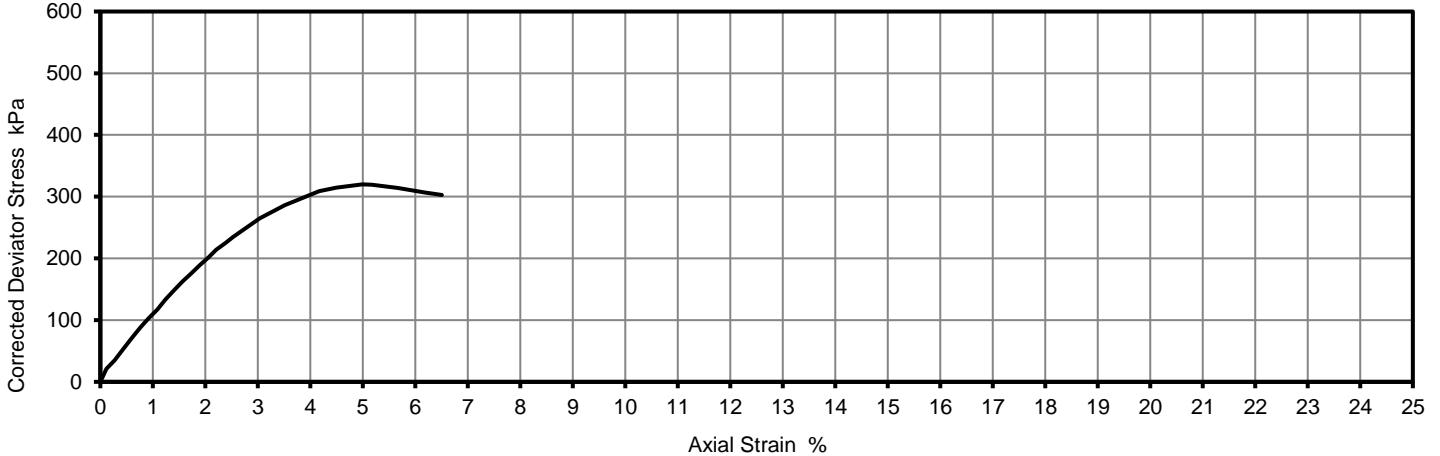
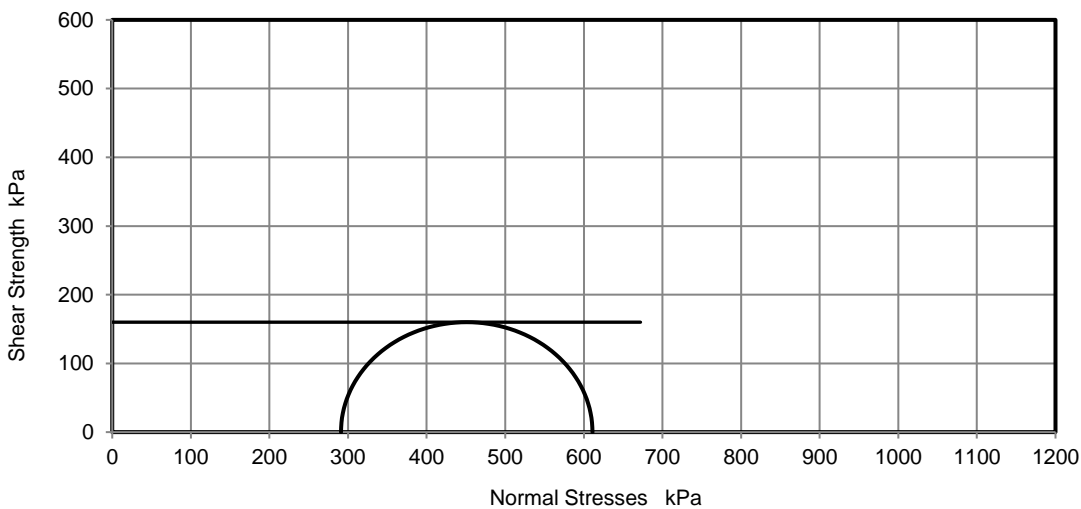
Deviator Stress v Axial Strain

Test Number	1
Length	191.54 mm
Diameter	103.77 mm
Bulk Density	1.92 Mg/m ³
Moisture Content	24 %
Dry Density	1.55 Mg/m ³
Membrane Correction	0.21 kPa

Rate of Strain	2.00 %/min
Cell Pressure	291 kPa
Axial Strain at failure	5.0 %
Deviator Stress, ($\sigma_1 - \sigma_3$) _f	320 kPa
Undrained Shear Strength, c_u	160 kPa $\frac{1}{2}(\sigma_1 - \sigma_3)_f$
Mode of Failure	Brittle
Membrane thickness	0.16 mm
