# HAMPSTEAD POLICE STATION, LONDON

## COMBINED PHASE 1 AND PHASE 2 GEO-ENVIRONMENTAL INVESTIGATION AND RISK ASSESSMENT

**Job Number:** LKC 22 5242

**Date:** July 2023

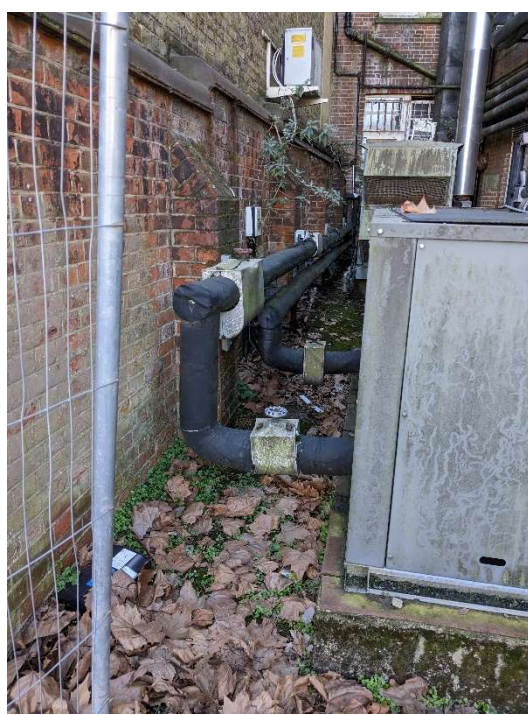
**Photograph 3:** eastern site boundary.

- The eastern boundary of the site is delineated by a brickwall to the adjacent property and access along the site boundary in this area is limited due to the presence of large external air conditioning units.

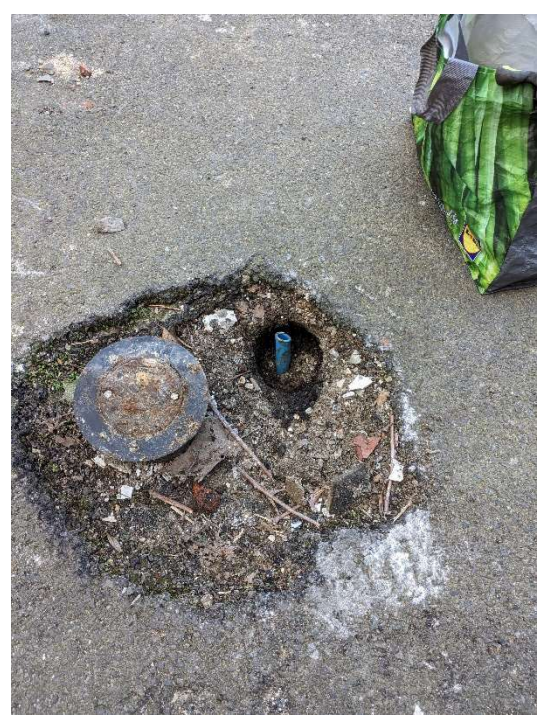
**Photograph 4:** Uncemented borehole cover

- Several borehole covers from a previous phase of ground investigation were noted in the rear of the property and these had not been cemented into position.

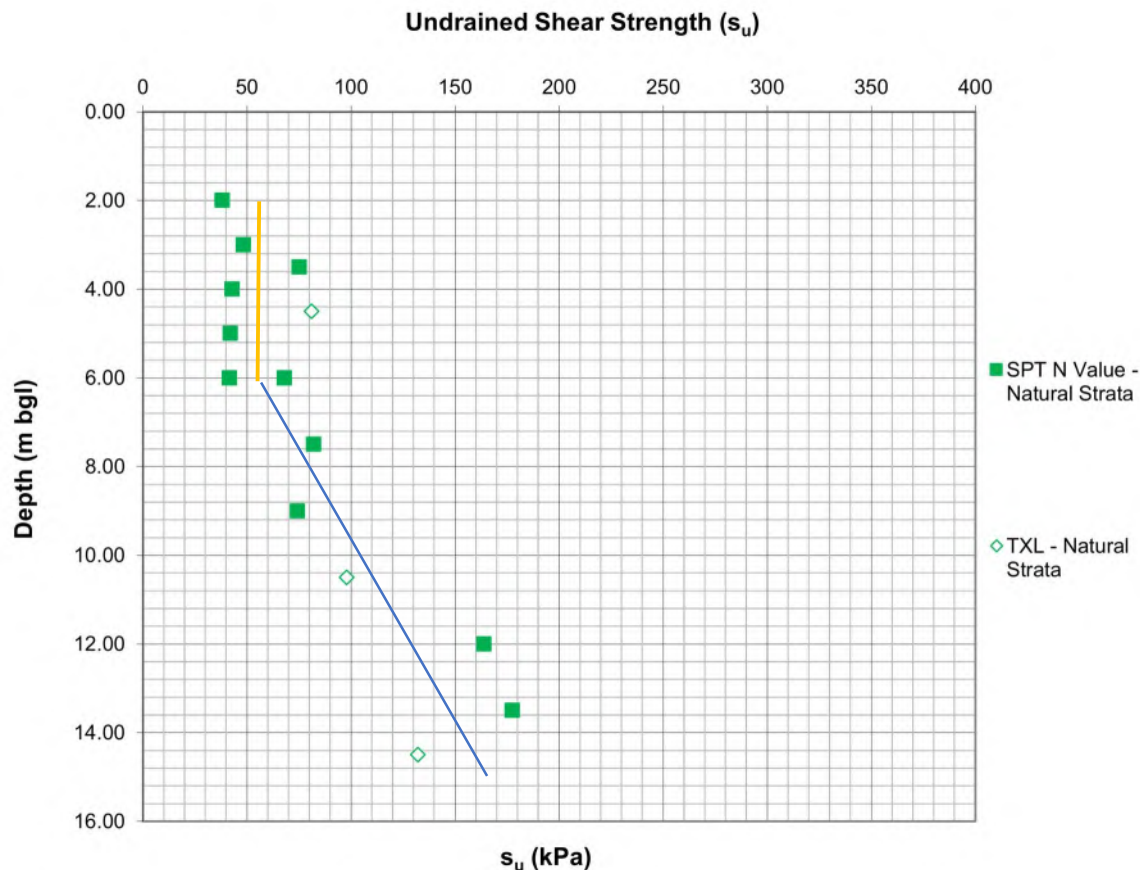
Graph 10-1: Summary of  $s_u$  vs depth from in-situ geotechnical testing.

A conservative  $s_u$  of 55kPa is assigned to the cohesive soils from a depth of approximately 2.00mbgl (at WS101 borehole location) to 6.00mbgl (design line in yellow in Graph 5-1) increasing to 80kPa at depth of 8.00mbgl and 130kPa at 12.00mbgl (design line in blue in Graph 5-1).

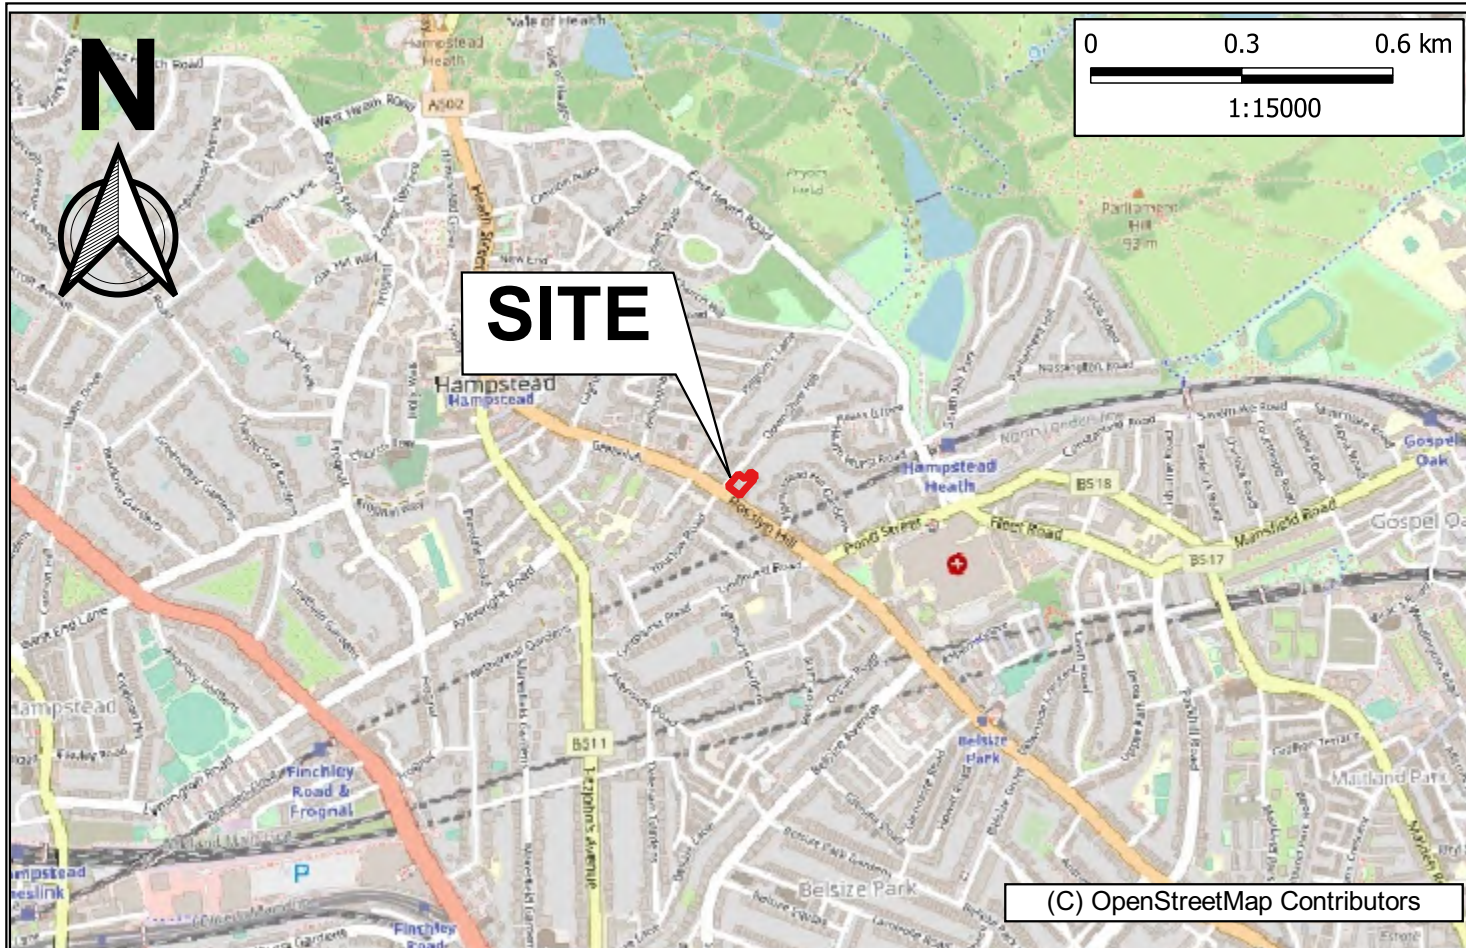
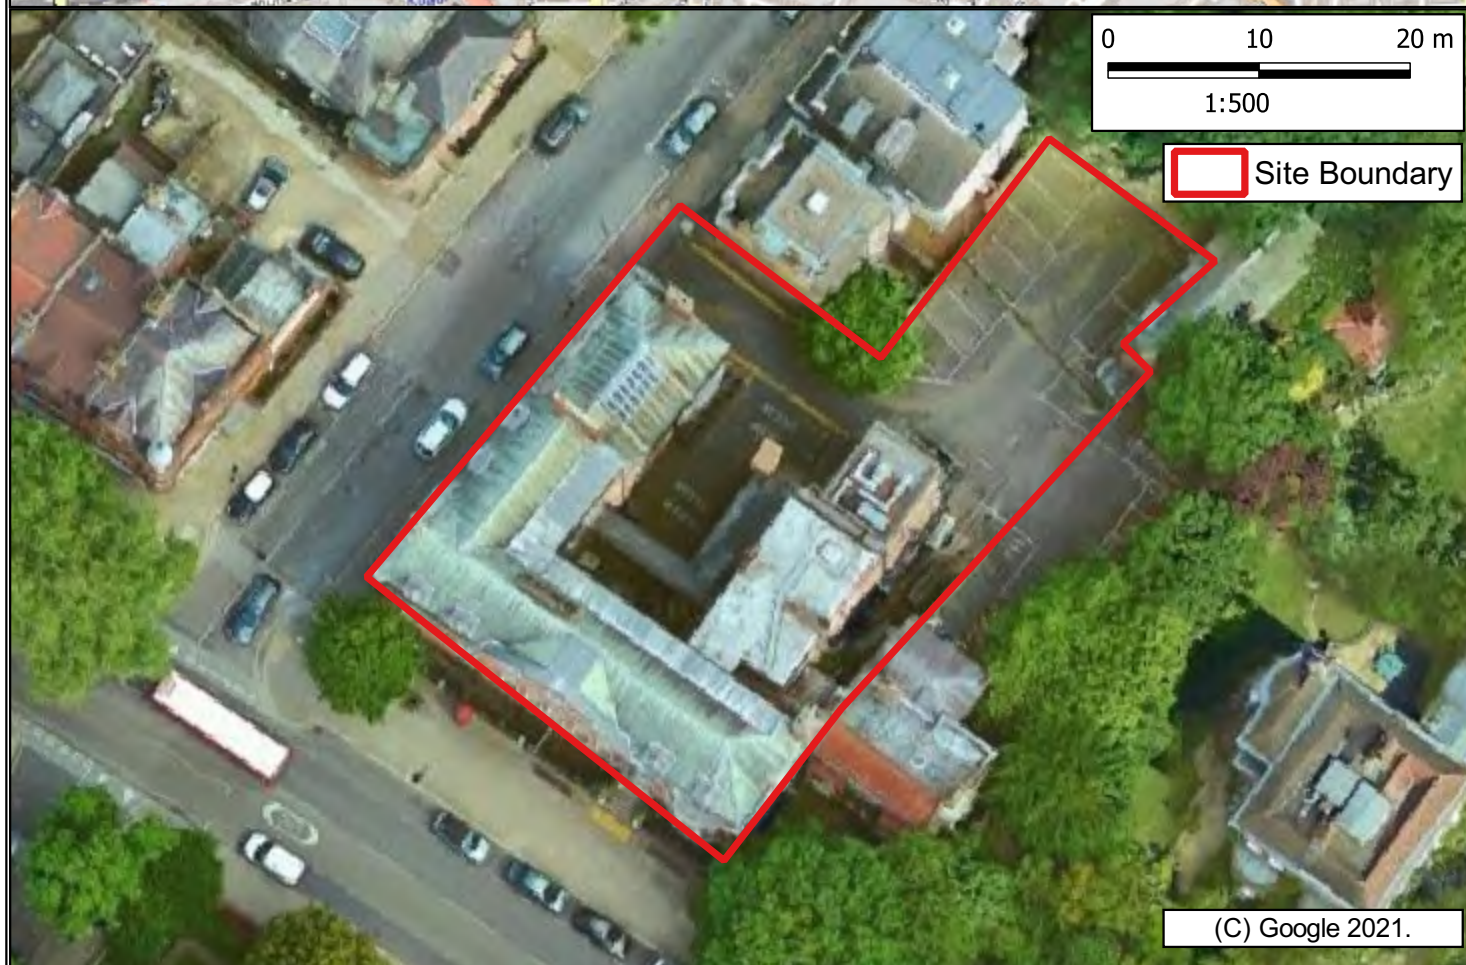
Client:  Rostrack Limited				Title:  Site Location & Boundary Plan

Site details are provided in Table 1-1. Figure 1 shows the site location and boundary. Figure 2 shows the existing site plan.

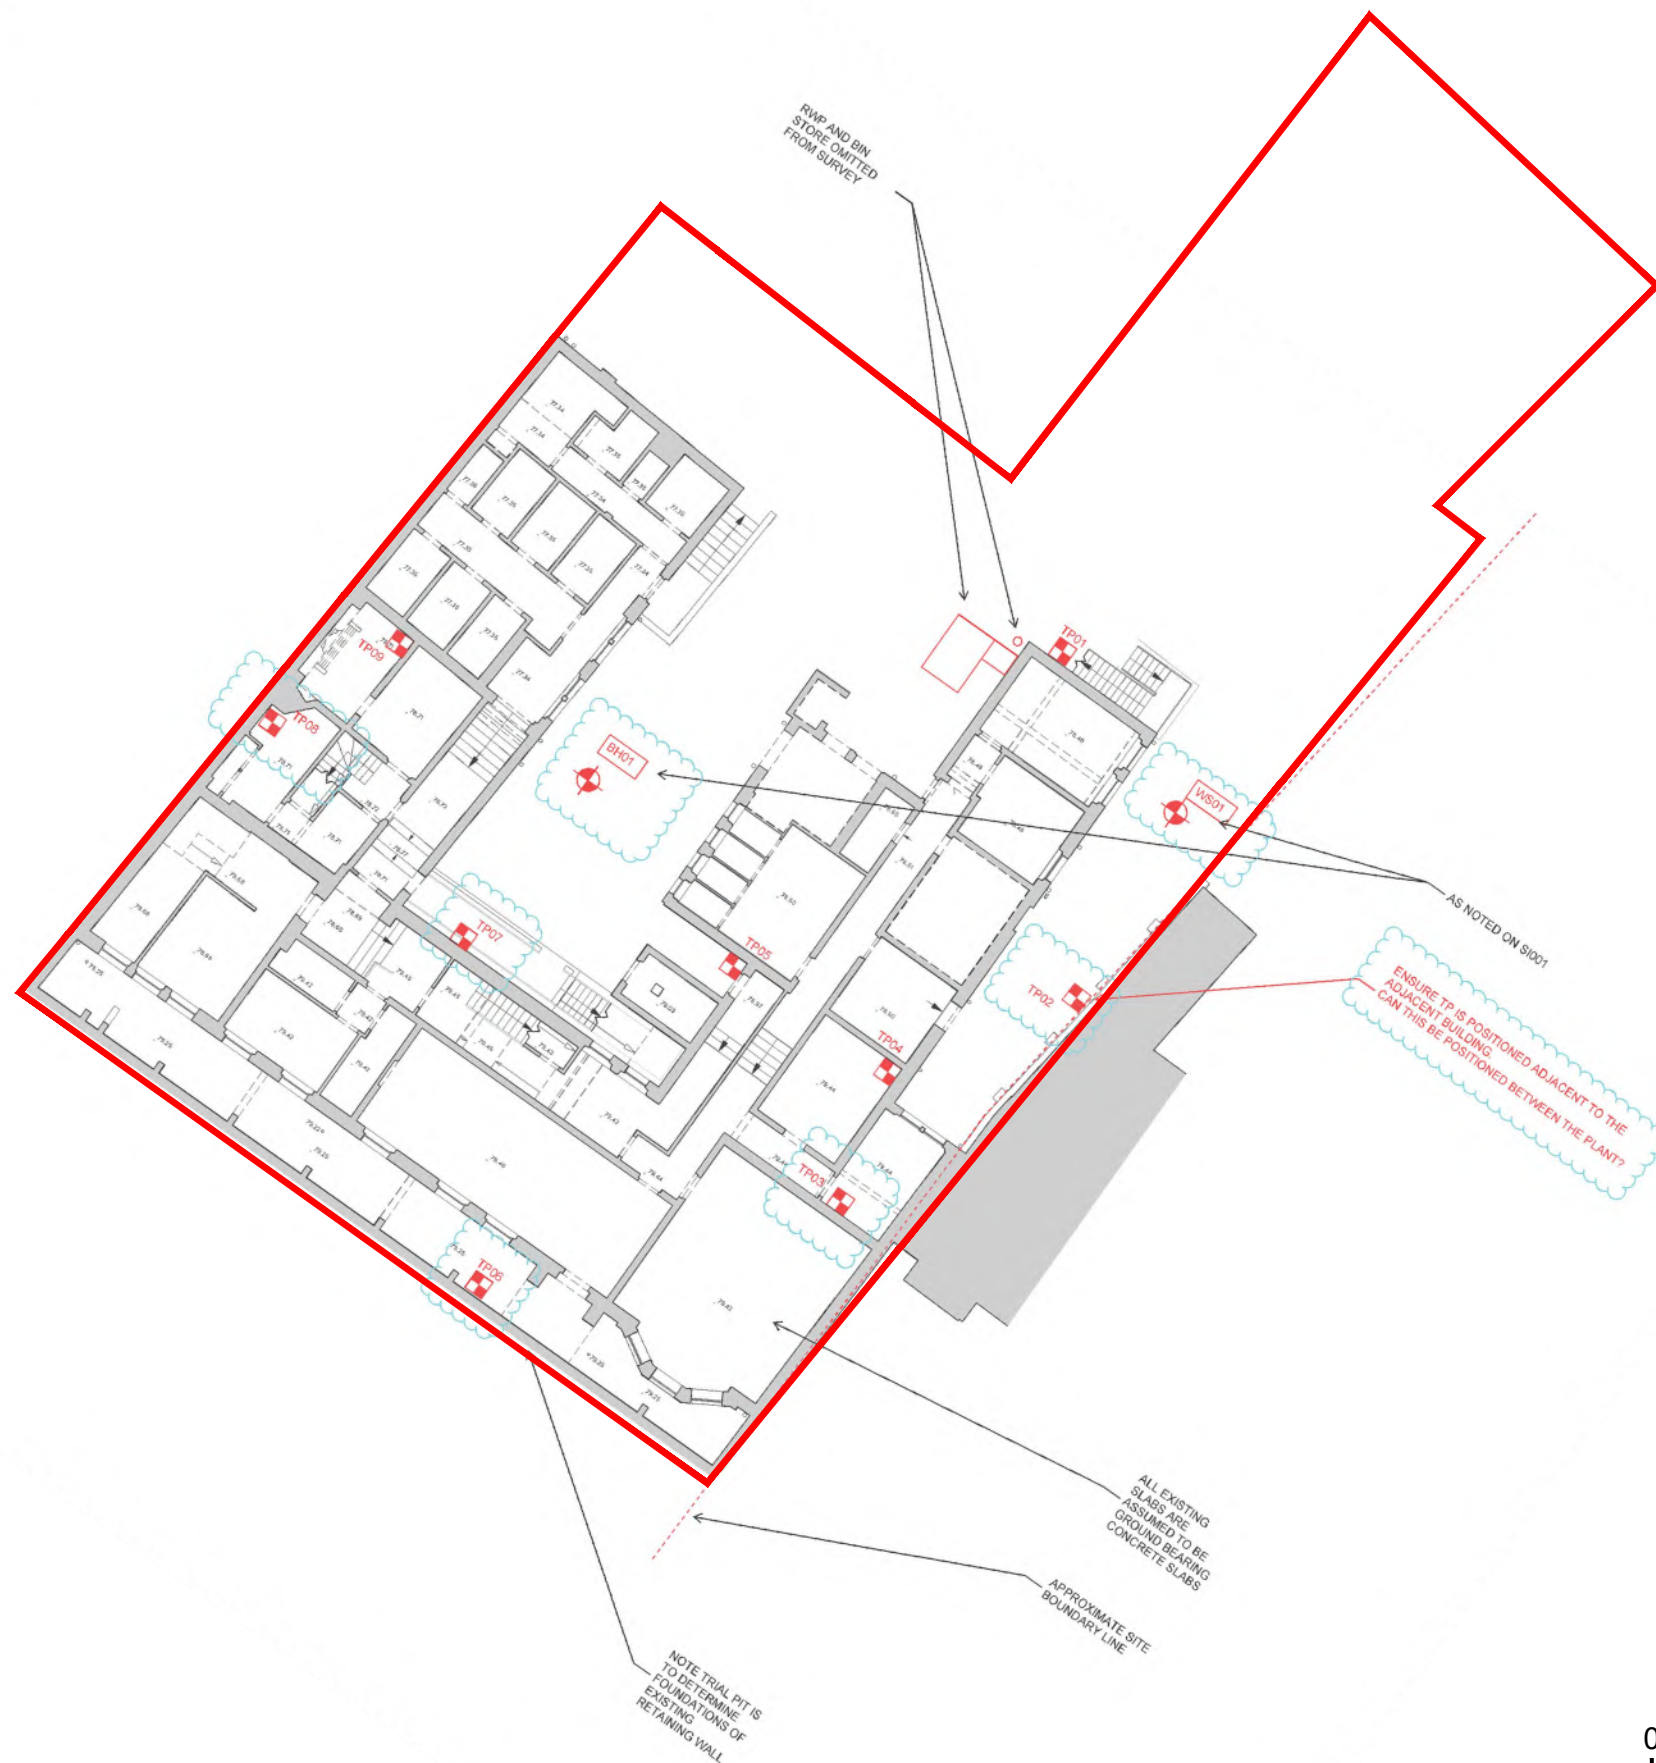
Client:			
Rostrack Limited			
Site:			
Hampstead Police Station			
Title:			
Site Investigation Plan			
Job No.:	Scale (See Scale Bar):	Figure:	Revision:
LKC 22 5242	See Scale Bar	3	A
Drawn By:	Checked By:	Drawn:	
AC	SJ	Mar 2024

- Site Boundary
- WS01 WINDOW SAMPLE
- BH01 BOREHOLE

TP01 TRIAL PIT (MIN 1m X 1m)
