**Land at 11-12 Ingestre Road
NW5 1UX**

**Biodiversity Enhancement Strategy
(Condition 22)**

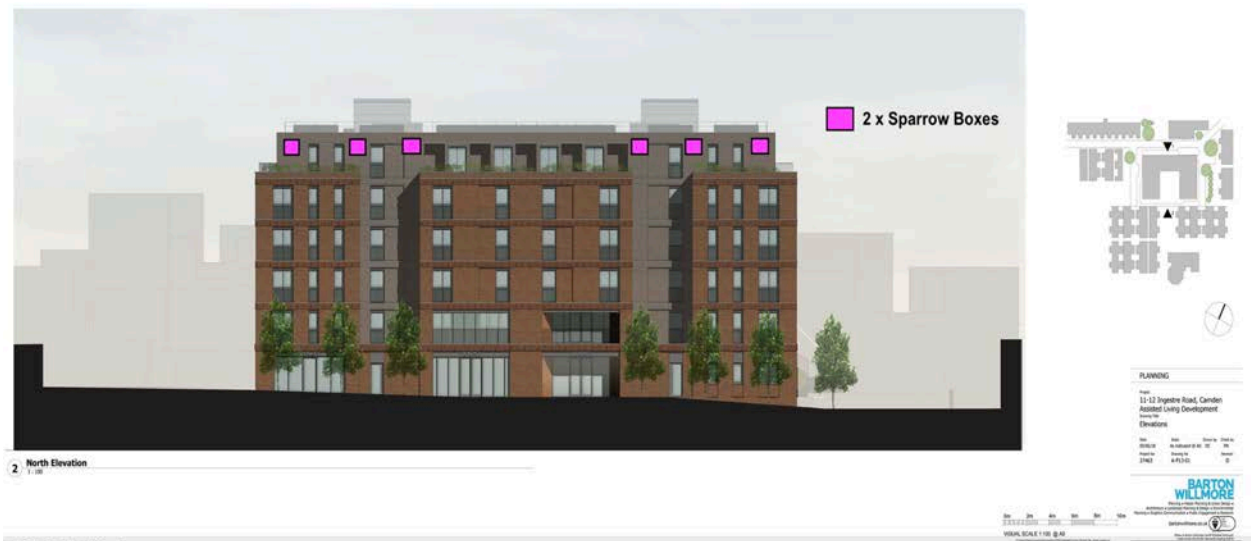
Figure 5: North facing locations of sparrow boxes (total 12 boxes)

- 3.4 The approximate location is shown in Figure 4 below, and Figure 5 shows the location of the boxes on the northern aspect. The sparrow boxes are to be located on the northern and eastern aspect of the building. The boxes should be in groups of two boxes together, with further groups of boxes spaced at approximately 2m along the northern and eastern edge of the building. A such a total of approximately 20 boxes will be established.

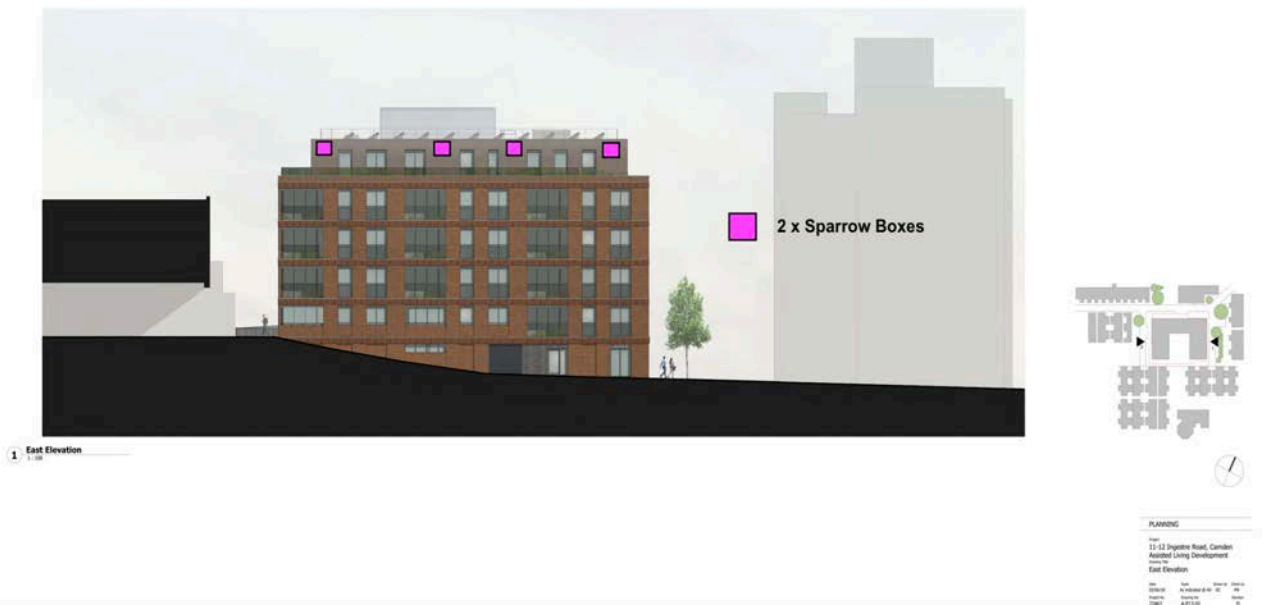
Figure 6: East facing locations of sparrow boxes (total 8 boxes)
