## Site Investigation Report

WHC reference: 7815

Address: 49 & 49a Gloucester Crescent, London, NW1 7EG

William Hunt Consulting were commissioned by Crawford & Company to undertake a site investigation within the area of concern, located at the front elevation of the property. Site Investigations to consist of 1No. Borehole together with 1No. Trial Pit alongside Moisture contents and Atterberg limit laboratory testing, Root identification and a CCTV Drainage Layout.

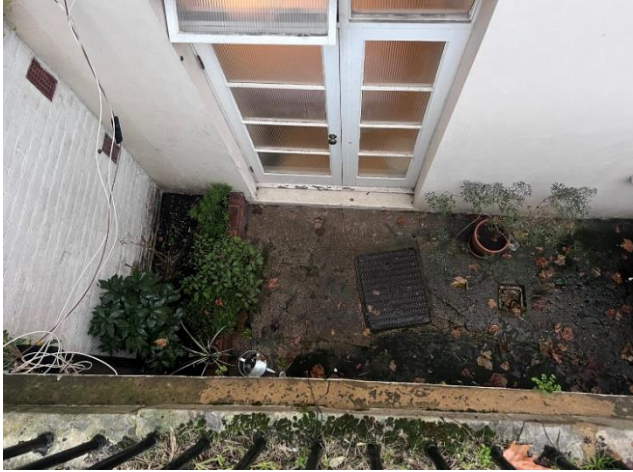
**Photo 1 – Area of Works**

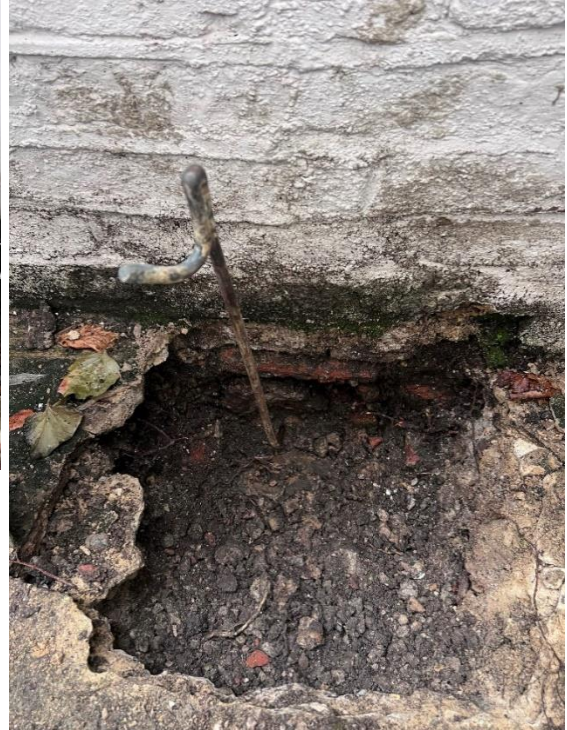
**Photo 2 – Trial Pit 1**

Trial Pit Details can be found in Appendix C where in trial pit 1, no foundation or projection were found to be present, with the retaining wall extending 0.31m below ground level.

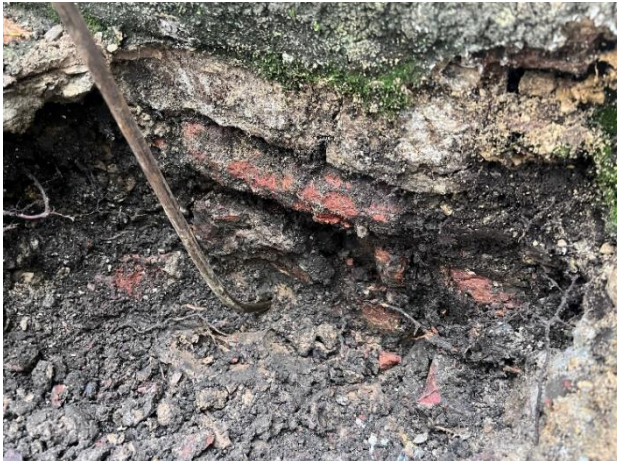
**Photo 3 – Trial Pit 1**

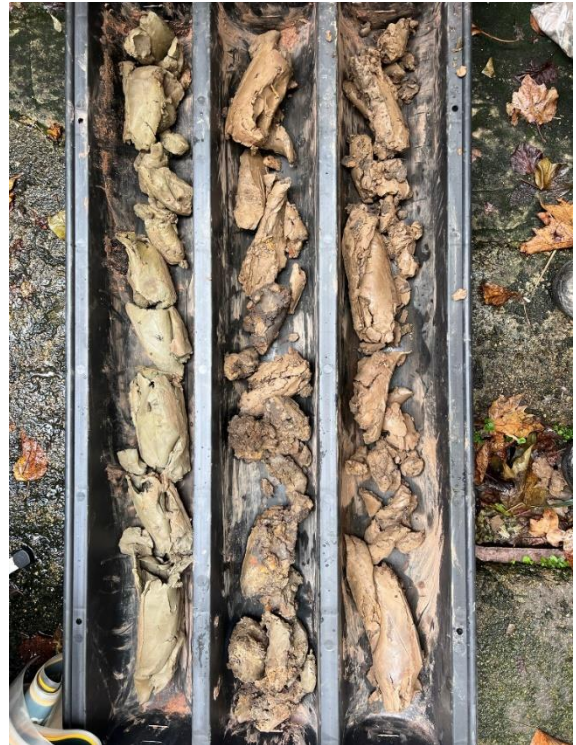
**Photo 4 – BH1 Cores (0.00m – 1.50m)**

Borehole Findings can be found in Appendix A, where in borehole 1, Concrete was found present from ground level to 0.15m below ground level, followed by Soft to Firm Clay to a depth of 0.31mbgl. Firm dark brown Clay was then recorded to a depth of 1.31mbgl, becoming light brown at 0.81m. Below this, light brown/grey firm Clay was then encountered to a depth of 1.81m below ground level, followed by stiff to very stiff light brown Clay to 2.31mbgl. Very stiff dark brown Clay was found to be present to a depth of 3.31m below ground level, at which point the borehole was terminated. Borehole did not encounter groundwater.

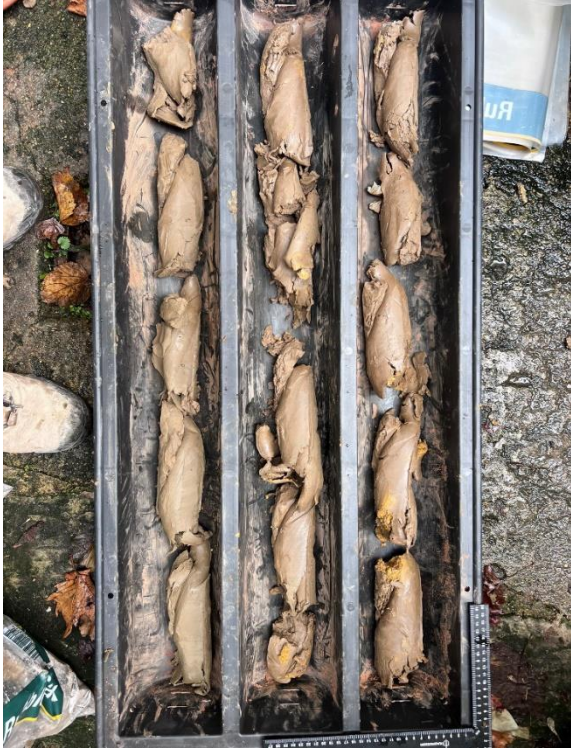
Photo 5 – BH1 Cores (1.50m – 3.00m)

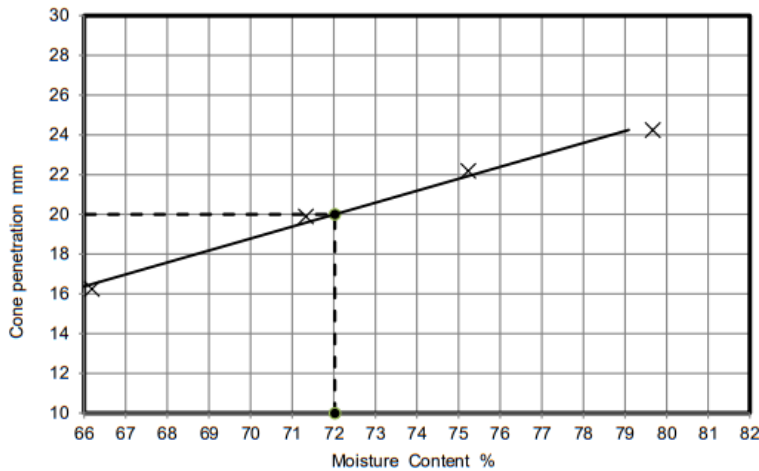
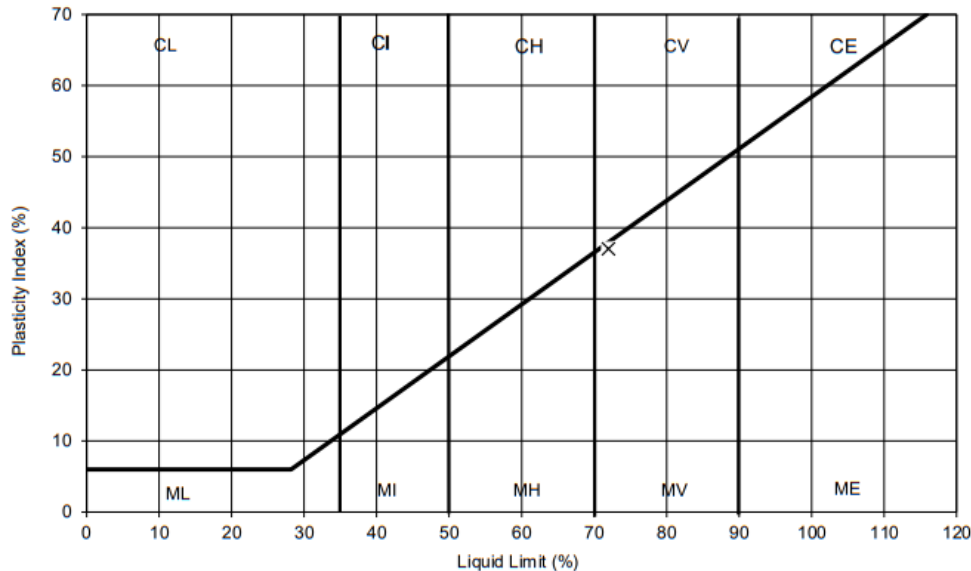
<b>LIQUID LIMIT, PLASTIC LIMIT AND PLASTICITY INDEX</b>		Job No.	34338	
			Borehole/Pit No.	BH1	
Site Name	49 & 49a Gloucester Crescent, London NW1 7EG		Sample No.	-	
Project No.	7815	Client	William Hunt Consulting	Depth Top	0.50 m
Soil Description	Orangish brown slightly mottled dark grey slightly gravelly silty CLAY (gravel is fm and sub-angular to rounded)			Depth Base	1.00 m
				Sample Type	D
				Samples received	06/11/2023
				Schedules received	06/11/2023
				Project Started	07/11/2023
			Date Tested	18/11/2023

NATURAL MOISTURE CONTENT	35	%
% PASSING 425µm SIEVE	96	%
LIQUID LIMIT	72	%
PLASTIC LIMIT	35	%
PLASTICITY INDEX	37	%

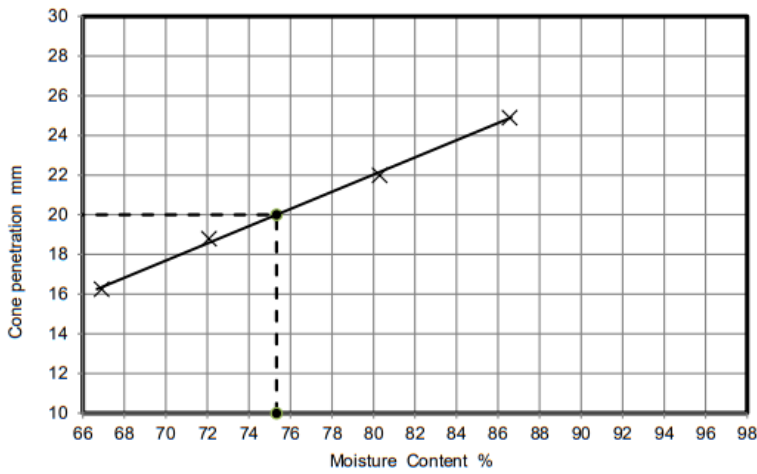
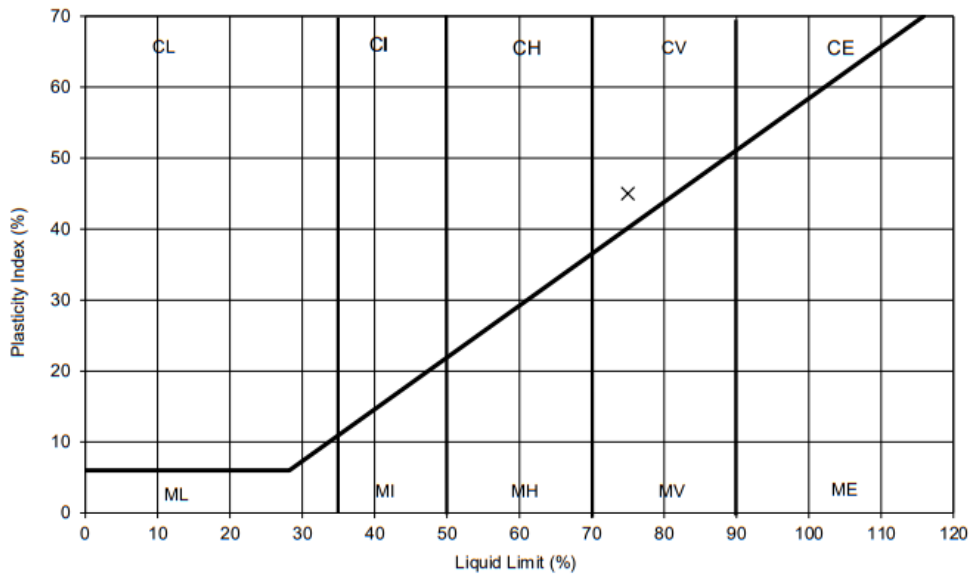
<b>LIQUID LIMIT, PLASTIC LIMIT AND PLASTICITY INDEX</b>			Job No.	34338
				Borehole/Pit No.	BH1
Site Name	49 & 49a Gloucester Crescent, London NW1 7EG			Sample No.	-
Project No.	7815	Client	William Hunt Consulting	Depth Top	1.50 m
Soil Description	Light orangish brown slightly mottled grey silty CLAY			Depth Base	2.00 m
				Sample Type	D
				Samples received	06/11/2023
				Schedules received	06/11/2023
				Project Started	07/11/2023
				Date Tested	18/11/2023

NATURAL MOISTURE CONTENT	33	%
% PASSING 425µm SIEVE	100	%
LIQUID LIMIT	75	%
PLASTIC LIMIT	30	%
PLASTICITY INDEX	45	%

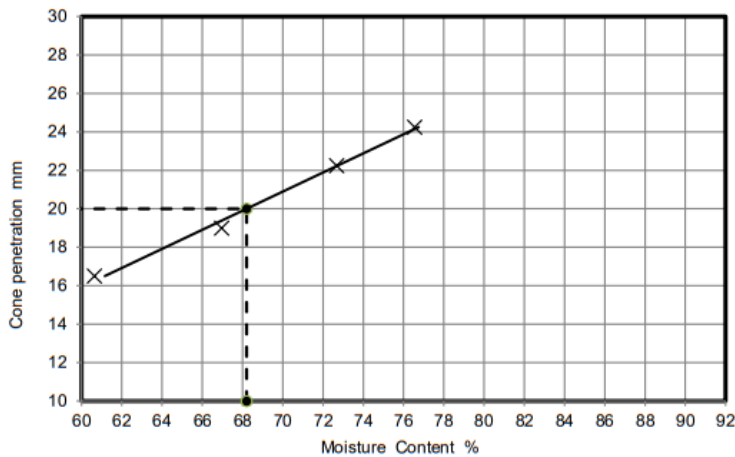
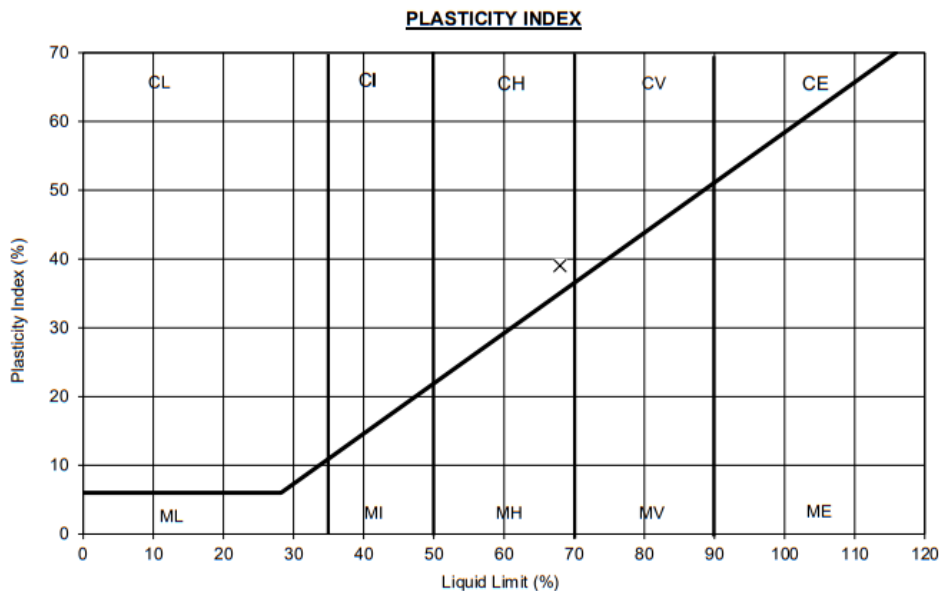
<b>LIQUID LIMIT, PLASTIC LIMIT AND PLASTICITY INDEX</b>		Job No.	34338	
			Borehole/Pit No.	BH1	
Site Name	49 & 49a Gloucester Crescent, London NW1 7EG		Sample No.	-	
Project No.	7815	Client	William Hunt Consulting	Depth Top	2.50 m
Soil Description	Orangish brown slightly mottled grey silty CLAY with scattered of selenite crystals			Depth Base	3.00 m
				Sample Type	D
				Samples received	06/11/2023
				Schedules received	06/11/2023
				Project Started	07/11/2023
			Date Tested	18/11/2023

NATURAL MOISTURE CONTENT	32	%
% PASSING 425µm SIEVE	100	%
LIQUID LIMIT	68	%
PLASTIC LIMIT	29	%
PLASTICITY INDEX	39	%

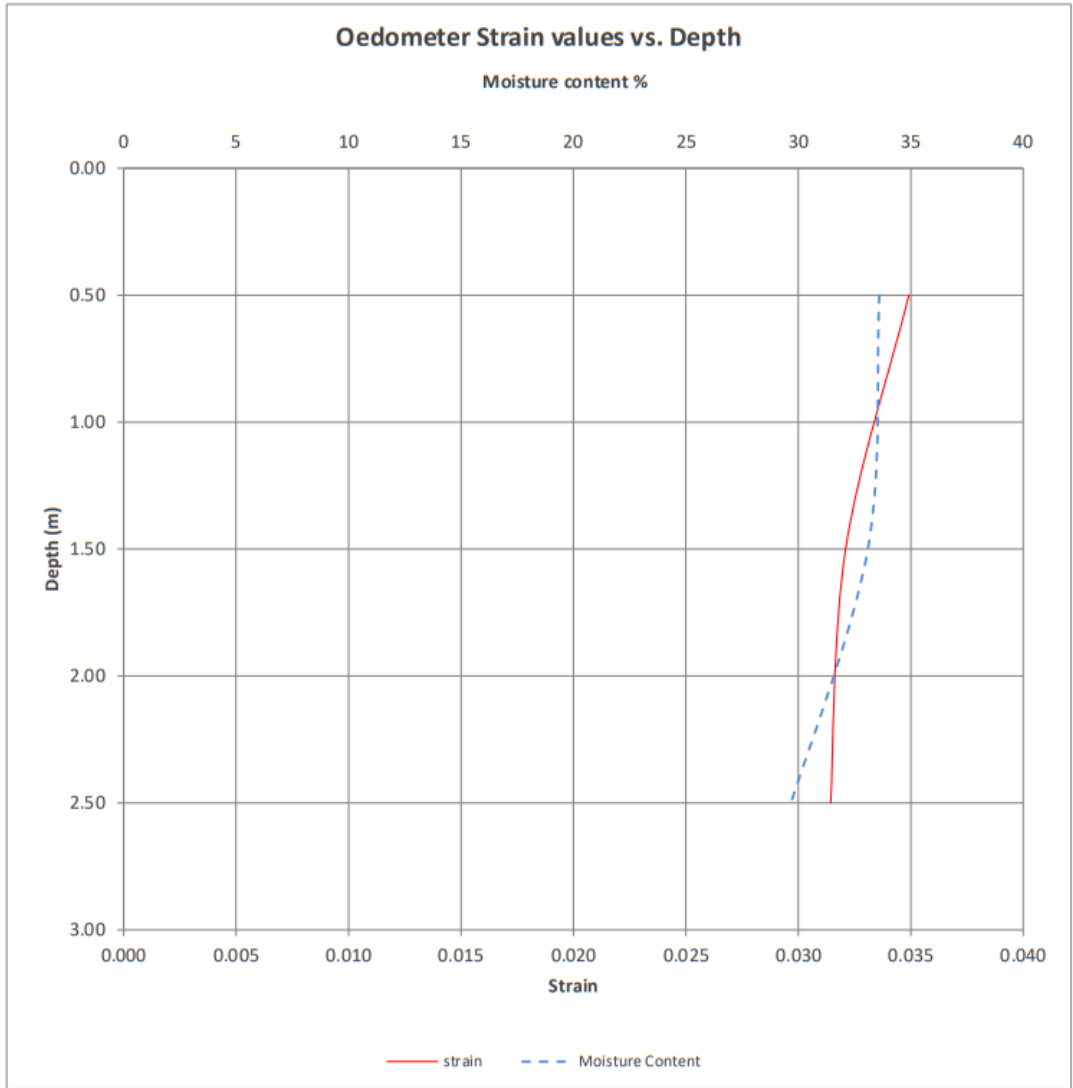
Predicted total free surface heave over depth of exploratory position      **40.20**      mm

<b>Summary of One Dimensional Swell/Strain - Plots</b>	
		<b>Job No.</b> 34338	<b>Project Name</b> 49 & 49a Gloucester Crescent, London NW1 7EG
<b>Project No.</b> 7815	<b>Client</b> William Hunt Consulting	<b>Samples received</b> 06/11/2023	<b>Schedule received</b> 06/11/2023
		<b>Project started</b> 07/11/2023	<b>Testing Started</b> 13/11/2023
