Fig 15: Geology – Local Borehole Records

Record boreholes from Ort House/126 Albert Street (island site) and 120 Arlington Road

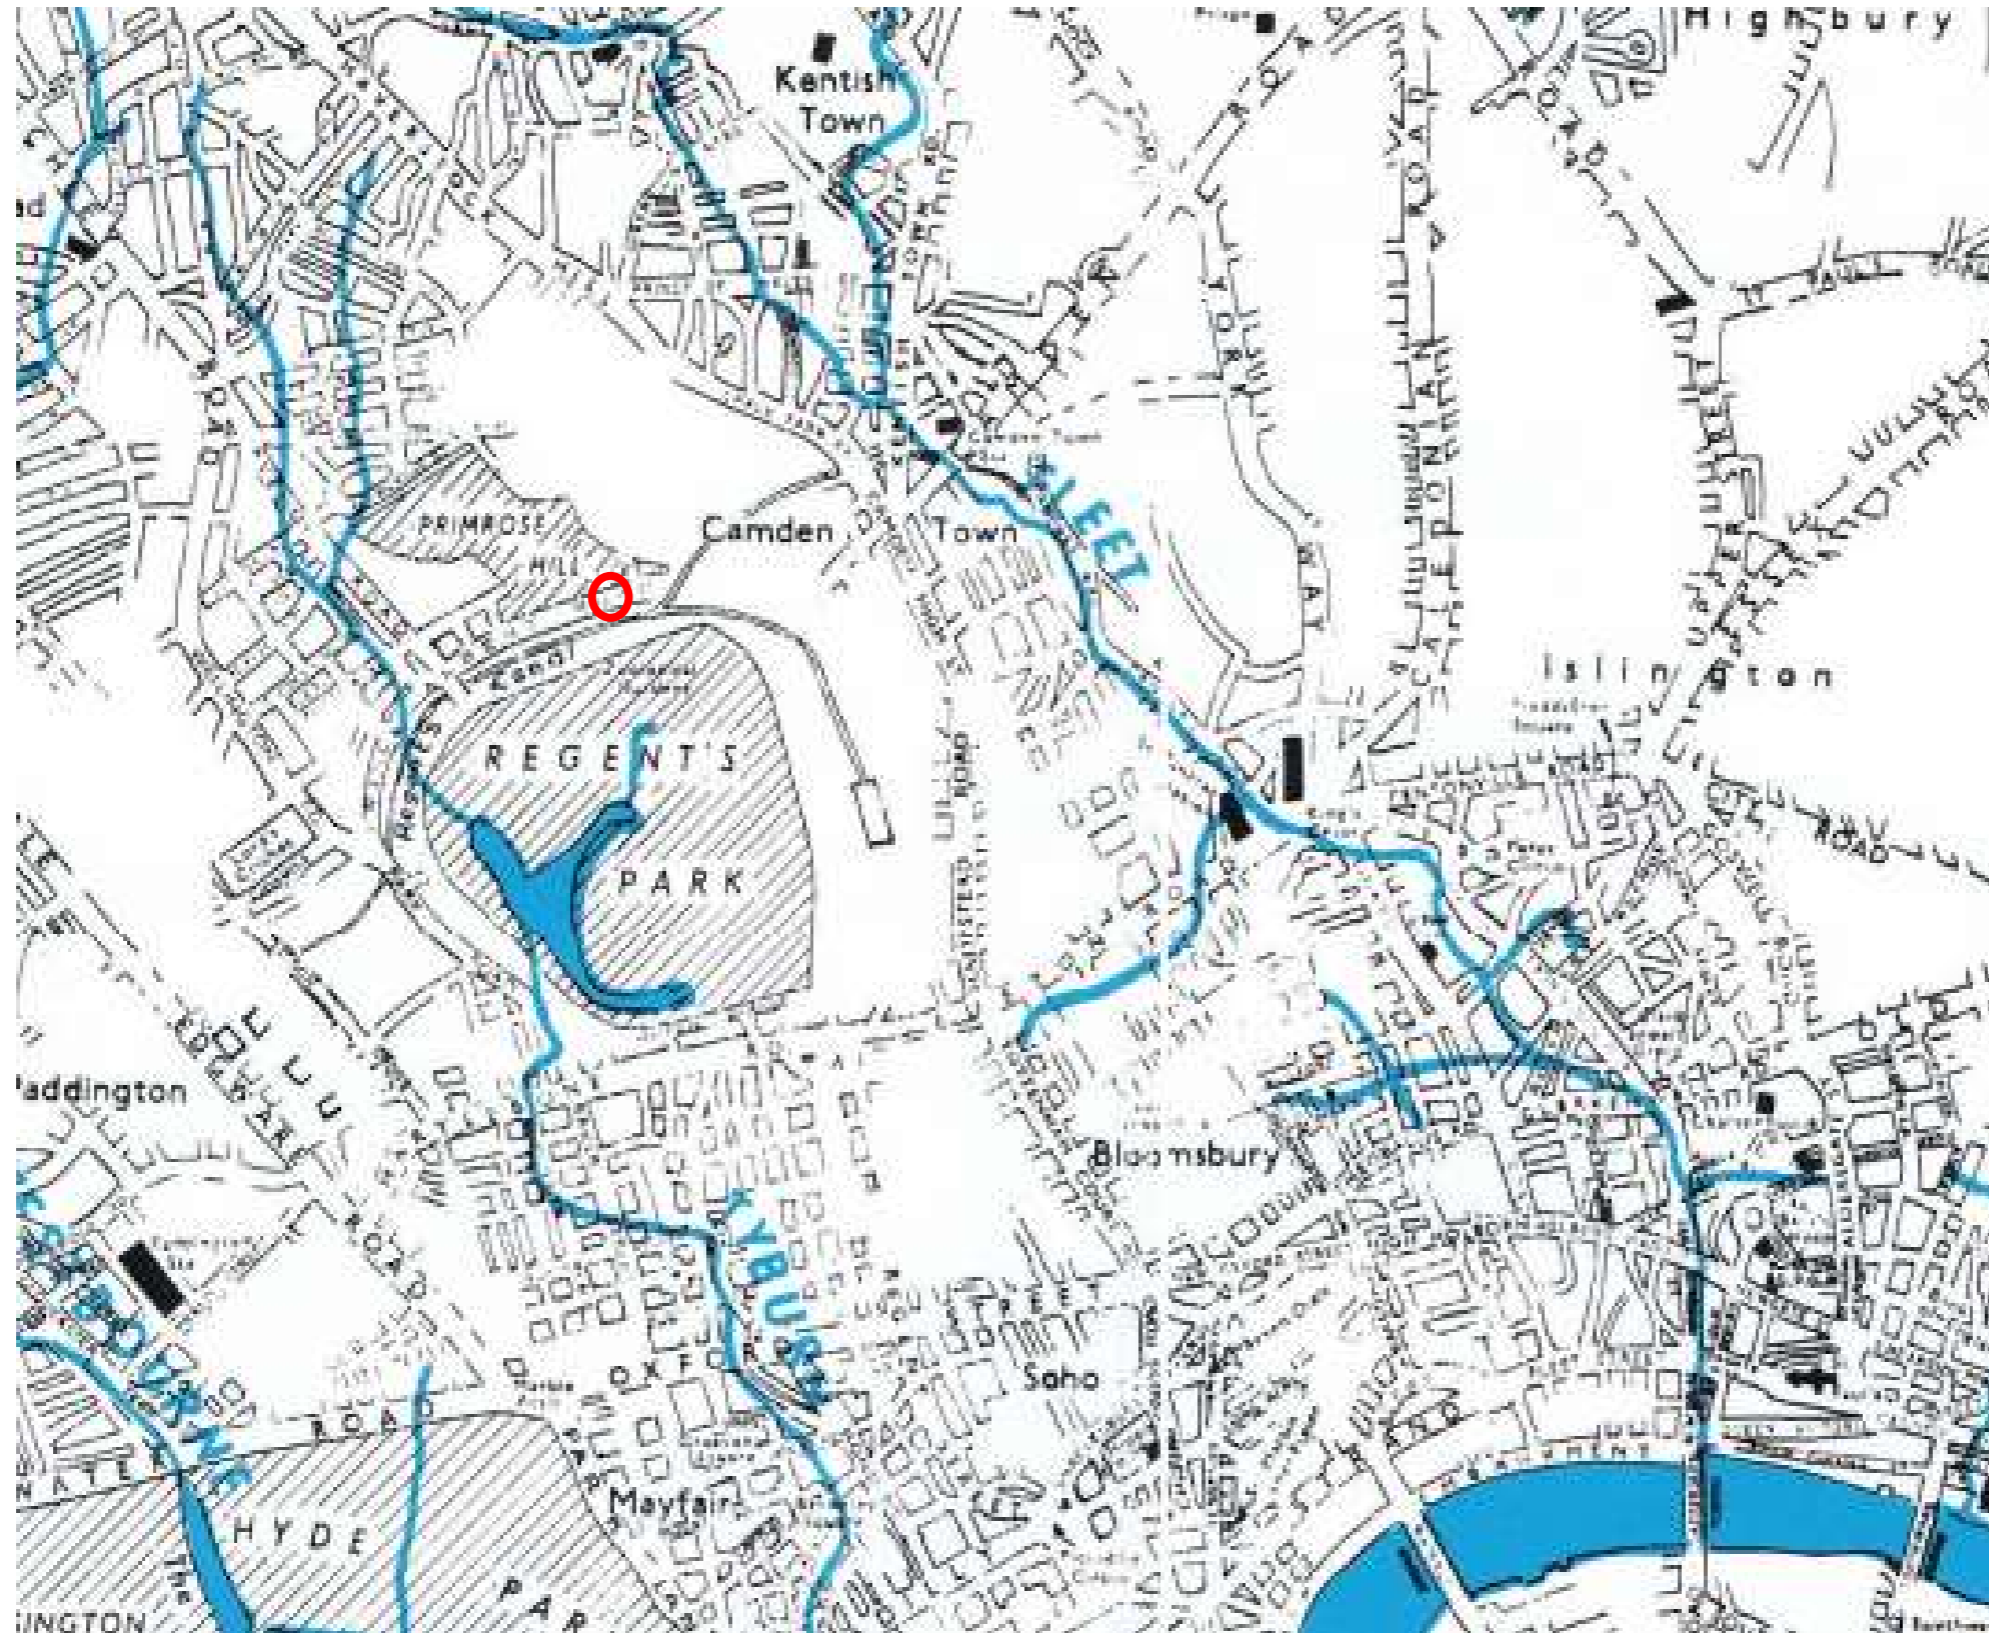
Fig 20: Hydrology -Lost Rivers

The Lost Rivers of London, Nicholas Barton

River Fleet approx. 365m to east, River Tyburn 2.25km to west.

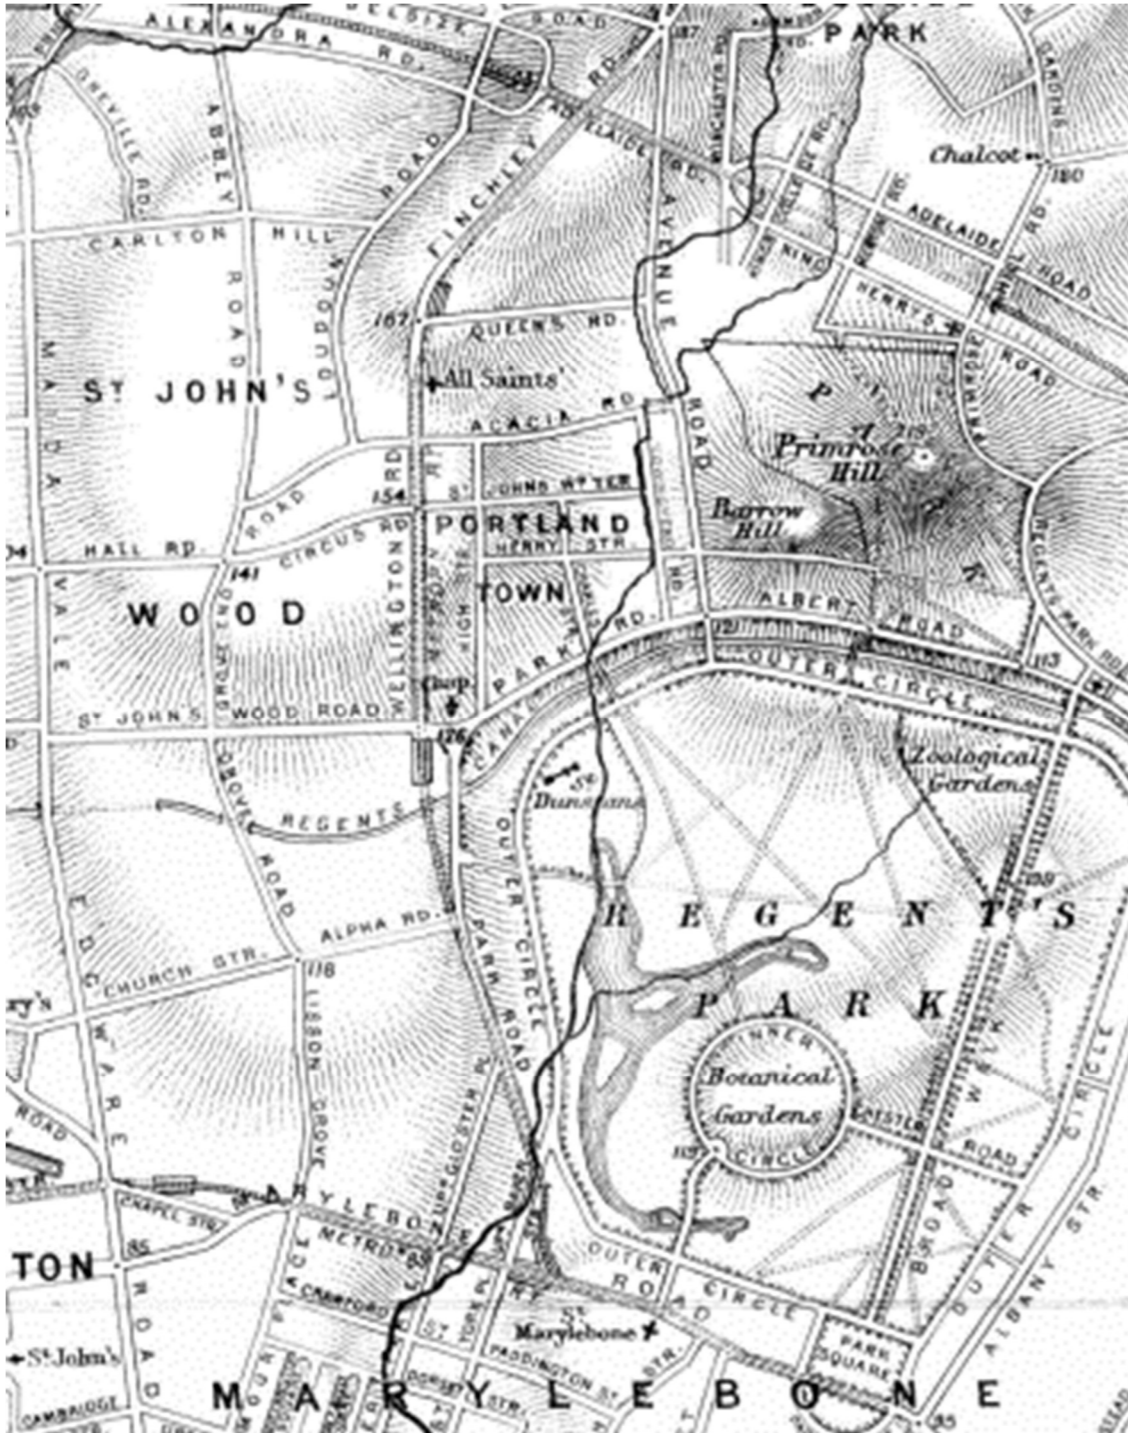
Figure 6a: LAMAS. 1890. Map of The Tybourne

Routes of the River Fleet and River Tyburn based on London and Middlesex Archaeological Society maps c 1890 and 1897

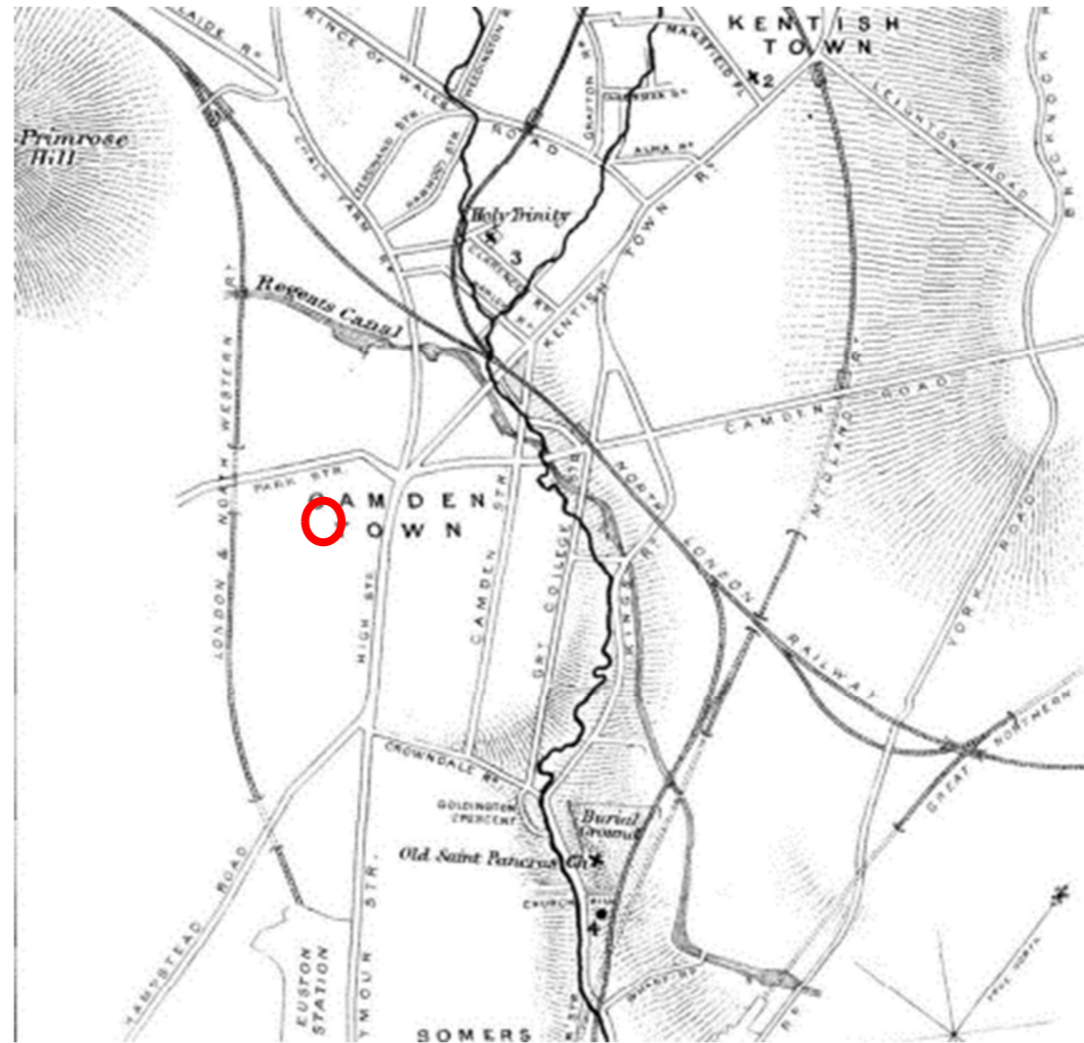
Figure 6b: LAMAS. 1897. Map of The Fleet or Hole-Bourne

River Fleet approx. 365m to east, River Tyburn 2.25km to west.

No tributaries in area of site
